The DONA V

PREVENTION BULLETIN 95-01

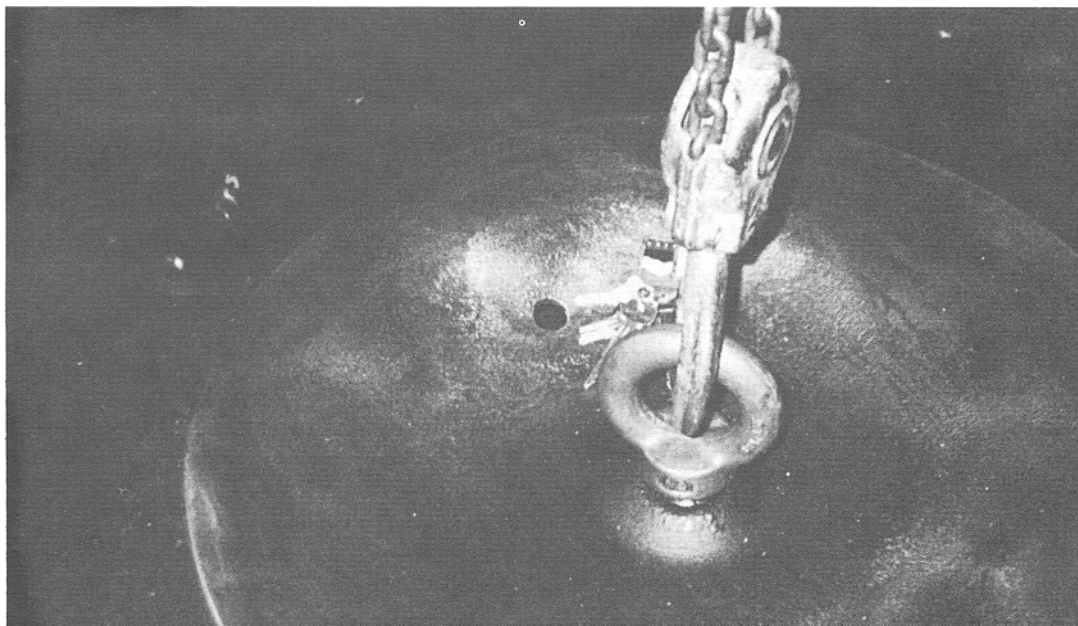
-- Probable cause shown above, a hole in the number two piston crown. --

The Office of Marine Safety determines that the probable cause of the main engine casualty on the DONA V was a hole in the piston crown of number two piston. The oil-cooled piston crown probably failed because of improper maintenance. It is likely that the number two piston crown had not been removed or cleaned for many years, allowing the accumulation of oil sludge on the crown's cooling surfaces. The loss of lube oil pressure caused the main engine to be shut down to avoid further damage to the engine.

The alarms sounded when the number two piston crown failed. The piston crown failure allowed the lube oil that was being used to cool the piston crown to enter the combustion chamber above the piston. The lube oil readily burned causing a high exhaust gas temperature. The engineer on watch had to shut down the main engine to prevent further damage from the loss of lube oil pressure.

From the information collected during the investigation, it is probable that the piston crown had not been removed from the piston body for many years, allowing carbon to accumulate and adhere to the cooling surface of the piston crown. It is presumed that the collected carbon considerably reduced the effects of the cooling oil, causing the piston crown to crack.

- Develop and adopt an engine maintenance program that includes the regular inspection of the oil side of piston crowns.
- Disseminate to vessel engineering personnel the engine manufacturers' preventative maintenance measures.
- Implement an accelerated schedule on the DONA V to inspect the oil side of all piston crowns to obtain baseline data on carbon accumulation.
- Provide sufficient time in port to enable the scheduling of main engine and other vessel maintenance.
