The VERBIER

OVERVIEW

Prevention Bulletin

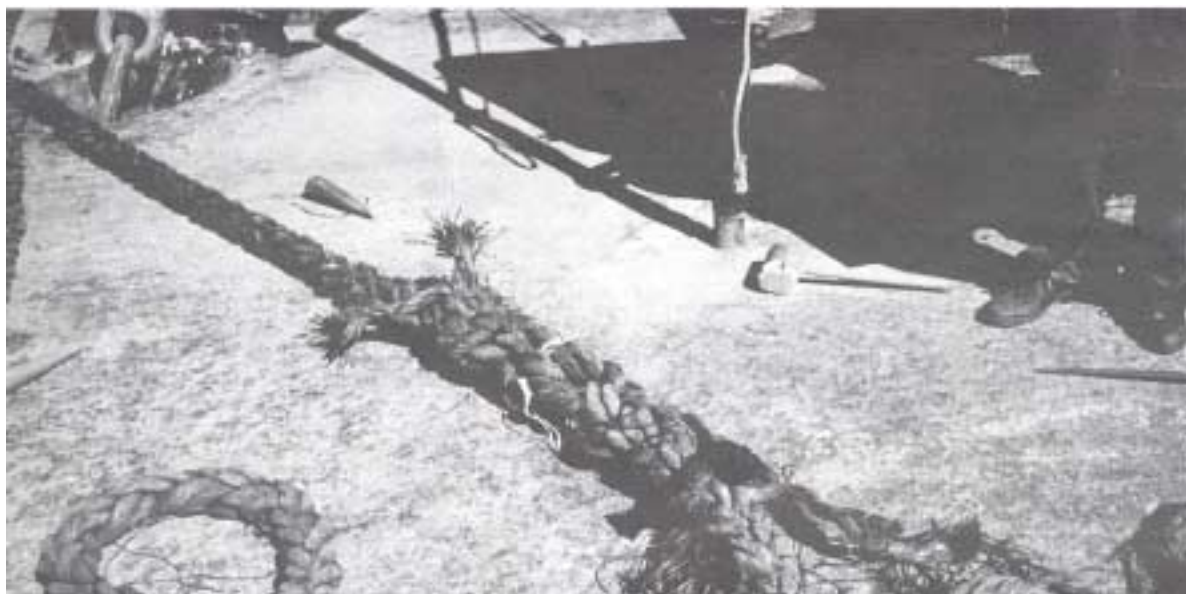
-- Parted mooring line used as tow line. Note the new splice. --

The JOSEPH T experienced similar problems in towing the VERBIER because of sheering, and, in the course of the tow, the nylon mooring line parted. This was likely caused by the sheering of the vessel and the VERBIER crew's failure to use chafing gear to protect the line from wear.

In the course of the emergency towing operation, the mooring line used by the VERBIER's crew, as an attachment point for the tugs' tow lines, parted at the vessel. This likely resulted from the VERBIER's sheering action under tow and the crew's failure to use chafing gear. In addition, the operator on the JOSEPH T indicated there was a delay in passing a new tow line from the tug to the VERBIER due to the inability of two of VERBIER's crew to handle the heavier towing line.

All vessels should have equipment suitable for emergency towing operations aboard. A mooring line will often prove unsuitable for use as a towing pendant. The difficulty of the crew in getting the tow line aboard shows the importance of an adequate towing rig deployable from the vessel in an emergency.
