The Importance of Identifying and Addressing Root Causes of Equipment Malfunction

Lessons Learned

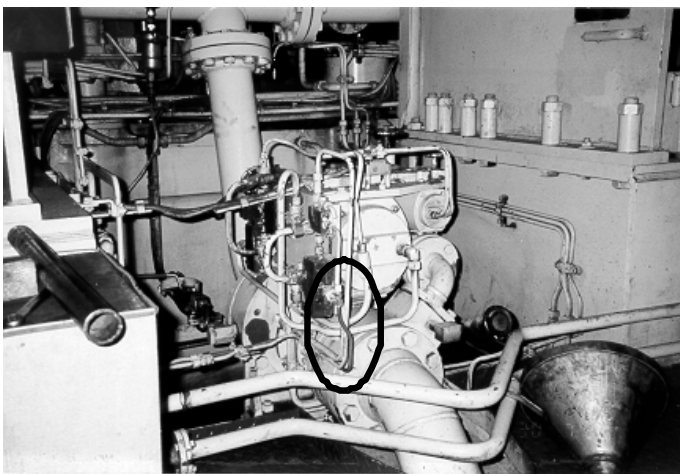
- A container ship drifted to within about 400 yards of shore when it was unable to restart its main engine after stopping to pick up a pilot. The problem was with the ship's start air system. Moisture in the system caused slide valves in the starting air distributor to stick. Although the company had taken some precautions to deal with the ongoing problem, the efforts were not effective in this case. Several months later an inspection found the

system had been modified to include manual drains for the high-pressure air receivers. It was also reported that some of the pilot air tubing on the main starting air valve had been renewed due to blocking problems on other vessels in the same class.

Main engine starting air valve that malfunctioned. Modification indicated by the unpainted copper tubing (circled).
