# The SUPER RUBIN

## OVERVIEW

On June 30, 1999, at about 0110, the cargo ship SUPER RUBIN overflowed a diesel tank while receiving bunkers (fuel) from the barge MEGHAN 102 in the Upper Vancouver Anchorage on the Columbia River. The oil overflowed containment onto the deck of the ship, pooled at the front of the house, spilled over the side of the ship onto the deck of the barge, and into the Columbia River.

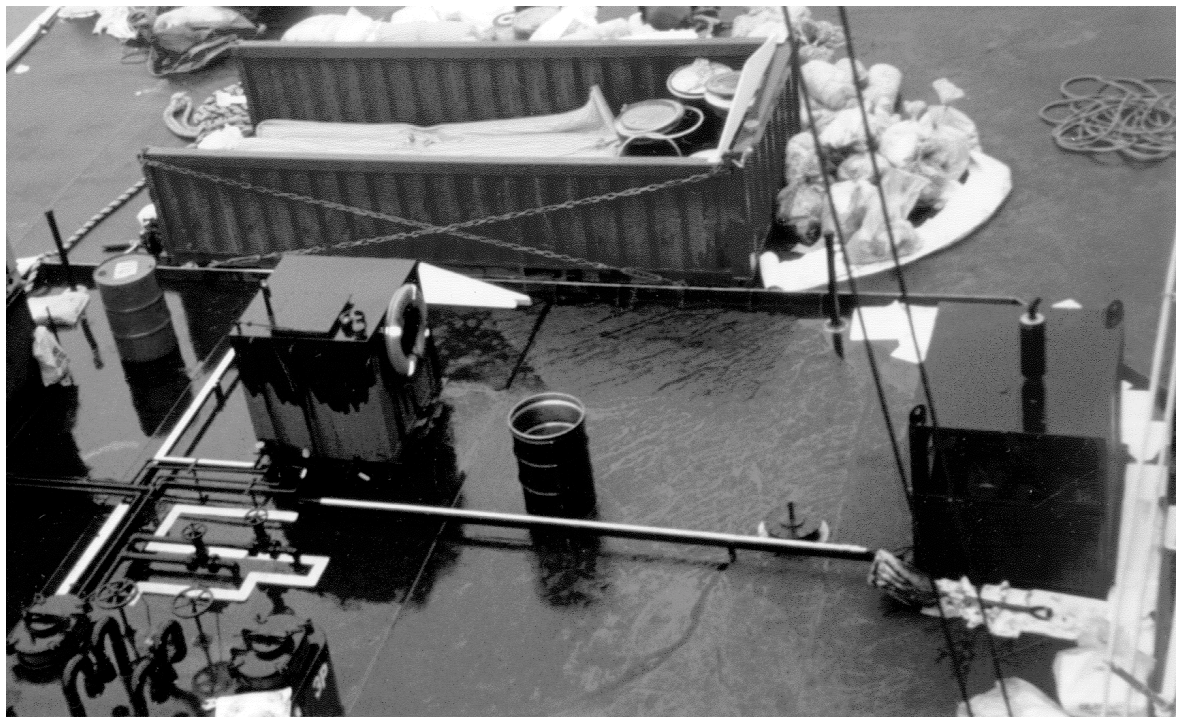
*Deck of barge MEGHAN 102. Note oil sheen and oiled absorbent pads*

At 0110 the C/E went on deck and noted the starboard DO tank overflowing through its tank vent. The Tankerman was alerted by air horn to stop the transfer. He stopped the pumps and noted that oil spilled heavily off the deck of the ship and on to the deck of the barge for about five minutes. The C/E also estimated that the tank overflowed for about five minutes. The total amount of FO transferred at the time of the shutdown was 292 barrels.

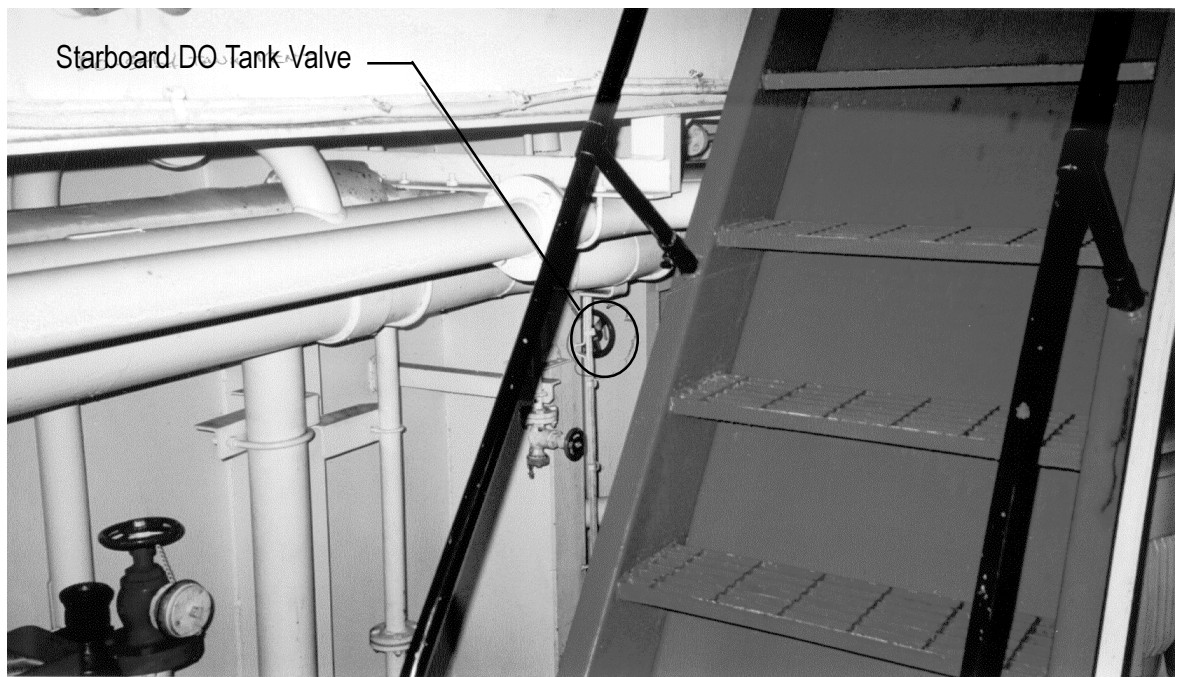
Vessels of this type typically have FO and DO transfer tank valves clustered against the forward bulkhead of the Engine Room. These centralized manifolds allow for easier transfer alignments. The SUPER RUBIN's starboard DO tank valve was located remotely, out-of-sight of the FO manifold. In addition, the valve could only be accessed by crouching beneath overhead piping. These factors likely contributed to the spill.

*Location of the starboard DO tank valve handle.*

- Ensure that work hour limitations are complied with, and that sufficient personnel are available to allow for compliance.
- Avoid scheduling bunkering operations immediately upon arrival in port, especially following difficult sea passages and prolonged passages in pilotage waters, in order to allow the crew sufficient rest to comply with work hour restrictions.
- Ensure that bunkering personnel understand the importance of following procedures, and do not become complacent about using standard checklists.
- When switching bunker tanks, ensure that tanks are sounded after being filled to confirm that oil is no longer flowing to them.
- Incorporate good ergonomic principles, to the maximum extent possible, in ship system design decisions, and carefully consider the influence of design decisions on operations safety.

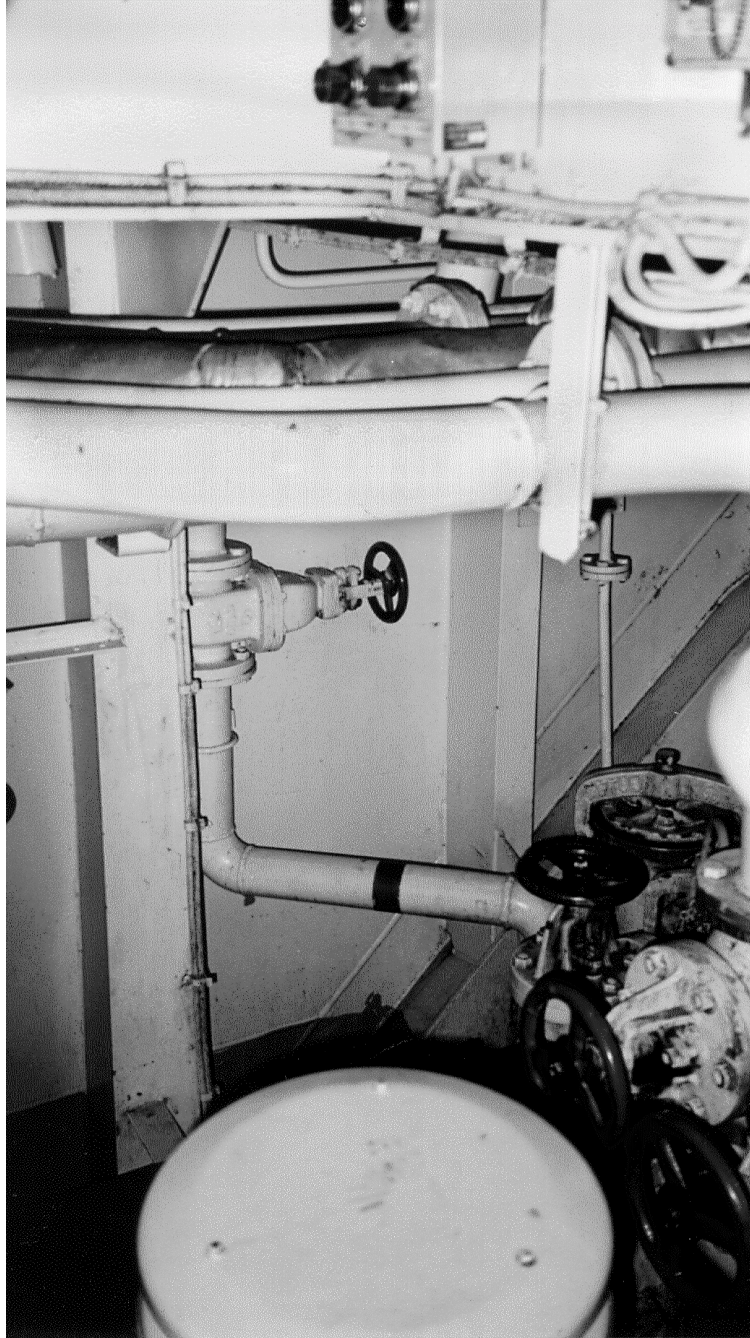
The 2/E changed the valve alignment in the engine room in preparation to load FO into the No. 1 port and starboard FO tanks. The 2/E failed to close the starboard DO tank valve.

*Starboard DO tank valve, located against forward bulkhead in engine room, behind stairwell and frame and away from fuel oil manifold. Note low overhang/ceiling of pipe rack. This valve was not secured prior to loading fuel oil.*
