The ARCO TEXAS

PREVENTION BULLETIN 01-02

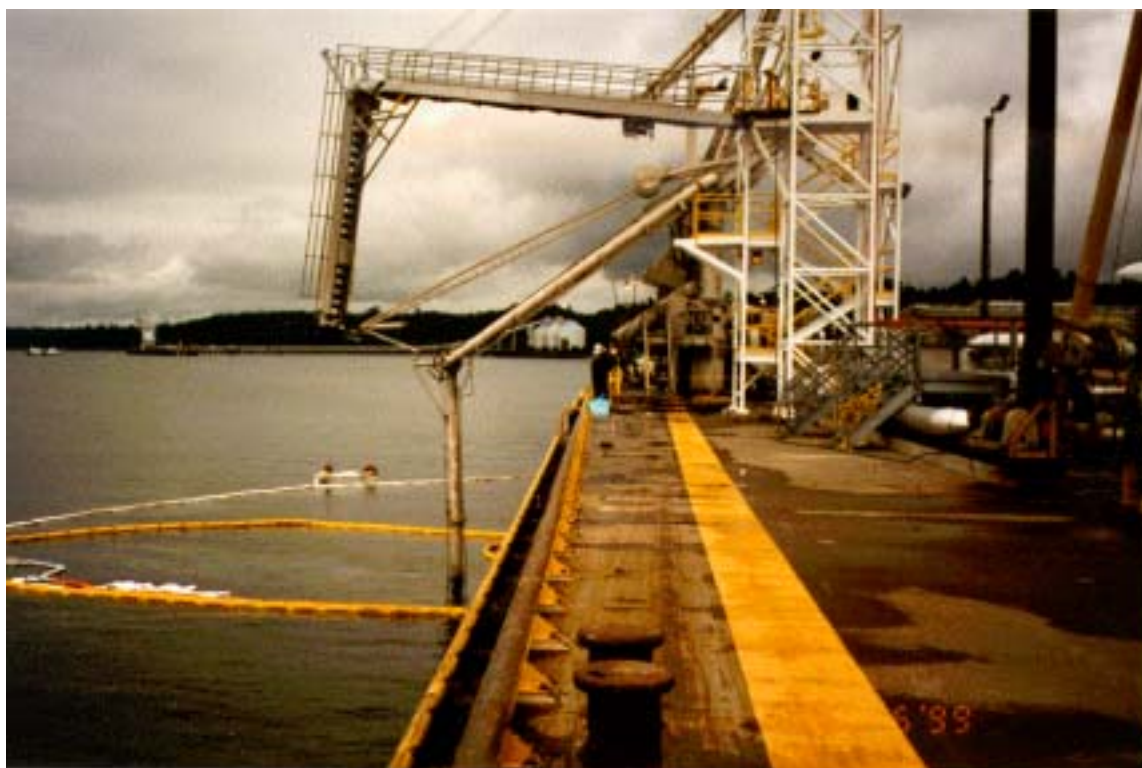
Figure 1. Picture shows damaged Mechanical Loading Arms and gangway at the Ferndale dock. View is to the north, showing dry-bulk dock in background. Note tugs moored off end of dry-bulk dock.

As a result of the breakaway incident the Nos. 3 and 4 MLAs at the facility dock were damaged. The No. 3 MLA was torn off the dock at its base (pedestal) and fell into the water. The No. 4 MLA was damaged and left hanging to the water. In addition, the dock's gangway and a fairlead on one of the mooring dolphins were damaged.

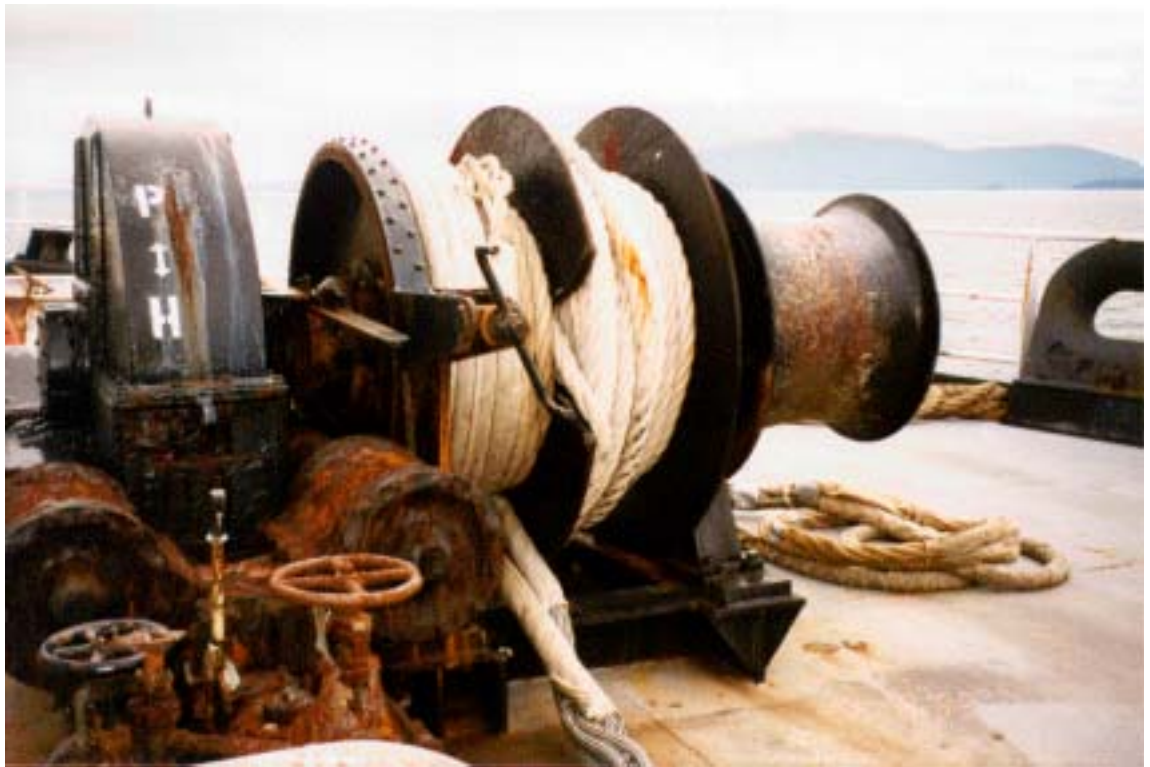
The probable cause of the breakaway and subsequent spill was the inadequate holding capacity of the ARCO TEXAS' aft mooring winches under the environmental load experienced. Factors that likely contributed to the breakaway include:

Figure 2. No. 1 mooring winch on bow of ARCO TEXAS. Note the dual (storage and working) drum design and the 2-inch Spectra® line. Two-prong handle at center is winch brake tightening mechanism.

- There were established maintenance procedures for the mooring winches, but not the winch brake bands, which were carrying the environmental load at the time of the breakaway.
- There was an existing problem prior to the breakaway incident with maintaining the winch brake bands squarely on the brake drums. This resulted in winch brake modifications implemented by the ship, without review by the company under their Safety Management System (SMS).
- Winch brake testing was not accomplished following the modification to the winch brakes implemented by the ship, contrary to OCIMF guidelines.
- Annual winch brake holding capacity tests, recommended by the OCIMF and ISGOTT (International Safety Guide for Oil Tankers and Terminals), were not accomplished.
- Records for the replacement of mooring winch brake bands were not maintained.

- Ensure company maintenance procedures require inspections of the winch brakes prior to each mooring operation, and include checks derived from the winch manufacturer's manuals. Ensure that these checks are documented and that any problems noted are addressed quickly.

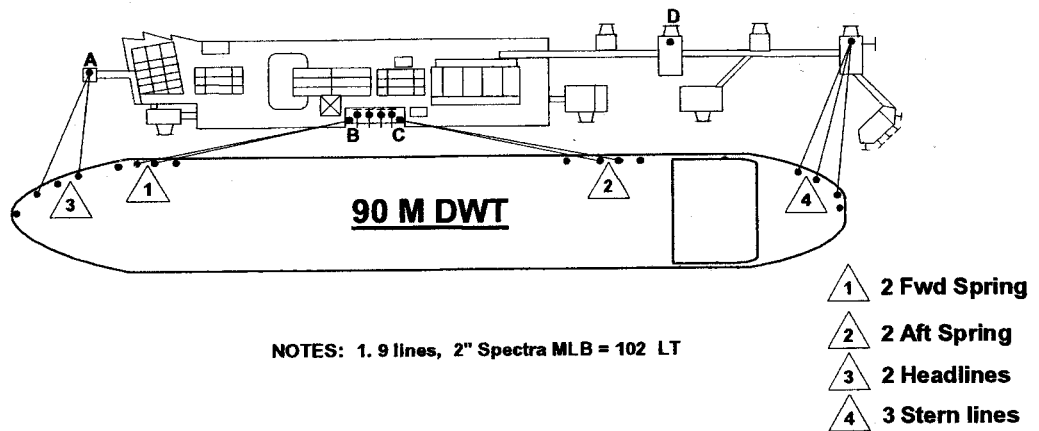
Figure 3. Mooring configuration for a tanker the size of the ARCO TEXAS. [From the facility's Marine Terminal Safety & Operations Manual.]

The mooring criteria for vessels the size of the ARCO TEXAS (90,000 d.w.t.) at the facility dock was based upon a mooring study that assumed a maximum current speed of one knot. That assumption was incorrect, as shown by historical data and post-incident measurement of tidal currents that indicate currents exceeding one knot.
