# The OVERSEAS WASHINGTON

## PREVENTION BULLETIN 03-01

### OVERVIEW

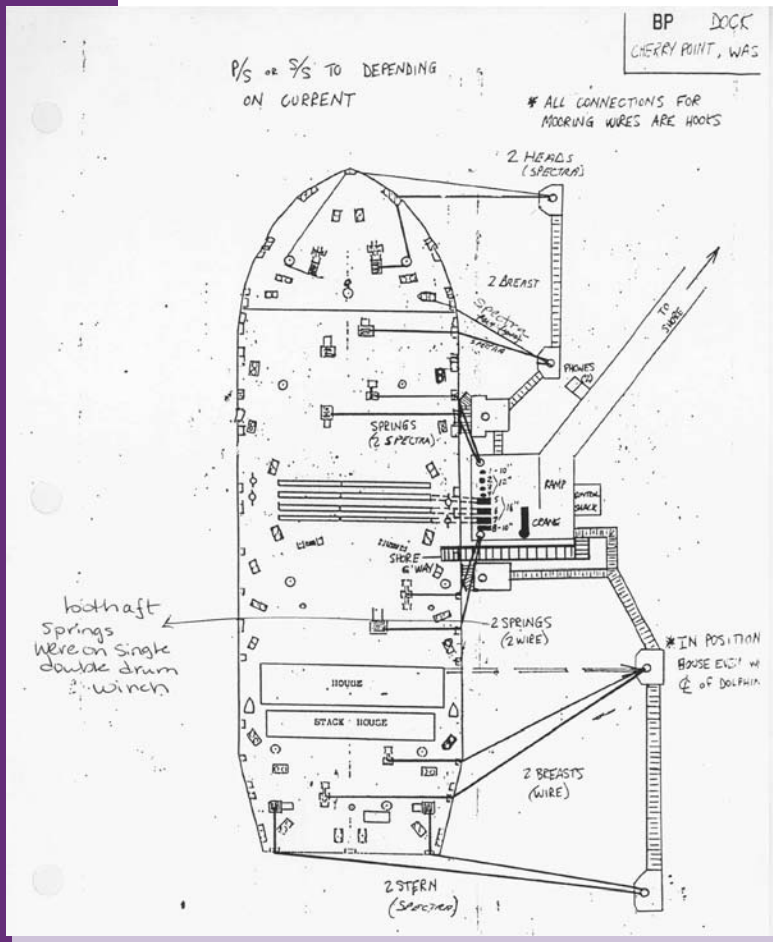
Vessel's mooring configuration.

The OVERSEAS WASHINGTON had a mixture of synthetic fiber and wire rope mooring lines. The mooring configuration on December 14<sup>th</sup> was two Spectra (synthetic fiber) head lines, one polypropylene foreword breast line (up on the forecastle made up to bits because the port side winch used for the breast line just aft of the forecastle was out of service), two Spectra headsprings, two wire rope after-springs, two wire rope after breast lines, and two Spectra stern lines. The vessel was using a combination of synthetic lines and wire rope as an interim arrangement while the old wire rope lines were in the process of being changed out to Spectra lines.

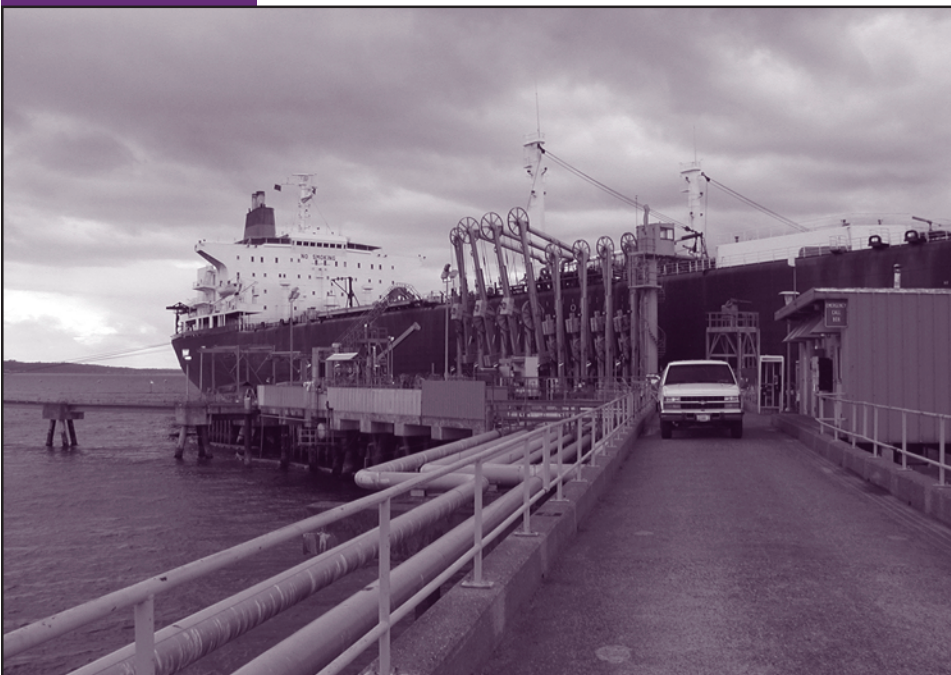
View of south dock loading platform.

As a result of the incident, MLAs and couplers Nos. 5, 6 and 7 were damaged. The facility’s gangway was also damaged. In addition, damage was sustained to the ship’s headers, the portion of the vessel’s piping which connects to the facility piping.
