A Survey of Zinc Concentrations in Industrial Stormwater Runoff

January 2006

Publication No. 06-03-009

By Steven Golding

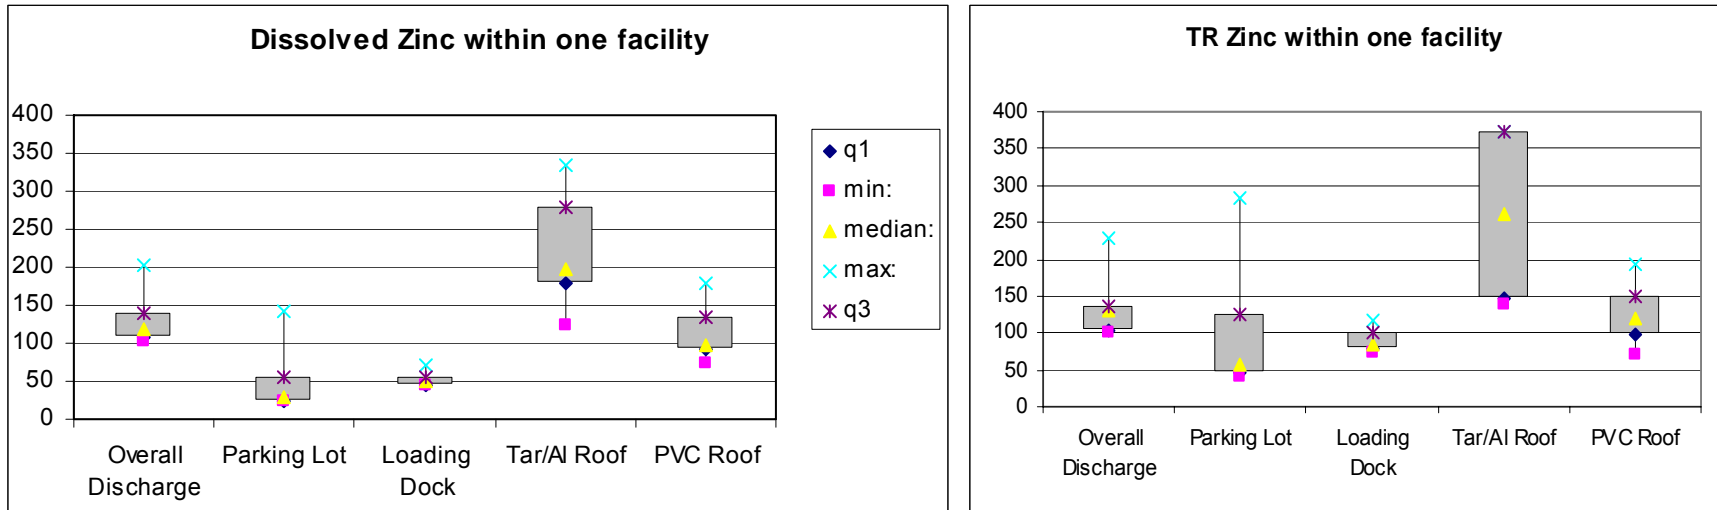
Samples of final stormwater discharge were drawn from the pooled water in the final catch basin at the edge of facility property, both by the facility for self-monitoring and in this monitoring study. The pooled water provided conditions for solid particles to settle out, as it did not appear to be flowing. This is consistent with the finding that the dissolved zinc fraction comprised most of the total zinc in the discharge sample (Table 5, Figure 1).

As Table 5 and Figure 1 show, zinc in roof runoff is mostly or all in the dissolved fraction. This is as expected, assuming zinc released from galvanized surfaces is in dissolved form. Parking areas and loading docks showed dissolved zinc being a portion of total recoverable (total) zinc. For the three days of loading dock sampling, 47%, 40%, and 34% of zinc were found in other than dissolved form (53%, 60%, and 66%, respectively, in dissolved form). The non-dissolved fractions at two Tree Top facility loading areas with tire dust evident were somewhat higher: 53% and 51% (Davis, 2005b). It may be that tire particles can be the major source of zinc particles (the portion of zinc not dissolved) in loading dock runoff samples. Further investigation would be needed to determine this.

Figure 1. Total and Dissolved Zinc Concentrations – Overall Facility Monitoring.
