# **Dam Safety Incident Report**

## **Benson Creek Flood, August 2014**

### **Okanogan County near Twisp, WA**

Issued: September 2014  
Publication Number: 14-11-011

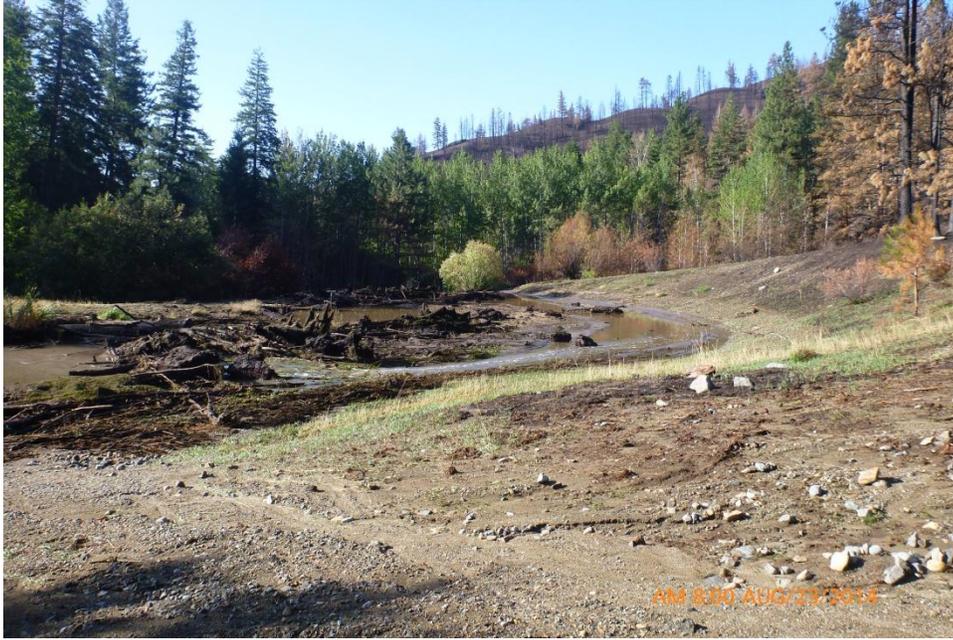
As noted previously, high runoff flows in conjunction with spillway blockages overtopped (flooded over) the embankments at Wenner Lakes No. 1, 2, 3 and 4. At Chalfa Dam (Wenner Lake No.1), floating debris partially obstructed the spillway. Some small erosion channels had started to form on the downstream face of the embankment from the overtopping flows, but did not cut into the dam crest by the time the overtopping flows receded.

1. Chalfa Dam (Wenner Lake No.1) spillway on Aug 23rd, looking downstream (south).

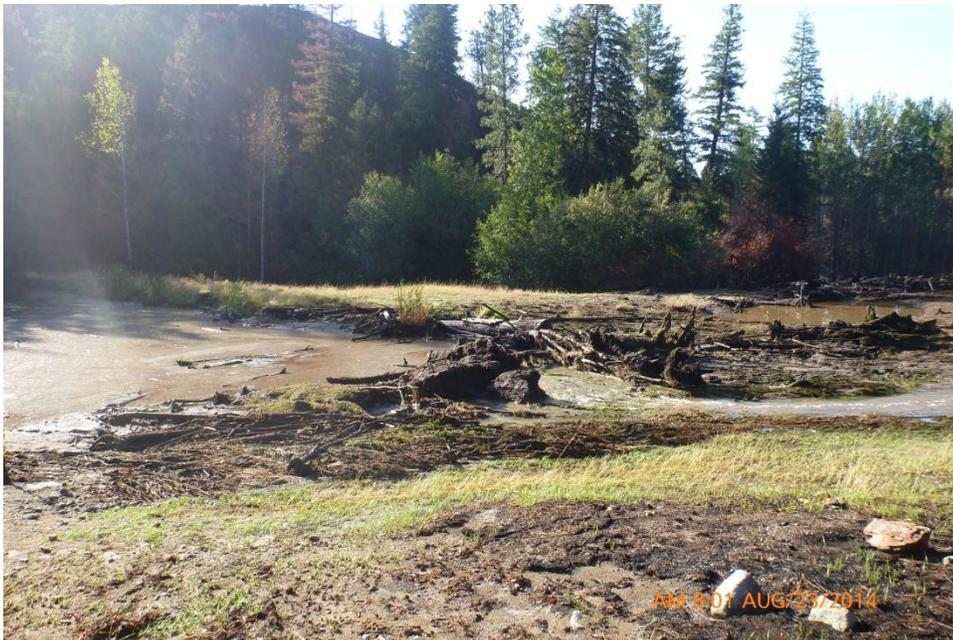
2. Chalfa Dam (Wenner Lake No.1) spillway entrance on Aug 23<sup>rd</sup>, looking left (east).

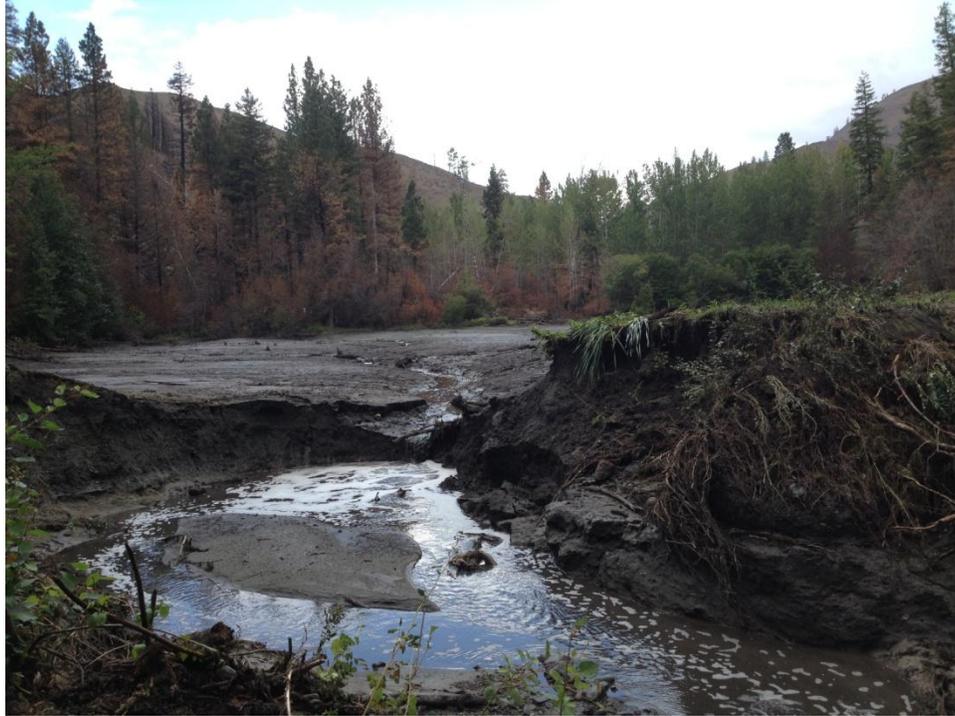
At Wenner Lake No.2, erosion in the spillway channel down-cut upstream into the lake, draining the 10 ac-ft. volume of the lake. At Wenner Lake No.3, erosion of the embankment in the vicinity of the culvert down-cut upstream into the lake, draining the 4 ac-ft. volume of the lake.

3. Wenner Lake No.2 eroded spillway on Aug 24<sup>th</sup>, looking upstream (north).

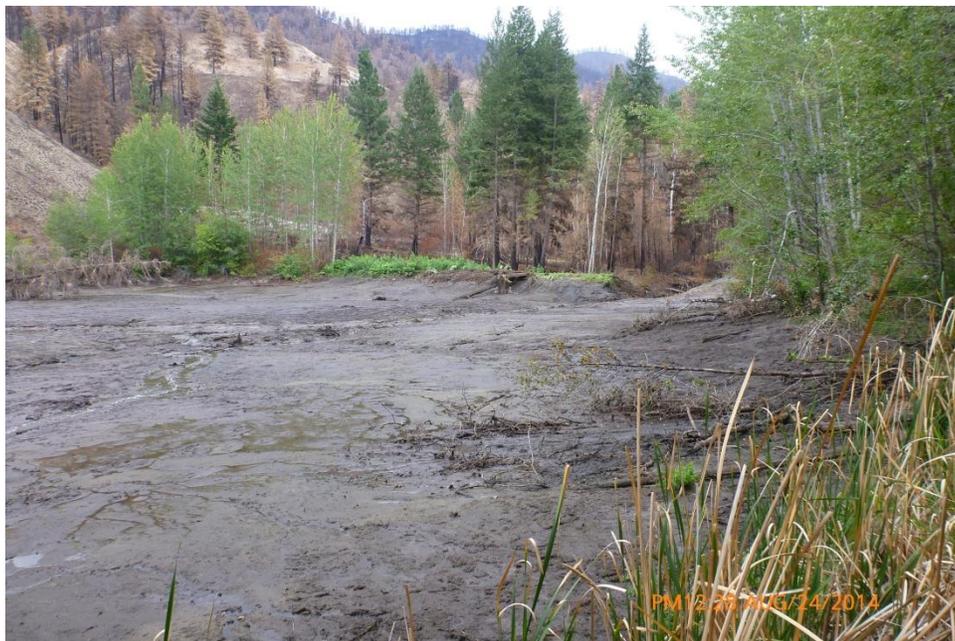
4. Wenner Lake No.2 dam and eroded spillway on Aug 24<sup>th</sup>, looking downstream (south).

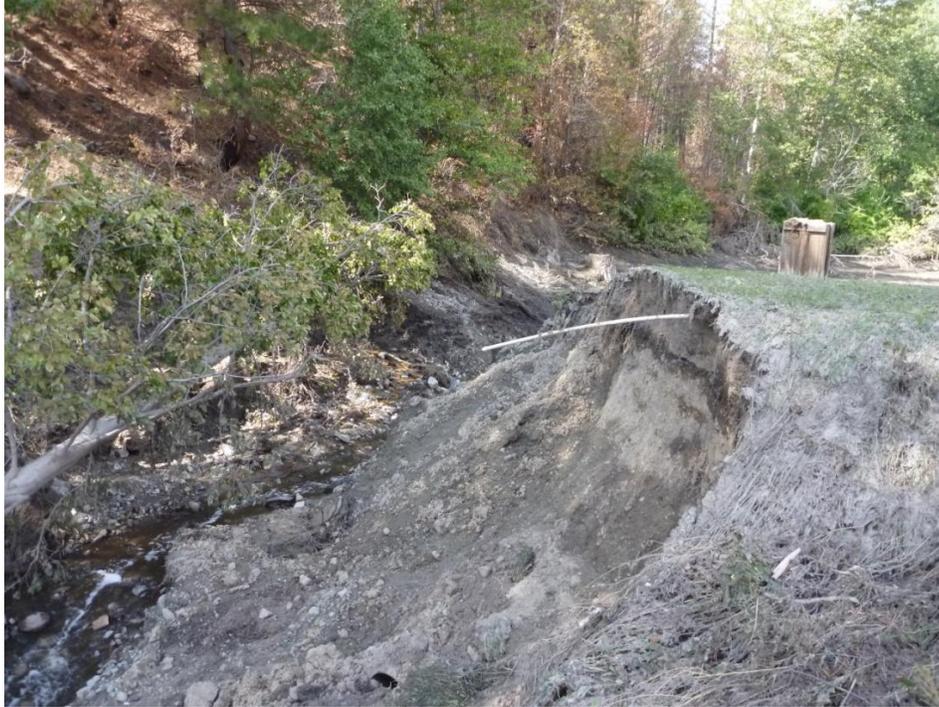
5. Wenner Lake No.3 eroded spillway on Aug 27<sup>th</sup>, looking upstream (north).

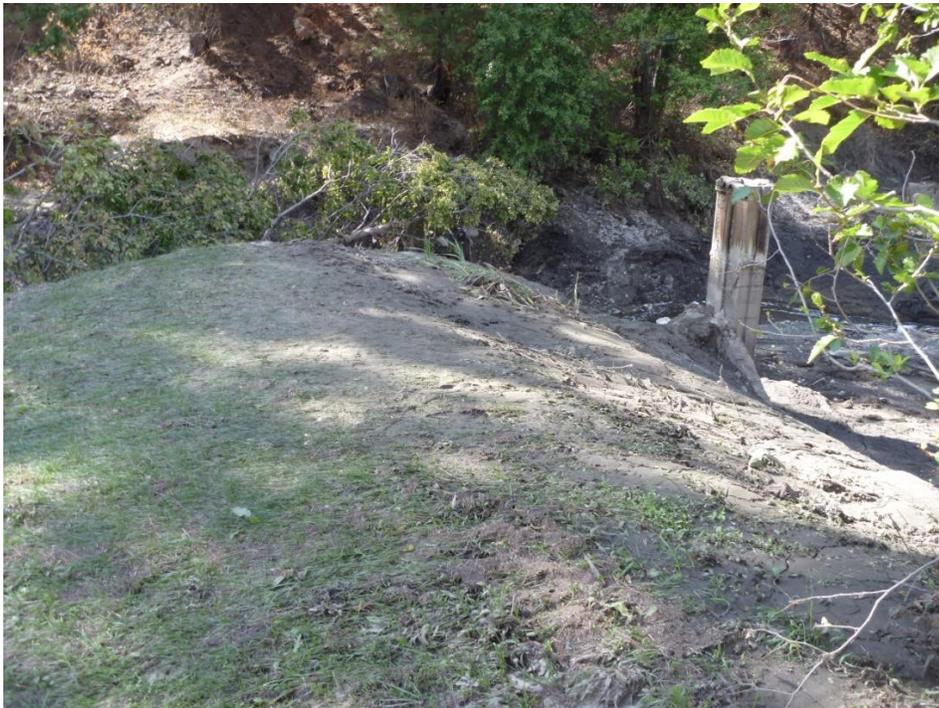
6. Wenner Lake No.3 dam and eroded spillway on Aug 27<sup>th</sup>, looking right (west).

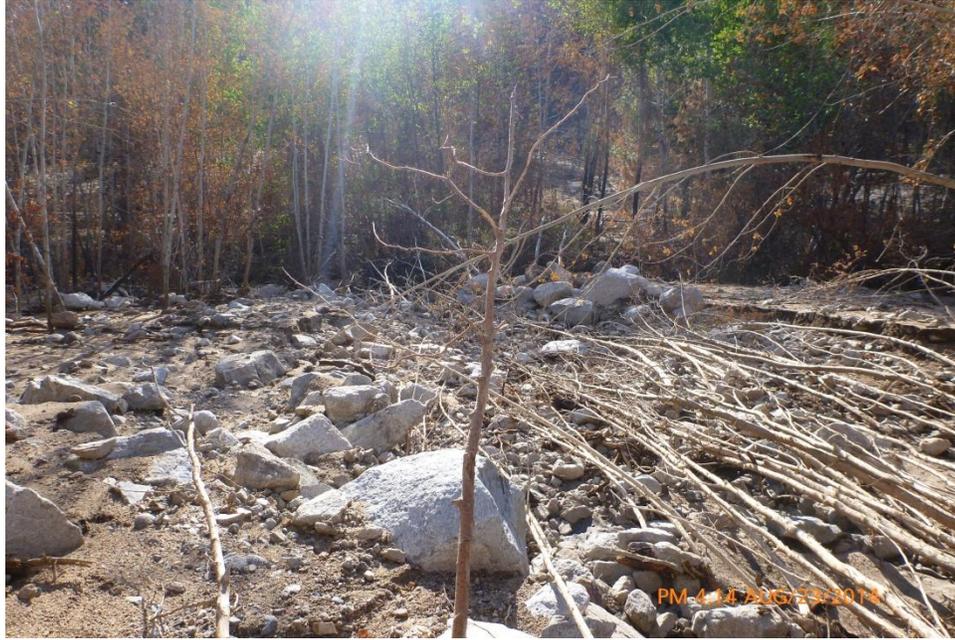
At Rabel Dam (Wenner Lake No.4), a debris flow from the hillside on the left side of the dam obstructed the spillway. Active intervention by the dam owners re-opened the spillway in time to prevent further damage to the dam and spillway. Some erosion channels had started to form on the downstream face of the embankment from the overtopping flows, but did not cut into the dam crest by the time the overtopping flows receded.

7. Rabel Dam (Wenner Lake No.4) existing spillway on Aug 23<sup>rd</sup>, blocked by debris flow, looking downstream (south).

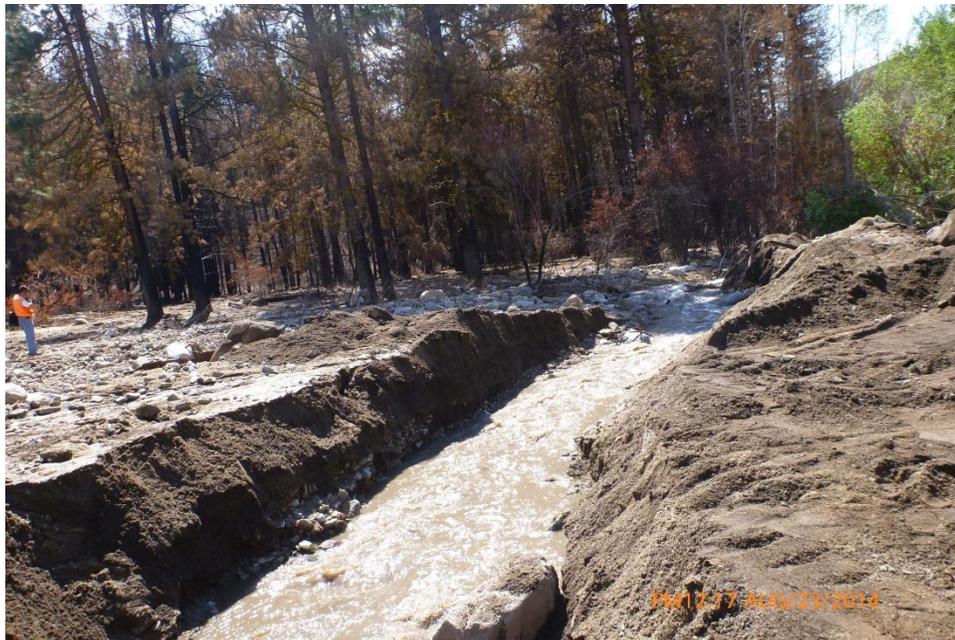
8. Rabel Dam (Wenner Lake No.4) new spillway channel on Aug 23<sup>rd</sup>, looking downstream (south).

- Rabel Dam owners and local excavation contractor, with guidance from USDA-NRCS, excavated a new spillway channel and worked to open the existing spillway channel.

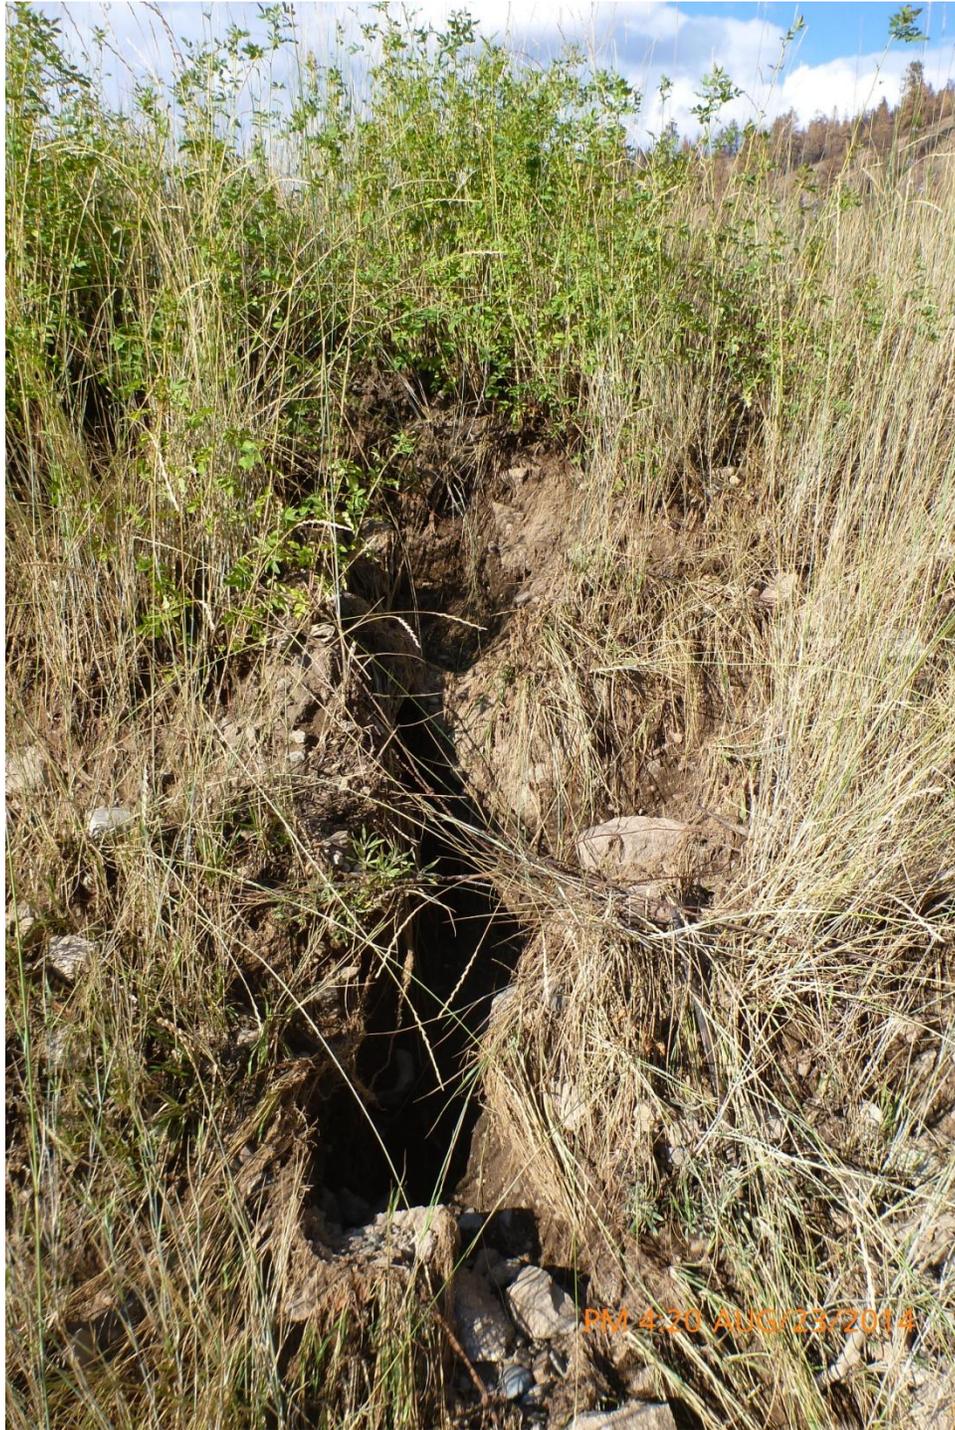
9. Rabel Dam (Wenner Lake No.4) downstream face on Aug 23<sup>rd</sup>, small erosion gully from overtopping flows; looking upstream (north).

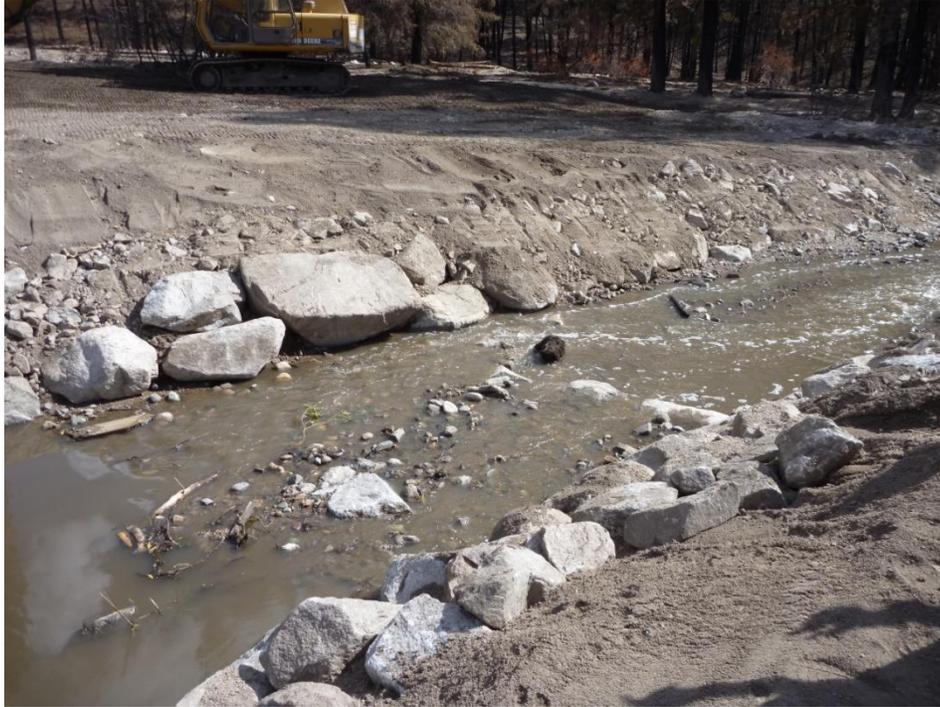
10. Rabel Dam (Wenner Lake No.4) new spillway channel on Aug 27<sup>th</sup>, pilot channel, looking downstream left (south).

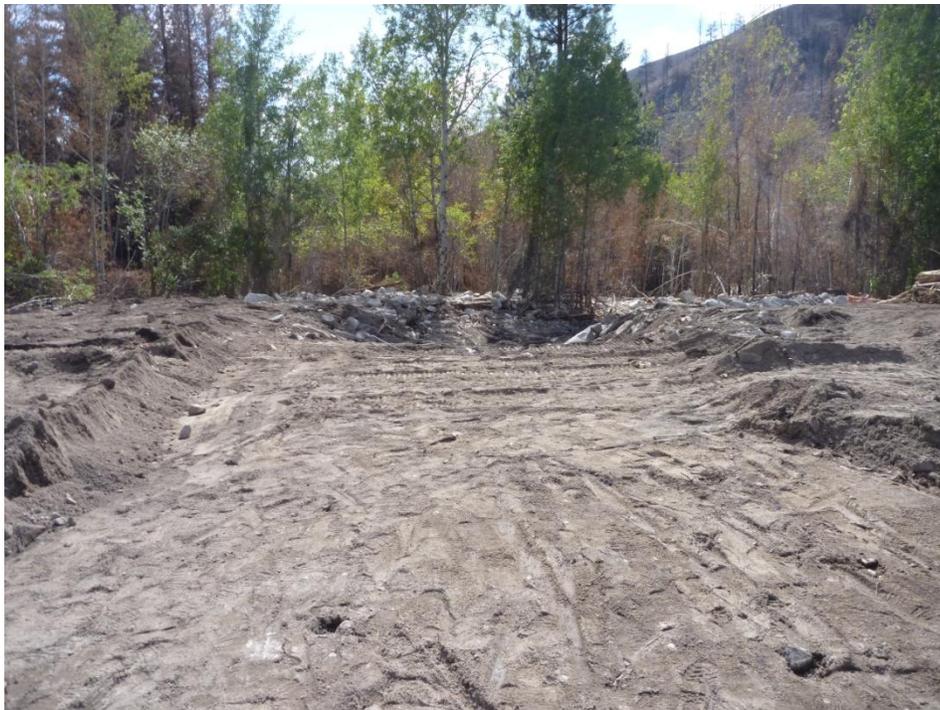
11. Rabel Dam (Wenner Lake No.4) new spillway on Aug 27<sup>th</sup>, high-flow channel to right of pilot channel; looking downstream (south).

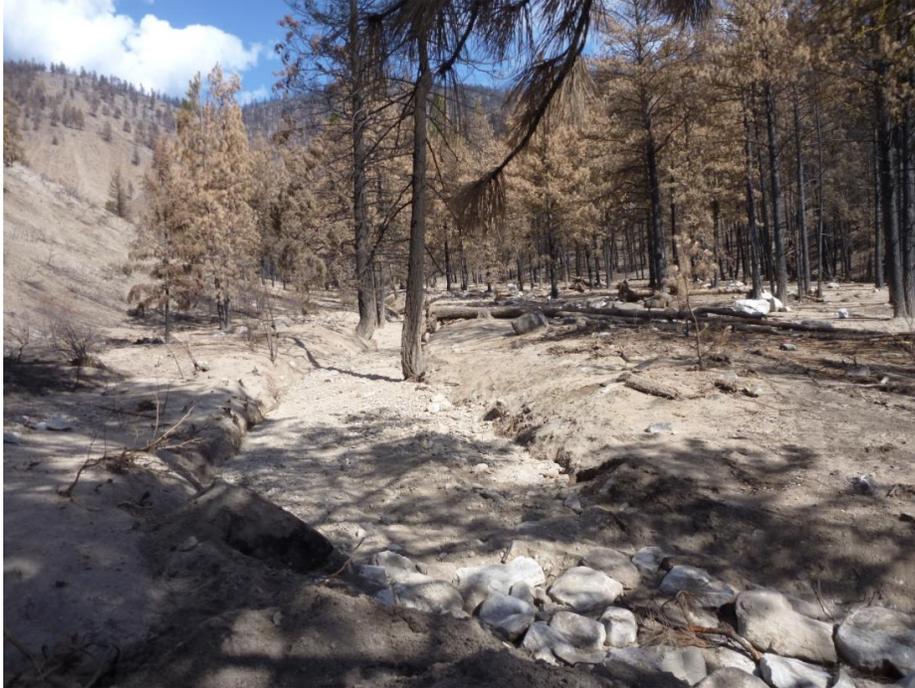
12. Rabel Dam (Wenner Lake No.4) on Aug 27<sup>th</sup>, valley at left abutment, source of debris flow that blocked the spillway; looking east. At the large trees, sediment is 5 feet thick.

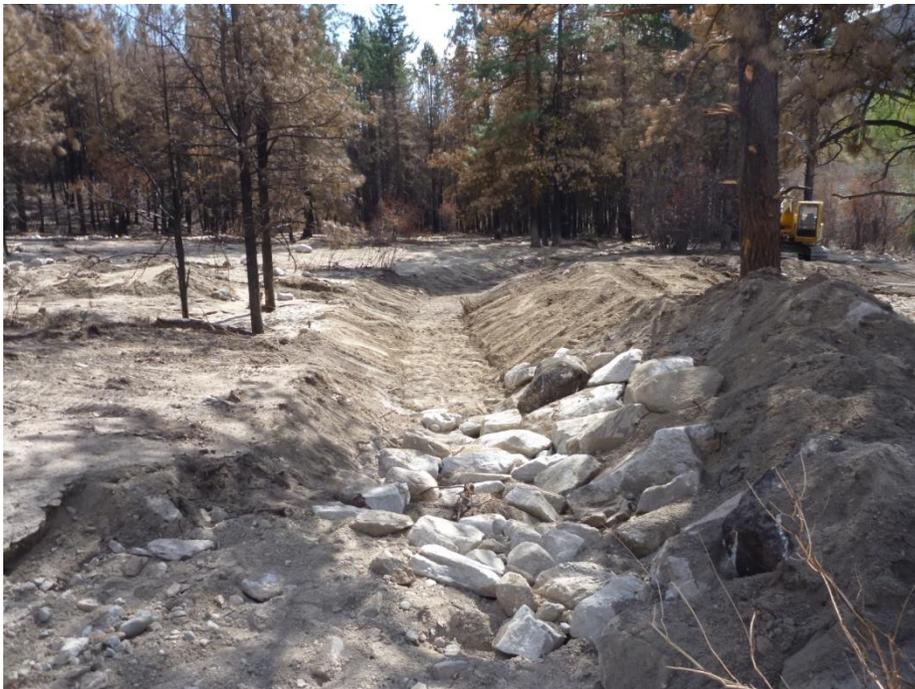
13. Rabel Dam (Wenner Lake No.4) on Aug 27<sup>th</sup>, new diversion channel at left abutment, looking downstream (south).

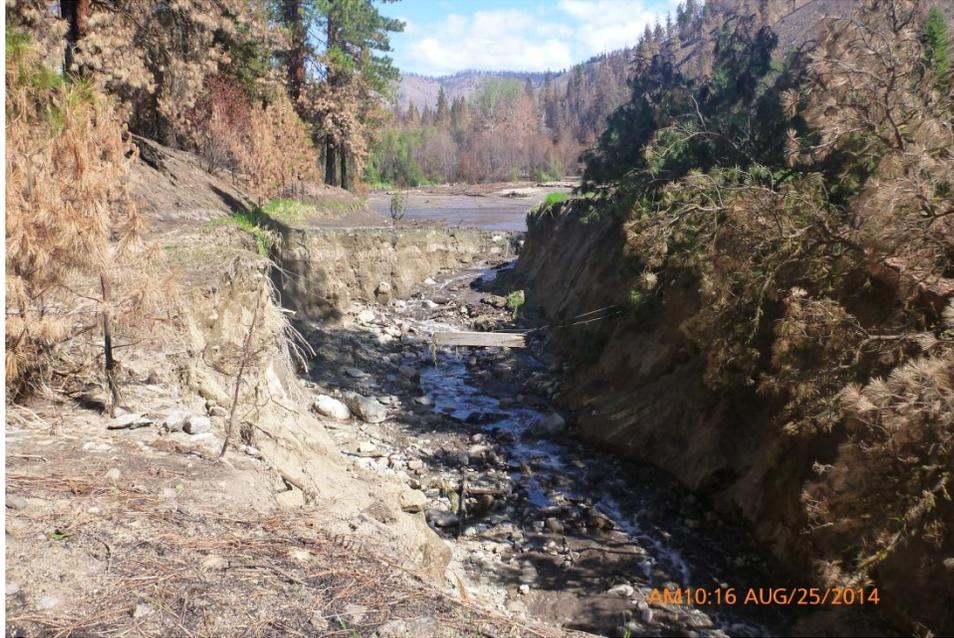
Erosion in the Hawkins Dam spillway scoured a channel 360 feet long, ranging in width from 18 to 45 feet wide and ranging in depth from 8 to 18 feet deep, with an estimated volume of about 6,600 cubic yards. The period of time that it took for this erosion to occur, and for the pond to drain, is still being analyzed and will be examined further in the hydrologic modeling of the Benson Creek watershed.

14. Hawkins Dam (Wenner Lake No.5) eroded spillway on Aug 25<sup>th</sup>, looking upstream (north).

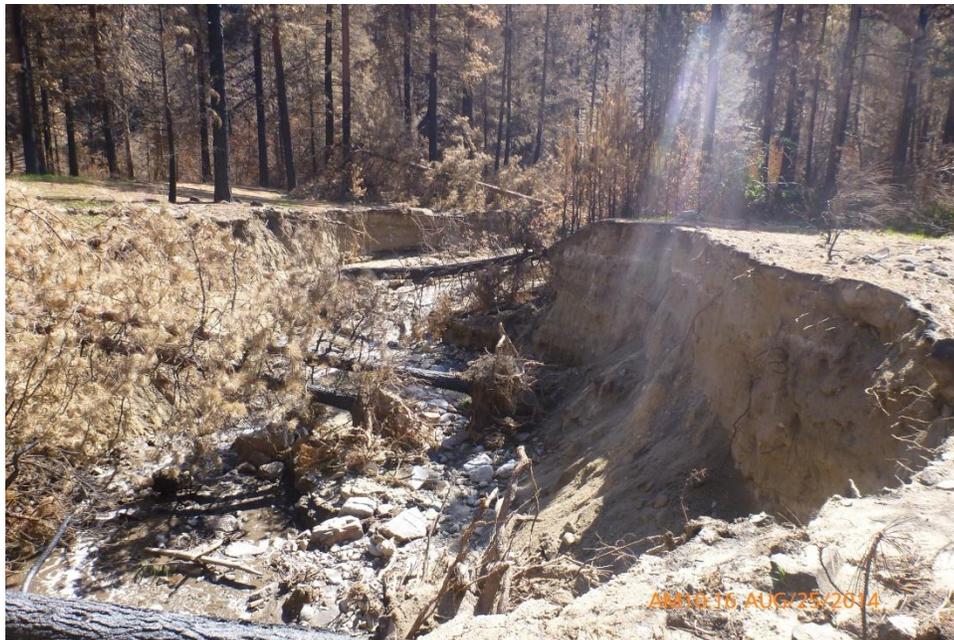
15. Hawkins Dam (Wenner Lake No.5) eroded spillway on Aug 25<sup>th</sup>, looking downstream (south).

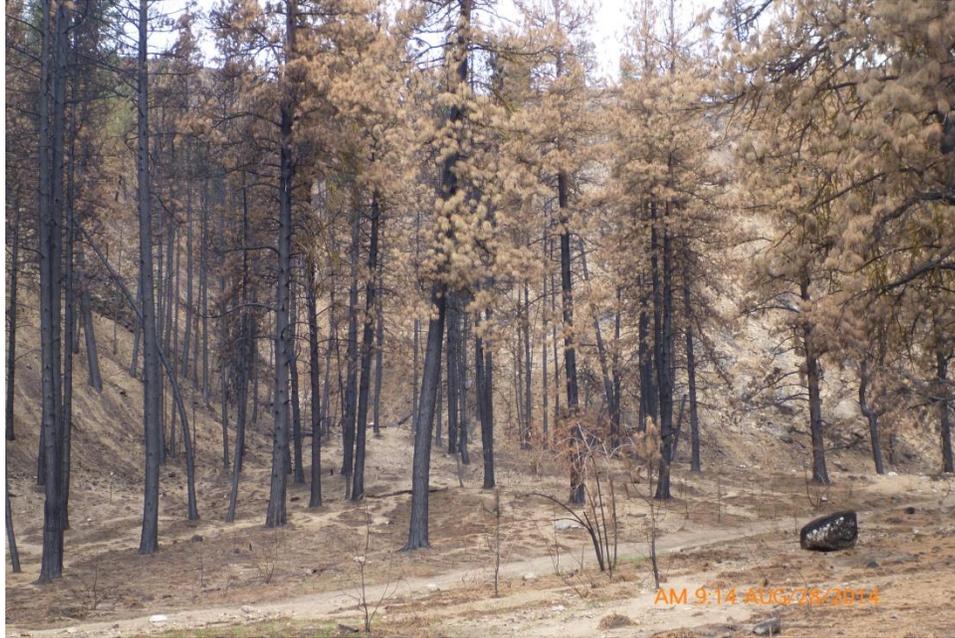
16. Lower Finley Canyon, downstream of Hawkins Dam on Aug 28<sup>th</sup>, debris flow from west side hillslope; looking west.

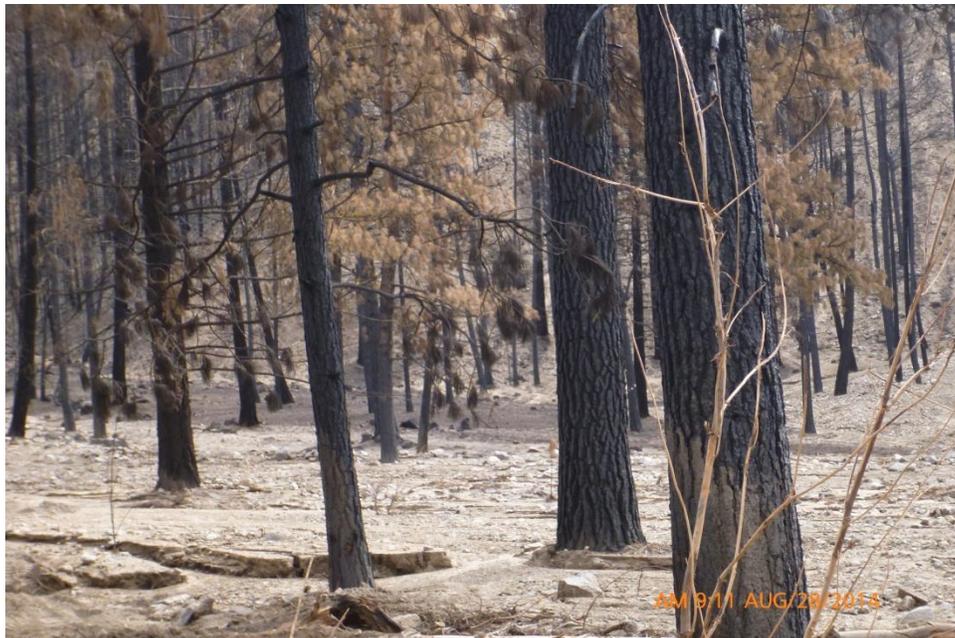
17. Lower Finley Canyon, downstream of Hawkins Dam on Aug 28<sup>th</sup>, debris flow from east side hillslope; looking east.
