AUTOMATED TANK GAUGING, HIGH LEVEL ALARMS, AND OIL SPILLS

WHY IT MATTERS

Vessels have grown while crew size has remained the same or decreased, promoting an increased reliance on automation. During fueling and internal transfers many vessels use automated tank level gauging and alarm systems. It is important that this equipment be properly installed, calibrated, maintained, and operated in order to prevent oil spills.

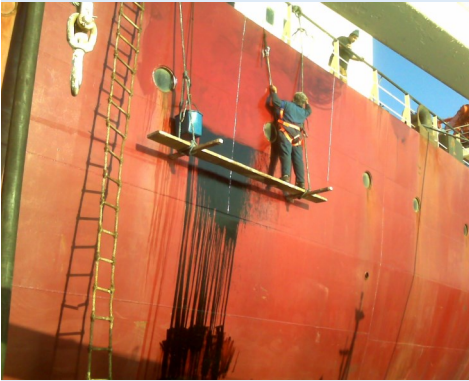
Side of ship being cleaned after a fuel oil overflow involving failure of a tank level gauging system and overflow alarm.

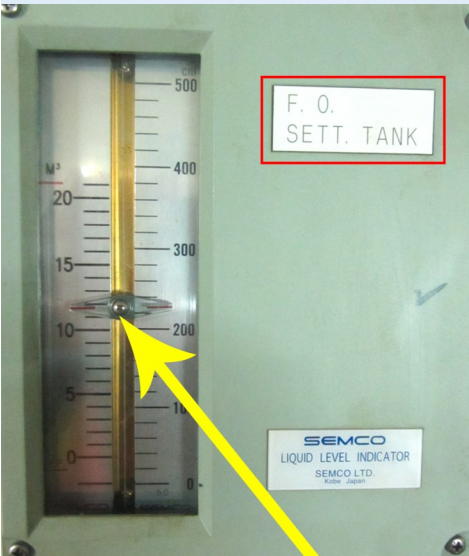
A local gauge on a fuel oil settling tank showed an incorrectly low reading, while the computer display for the tank correctly indicated a high level condition in the tank.

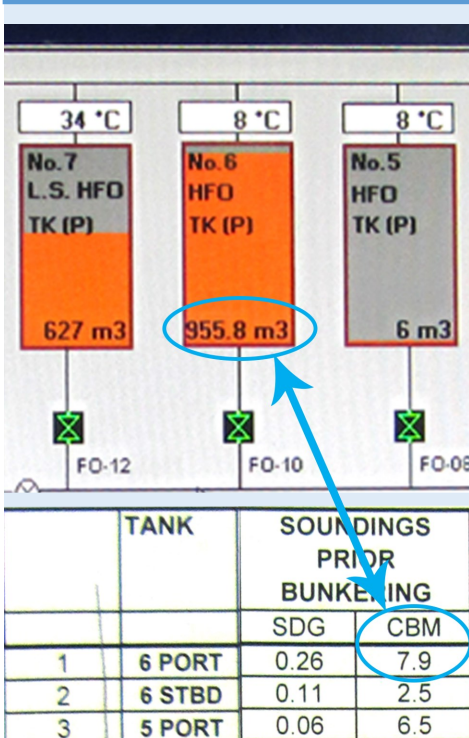
Prior to bunkering, a heavy fuel oil tank had a remote reading of 955.8 cubic meters (about full) while the manual sounding was 7.9 cubic meters (about empty). Discrepancies like this should be promptly addressed and communicated to appropriate crewmembers and company personnel.
