# Aladdin Plating Site Groundwater Monitoring Results, 2022-2023: Data Summary Report

**Environmental Assessment Program**

**Publication 24-03-027**

**December 2024**

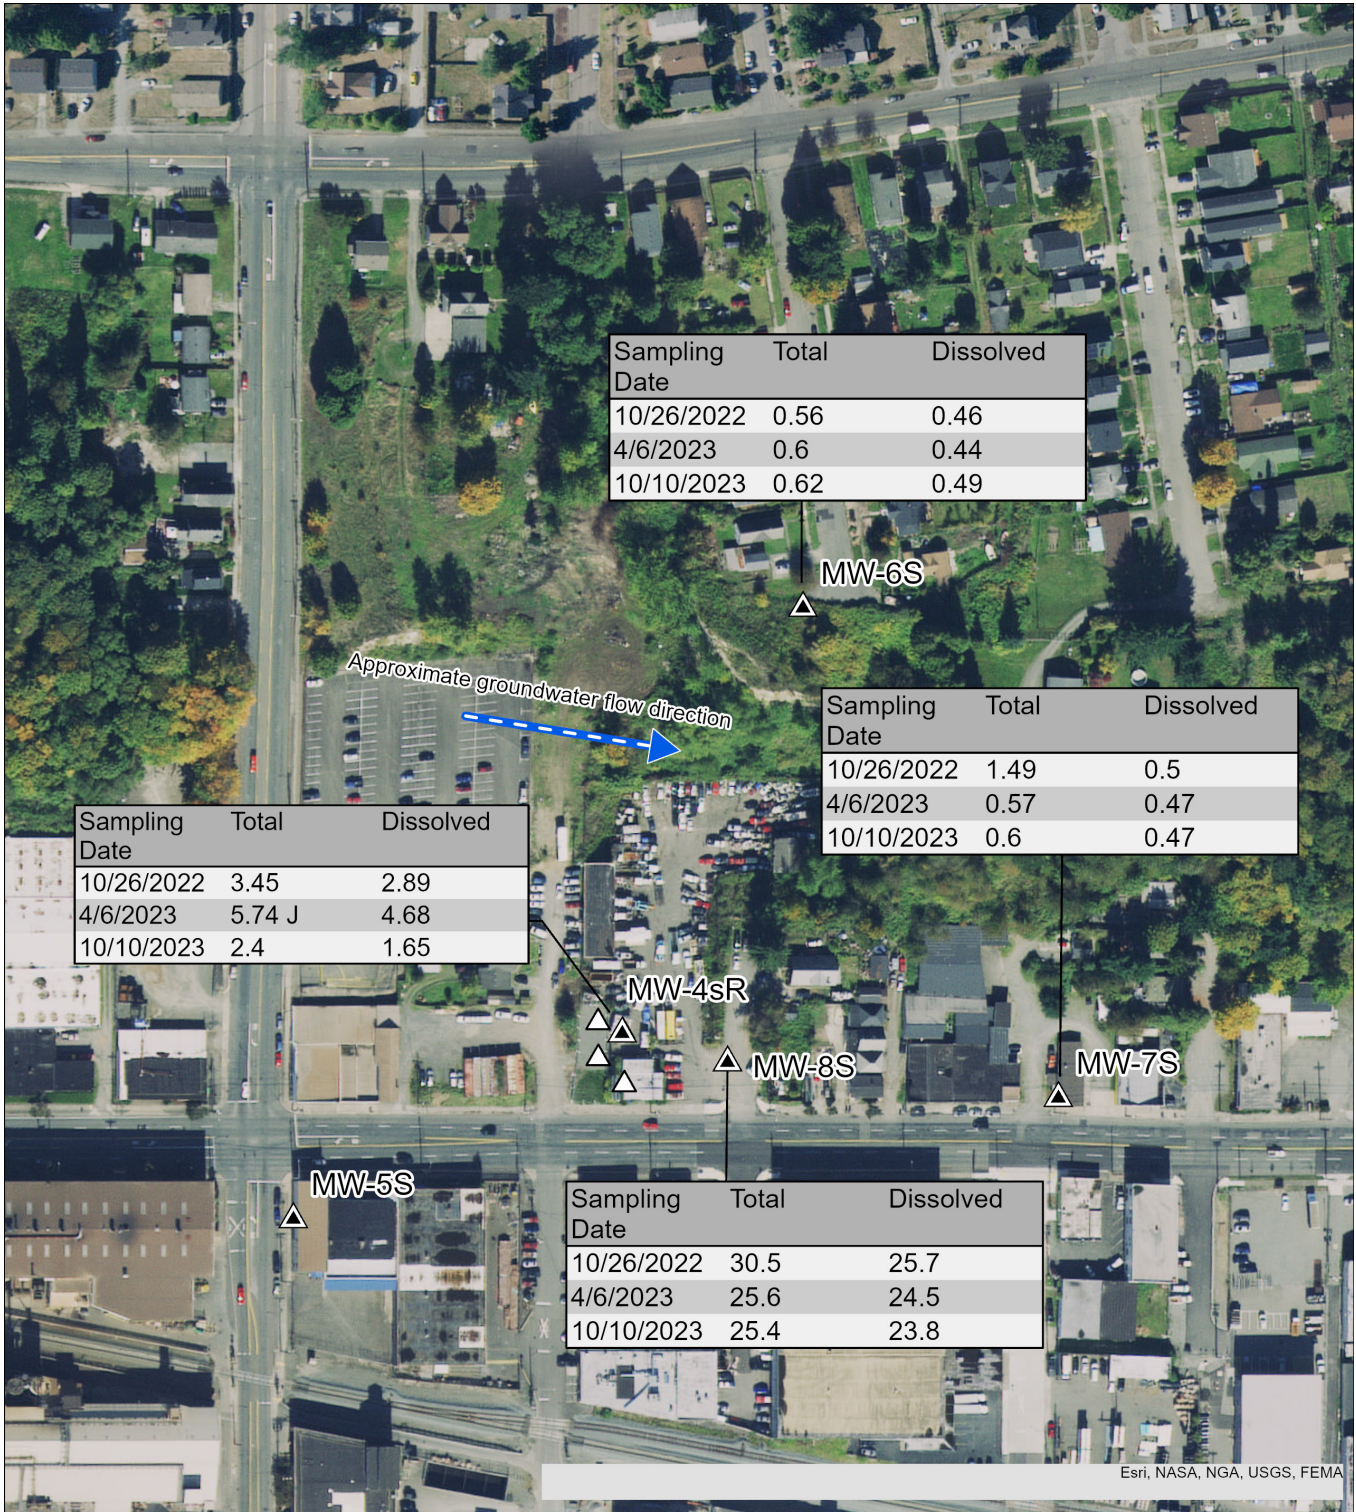
**Figure 3. Total and Dissolved Chromium Concentrations (µg/L) in 2022 and 2023**

Well MW-4sR is in the footprint of the 2018 excavation performed by GeoEngineers and placed near the former location of wells MW-4s and MW-4d. Concentrations of total and dissolved nickel in this well continue to exceed (not meet) the applicable cleanup levels as specified in the Cleanup Action Plan (GeoEngineers 2014b, WAC 173-340-740). Nickel results in MW-4sR indicate a decrease in concentrations following the 2018 soil excavation (Appendix A). Chromium concentrations in well MW-4sR were below the cleanup levels during all sampling events.

Well MW-6s is located atop a bluff approximately 470 feet from and crossgradient to well MW-4sR. Chromium and nickel concentrations in well MW-6s were far below their respective cleanup levels during all sampling events.

Analytical data from samples collected during the October 2022, April 2023, and October 2023 sampling events indicate that the near-surface aquifer at the former Aladdin Plating site continues to be impacted by nickel contamination. Total and dissolved nickel concentrations in wells MW-4sR and MW-8s are higher than (not meeting) applicable cleanup levels, representing near-source and downgradient contamination, respectively.

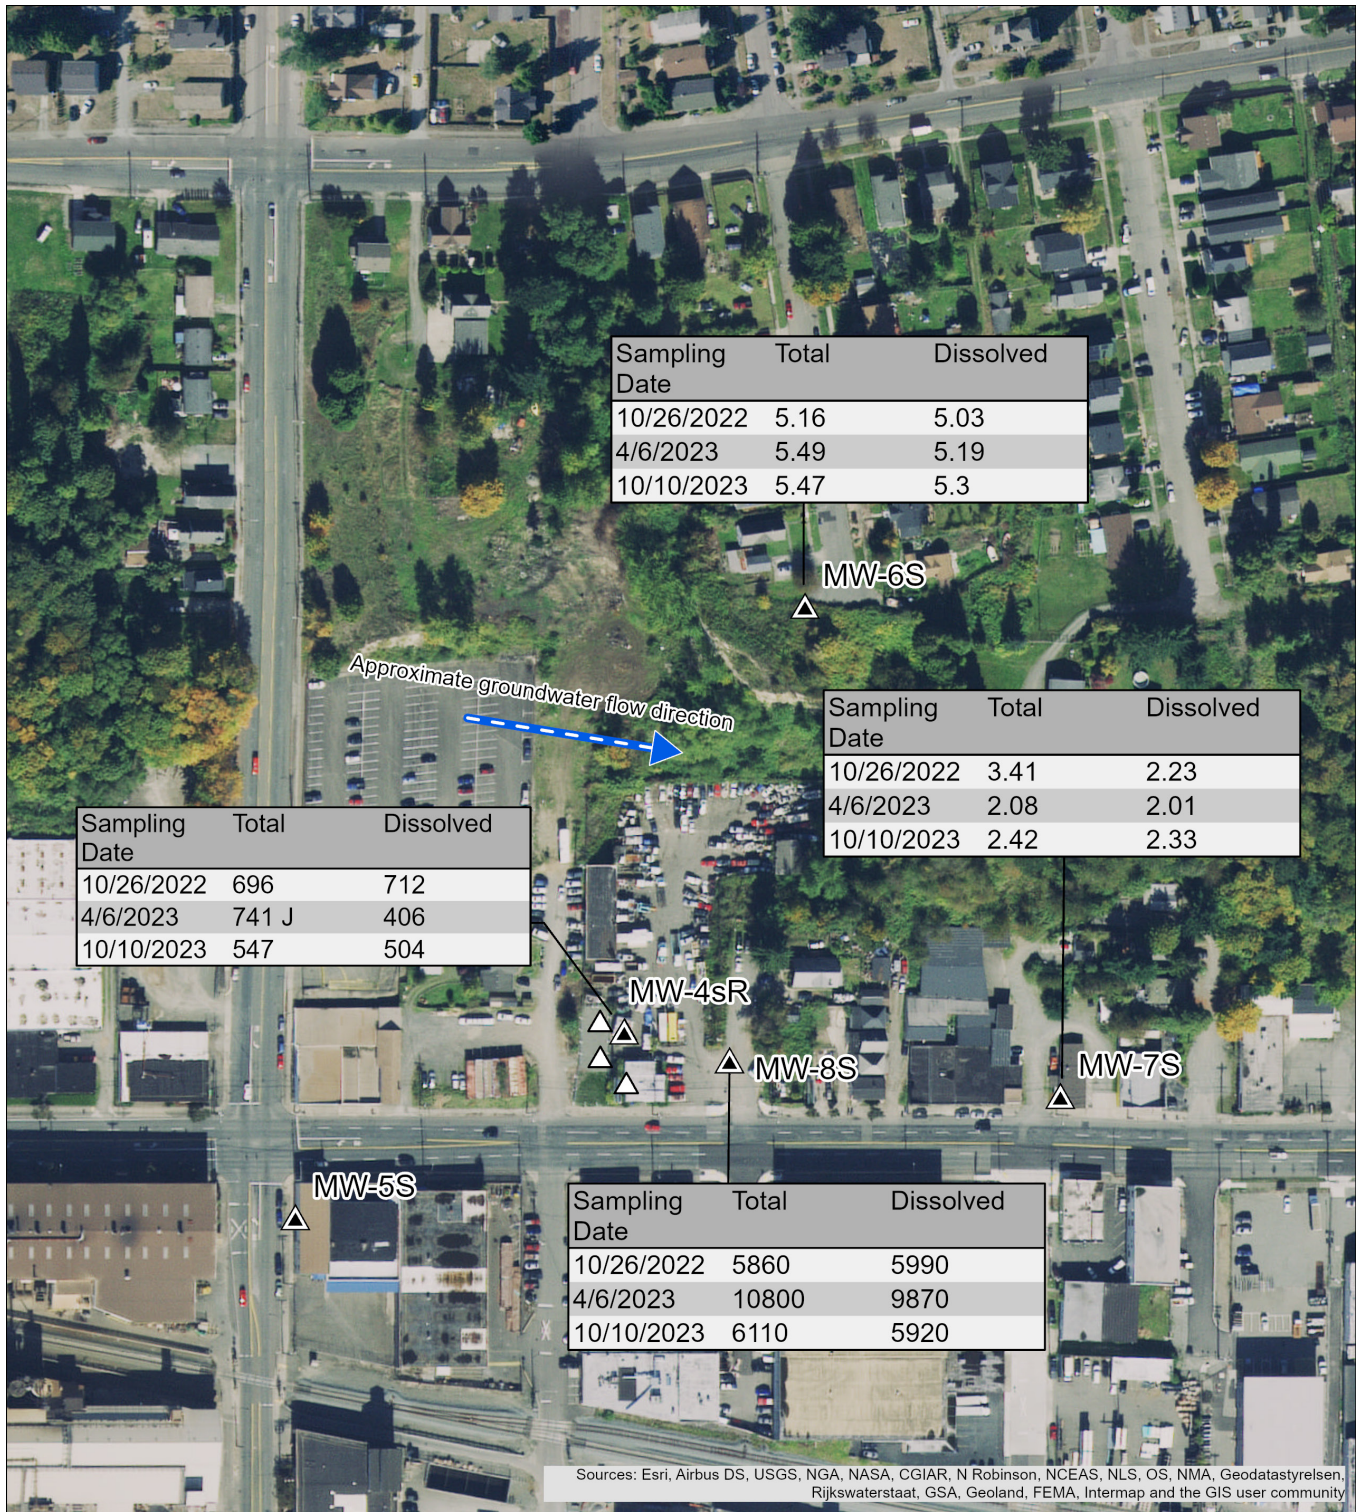
**Figure 4. Total and Dissolved Nickel Concentrations (µg/L) in 2022 and 2023**

Analytical results from groundwater samples between 2022 and 2023 indicate continued nickel impact on the near-surface aquifer at the former Aladdin Plating site. While nickel concentrations have decreased since initial site activities began in 2005, groundwater samples from the site continue to exceed (not meet) cleanup levels for nickel as established by the Cleanup Action Plan submitted by GeoEngineers in 2014, ranging as high as 10,800 µg/L for total nickel at MW-8s in April 2023.

Well MW-8s is located approximately 110 feet downgradient of well MW-4sR. Both wells share similar construction depths and screened intervals (Table 1). Concentrations of total and dissolved nickel in well MW-8s continue to far exceed (not meet) the applicable cleanup levels. Well MW-8s had the highest nickel concentrations of all wells sampled in 2022 and 2023, with total nickel ranging from 5,860 µg/L to 10,800 µg/L and dissolved nickel ranging from 5,920 µg/L to 9,870 µg/L (Figure 4). Nickel concentrations in MW-8s were the highest in the April 2023 sampling event, however, these results indicate decreasing concentrations from historical concentrations (Appendix A). Chromium concentrations in MW-8s were below the cleanup levels during all sampling events.

Well MW-7s is located approximately 450 feet downgradient of well MW-4sR. Well construction details are similar to MW-4sR and MW-8s, however, MW-7s is screened three feet deeper (Table 1). Chromium and nickel concentrations in samples collected from well MW-7s during all sampling events were considerably below their respective cleanup levels.

Comparisons of data from samples collected at well MW-4sR during the October 2022, April 2023, and October 2023 events indicate a gradual decrease in chromium and nickel at this location following the second site soil excavation in 2018 (Tables 5, 6 and 7, Figures 3 and 4, Appendix A). While contaminant concentrations at MW-8s continue to far exceed (not meet) cleanup levels, these concentrations also reflect a decrease following the 2018 soil excavation, indicating that the source removal is effectively reducing concentrations of chromium and nickel in the near-surface aquifer.

- Semi-annual groundwater monitoring events should continue as scheduled due to nickel concentrations which continue to exceed (not meet) established cleanup levels. Analytical results from these sampling events indicate that source removal of impacted soil onsite has reduced concentrations of chromium and nickel in the near-surface aquifer, however, further semi-annual monitoring is necessary to confirm that these concentrations continue to naturally attenuate towards cleanup goals.
