## **Fourth Periodic Review Pacific Detroit Diesel Allison Company**

**6615 East Mallon Avenue**

**Facility Site ID: 739, Cleanup Site ID: 914**

November 2025, Publication 25-09-029

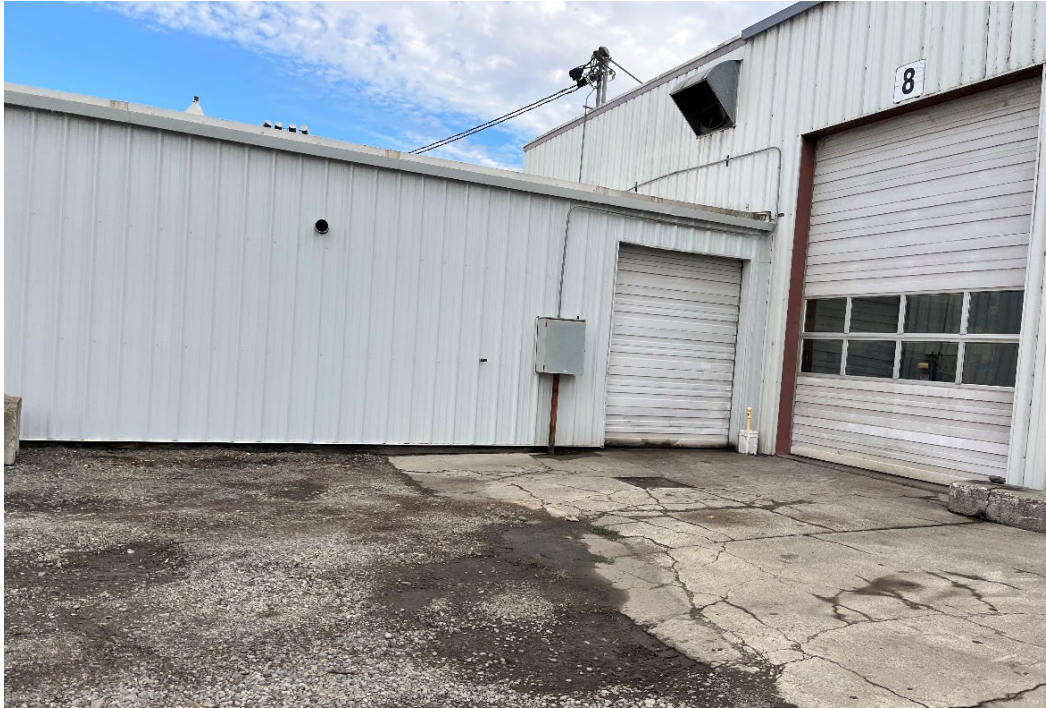
**Photo 3: Area of remaining contamination near former steam room — from the west**
