# **Wyckoff/Eagle Harbor Superfund Site**

## **30-Month Report No. 1**

May 2026 Publication 26-09-065

## Wyckoff Regulatory Buoys Inspections & Vinyl Replacement November 2025

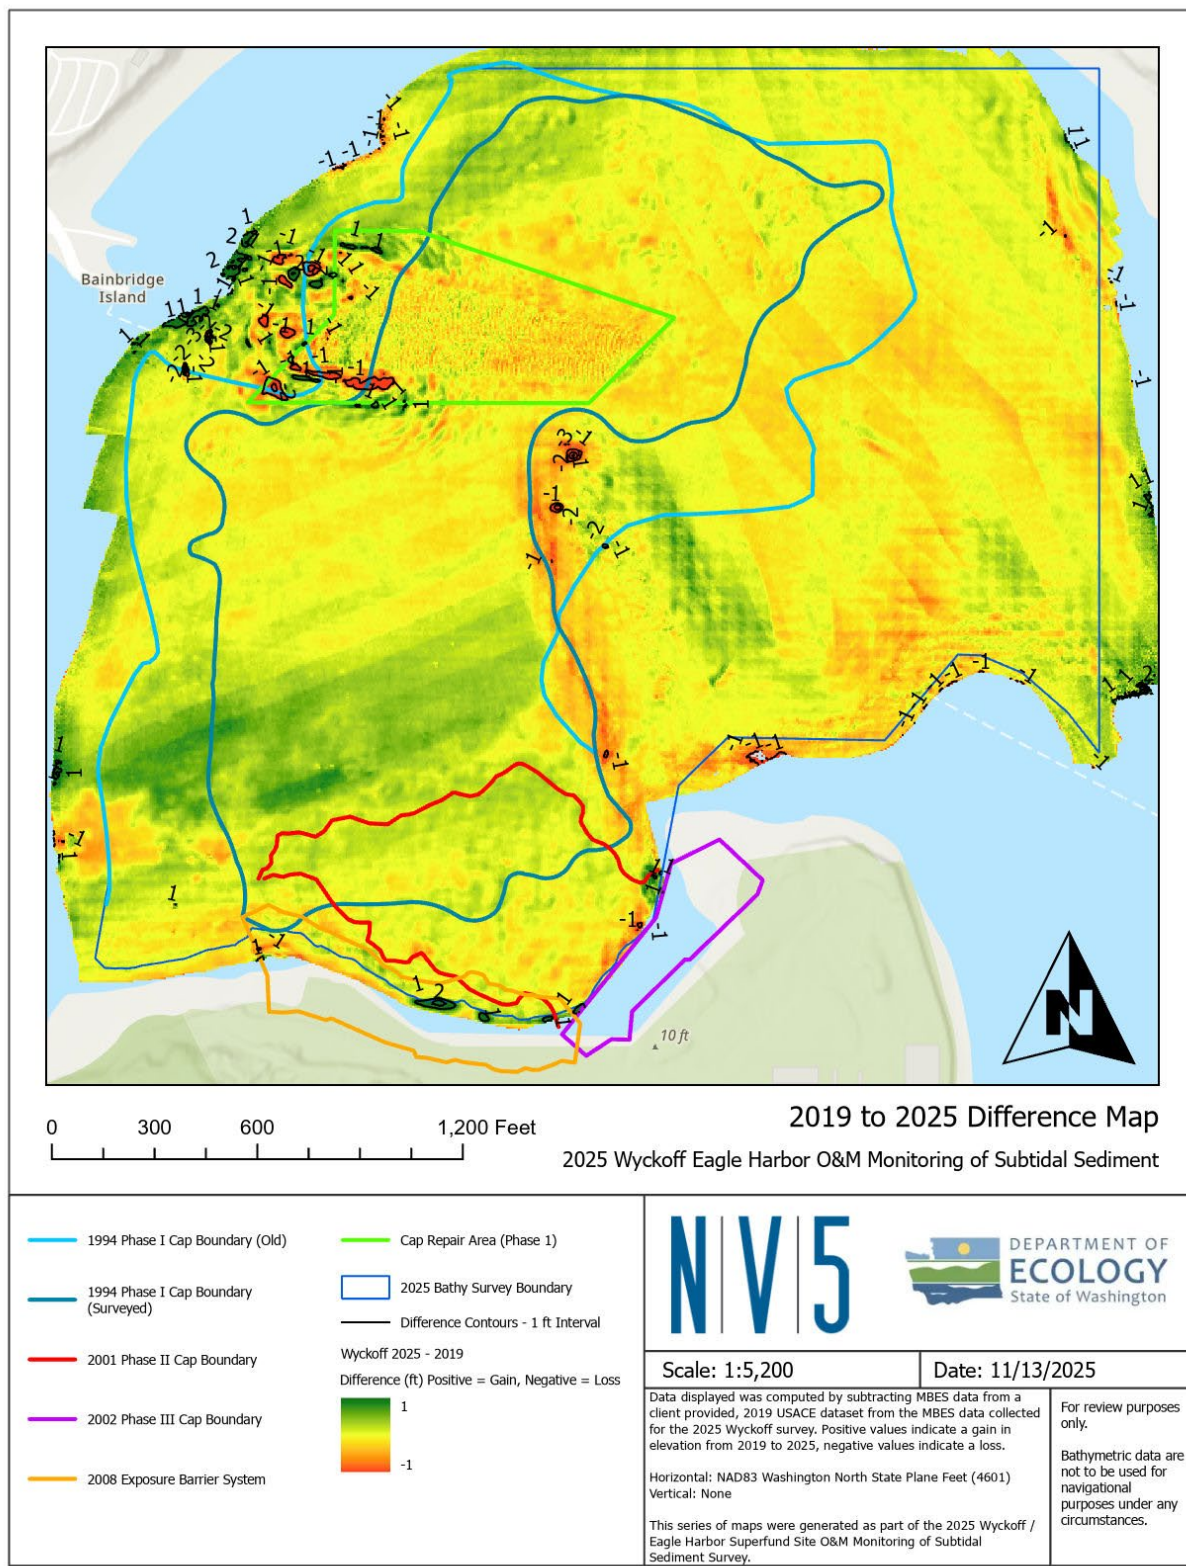
Figure 2: Bathymetric survey differences between 2019 and 2025

in Figure 2. Per the QAPP, any capped area with an elevation loss of more than one foot is considered a change of concern and triggers a secondary inspection.

Comparison of the 2025 bathymetry with the 2019 USACE data detected minimal overall elevation change across the survey area, with the average difference of less than 0.02 feet. Most of the subtidal sediment maintained a stable elevation. Four limited locations with changes of concern were identified within the subtidal sediment area transferred to Ecology, two near the ferry terminal and two along the steep slope of a shoal. All locations with changes of concern were further evaluated via drop camera surveys that collected discrete images with laser scaling.

Only one of the locations with change of concern, the location near the ferry terminal, was within the surveyed bounds of the 1994 cap, i.e. Phase I cap. The other three locations were at the bounds of the cap where cap material was placed at a thickness between 0-1 feet and serve only a transitional/grading area for the more substantive cap placement. No changes of concern were detected over the remedial area hotspots.

Based on bathymetric survey data, discrete images, discussions with the contractor, and knowledge of Eagle Harbor, the causes of elevation changes of concern are likely as follows: (1) Elevation changes in the vicinity of the ferry terminal and directly below the ferry route is very likely due to ferry propellor turbulence (i.e., prop wash) from the ferry operations and (2) The elevation change at the slope of the shoal is likely from the natural erosion of material (particularly larger material like cobbles) down the steep slope of the shoal. This phenomenon is visible in historical imaging dating back to 2011.

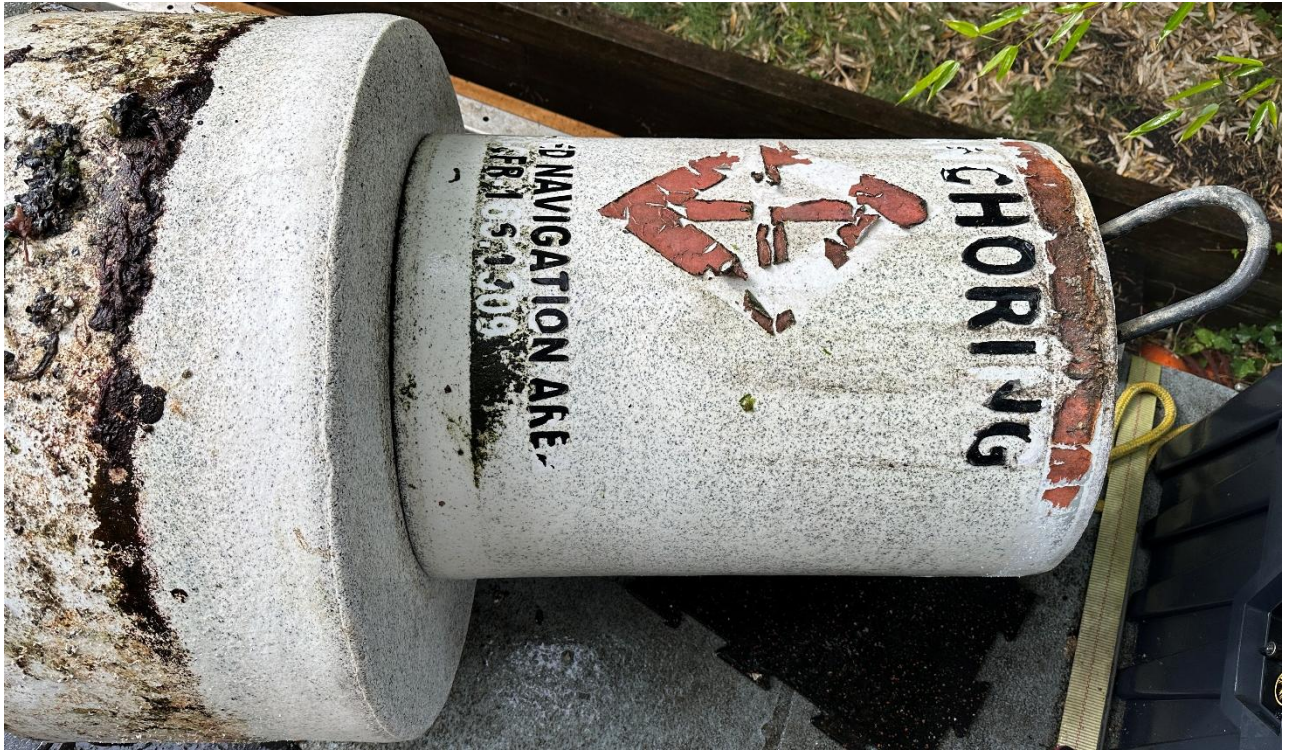
Buoy 1: Onsite with markings installed

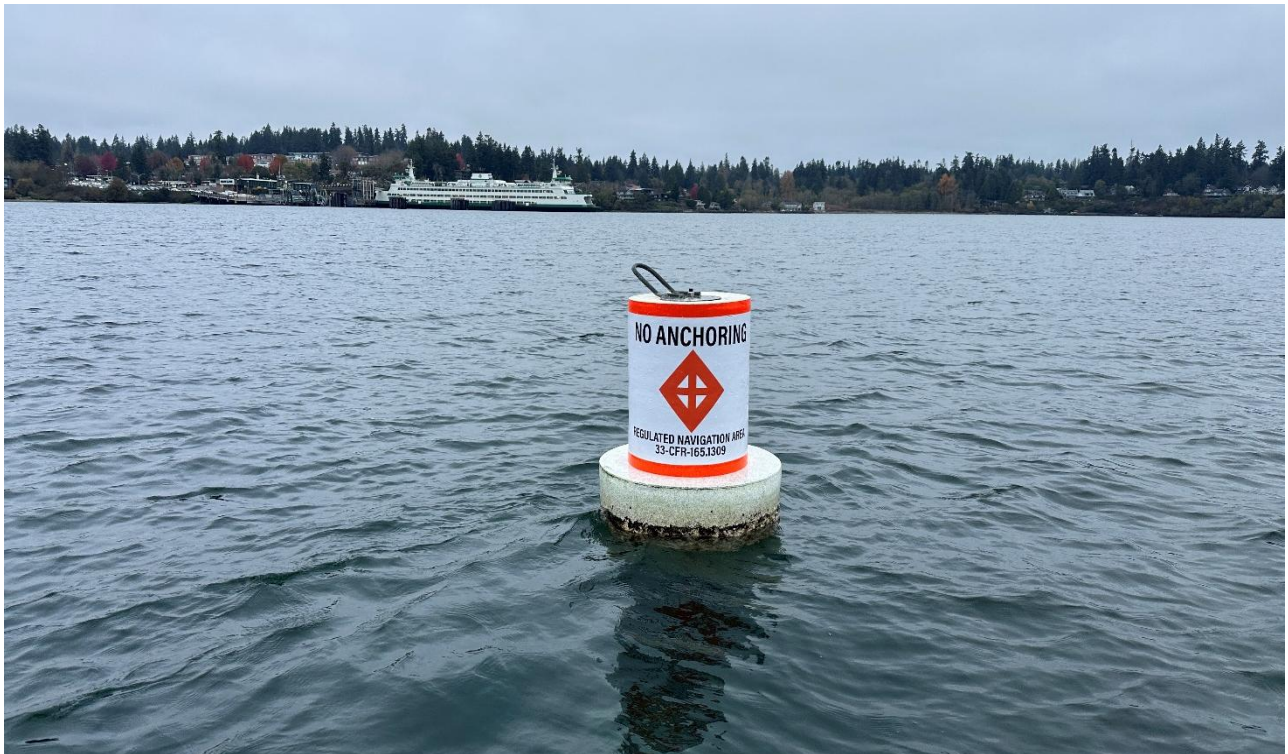
Buoy 1: Typical previous stickers peeling. Letting unclear.

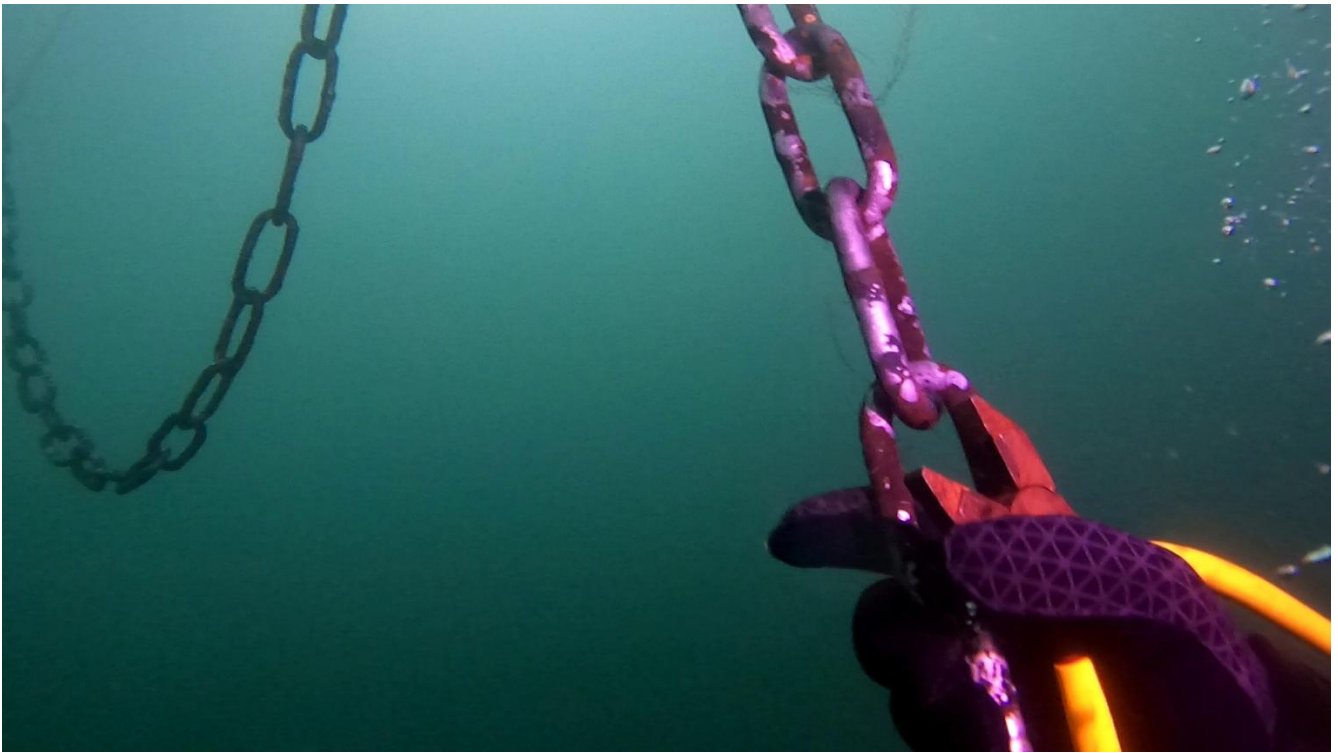
Buoy 4: New vinyl markings installed.

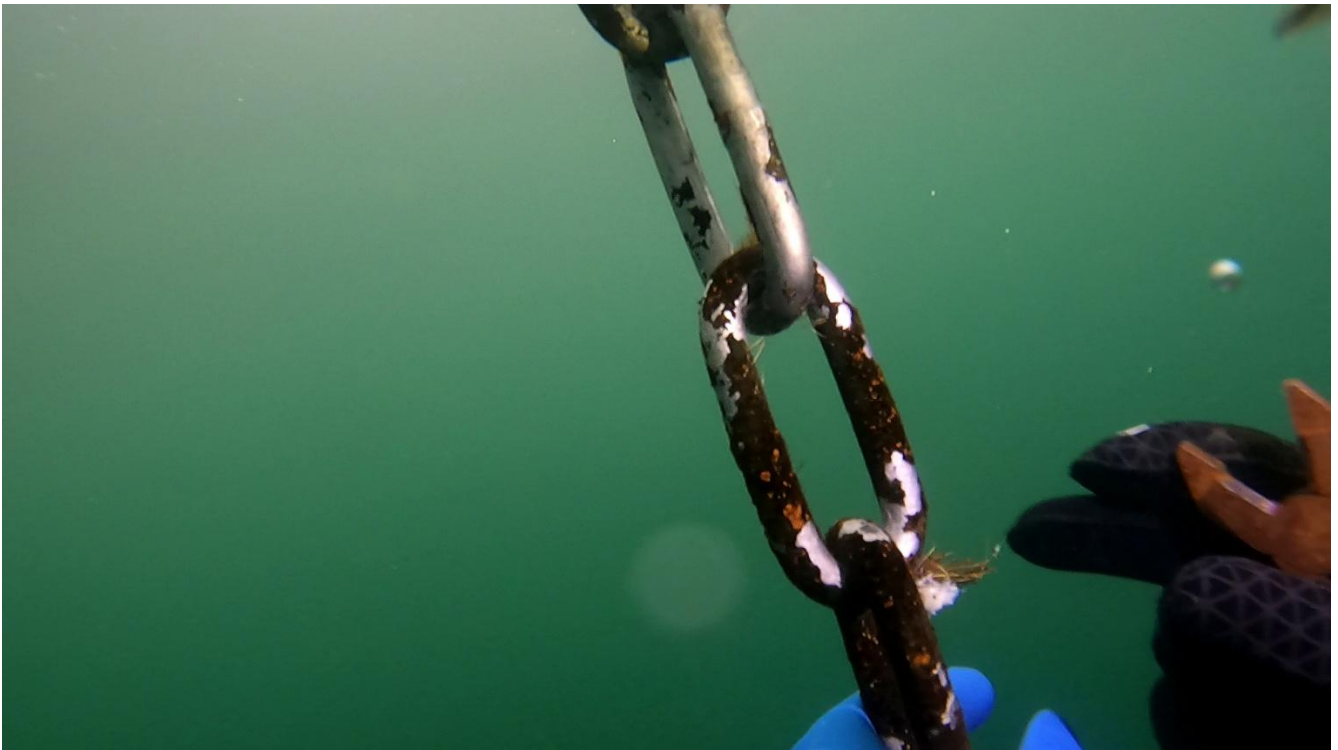
Buoy 2: Typical chain condition

The chain on buoys 2 & 3 should also considered for replacement within 2 years. At this time, associated shackles should be replaced as well.

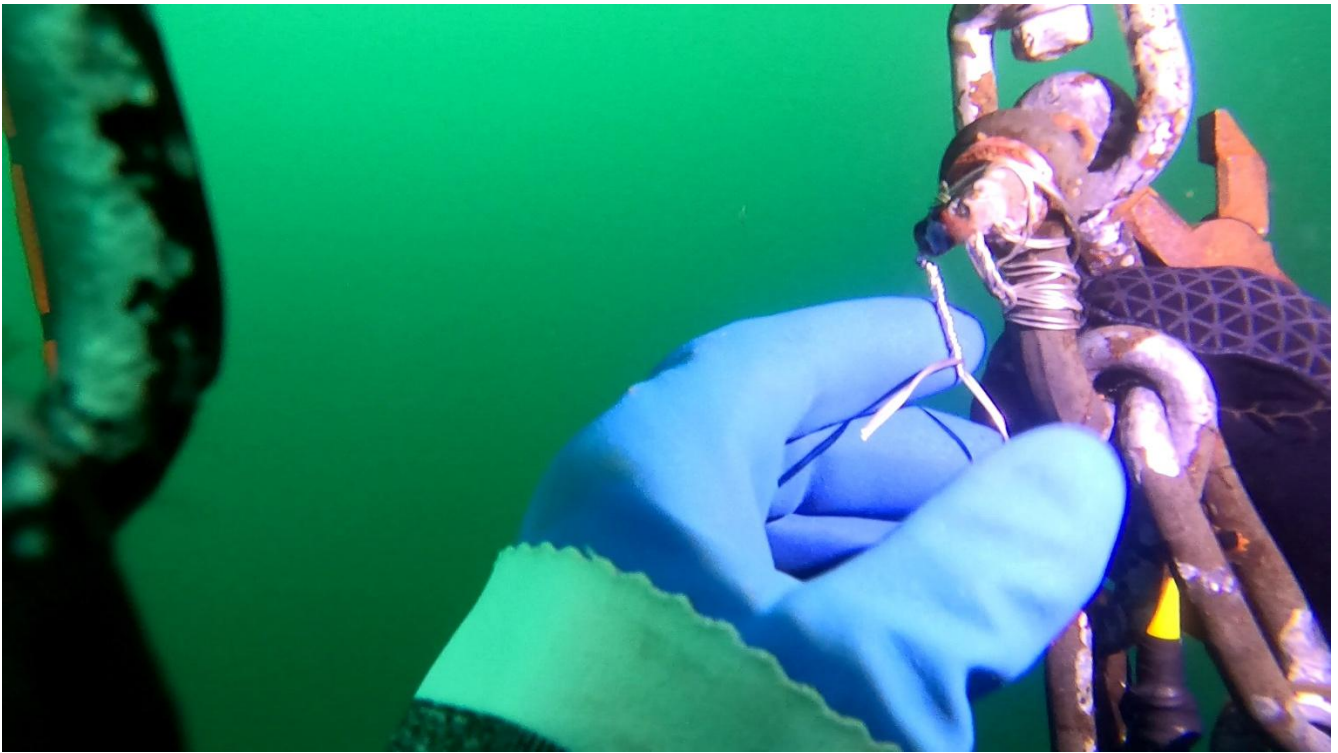
Buoy 2: Typical chain condition

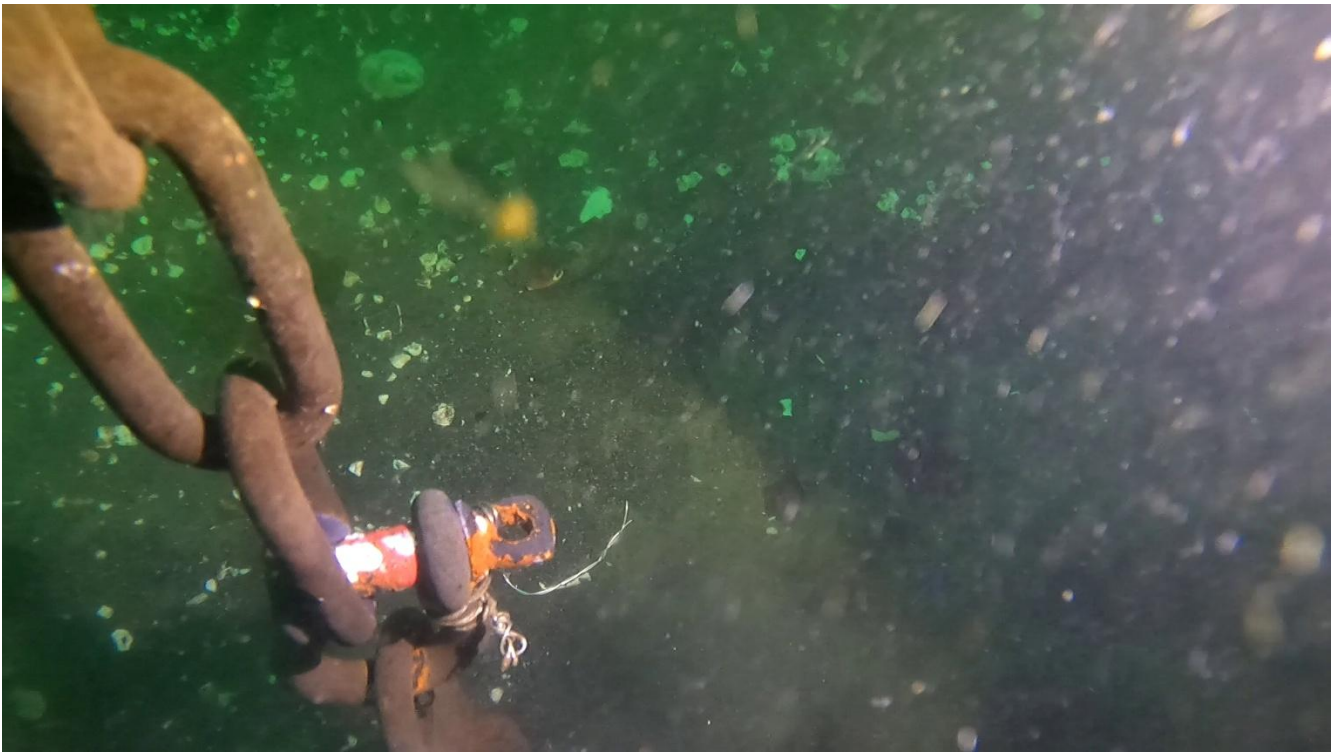
Buoy 2: Can removed. Threads bent likely from vessel impact

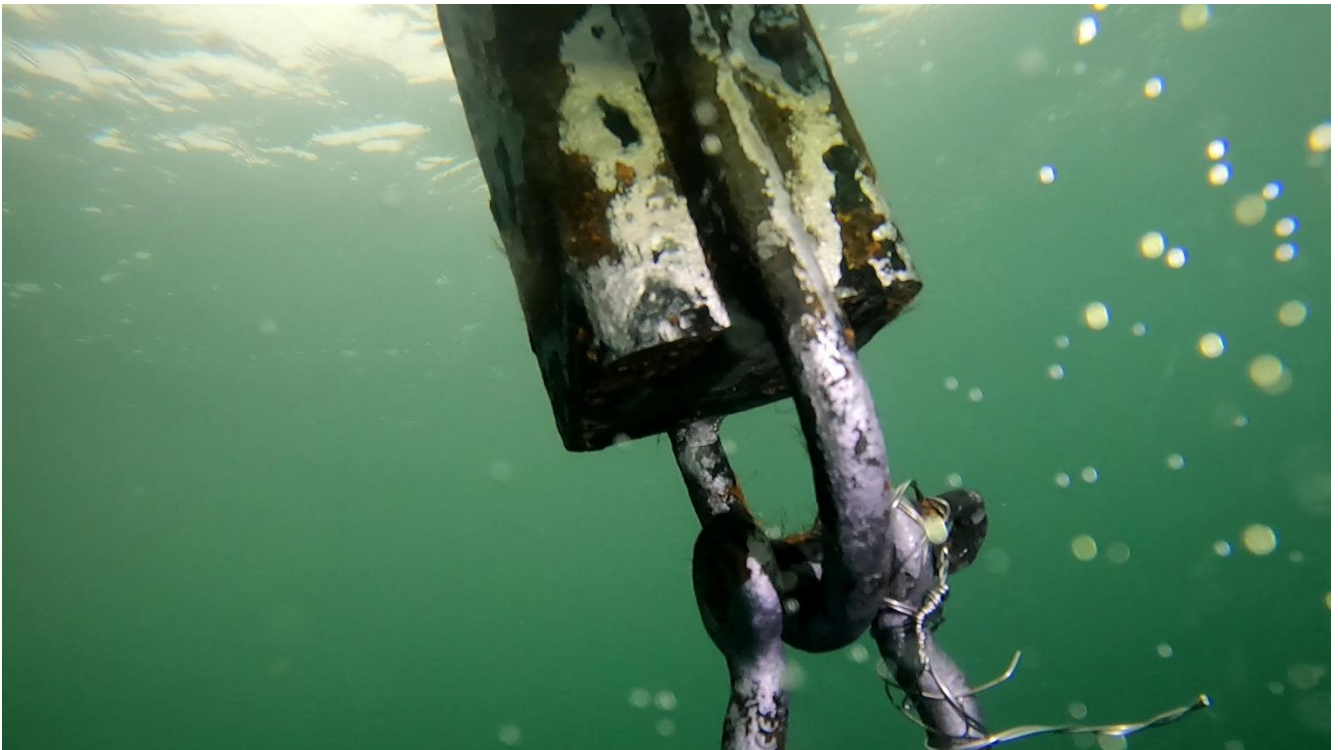
Buoy 3: Typical Anchor shackle and lower chain condition. Galvanizing intact, lower section of chain in good condition.

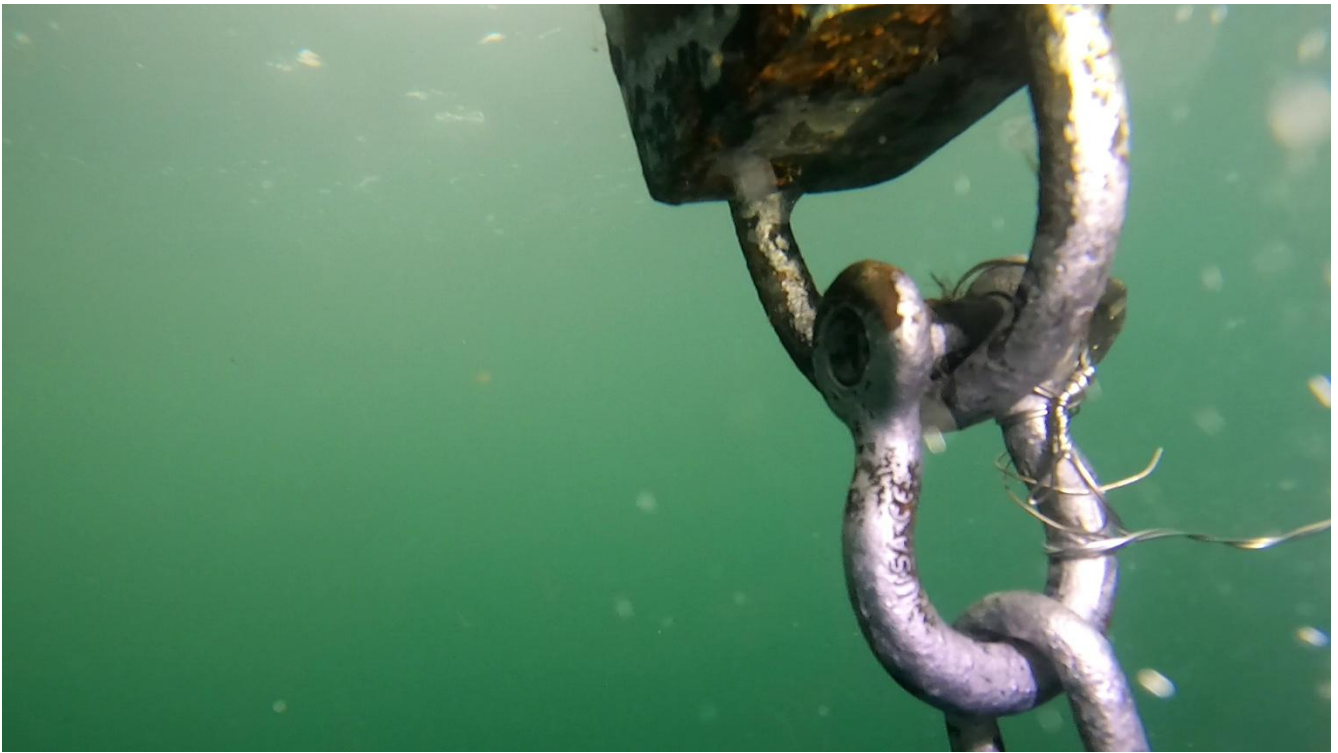
Buoy 4: Mooring eye at bottom of buoy pipe, deterioration present.

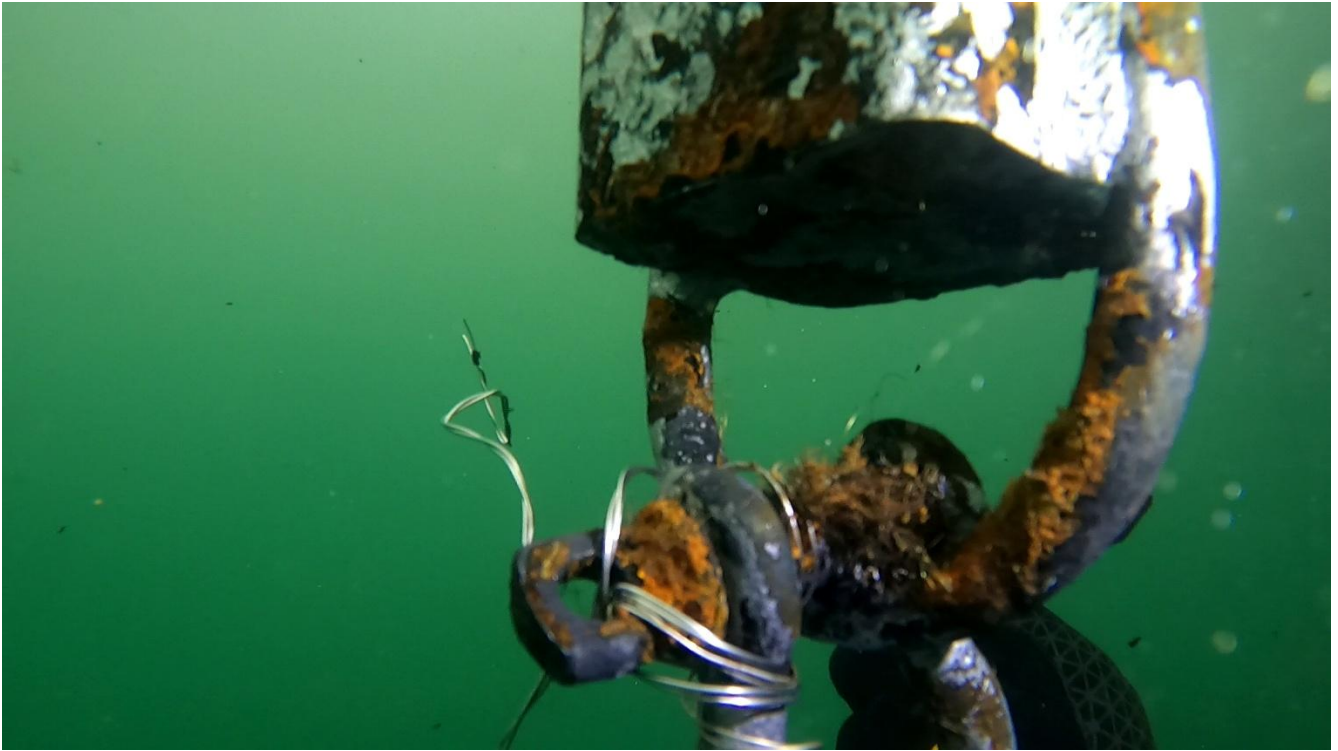
Buoy 2: Mooring eye at bottom mid-line float. Typical condition, eye deteriorating.

The mid-line floats are rod-type mooring buoys with an eyelet at the top and bottom of the buoys. The lower eye is connecting the buoy to the chain & is beginning to deteriorate from typical underwater conditions. These mid-line floats should be flipped over when the chains are replaced so the fresher eye can be used, prolonging the life the buoys for another 2+ years.

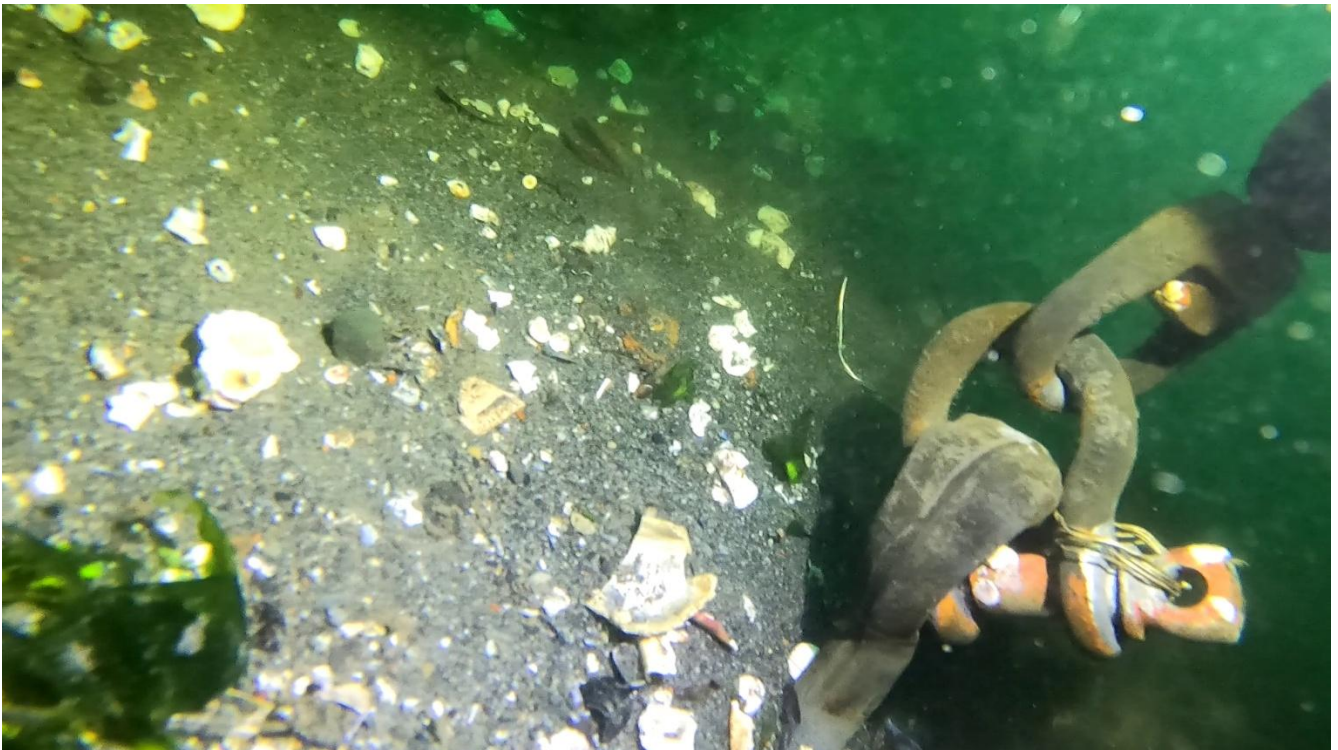
Buoy 2: Mooring eye & shackle at bottom of buoy pipe, deterioration present on both.

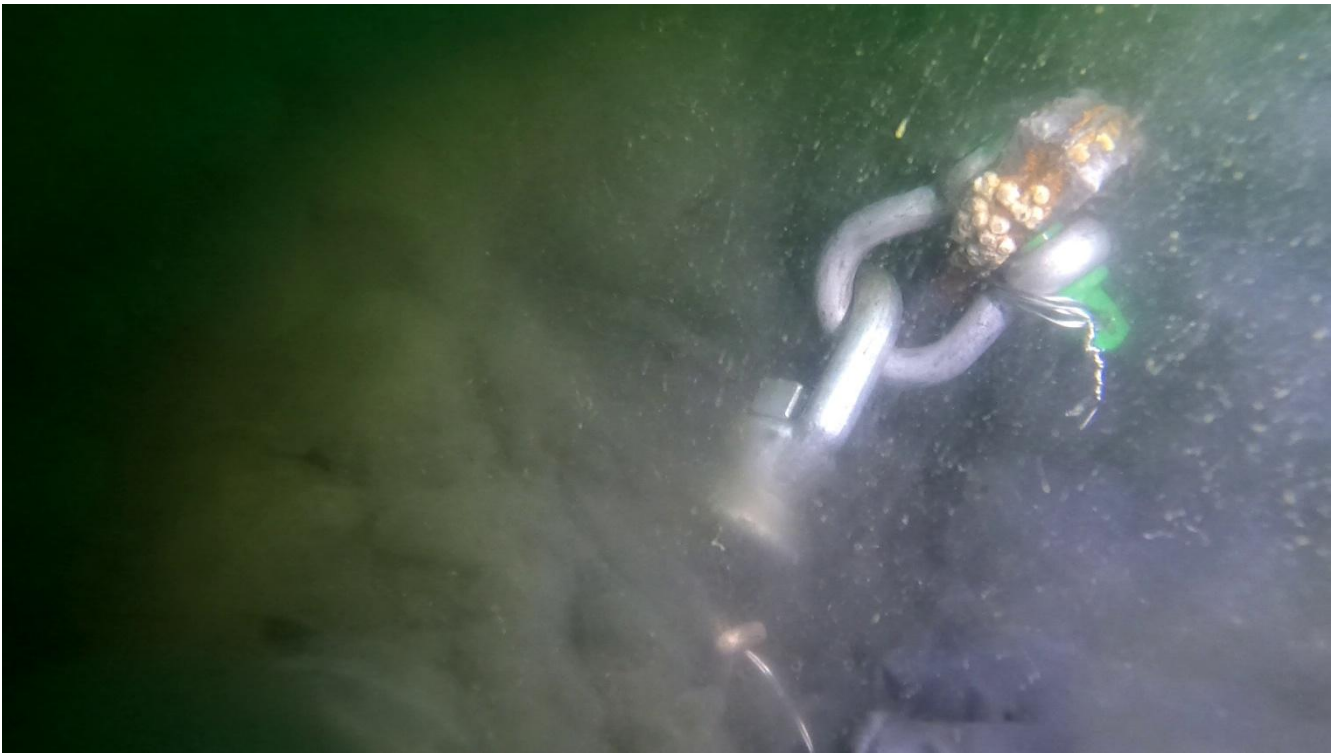
Buoy 3: Anchor eye, shackle, and swivel in good condition.

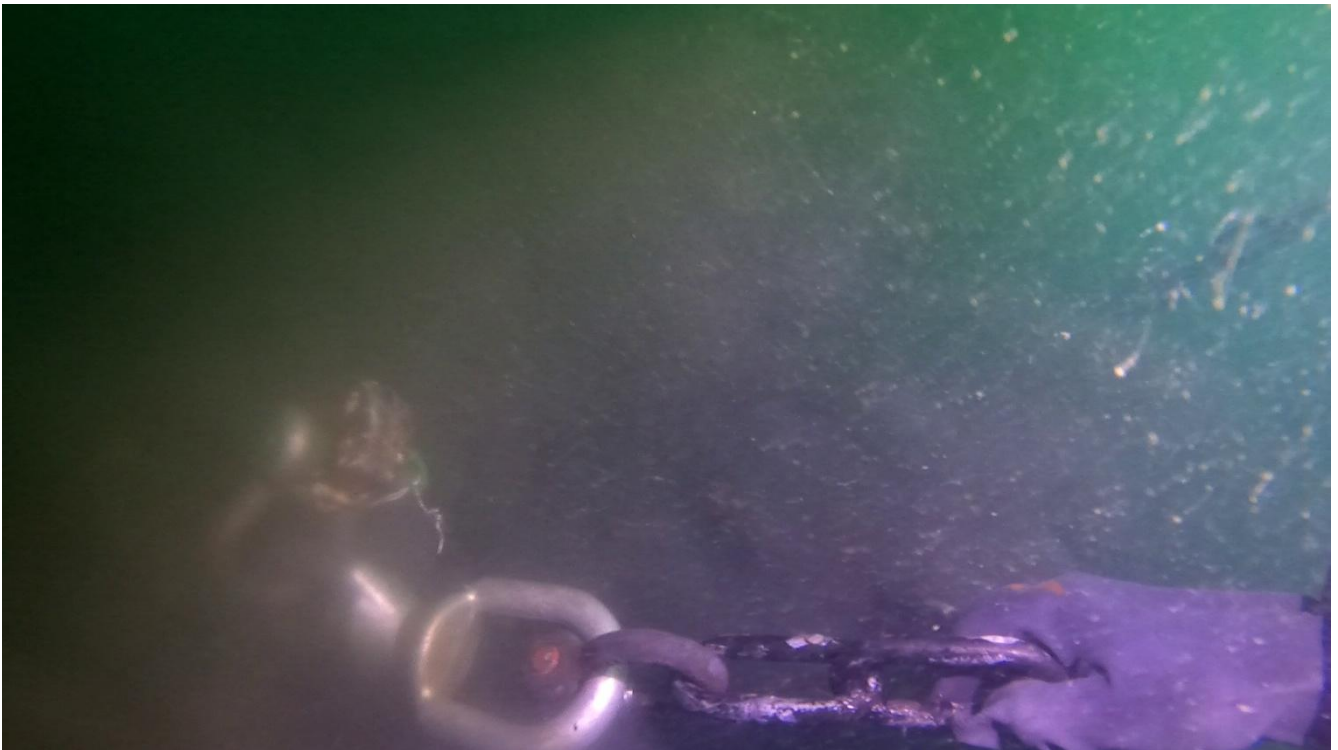
At this time, SDS also replaced the swivel on buoy 3 with a ¾" galvanized eye-eye swivel. The existing swivel was a 5/8" jaw-eye swivel which are prone to premature failure. During the inspection, the cotter pin securing the clevis pin was deteriorated and on the verge of causing failure.

Buoy 3: New anchor shackle & swivel installed.

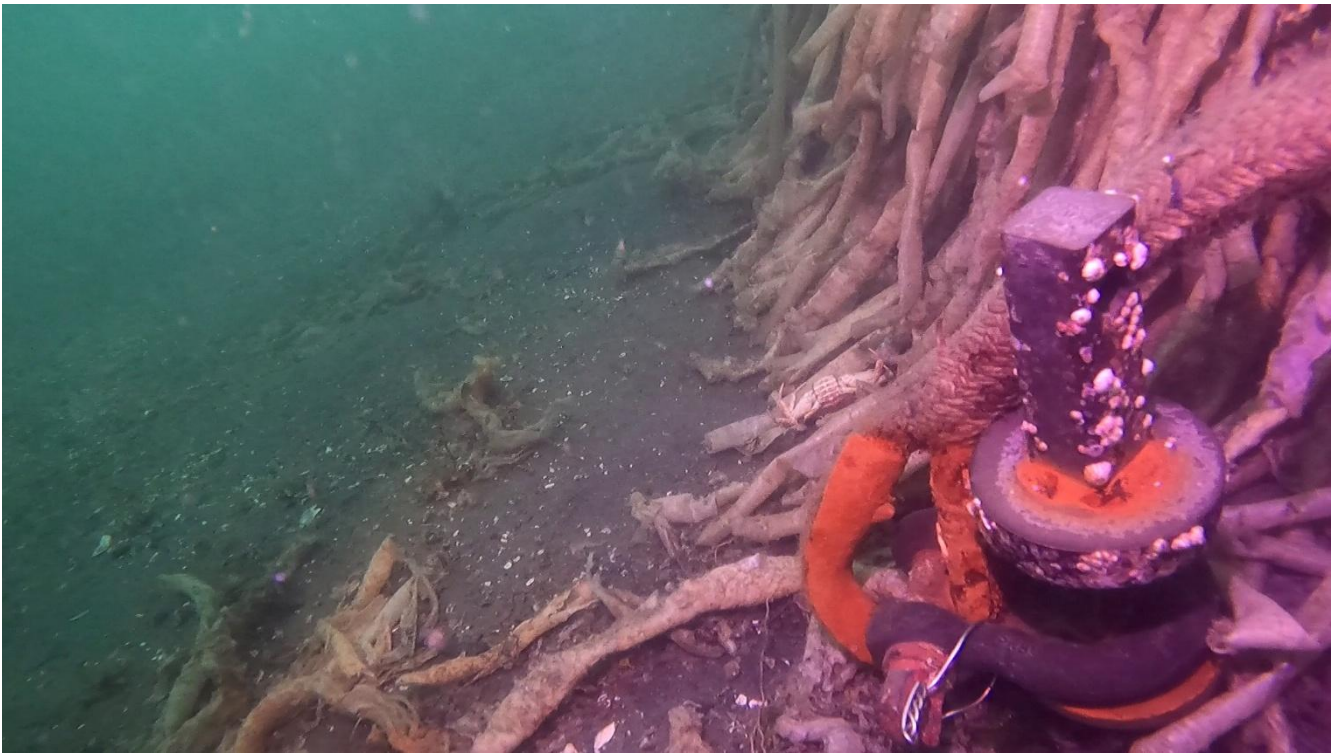
Buoy 3: New anchor shackle & swivel installed.

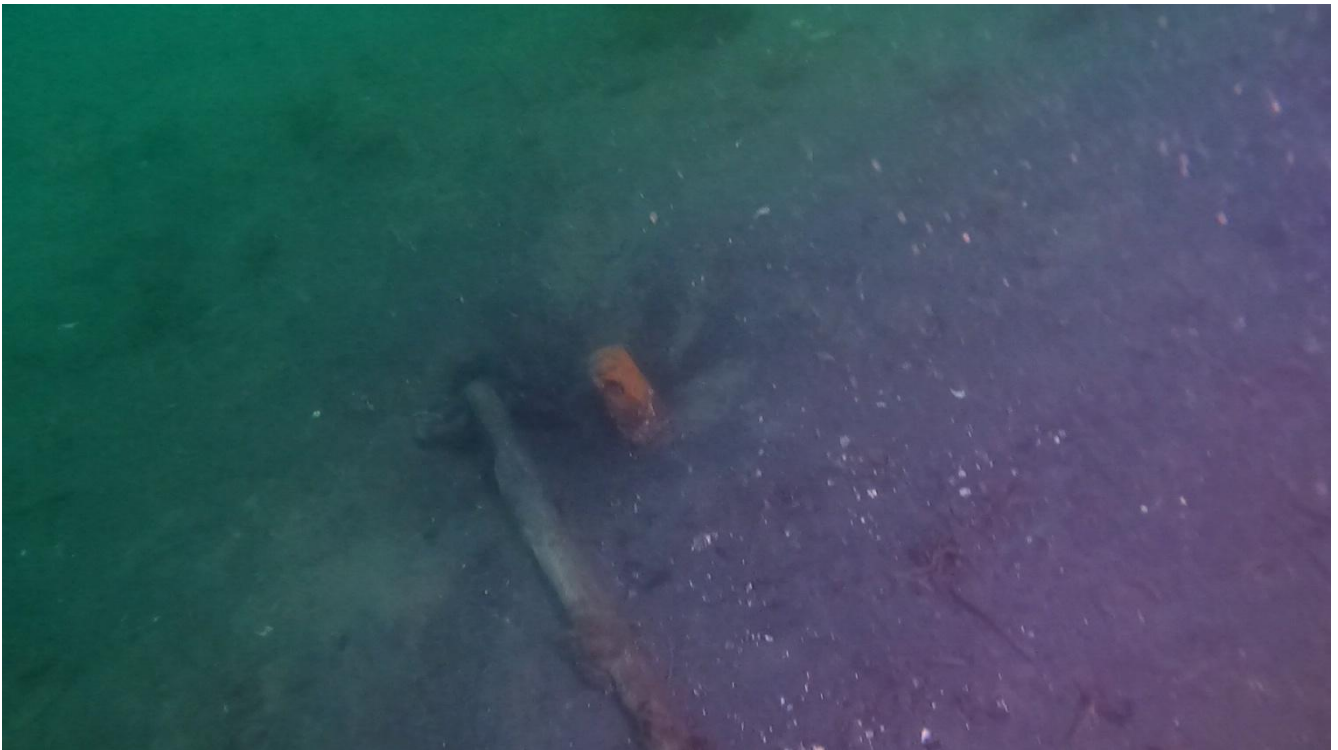
Buoy 1: Anchor & tubeworms located.
