## Ground Water Contamination Along Interstate 405 Southern Snohomish County, Washington

This is an investigation of ground water conditions in order to determine if a well had been damaged by nearby highway construction. Prepared by Paul A. Eddy, Office of Technical Services, Department of Ecology, Olympia, Washington, March 1971.

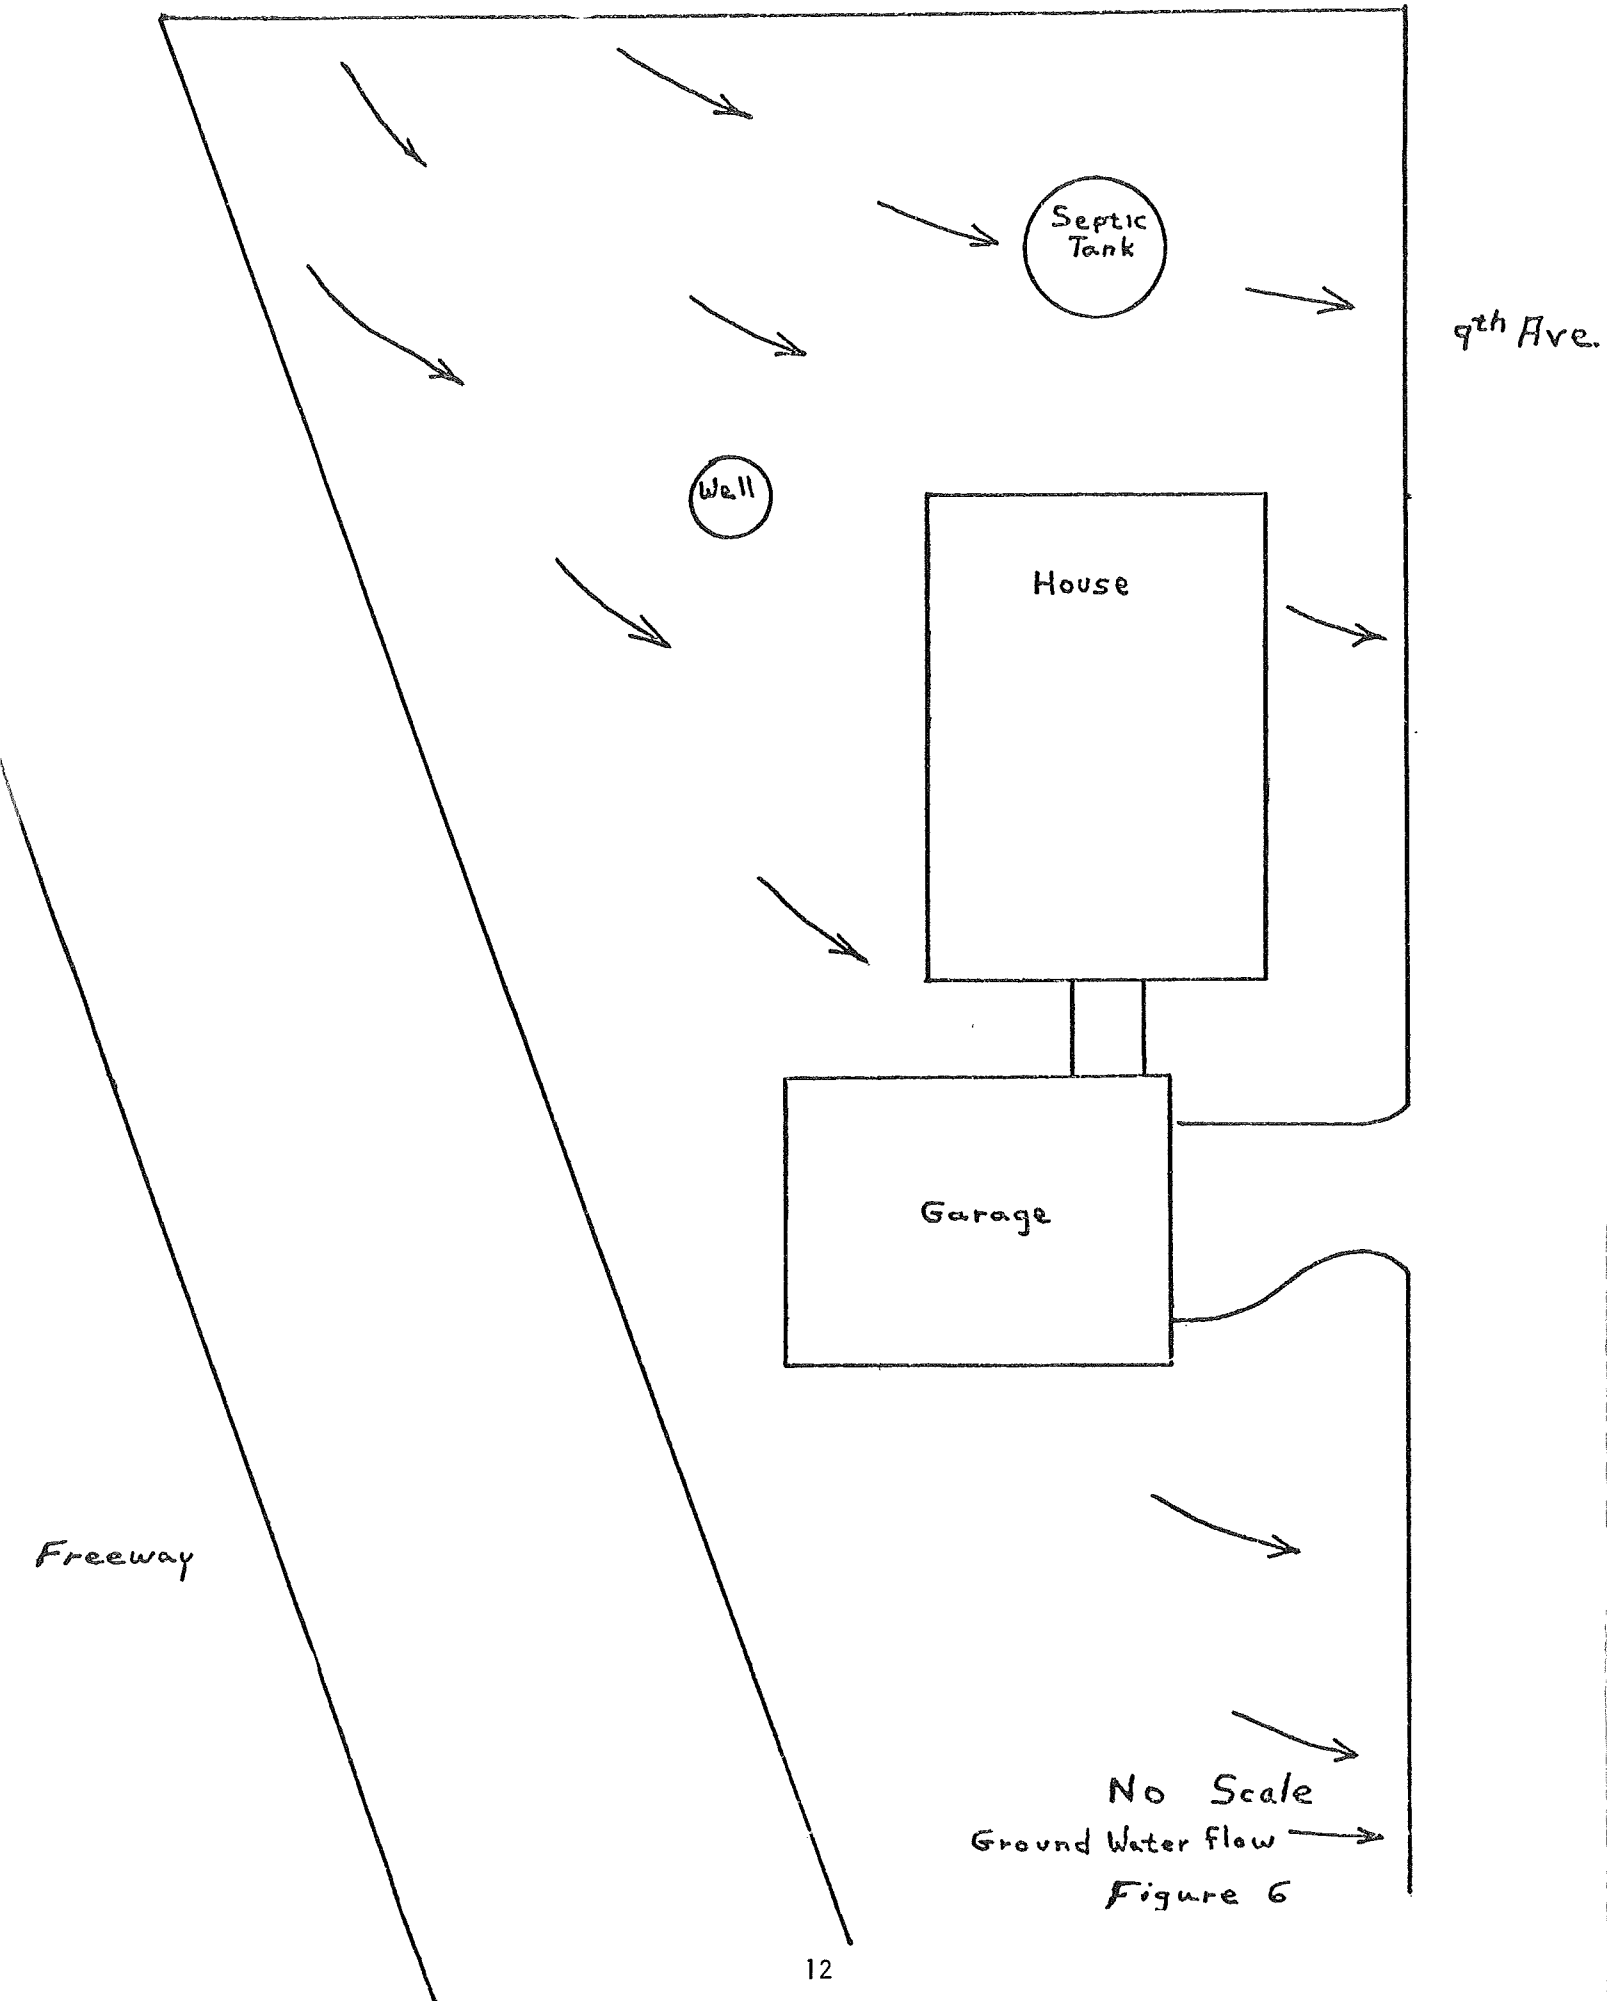
No Scale  
Ground Water flow →  
Figure 6

The well in question lies geographically near the southern edge of Snohomish County and is within Section 30, Township 27 North, Range 5 East of the Willamette Meridian, (fig. 1). The altitude of the well is approximately 190 feet above sea level and lies on a relatively flat area with hills raising to the west to an altitude of about 500 feet. The well is located 34 feet west of the northwest corner of the house (fig. 6).

The direction of ground-water flow before construction is shown on figure 4 and if compacting because of highway construction occurred within the aquifer the present flow lines are shown on figure 5. Only where large amounts of fill material was required could we expect compaction within an aquifer to occur. Apparent ground-water flow on the property is shown on figure 6.

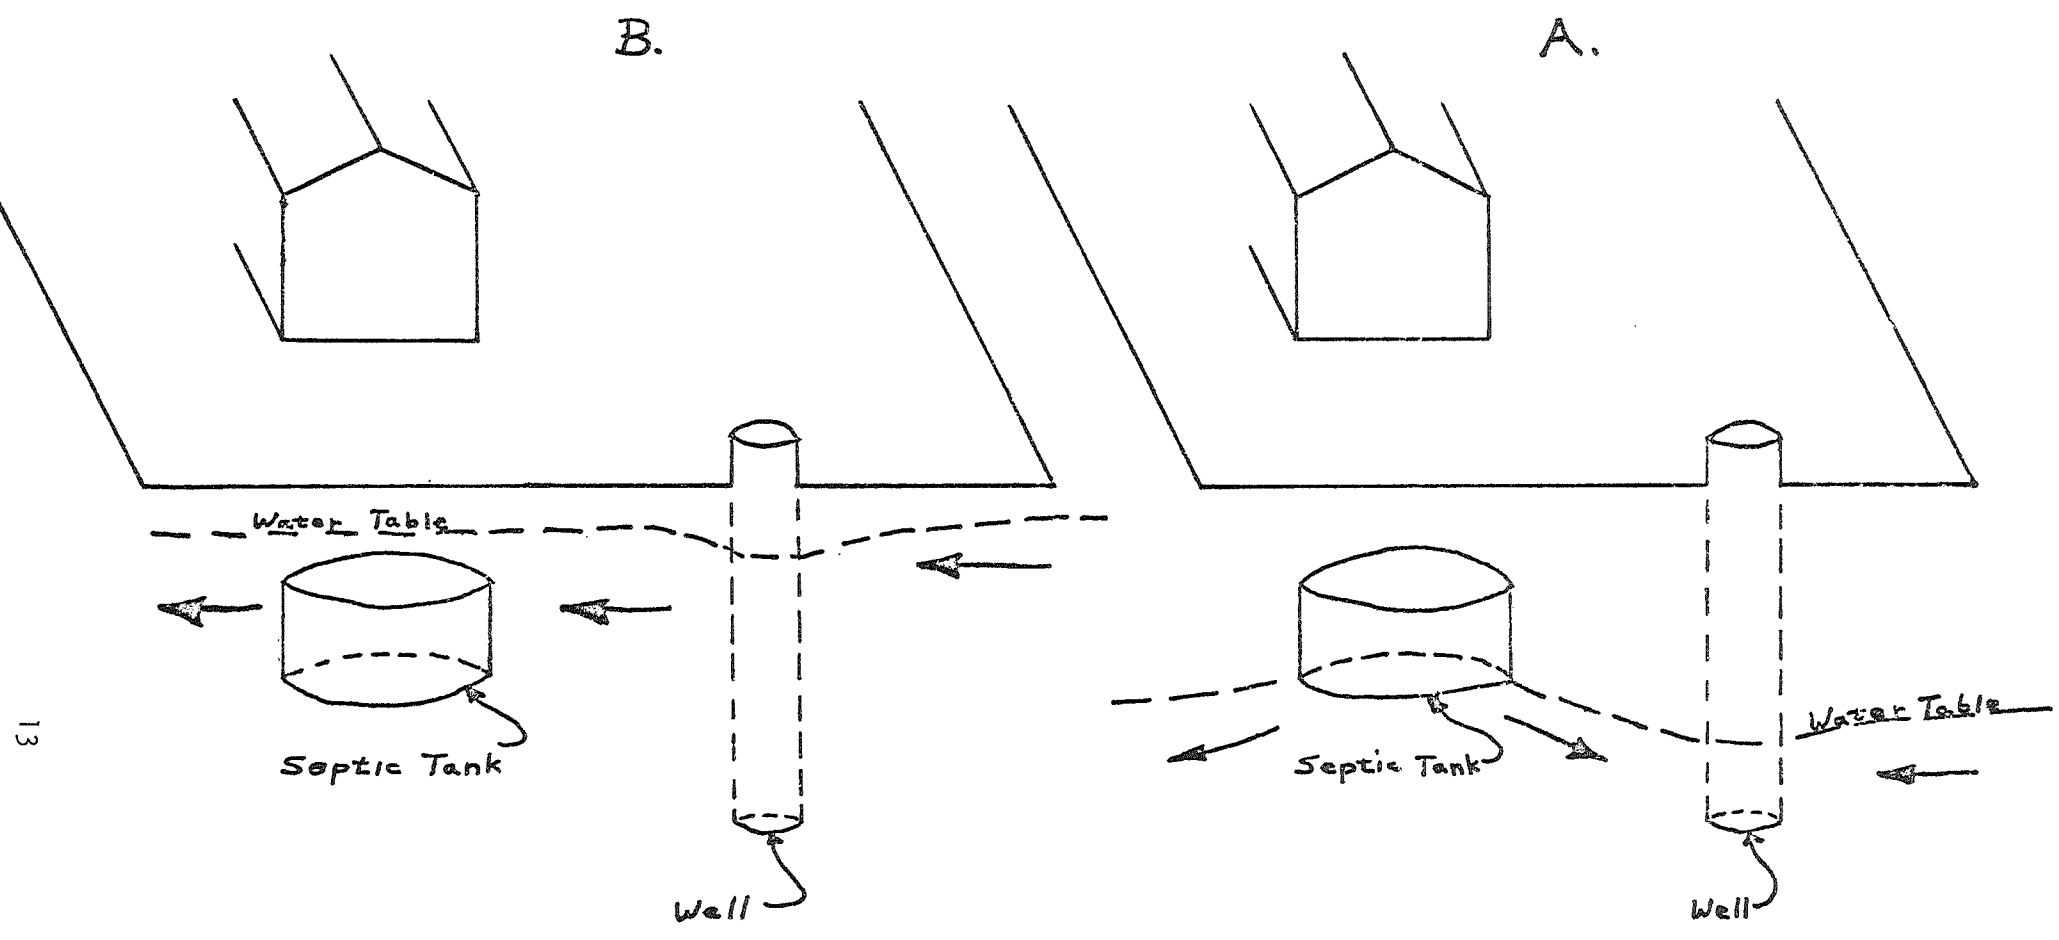
Figure 7

the water level in the well was lowered last summer, which the R. D. Aye report indicated, it is entirely possible that the ground-water gradient in proximity to the well was reversed. This reversal of the ground-water gradient could and probably would occur whenever the water level dropped during the summer months (Figure 7A).

While the septic tank was functioning properly little or no contamination reached the well, however when the malfunction occurred it then allowed pollution to enter the recharge area of the well. When additional water was added to the ground-water system during the winter months the water level would rise to near land surface allowing the ground-water gradient to return to its original course. (figure 7B)

It does appear that pollution due to the septic tank malfunction is the primary source of contamination. When the water level is low in the well the ground-water gradient is locally reversed allowing contamination or recycling of household water to occur.
