SUBJECT: BUDD INLET SURVEY OF AUGUST 27, 1975

DATE: August 28, 1975

State of
Washington
Department
of Ecology

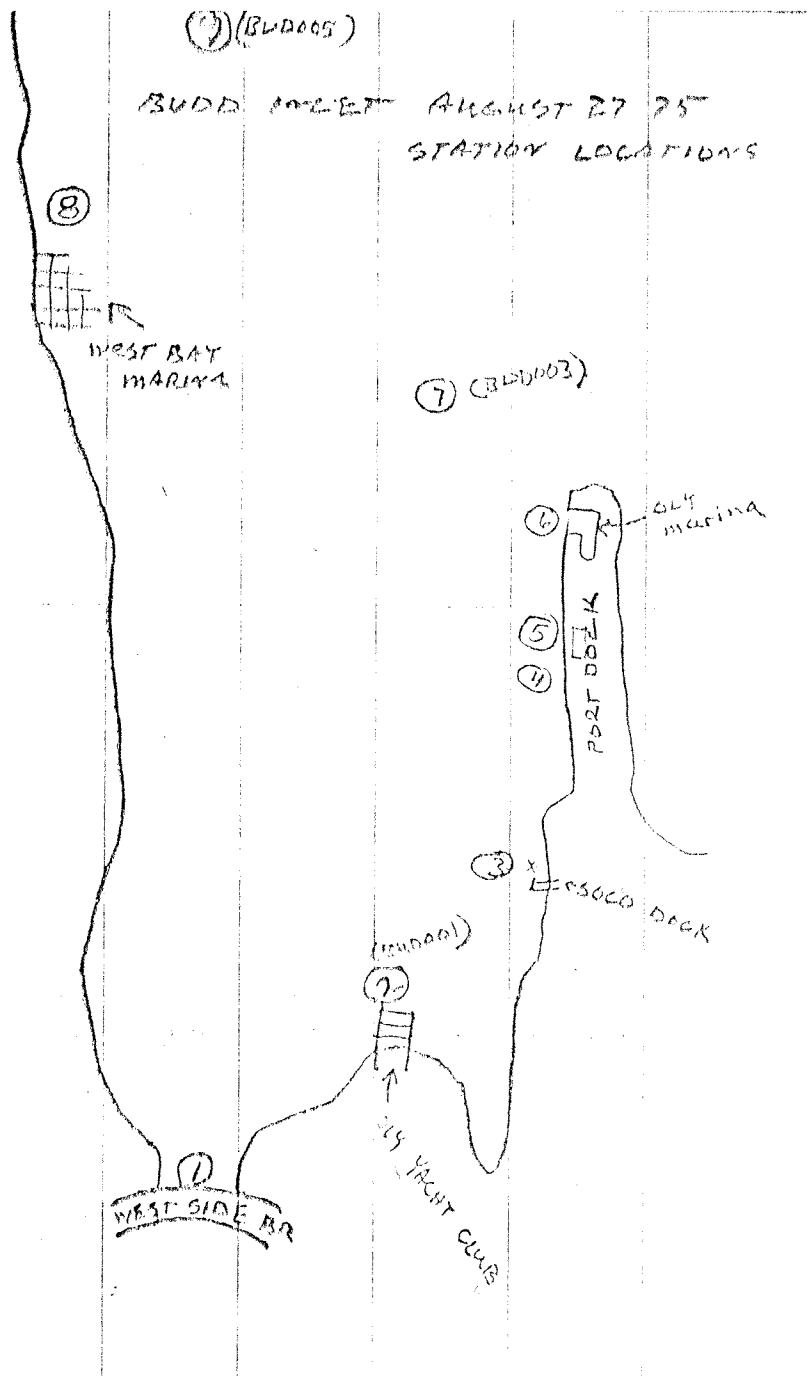
SHORT D.O. RECEIVING WATER
SURVEY CONDUCTED ON LOWER
BUDD INLET TO FURTHER
INVESTIGATE LOW D.O. OF
13 NOTED AT BUDDOI THIS
MORNING BY G. CLOUD (MARINE
FLIGHT)

D.O. ANALYSES BY IBC PROBE
AND WINKLER - READINGS
TAKEN BETWEEN 1330 AND
1530 HOURS ON OUTGOING
TIDE

OLYMPIA STP DISCHARGING
NEAR STANDARD OIL DOCK
THROUGHOUT AND PRIOR TO
STUDY. CAPITAL LAKE NOT
DRAWN DOWN

STATION	IBC	WINKLER
1	5.2	5.6
2	2.9	3.1
3	8.0*	6.4
4	1.2*	
5	.3*	.4
6	.3*	1.5
7	4.2	
8	10.2	8.7
9	>15**	13.4

* ERRATIC READINGS DUE TO
SHIFTING "POCKETS" OF LOW
DO.

** ALGAE BLOOM ELEVATING
D.O.
