M E M O R A N D U M

December 12, 1975

Subject: Ferndale Sewage Treatment Plant

STP Survey Report Form

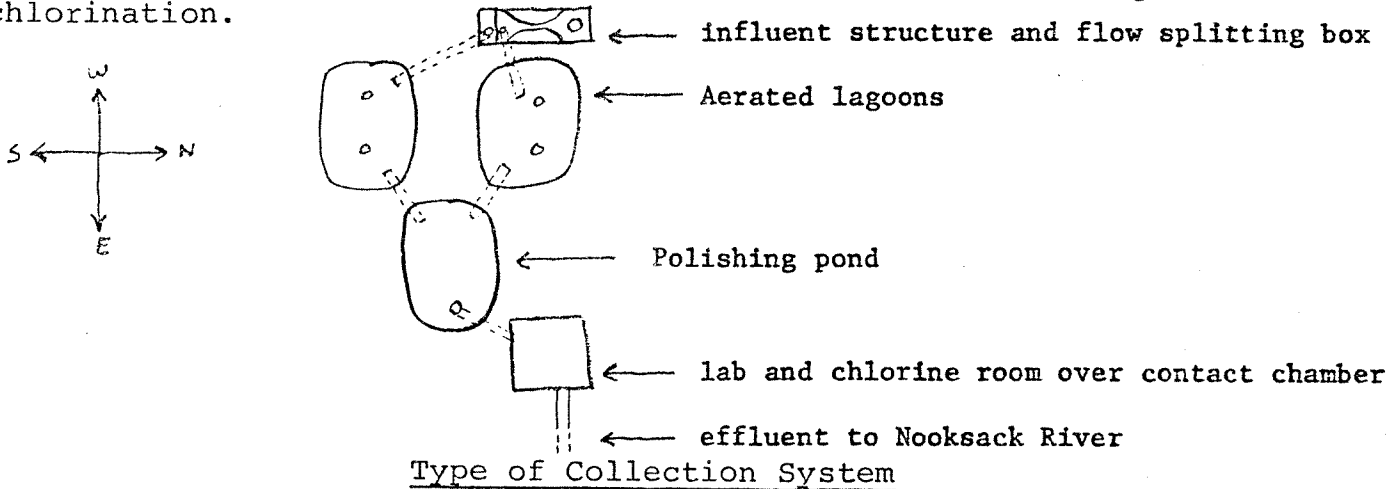
Furnish a flow diagram with sequence and relative size and points of chlorination.

COMMENTS: poorly designed and maintained
