DEPARTMENT OF ECOLOGY

WA-01-0040

To: Bruce Johnson/Roger Stanley
From: Bill Yake
Subject: Georgia Pacific, Bellingham, Class II Inspection

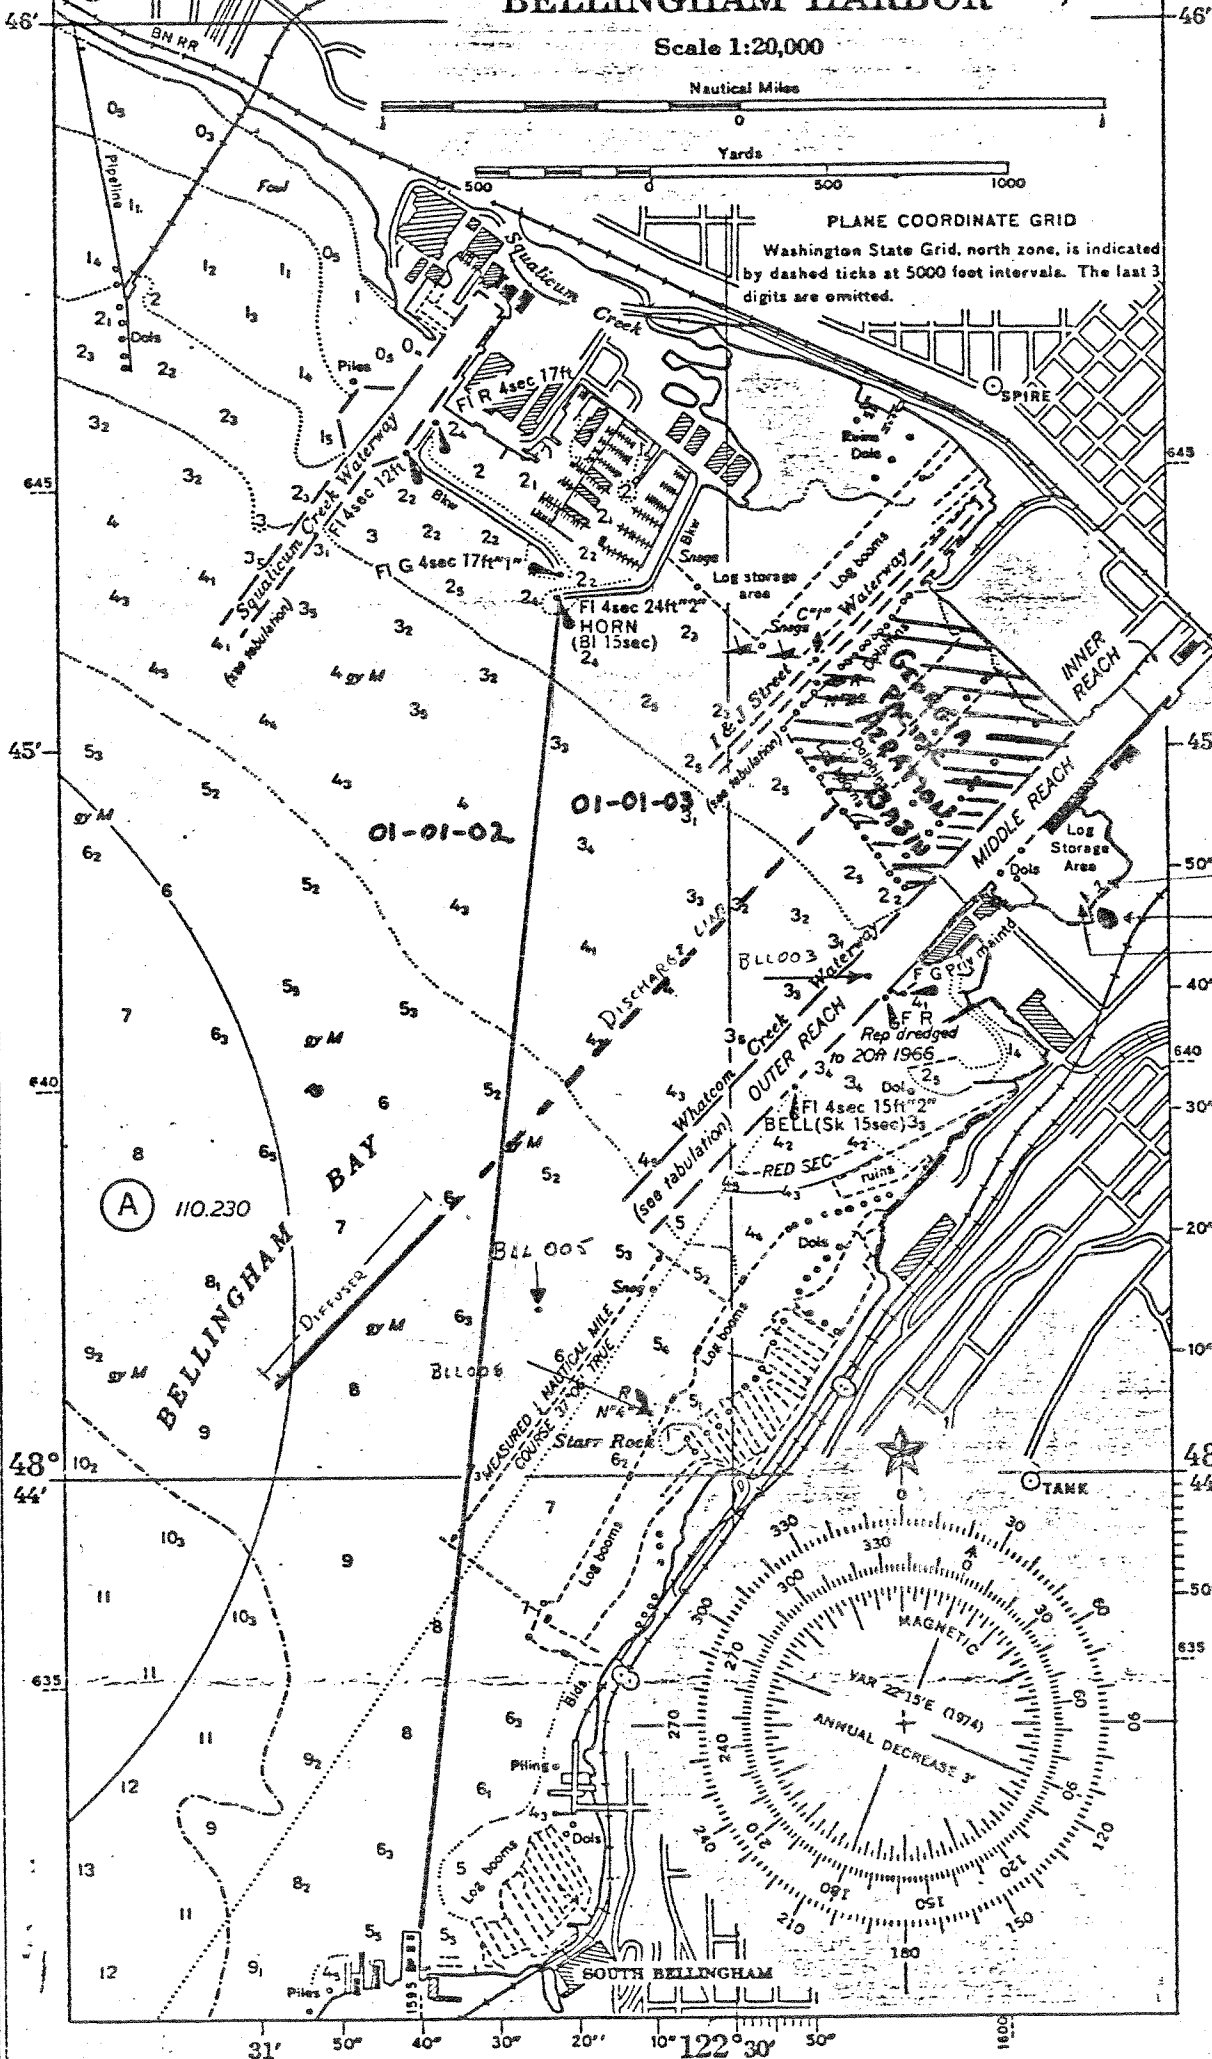
FIGURE - 1 BELLINGHAM HARBOR

Table 3 summarizes all mercury and metals analyses. Grab samples of the influent to and effluent from the Adam's filters provide an indication of the treatment efficiency of mercury contaminated wastewaters. Backwash from the Adam's filters is intermittently discharged to a holding pond (see Figure 1). The pond also receives other mercury contaminated wastewaters. Water is pumped from the pond and cycled through the sulfate/Adam's filter treatment system with only backwash returned to the pond. Flecks and globules of mercury were apparent on the pond banks and bottom.

A bank-side grab sample was obtained from Whatcom Waterway northeast of the mercury pond (see Figure 1). The pond is separated from the waterway by 30 to 50 feet of earth at this point. The detected concentration of mercury in this sample was 0.68 $\mu\text{g}/\text{l}$. This compares to the EPA water quality criteria of 0.10 $\mu\text{g}/\text{l}$ for the protection of marine aquatic life.

Approximately 75 to 100 feet northeast of this sampling point an unidentified discharge was noted during low tide. The pipe was partially submerged and was discharging a red-brown effluent to the waterway. A grab sample was obtained near the pipe. This sample represents the effluent/waterway mixture near the pipe and contained 71 $\mu\text{g Hg}/\text{l}$. This discharge is not referenced in the NPDES permit and Georgia Pacific personnel could not identify its source.

4. An unidentified and unpermitted discharge was observed near the mercury pond. Mercury content in this discharge was substantial ($>71 \mu\text{g Hg/l}$), although total flow at the time of observation was not high. This discharge should be properly accounted for and treated, rerouted, or sealed, as appropriate.
