DEPARTMENT OF ECOLOGY

MEMORANDUM November 6, 1979

Subject: Waitsburg Class II Inspection

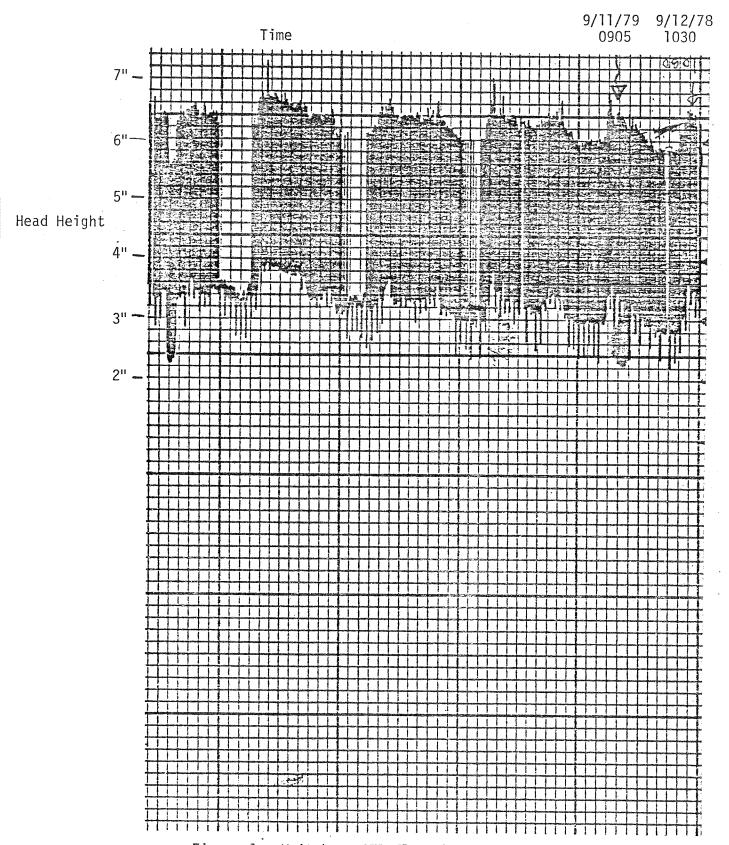
Figure 1. Waitsburg STP flow chart

Another set of design deficiencies severely limit the effectiveness of the chlorination system. Effluent flow (see Figure 1) fluctuates dramatically because of the intermittent operation of the wet well pumps. The chlorination system is not flow proportional. The operator is, therefore, caught between two evils. Either he sets the chlorine feed high enough to achieve adequate disinfection at peak effluent flows (minimum contact time and maximum volume) and creates chlorine toxicity problems in the creek, or he sets the chlorine feed low enough to prevent receiving water toxicity and fails to disinfect the majority of the effluent. The Eastern Region has chosen, probably wisely, to limit effluent chlorine at the expense of adequate disinfection. Thus the order limits chlorine residual rather than fecal coliform concentration.

An additional difficulty with the flow measuring system is caused by the lack of a totalizer on the recording device, the constant variation in flows due to the pumping system, and the slow chart advance. As a result, flow must be determined by estimating the mean flow from a trace like the one shown in Figure 1.
