STATE OF
WASHINGTON

DEPARTMENT OF ECOLOGY

M E M O R A N D U M

To: John Hodgson
From: John Bernhardt and Tim Determan
Subject: Omak Groundwater Contamination

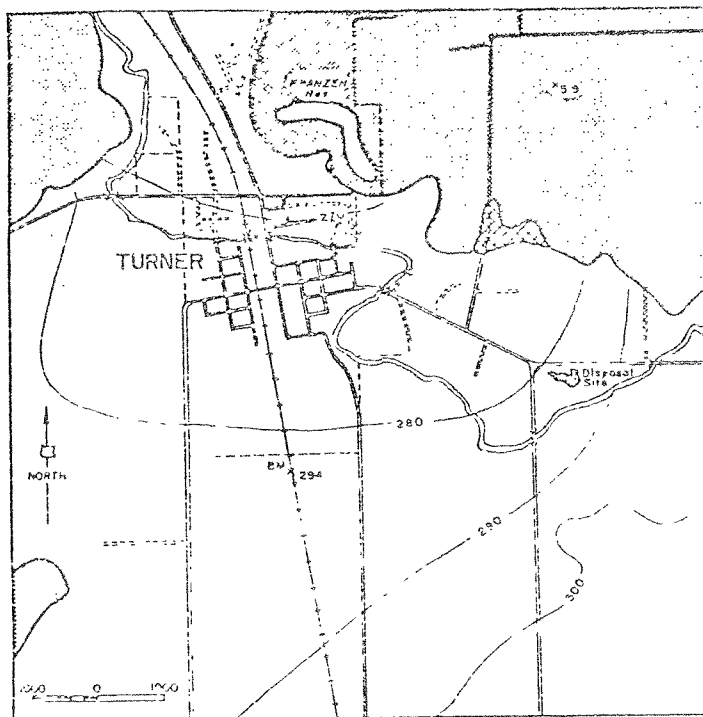
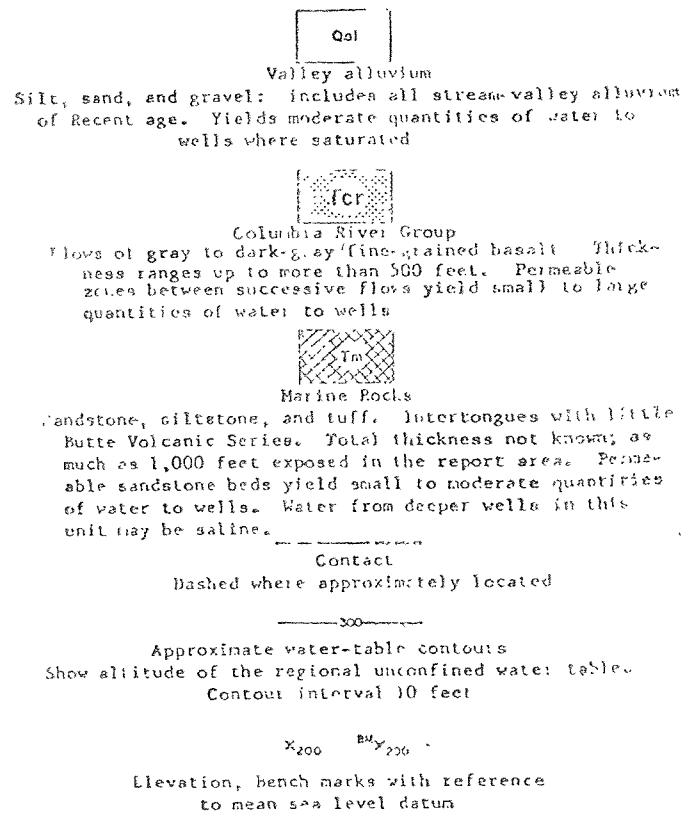
Fig. 3. Geology and water table in the Turner study area (after Hampton, 1972).

Hampton (1972) roughly mapped the surface of the water table in the problem area (see Figure 3). This map indicates a general downgradient, lateral movement of ground water from the east-southeast toward the west-northwest in the vicinity of the disposal site.

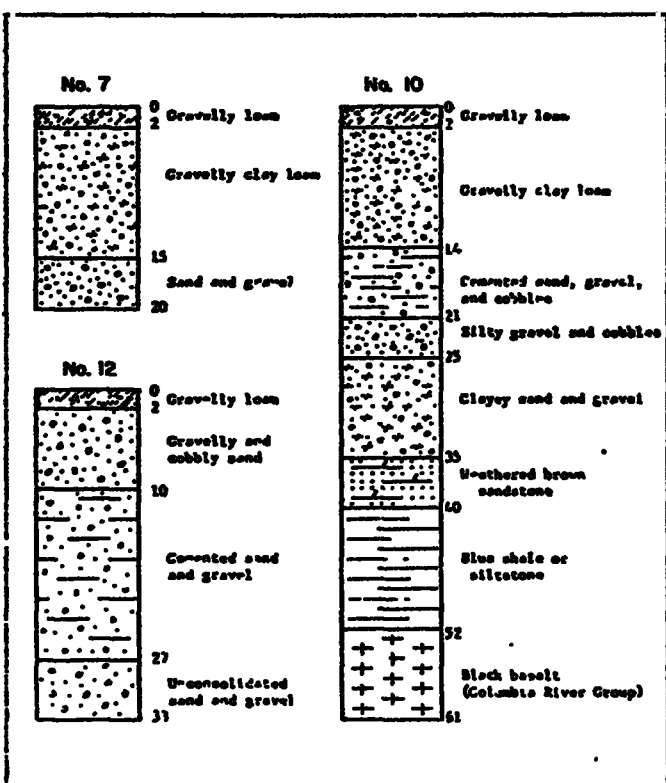
Most of the ground water being developed in the area is extracted from the Recent alluvial deposits. The depth of the gravels ranges from about 50 feet (15 meters) at well number 12, Figures 4 and 5, to at least 100 feet (30 meters) in wells south

Fig. 4. Available well logs from water wells in the Turner study area.

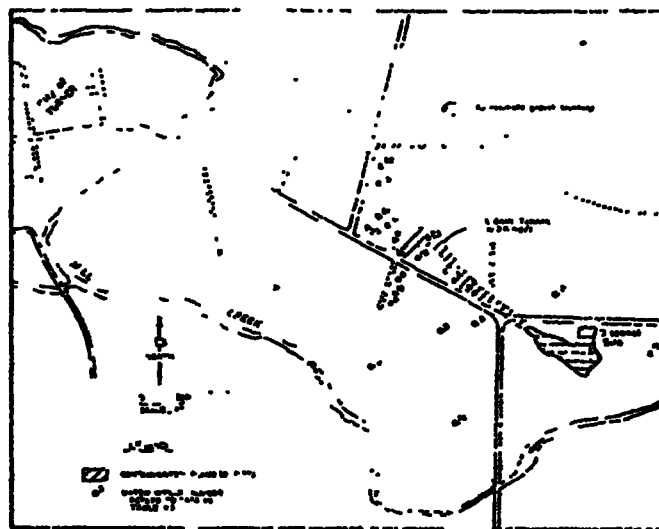
Fig. 5. Lignin-tannin contaminant plume, August 18, 1972.

An initial drop in pH and an increase in total acidity of contaminated ground water were anticipated. These conditions were confirmed in the downgradient wells affected by the wood waste leachate. However, of the chemical constituents used to detect the movement of the leachate, lignin-tannin concentrations seemed to be the most reliable indicator. According to McKee and Wolf (1963), a tannic acid concentration of from 2 to 4 milligrams per liter (mg/l) imparts a woody taste and odor to water. Odors and a yellow-brown discoloration in the well-water samples collected in this investigation were observed to occur at levels as low as 0.4 mg/l. Therefore, the approximate areal extent of shallow ground water containing at least 0.4 mg/l of lignin-tannin, as tannic acid, was plotted. Figures 5 and 6 show the extent of the contaminated shallow ground water on August 18, 1972 and

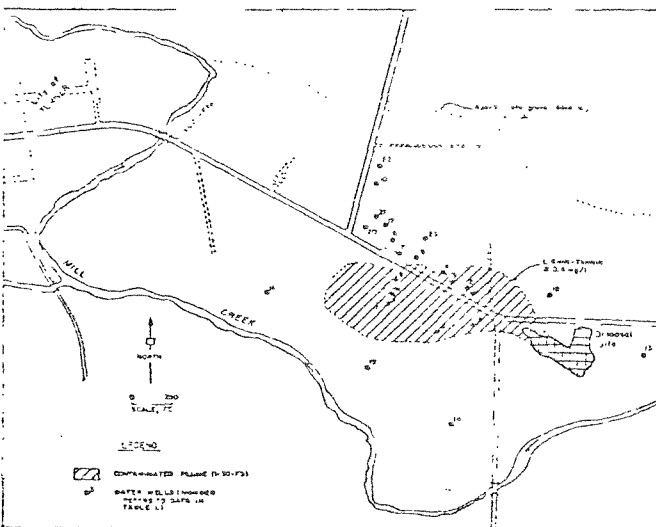
The study area receives an average of over 45 inches (110 centimeters) per year of incident precipitation. More than 12 inches (30 centimeters) of rainfall occurred between the August 1972 and January 1973 surveys used in developing Figures 5 and 6. During the January 30, 1973 survey, the water table was observed to be at the land surface in the low lying areas. The change in the local flow regimen and the predicted lateral migration appeared to have occurred, as evidenced by the larger plume in late January of 1973 (see Figure 6). The area affected by the leachate contaminated ground water increased from approximately 4 acres (1.7 hectares) and 1000 feet (330 meters) downgradient from the disposal site in August 1972 to about 15 acres (6 hectares) and 1500 feet (460 meters) downgradient in January 1973.

Fig. 6. Lignin-tannin contaminant plumes, January 30, 1973.
