DEPARTMENT OF ECOLOGY

M E M O R A N D U M

December 1, 1983

Subject: Longview Diking District Study

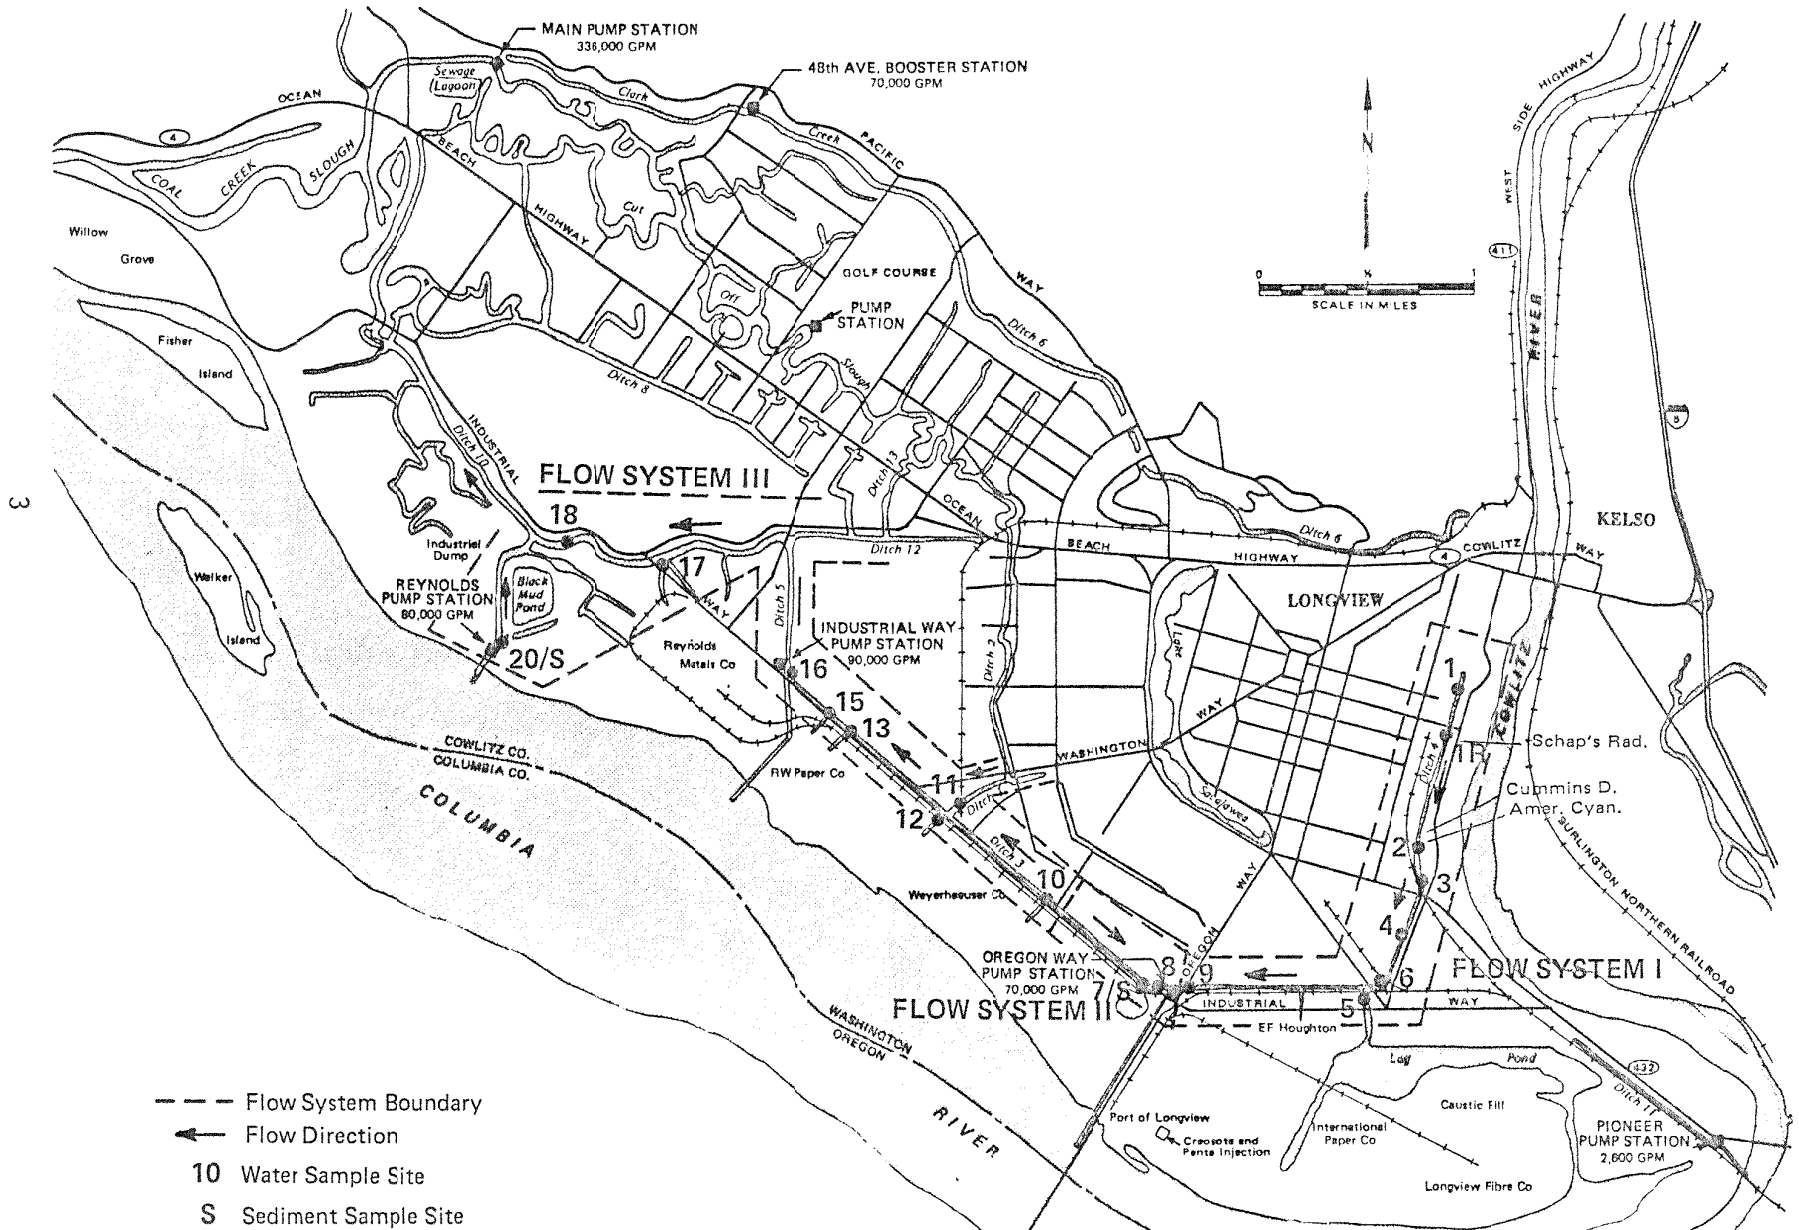
Figure 1. SAMPLING LOCATIONS ON LONGVIEW DITCHES. MAP MODIFIED FROM CONSOLIDATED DIKING IMPROVEMENT DISTRICT NO. 1, 1982.

At the time of sampling, the Industrial Way pump station was not operational. The Reynolds pump station was functional; however, not operating during the survey. The observed direction of flow is indicated in Figure 1. Flows in the ditches and in the discharges to the ditch were not measured. Water levels in the ditches on the 26th were about two feet higher than on the previous day due to heavy precipitation on the evening of the 25th and the morning of the 26th.

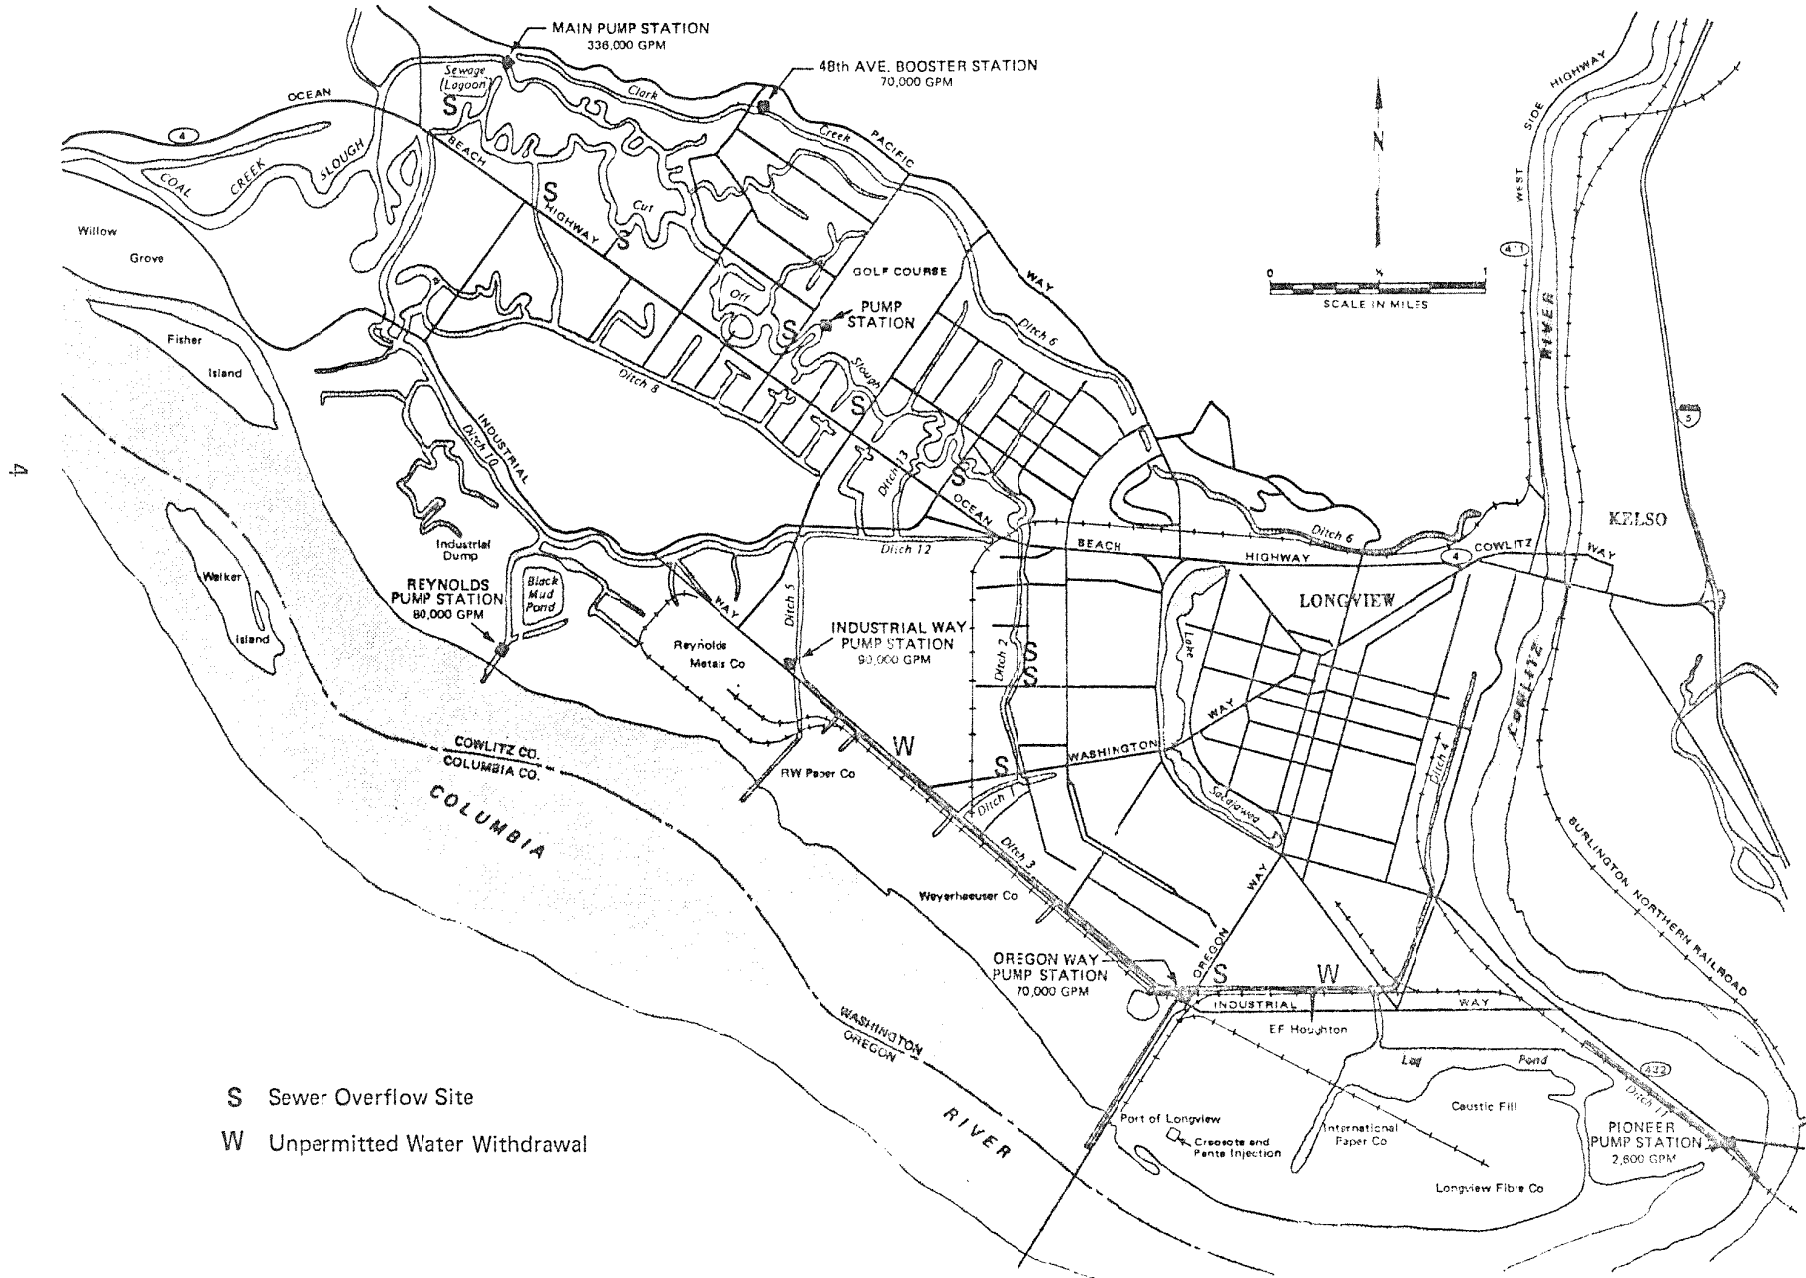
Figure 2. LOCATION OF SANITARY SEWER OVERFLOWS AND UNPERMITTED WATER WITHDRAWALS. MAP MODIFIED FROM CONSOLIDATED DIKING DISTRICT NO. 1, 1982.

Locations of 10 of the 11 sanitary sewer overflow sites are shown in Figure 2 (Zandi, 1983; Edtl, 1983). Bypasses are manually controlled and events recorded in a log maintained by the city engineer (Edtl, 1983). The record for 1982 indicates bypasses occur most frequently to ditches 6 and 7 in the north section of town and in ditch 2 in the central section near Hudson Street. Bypasses occur primarily in the months of heavy precipitation; however, none were recorded during the period of this sampling.

The locations of the sewer bypasses are given in Figure 2. As noted previously, the bypasses generally occur during the winter months and based on recent records, occur most frequently on the north edge of town to ditch 6. The bypasses are caused in part by groundwater infiltration and inflow during the winter months. The infiltration means that the sewage is diluted at the time of bypass and is subsequently diluted by flow in the ditches. Because ditch and bypass quality and quantity have never been simultaneously determined and there were no bypasses occurring at the time of this sampling, a quantification or estimation of impacts was not possible. It may be possible to quantify impacts during future field work; however, a bypass event will not be a prerequisite for sampling.
