Water Body No. WA-39- 1110 (Segment No. 18-37-02)

SELAH WASTEWATER TREATMENT PLANT RECEIVING WATER SURVEY OCTOBER 1988

by Joe Joy

January 1990

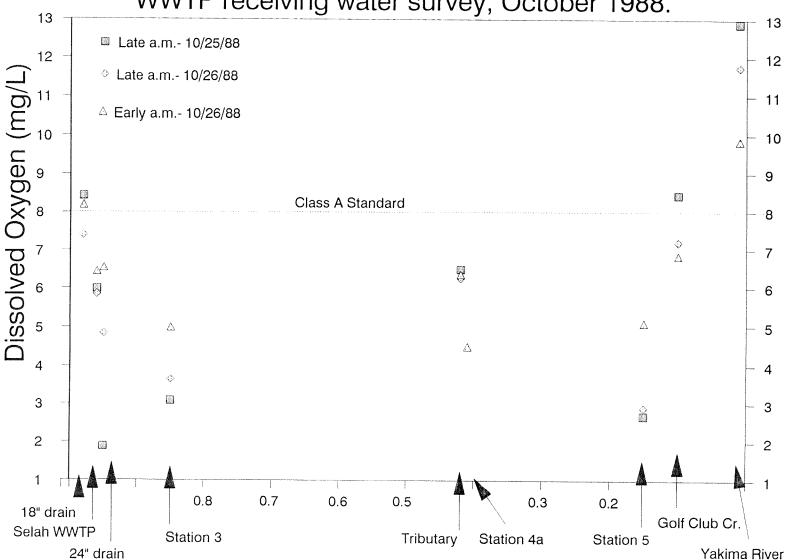
Figure 2. Dissolved oxygen concentrations at sites during Selah WWTP receiving water survey, October 1988.

In general, the "upstream" receiving water quality was very poor. It had a relatively low volume (less than 5 cfs), and high temperature (greater than 18 degrees C.). Fecal coliform levels (1100 to 15,000 organisms/100 mL) in samples taken from both sites greatly exceeded Class A criteria (Table 5). Although Station 1 dissolved oxygen (D.O.) concentrations were usually in compliance with the 8 mg/L Class A water quality standard, Station 2 concentrations were often less than 5 mg/L (Figure 2).

Sphaerotilus communities prefer simple carbohydrates and organic acids (indicated by high carbonaceous BOD concentrations), pH above 7, instream D.O. above 3 mg/L, and an optimum temperature of 22°C. (Schwoerbel, 1987). All riffle areas of the ditch were nearly ideal environments for optimum growth of this community. The metabolic activity of the heterotrophic organisms kept the D.O. below 5 mg/L at all sites in the ditch to its confluence with the Yakima River (Figure 2).

In contrast to the 24-inch drain, the WWTP effluent had BOD concentrations less than 3 mg/L (Table 5), with D.O. concentrations from 5.8 mg/L to 6.45 mg/L (Figure 2). Since the average initial dilution ratio of effluent in the ditch was 1.4:1, and 3.2:1 after Station 2, the low D.O. WWTP effluent would have had a local impact on the ditch under more favorable receiving water quality conditions. For example, at 3.2:1 dilution of background cooling water with D.O. at 8.0 mg/L, a loss of 0.5 mg/L could be expected after complete mixing.

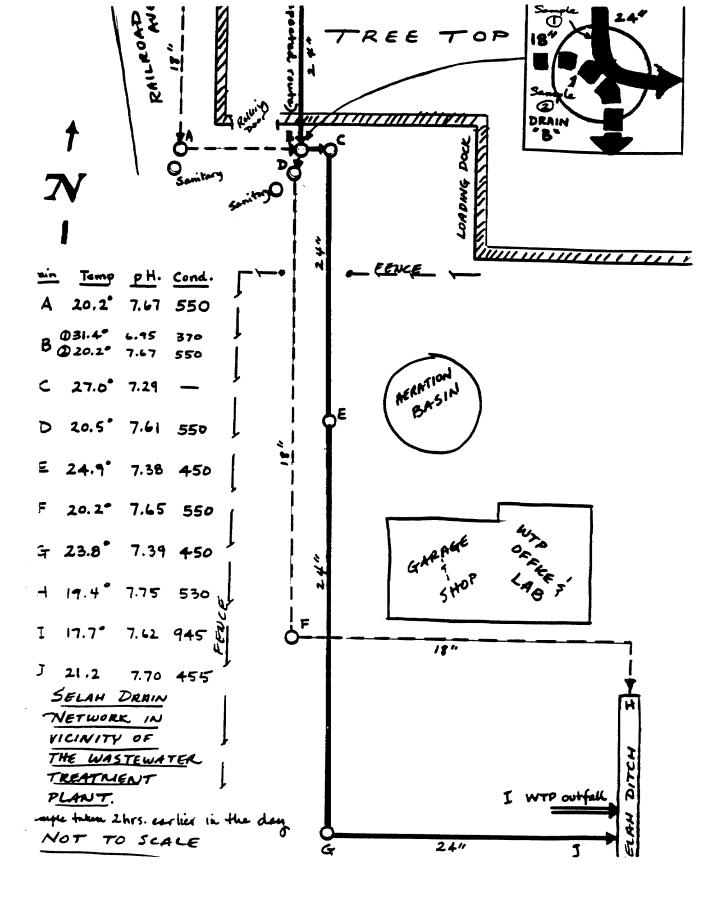
We failed to locate any manholes for the 24 inchestorm drain system between 2nd Avenue and Drain "9". The drain line probably travels under Tree Top since the building was built on the old road after the city sold Tree Top an easement. Joe Ford, the wastewater treatment operator, thought there may be a manhole on the north side of the Tree Top building. Unfortunately, while we were there this area was under hundreds of apple boxes. From 2nd Avenue north along Railroad Avenue to Naches Avenue, there was no flowing water in the 24 inch drain line.

Mannoles "B", "C", "E", "G", and outfall "J", all had a fruit odor which suggests a misconnection with a condensate or other product line. Tentative laboratory analyses of total organic carbon indicate the water from outfall "J" will have a BOD greater than 100 mg/L. while water from outfall "H" will be less than 20 mg/L (personal conversation with F. Crawford, Manchester Laboratory). As you stated yesterday, engineers from Tree Top and the City of Selah should be notified of the problem, the drain under the building should be traced, and the errant discharge to the 24 inch line should be eliminated.
