Appendices I and J

Effectiveness of Forest Road and Timber Harvest Best Management Practices with Respect to Sediment-Related Water Quality Impacts

December 1999
Publication No. 99-350

by
Ed Rashin
Casey Clishe
Andy Loch
Johanna Bell

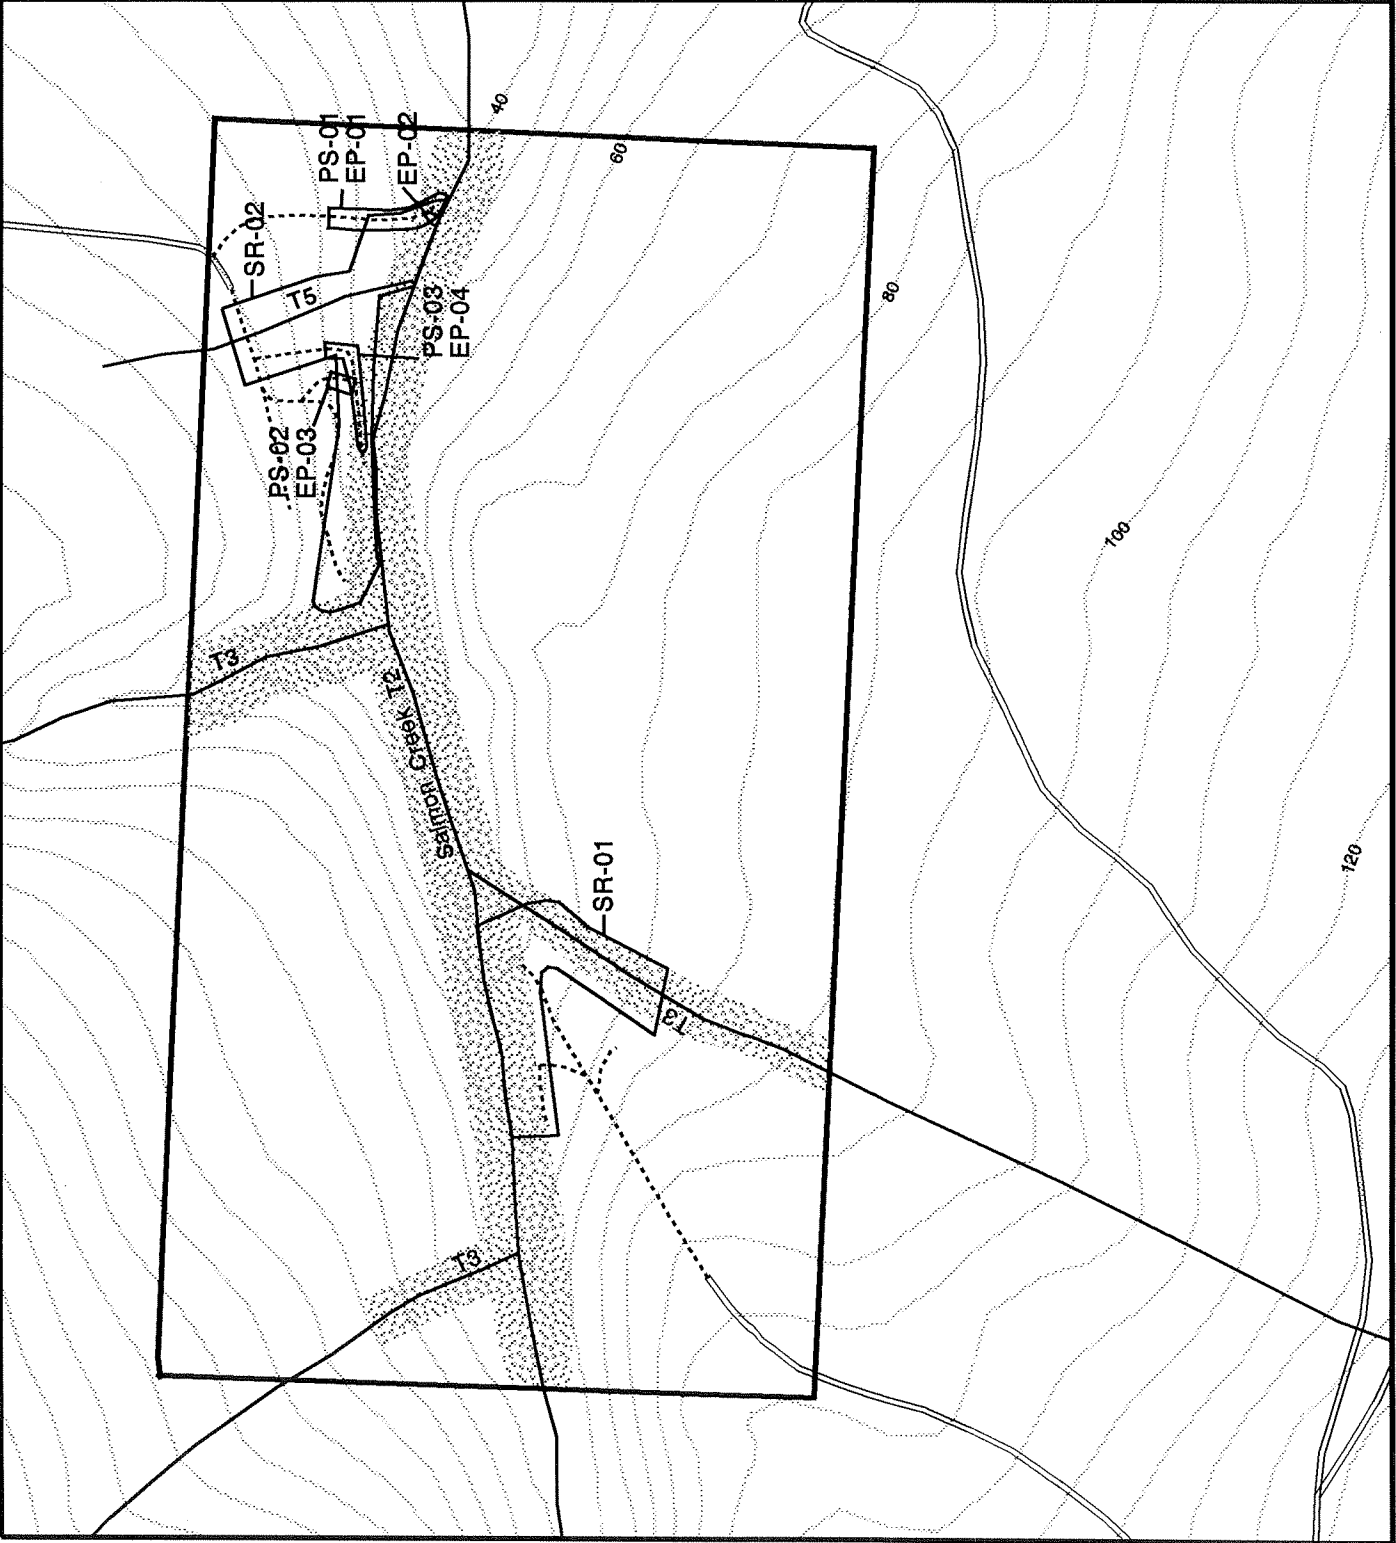
Study Site: O-01: Salmon Creek - Clearcut harvest, with RMZ and harvest without stream buffers		BMP Effectiveness Ratings		
Survey Employed	Harvest w/ RMZ & Streambank Integrity BMPs (WAC 222-30-020(2-4) & -030 & -040 & 050)	Harvest with no buffers (Type 4 and/or 5 Waters)	Harvest with RL TAs (Type 4 and/or 5 Waters) (WAC 222-30-020(6))	
	Ground-based Yarding	Ground-based Yarding	Ground-based Yarding	
Sediment Routing: SR-01 SR-02BU SR-02NB	Effective Effective	WAC 222-30-070	WAC 222-30-060	WAC 222-30-060
Photo Point (Skid Trails): PS-01, PS-02, & PS-03	Effective			
Erosion Pin Networks: EP-01, EP-02, EP-03, & EP-04	Effective			
Case Narrative: The RMZs were effective at preventing chronic sediment delivery directly to Salmon Creek and its buffered tributaries from activities or erosion features directly attributable to current harvest practices. Yarding within an RMZ resulted in erosion features which delivered to a Type 3 stream (SR01--1993), but delivery from these features did not persist. Windthrow, which may be indirectly associated with the clearcut harvest, and a pre-existing mass wasting feature are the primary source of sediment to Salmon Creek, which was buffered with a wider than required RMZ that extended to or nearly to the slope break at the edge of a steep inner gorge. Windthrow was severe in portions of the inner gorge. Gully development and other chronic erosion problems on skid trails (some of which entered the inner gorge and the RMZ) were prevented through the use of water bars and berms. Chronic sediment delivery to an unbuffered Type 5 stream was documented at the crossing of a major skid trail.

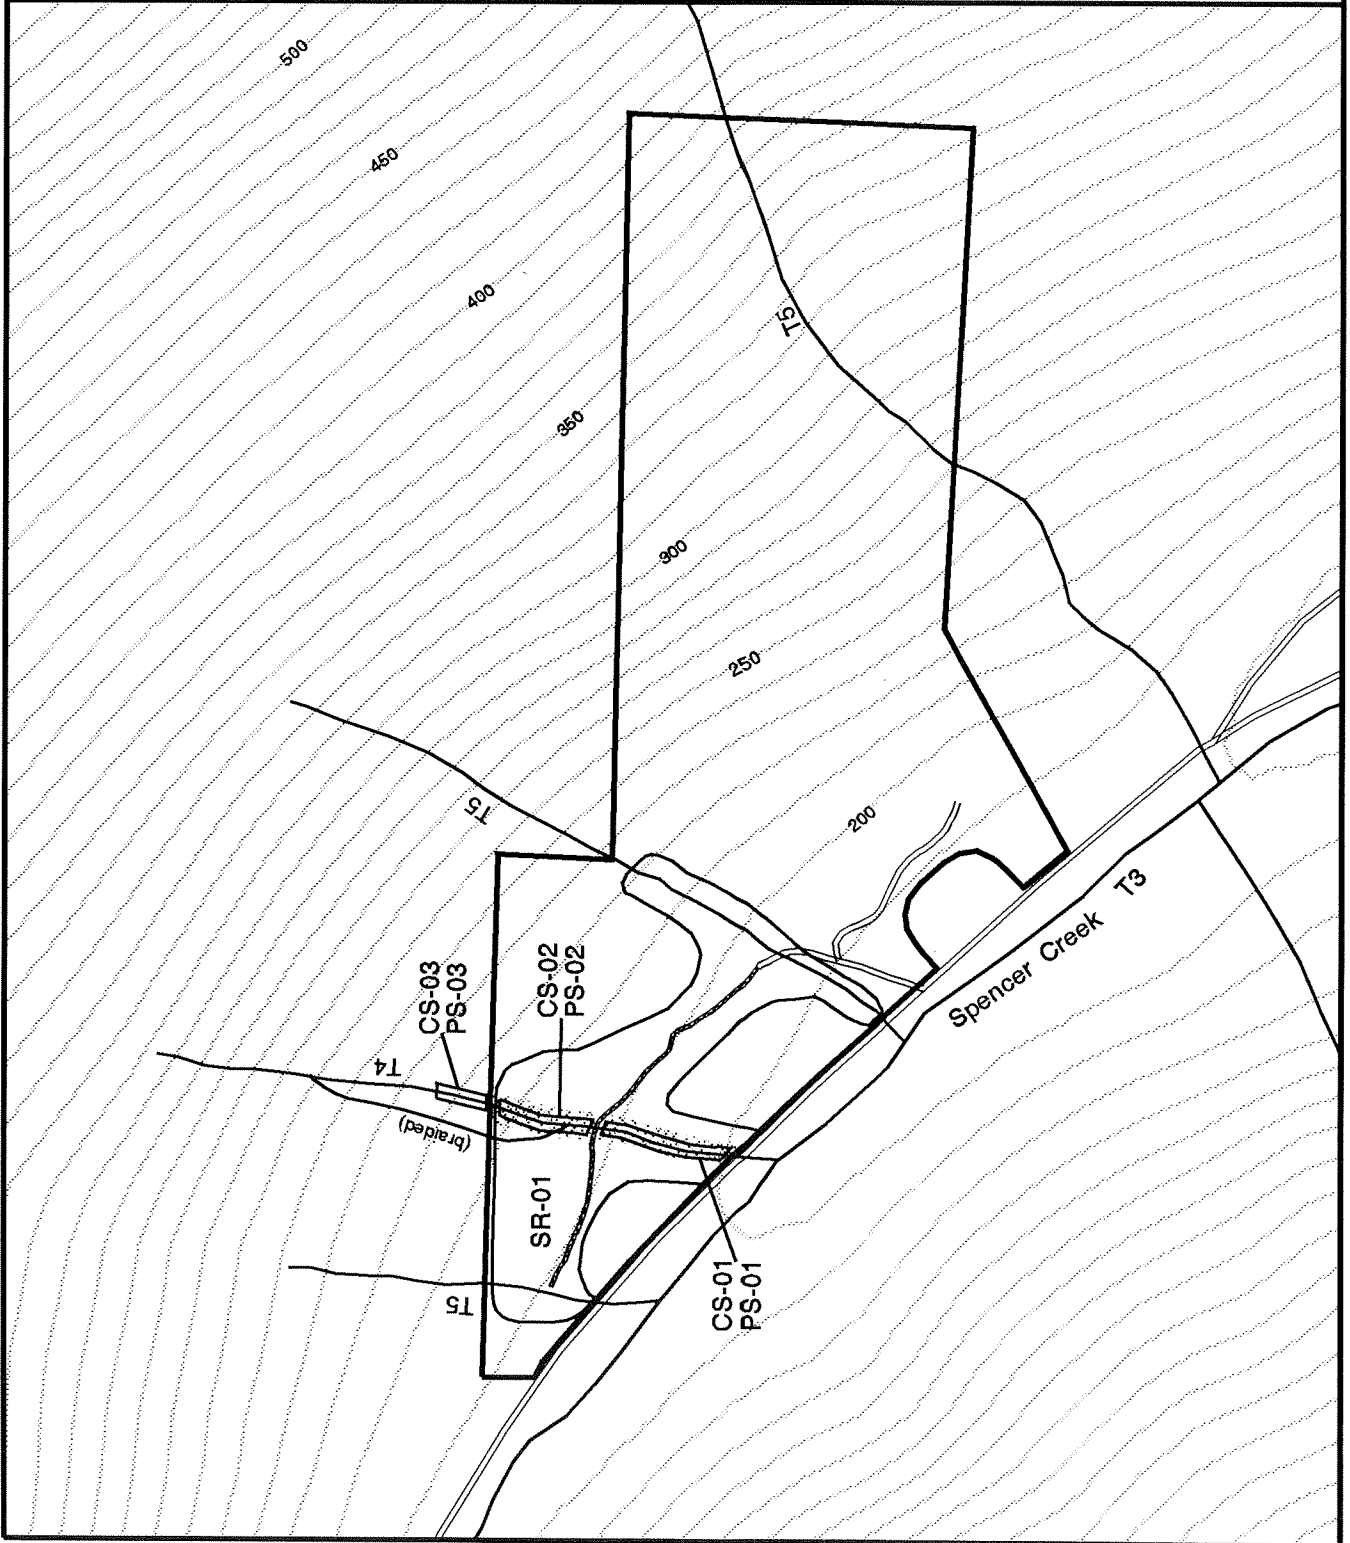
Study Site:	O-02: Walker Pass - Clearcut harvest, with RLTA and harvest without stream buffers			
	BMP Effectiveness Ratings			
Survey Employed	Harvest w/ RMZ & Streambank Integrity BMPs (WAC 222-30-020(2-4) & -030 & -040 & 050)	Harvest with no buffers (Type 4 and/or 5 Waters)	Harvest with RLTA's (Type 4 and/or 5 Waters) (WAC 222-30-020(6))	
	Ground-based Yarding WAC 222-30-070	Cable Yarding WAC 222-30-060	Ground-based Yarding WAC 222-30-070	Cable Yarding WAC 222-30-060
ASPECT 1: Effectiveness in terms of chronic erosion with delivery to surface waters.	Sediment Routing: SR-01BU SR-01NB	Not Effective	Not Effective	Not Effective
Case Narrative: Chronic sediment delivery from harvest-attributable erosion features was documented in the area of the RLTA as well as where type 5 streams were not buffered. Where the RLTA practice was used, chronic sediment delivery was limited to skid trail crossings and one other yarding erosion feature, whereas more substantial amounts of chronic sediment delivery were observed in one of the un-buffered streams, particularly from a landing and temporary crossing.

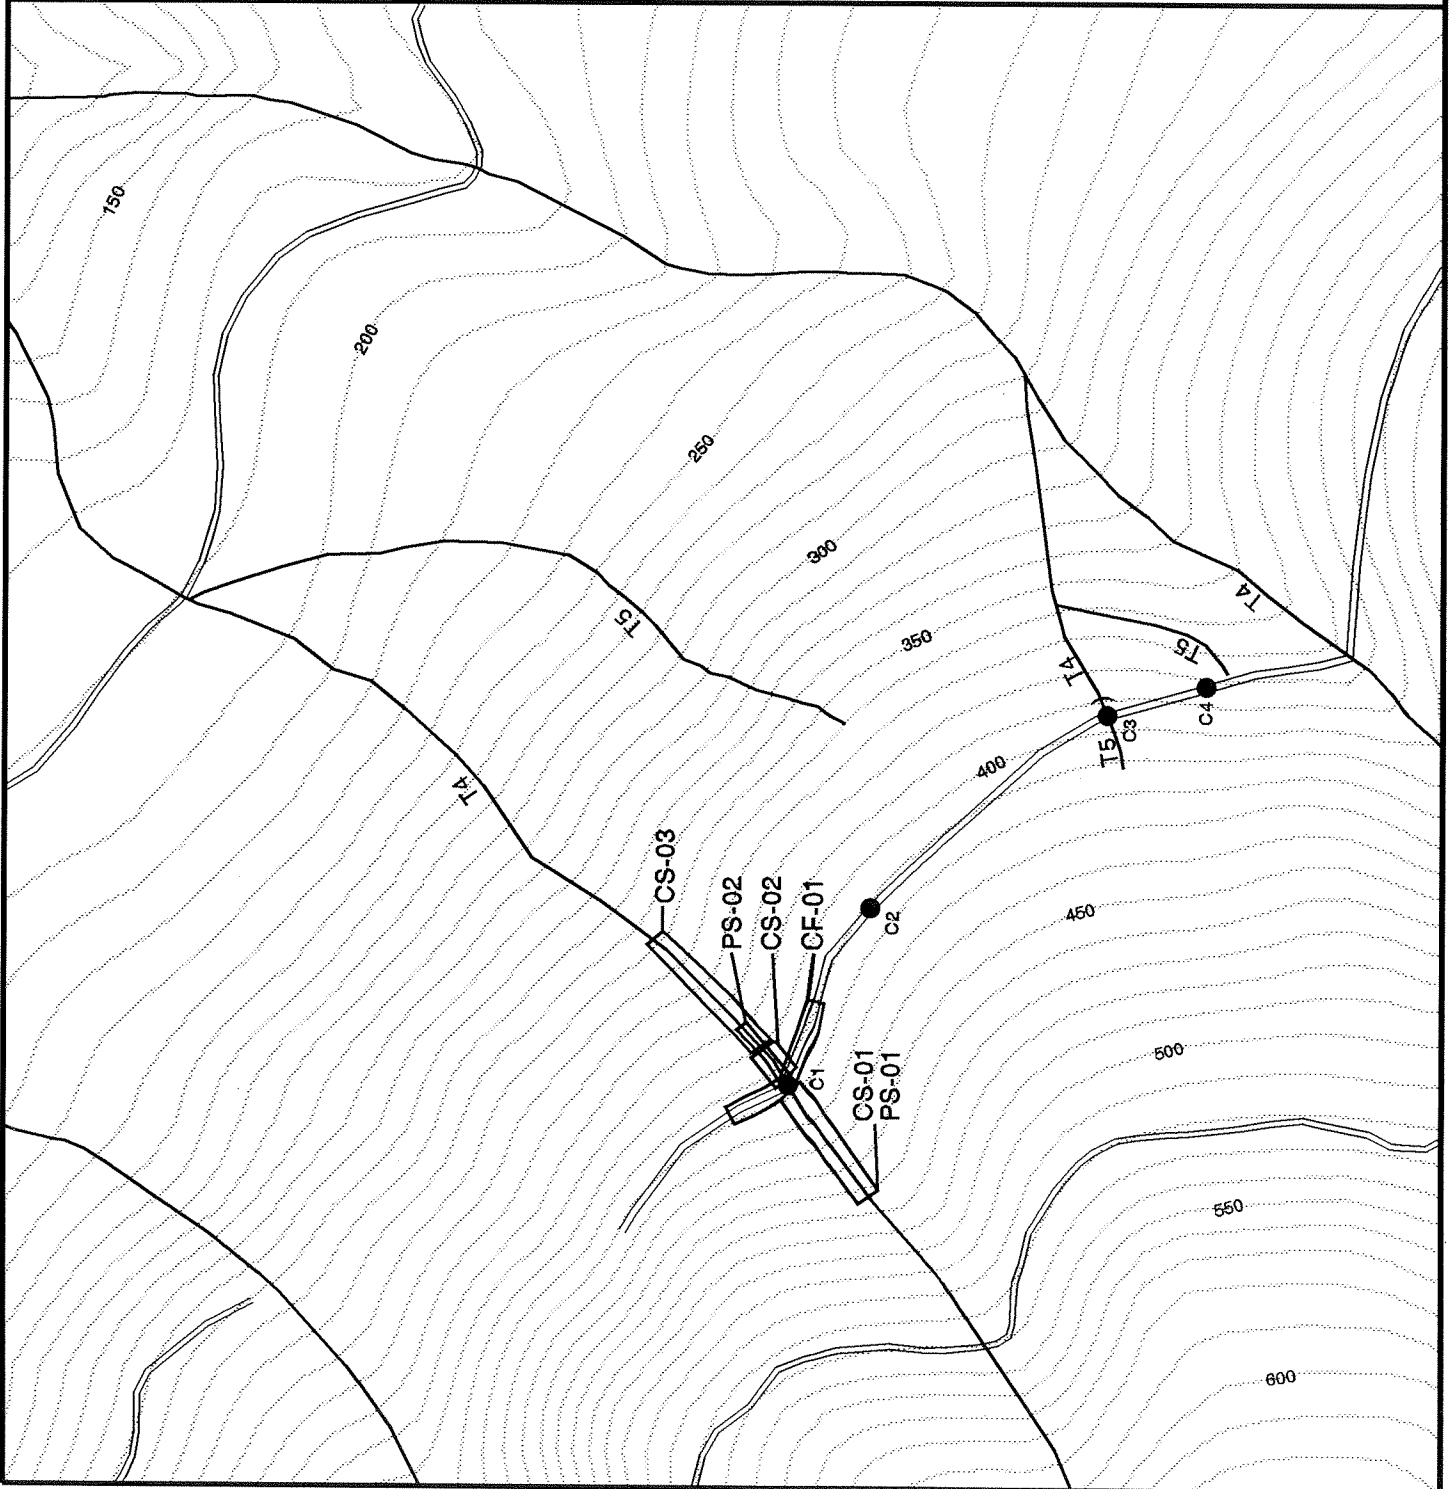
Study Site: O-03: Jupiter Road - New Road Construction		BMP Effectiveness Ratings		
Survey Employed	Culvert BMPs	Road Construction BMPs	Cutsoles	Fillslopes
	Stream Xings WAC 222-24-040	Relief WAC 222-24-025		WAC 222-24-030
ASPECT 1: Effectiveness in terms of chronic erosion with delivery to surface waters.	Culvert Condition: CC-01 Not Effective	Effective		
	Cutbank/Fillslope: CF-01		Not Effective	Not Effective
Case Narrative:	Relief culverts did not deliver sediment to streams over the monitoring period, and are rated effective. Channelized sediment transport distances downslope of relief outfalls ranged from 10 to 50 meters. There was substantial erosion, including gulying of the very large fill at the Type 4 crossing, and gulying of cut slopes, with chronic sediment delivery to streams at both road crossings. An estimated 25 m ³ of sediment was eroded and delivered from gully erosion on the fill over the Type 4 alone. Gullies persist on the culvert fill and on cutsoles despite otherwise vigorous growth of grass/clover following hydromulching the first spring after construction. One problem observed was the filling of the ditches due to gulying and sloughing of cutsoles, which apparently diverted drainage across the road onto fillslopes, combined with the fact that the road surface was crowned/outslopped as it approached the stream crossing. Chronic delivery from fillslopes was not limited to localized erosion of the culvert fill, but also included delivery of material eroded from the cutslope, ditch, and road surface which was diverted across the fill. Fillslope erosion was also found to be a source of sediment to a type 5 stream that was located just downslope of another section of the new road construction.

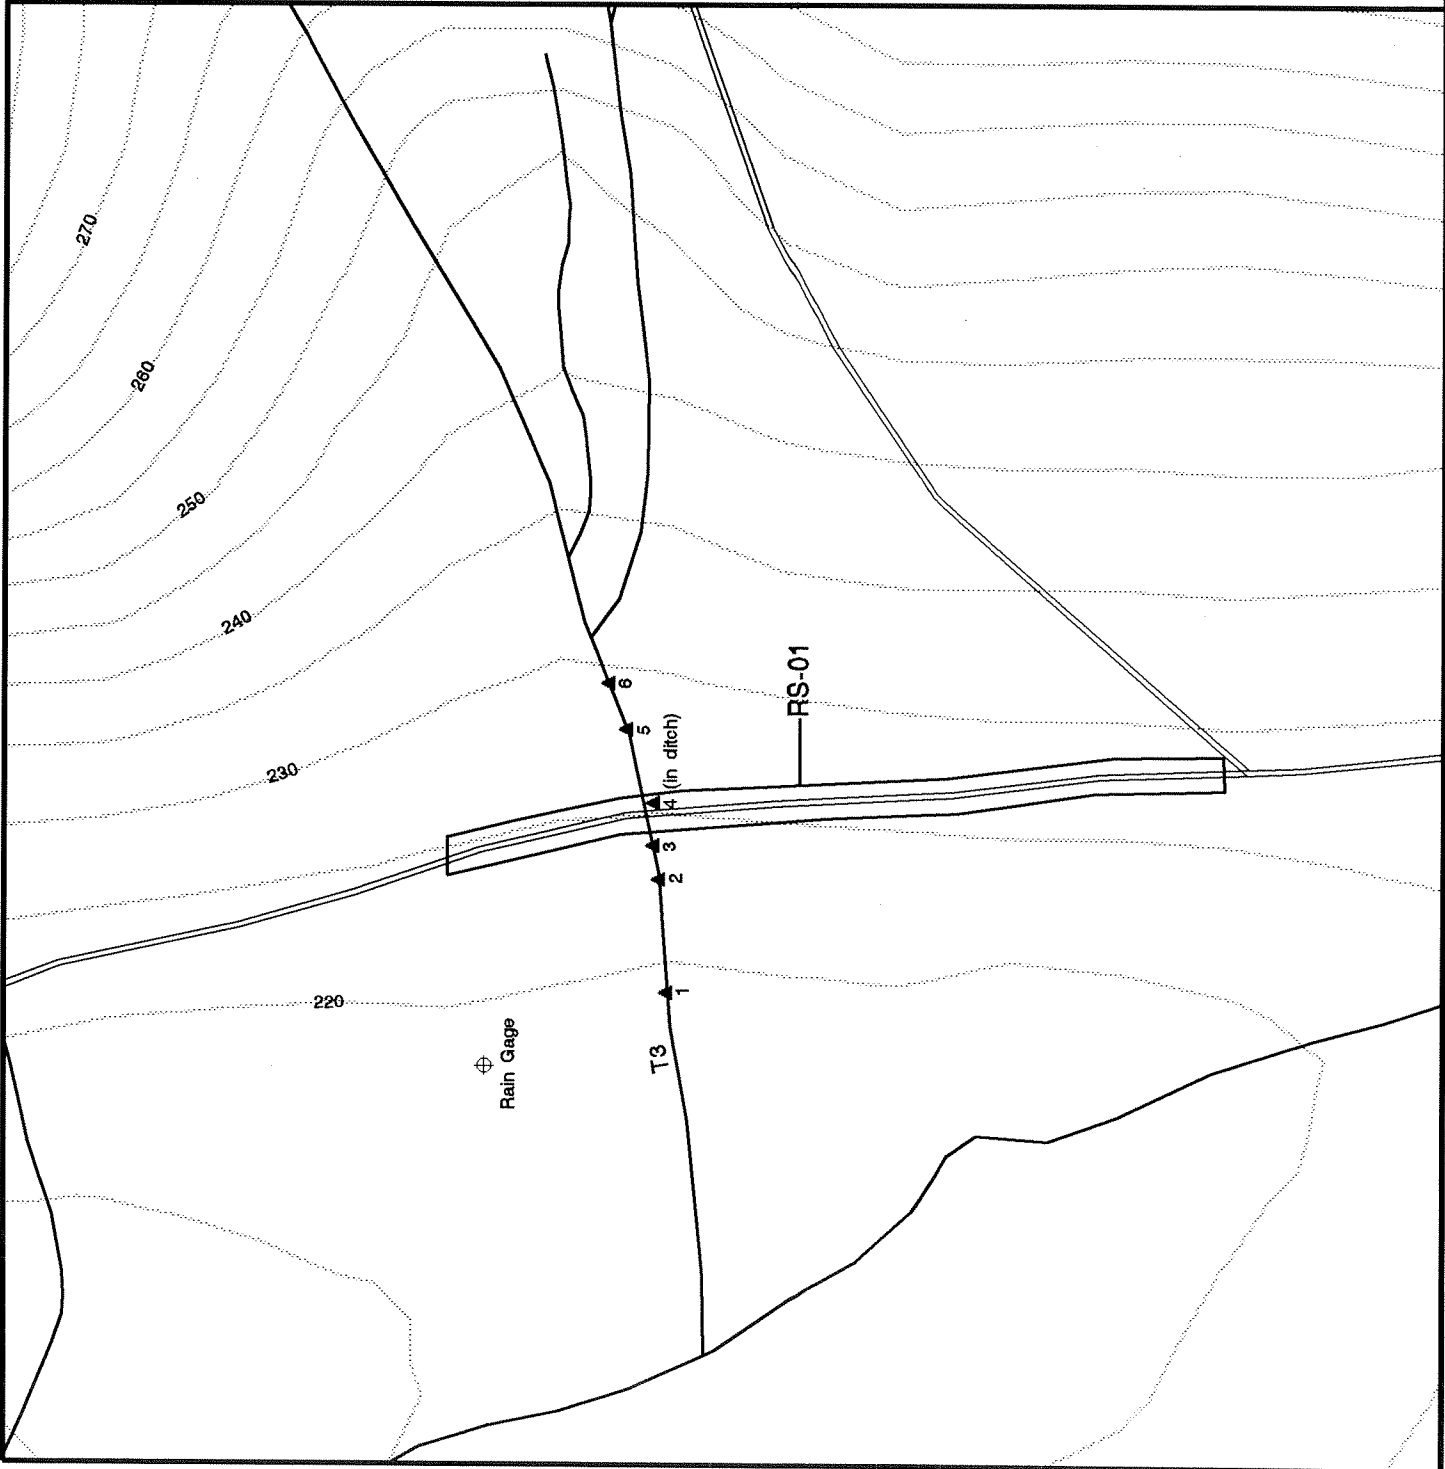
<p>Study Site: O-04: 9000 Mainline Road - Active haul road maintenance practices</p>	<p>BMP Effectiveness Ratings Active Haul Road Maintenance WAC 222-24-050(2) & (4)</p>	
<p>ASPECT 1: Effectiveness in terms of chronic erosion with delivery to surface waters.</p>	<p>Survey Employed Road Surface Condition Survey: RS-01</p>	<p>Indeterminate</p>
<p>Case Narrative:</p>		<p>An indeterminate call is given because the survey was not conducted during a runoff event. However, surveys conducted during a light rain event representative of winter base flow conditions generally reflected a travelway adequately maintained along the study segment for such ambient conditions, with the thickness of fines on the road surface less than 1 cm in the center of the road, and generally 2-10 cm along the edges of the travelway. No rutting or rilling of the road surface was apparent. Ditchlines and cut and fill slopes were well-vegetated. Traffic on the day of sampling included 36 heavy vehicles (11 loaded log trucks, 10 unloaded log trucks, and 15 loaded dump trucks) and 21 light vehicles over a 7.5 hour period.</p>

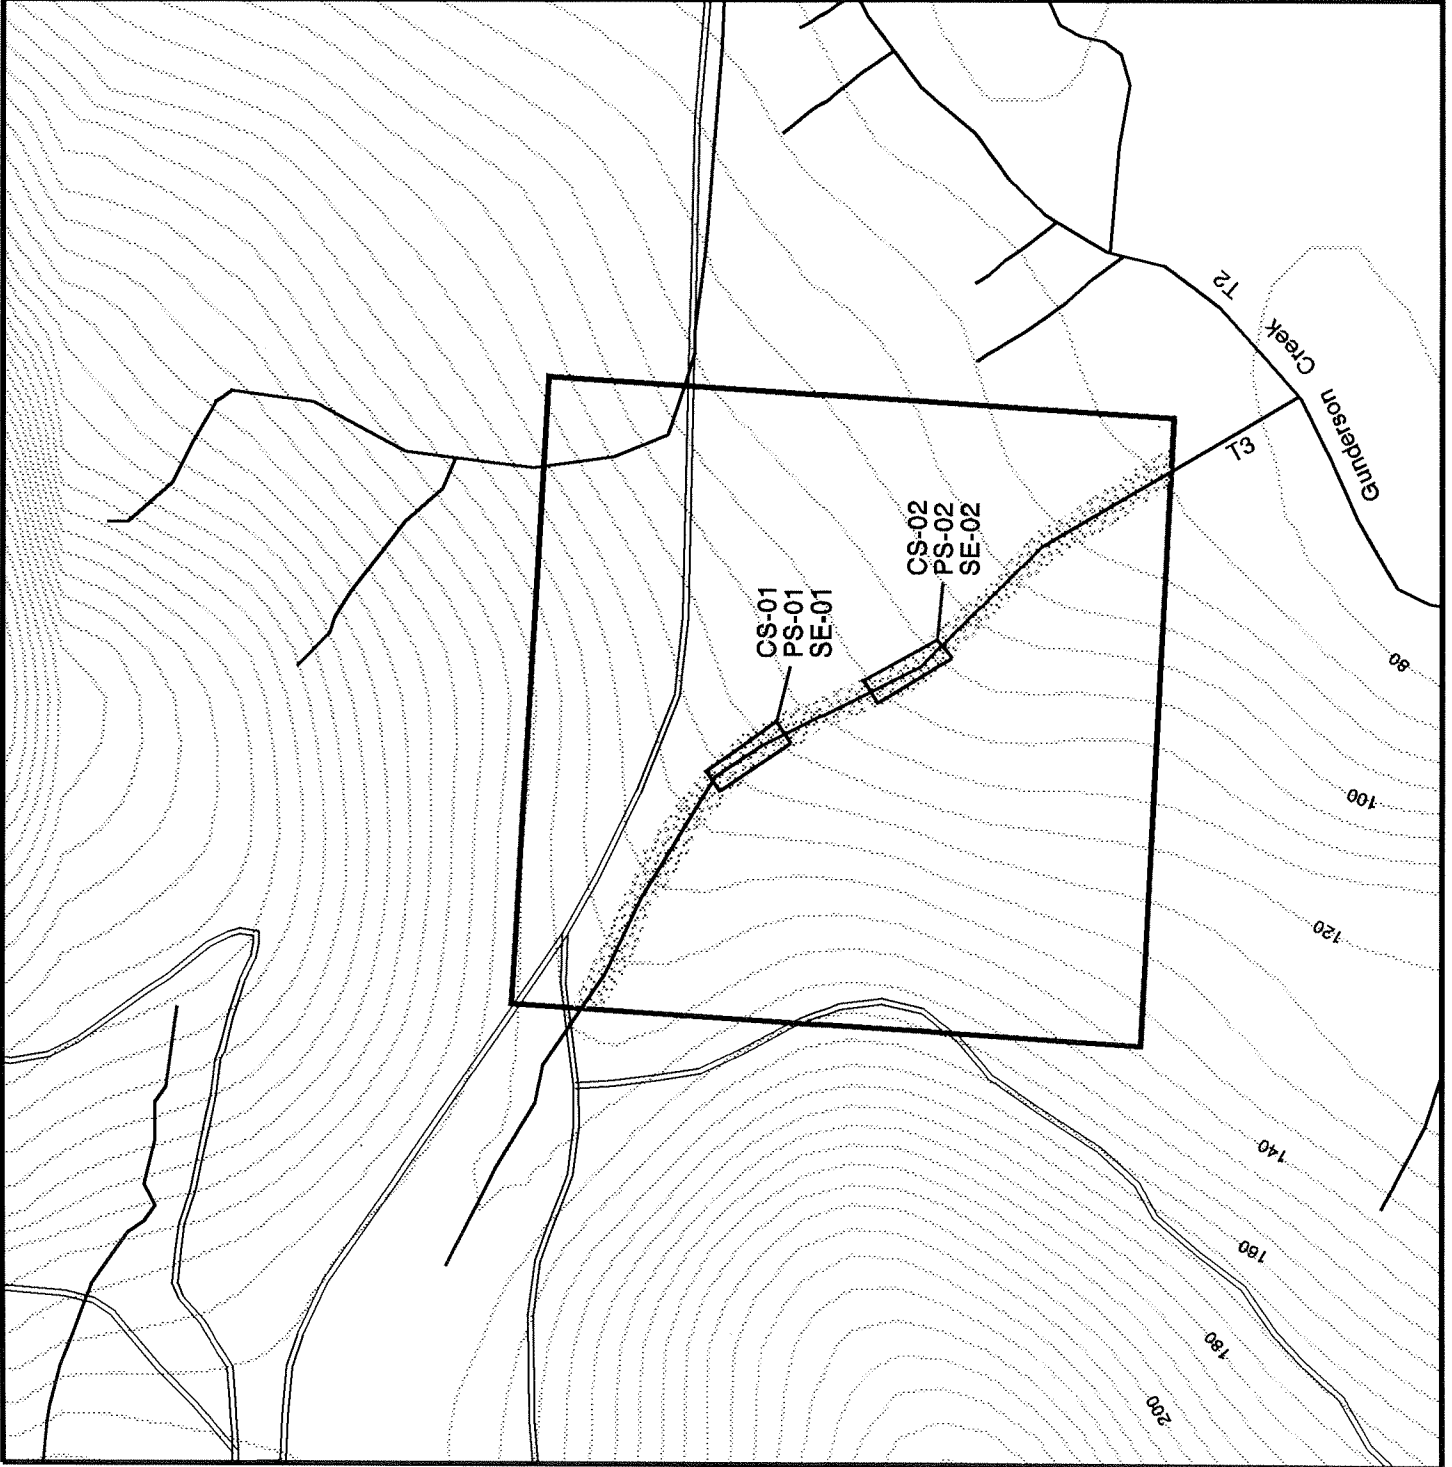
Study Site: O-07: Gunderson 2 - Clearcut harvest with RMZ		BMP Effectiveness Ratings	
Survey Employed	Harvest w/ RMZ & Streambank Integrity BMPs (WAC 222-30-020(2-4) & -030 & -040 & 050)	Harvest with no buffers (Type 4 and/or 5 Waters)	Harvest with RLTA's (Type 4 and/or 5 Waters) (WAC 222-30-020(5))
	Ground-based Yarding WAC 222-30-070	Ground-based Yarding WAC 222-30-070	Ground-based Yarding WAC 222-30-070
	Cable Yarding WAC 222-30-060	Cable Yarding WAC 222-30-060	Cable Yarding WAC 222-30-060
ASPECT 1: Effectiveness in terms of chronic erosion with delivery to surface waters.	No separate erosion/delivery surveys were conducted.		
Case Narrative:	While no sediment routing or other delivery surveys were conducted to evaluate this harvest practice, it was noted during in-stream surveys that there was no sediment delivery within the RMZ reaches evaluated that was directly attributable to timber falling or yarding or due to site preparation. Windthrow which occurred following the harvest was a source of sediment and channel disturbance, but this also contributed beneficial woody debris to the stream. Fine sediment was observed routing through the study reaches both before and after the harvest, and this is most likely attributable to the mainline haul road located upstream of the study reaches, which traverses the northern part of the subject harvest unit.

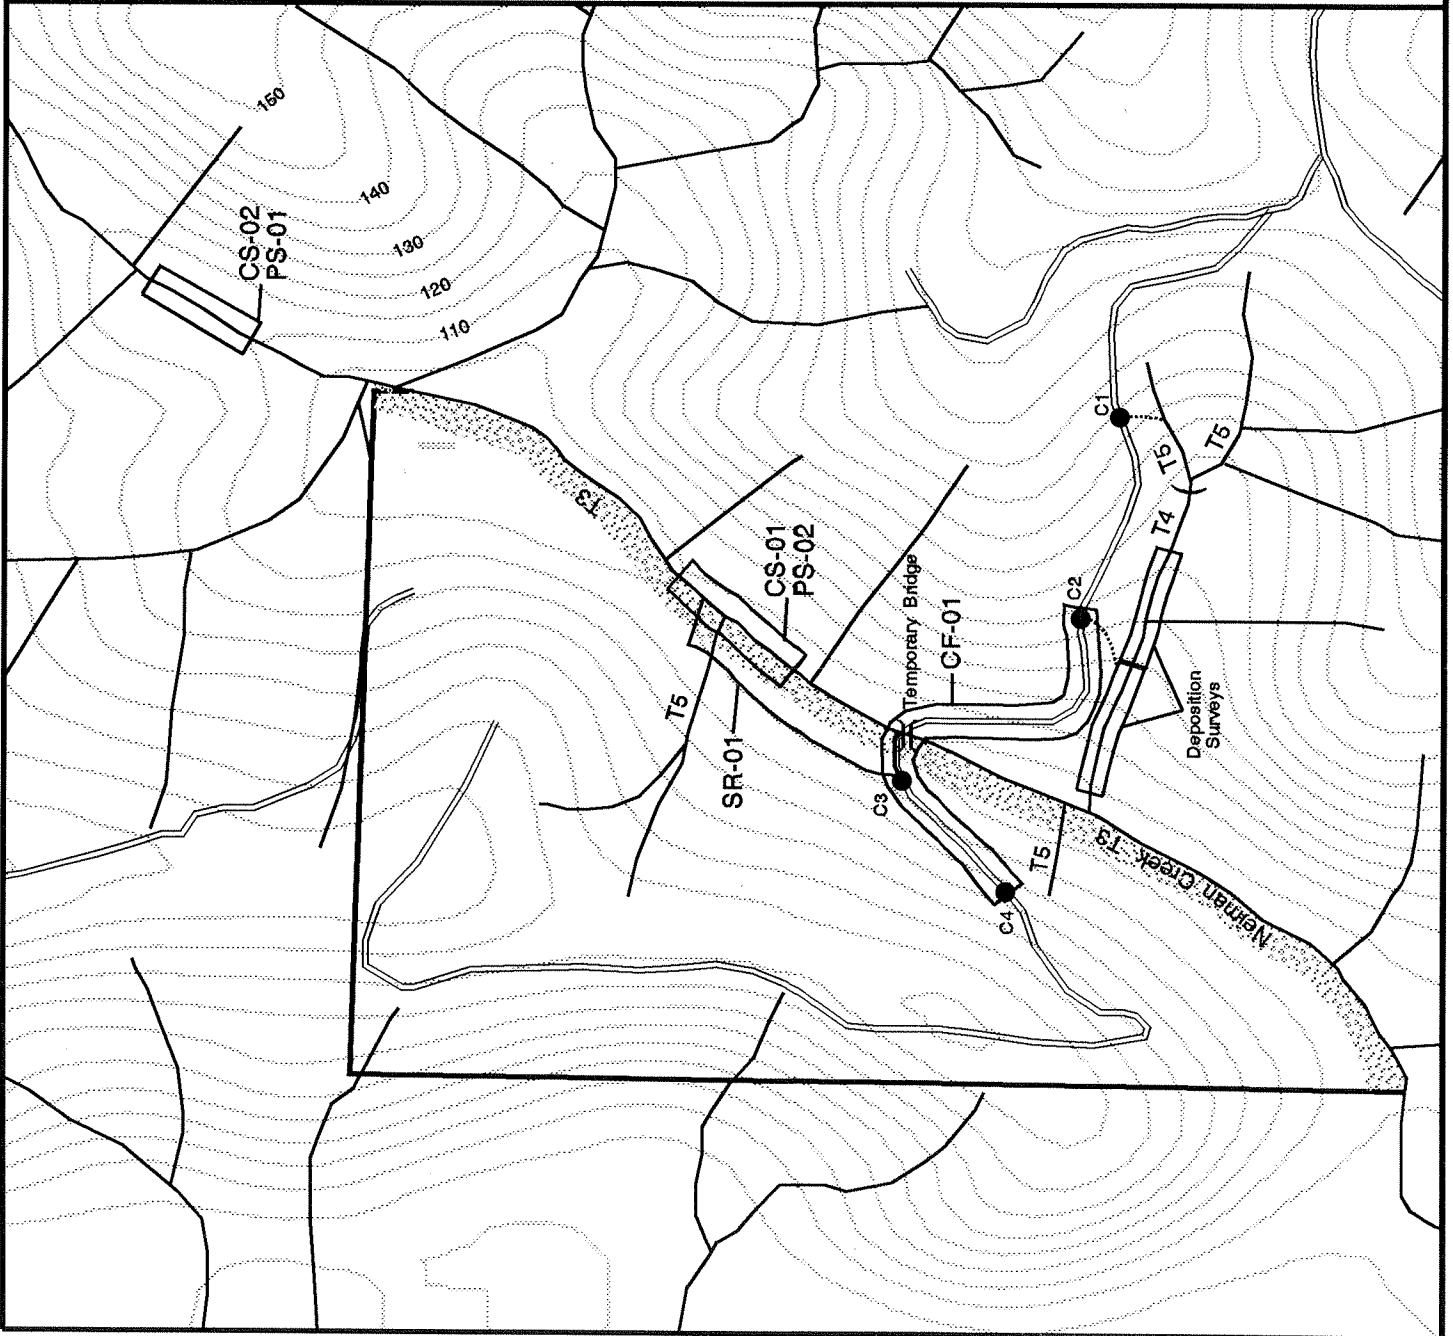
Study Site:	W-02: Neiman Creek - Clearcut harvest with RMZ, and harvest without stream buffers		BMP Effectiveness Ratings	
	Survey Employed	Harvest w/ RMZ & Streambank Integrity BMPs (WAC 222-30-020(2-4) & -030 & -040 & 050)	Harvest with no buffers (Type 4 and/or 5 Waters)	Harvest with RLTA's (Type 4 and/or 5 Waters) (WAC 222-30-020(5))
		Ground-based Yarding WAC 222-30-070	Ground-based Yarding WAC 222-30-070	Ground-based Yarding WAC 222-30-070
		Cable Yarding WAC 222-30-060	Cable Yarding WAC 222-30-060	Cable Yarding WAC 222-30-060
ASPECT 1:				
Effectiveness in terms of	Sediment Routing SR-01BU	Effective		
chronic erosion with delivery to surface waters.	SR-01NB	Effective	Effective	
Case Narrative:	The RMZ was effective at preventing direct sediment delivery to Neiman Creek and the adjacent wetlands on its floodplain. The RMZ was not entered by harvesting or yarding equipment in the vicinity of the survey area. Sediment delivery to the un-buffered Type 5 stream, from skid trail yarding features adjacent to and crossing the stream, was documented during the first year following harvest, but delivery from these features was not chronic. There was a substantial degree of natural revegetation of harvest erosion features between the first and second year surveys.

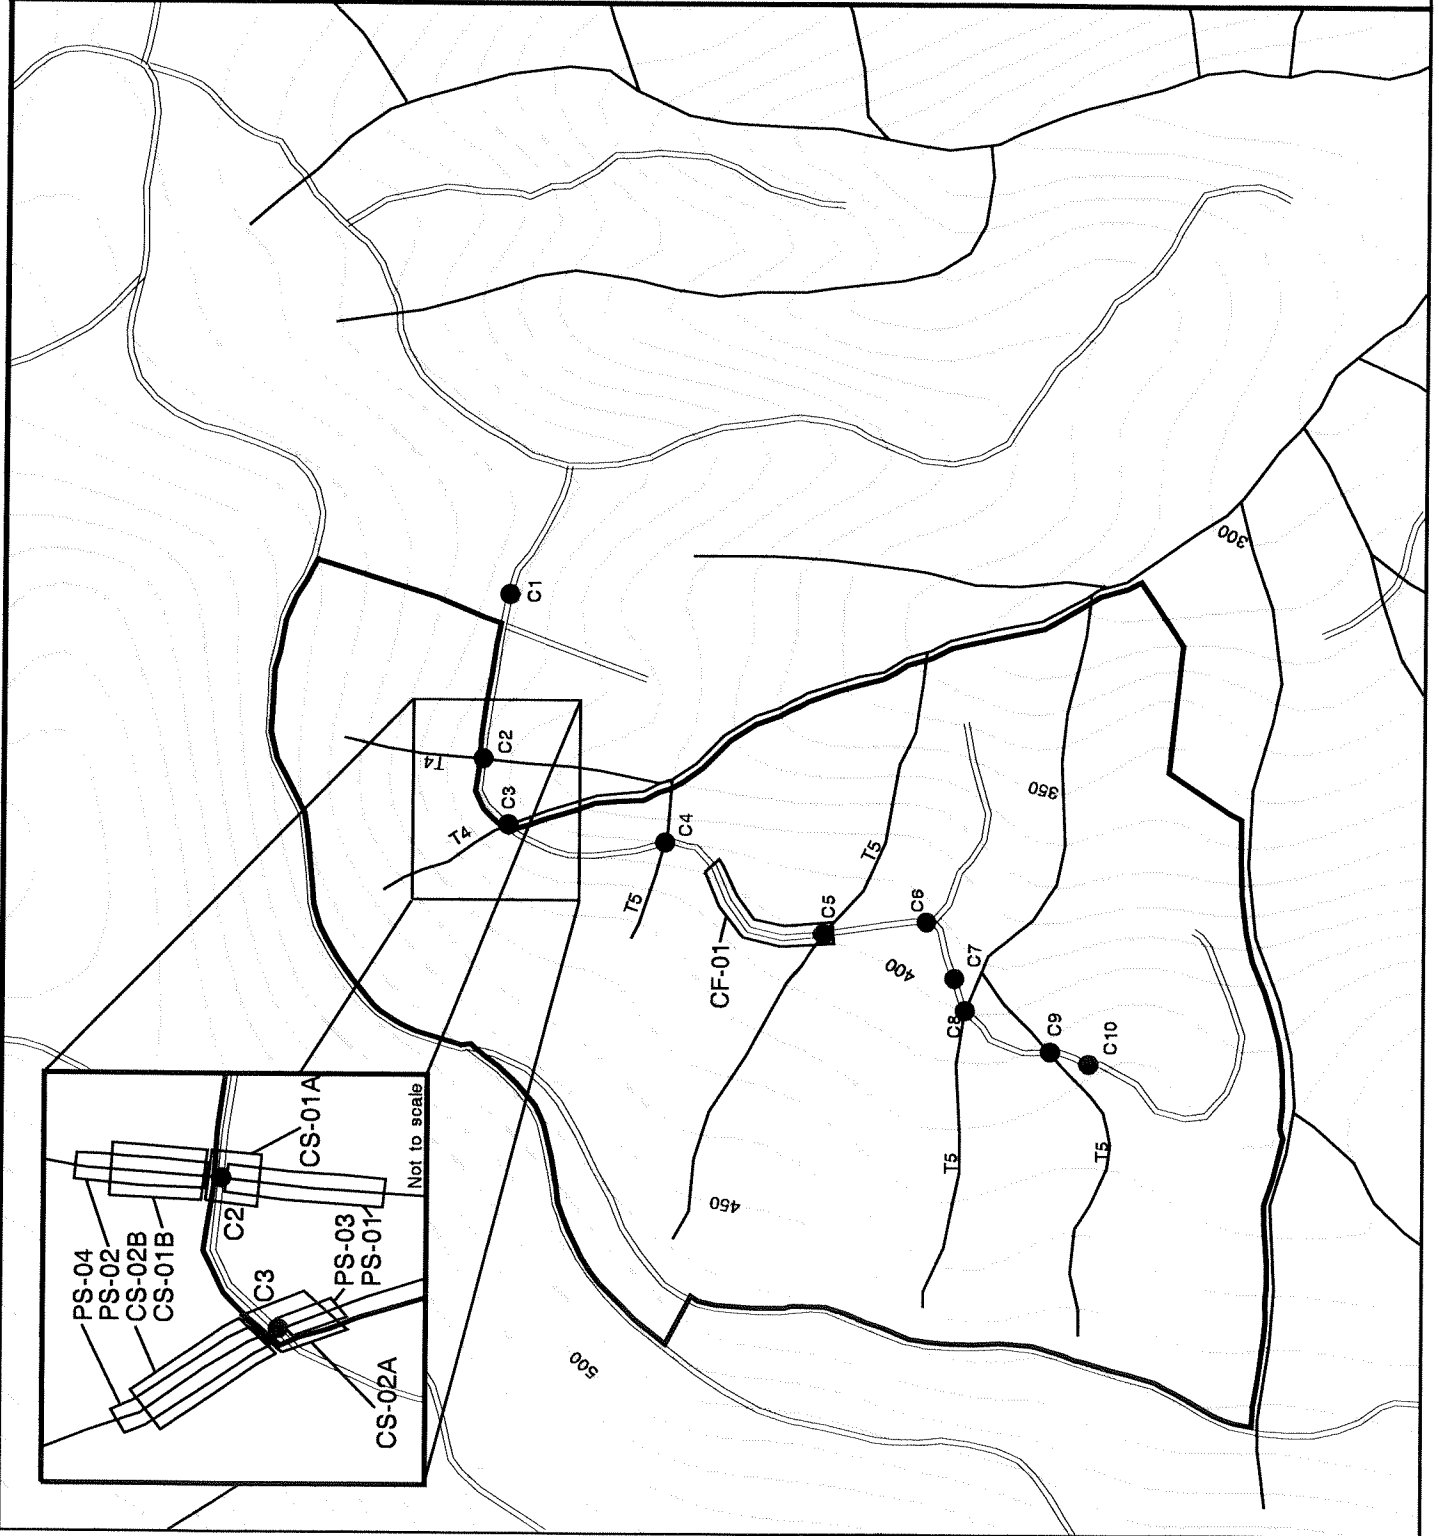
<p>Study Site:</p>	<p>W-03: Train Whistle - Clearcut harvest without stream buffers</p>		
<p>Survey Employed</p>	<p>Harvest w/ RMZ & Streambank Integrity BMPs (WAC 222-30-020(2-4) & -030 & -040 & 050)</p> <p>Ground-based Yarding WAC 222-30-070</p> <p>Cable Yarding WAC 222-30-060</p>	<p>BMP Effectiveness Ratings</p> <p>Harvest with no buffers (Type 4 and/or 5 Waters) (WAC 222-30-020(5))</p> <p>Ground-based Yarding WAC 222-30-070</p> <p>Cable Yarding WAC 222-30-060</p>	<p>Harvest with RLTA's (Type 4 and/or 5 Waters)</p> <p>Ground-based Yarding WAC 222-30-070</p> <p>Cable Yarding WAC 222-30-060</p>
<p>ASPECT 1: Effectiveness in terms of chronic erosion with delivery to surface waters.</p>	<p>No separate erosion/delivery surveys were conducted to evaluate harvest practices.</p>		
<p>Case Narrative:</p>	<p>While no sediment routing or other erosion/delivery surveys were conducted to evaluate this harvest practice, it was noted during in-stream surveys that stream valley hillslopes were eroding due to disturbance by shovel logging activities.</p>

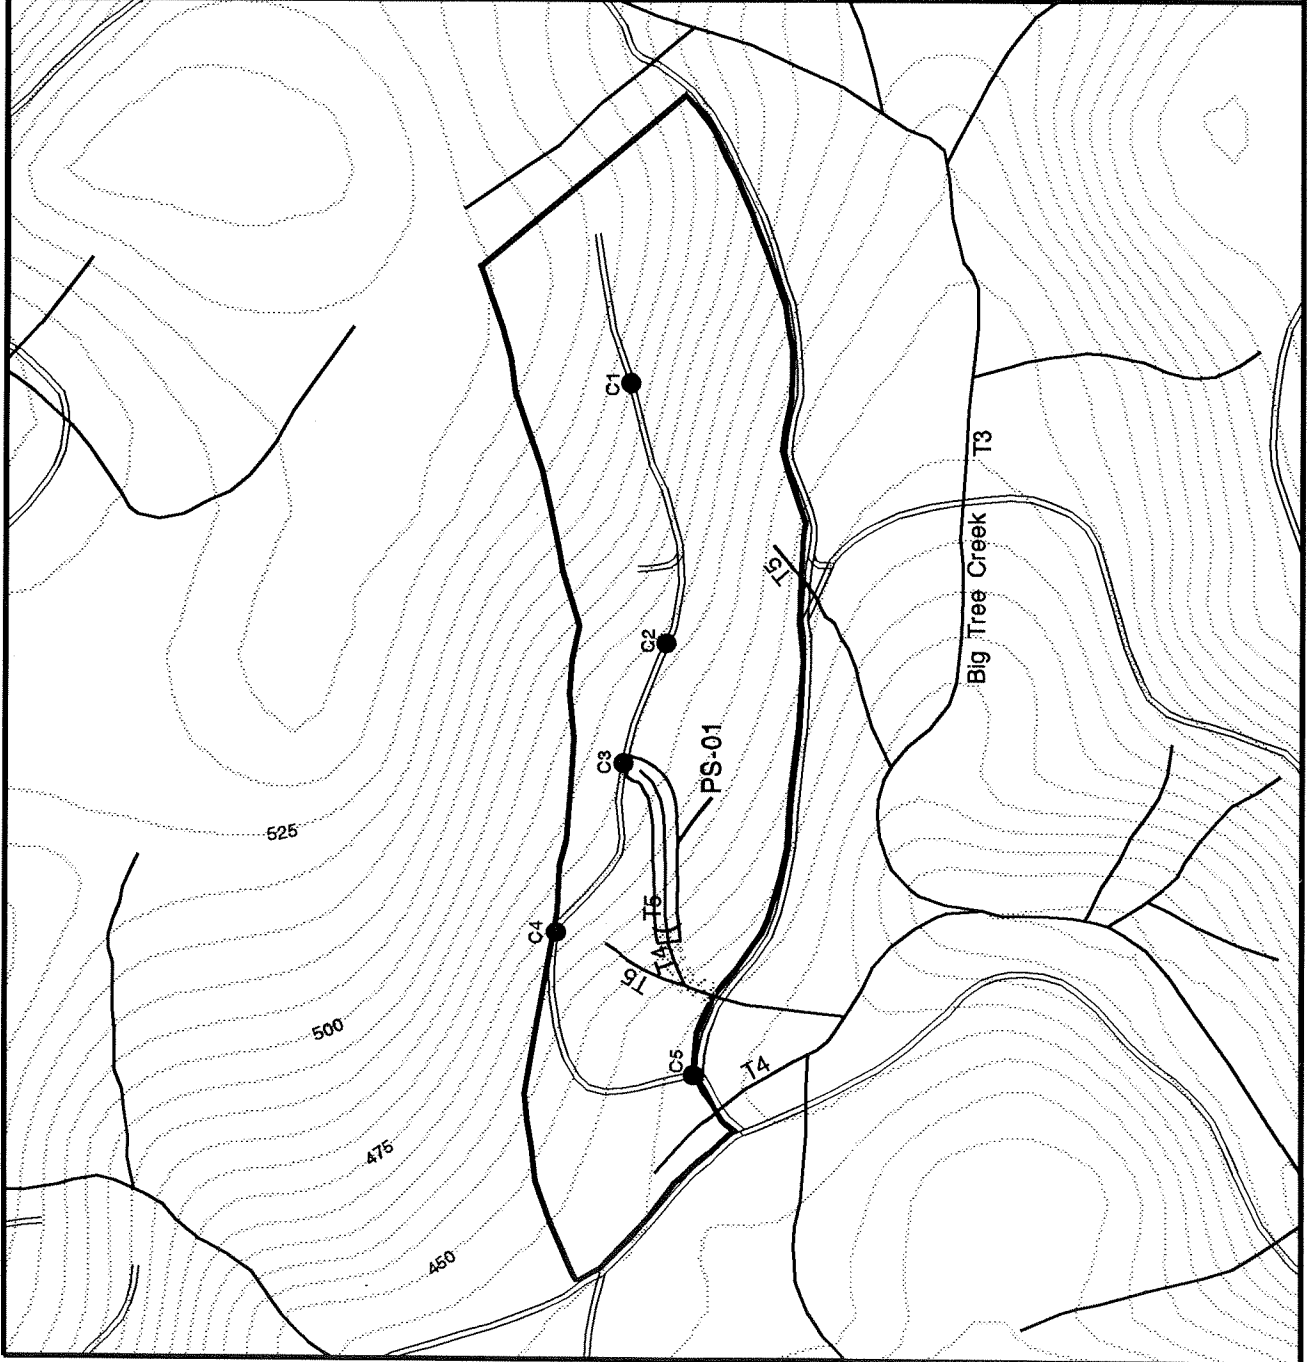
Study Site:	W-05: Bus Stop - New Road Construction		BMP Effectiveness Ratings	
	Survey Employed	Culvert BMPs	Relief	Road Construction BMPs
	Stream Xings WAC 222-24-040		WAC 222-24-025	Fillislopes WAC 222-24-030
ASPECT 1: Effectiveness in terms of chronic erosion with delivery to surface waters.	Culvert Condition: CC-01		Effective	
Case Narrative:	Practices for relief culverts at this site are rated effective because relief culverts did not deliver sediment to streams over the 15-month monitoring period following road construction. Sediment transport distances downslope of relief outfalls ranged from less than 1 meter to 8 meters. Two of the four relief culverts were located in un-channelized drainage swales, approximately 40-80 meters above type 5 channel heads. Practices employed at this site which likely contributed to the lack of downslope sediment transport included large sediment traps at one of the culverts and the use of rock riprap in the ditch leading to the relief culvert that was in closest proximity to a stream.

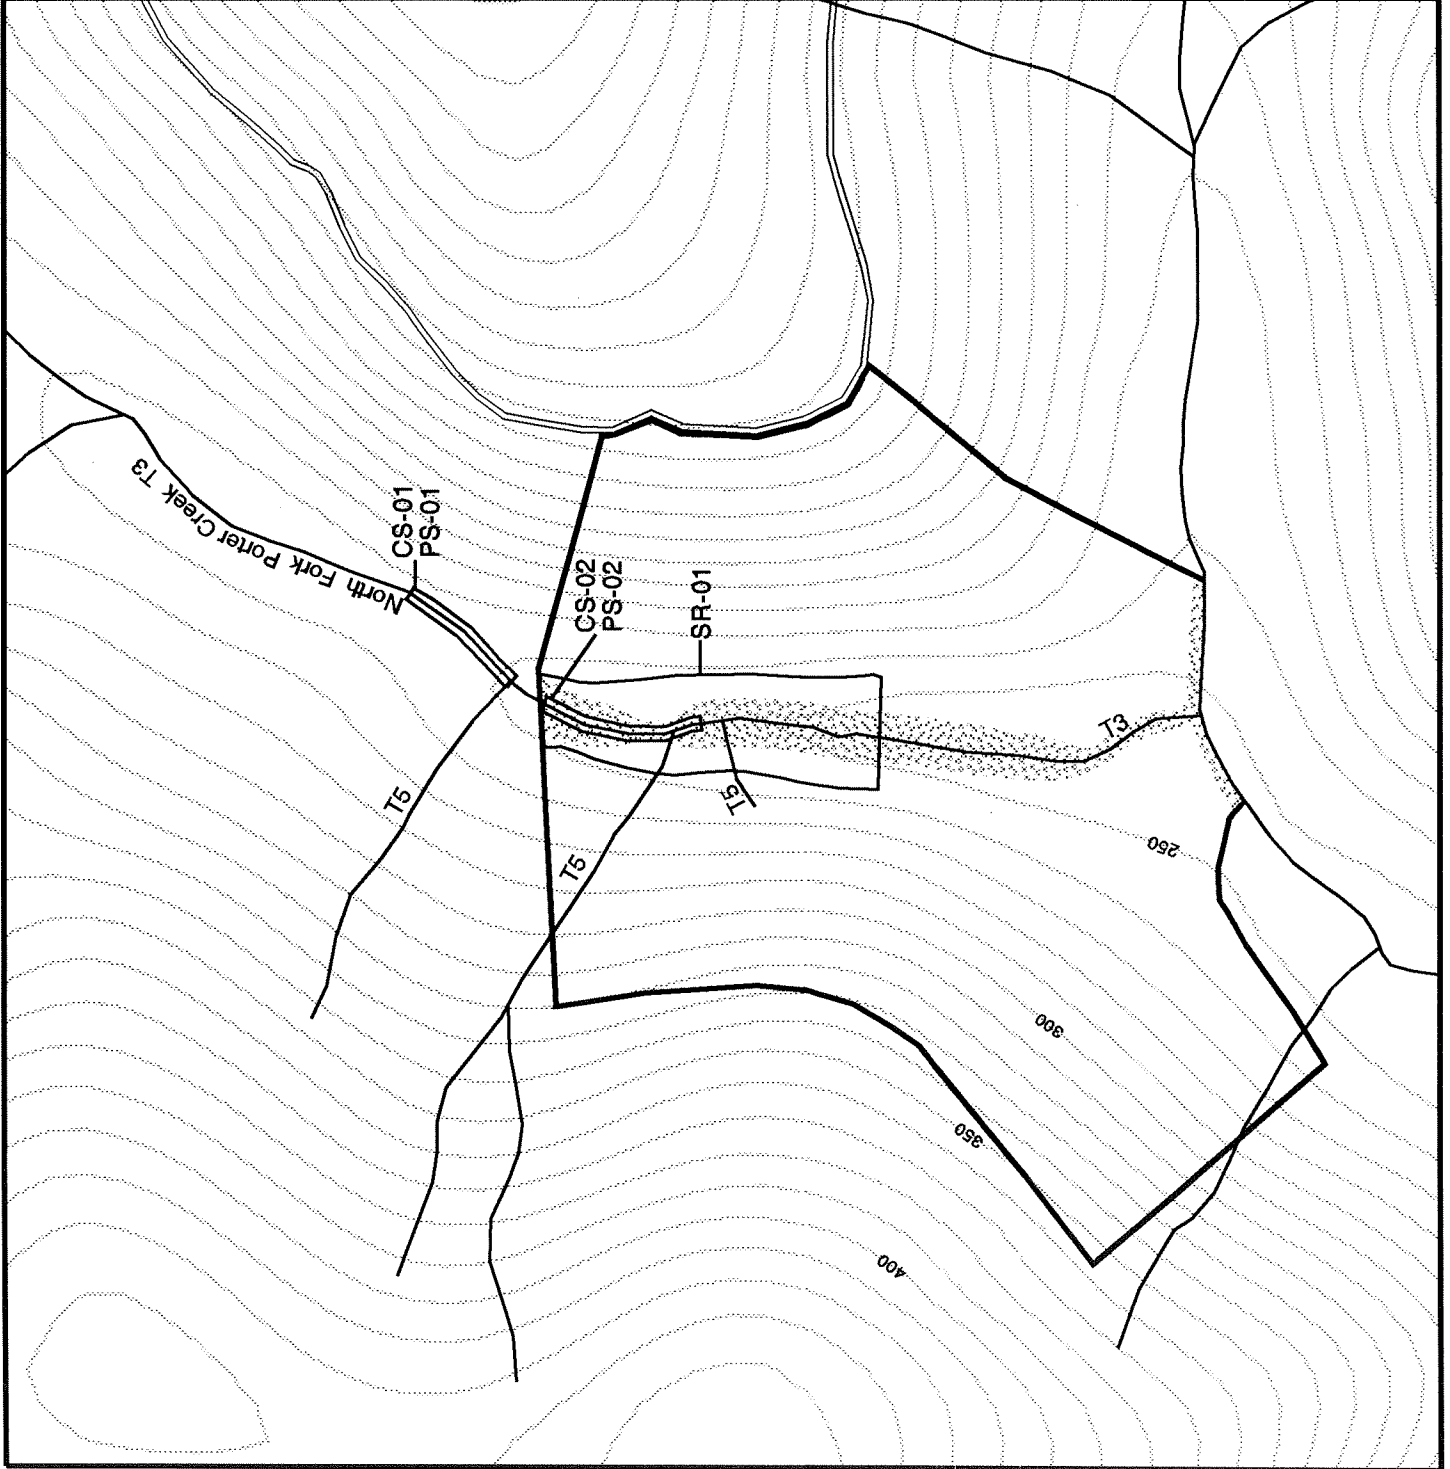
<p>Study Site: W-06: Pot Pourri - Clearcut harvest with RMZ</p>	<p>Survey Employed</p> <p>Harvest w/ RMZ & Streambank Integrity BMPs (WAC 222-30-020(2-4) & -030 & -040 & 050)</p> <p>Ground-based Cable Yarding WAC 222-30-070 WAC 222-30-060</p>	<p>BMP Effectiveness Ratings</p> <p>Harvest with no buffers (Type 4 and/or 5 Waters) (WAC 222-30-020(5))</p> <p>Ground-based Cable Yarding WAC 222-30-070 WAC 222-30-060</p>	<p>Harvest with RLITAs (Type 4 and/or 5 Waters)</p> <p>Ground-based Cable Yarding WAC 222-30-070 WAC 222-30-060</p>
<p>ASPECT 1: Effectiveness in terms of chronic erosion with delivery to surface waters.</p>	<p>Sediment Routing: SR-01</p>	<p>Effective</p>	
<p>Case Narrative:</p> <p>Application of RMZ practices at this unit were effective at preventing direct sediment-related water quality impacts to the Type 3 stream. There was short-term sediment delivery to the Type 3 stream from one yarding feature, and indirect delivery via unbuffered tributaries. It was noted that cable yarding at this unit was accomplished with minimal ground disturbance, apparently due to good log suspension. Although sediment effects in unbuffered Type 4/5 waters was not specifically evaluated at this study site, disturbance of a Type 5 stream/wetland area and delivery of sediment to another Type 5 stream was observed. Within the sediment routing survey area, delivery from harvest-related erosion features was not chronic; harvest erosion features which delivered had re-vegetated by the time of the follow-up survey.</p>
