Appendices I and J

Effectiveness of Forest Road and Timber Harvest Best Management Practices with Respect to Sediment-Related Water Quality Impacts

December 1999
Publication No. 99-350

by
Ed Rashin
Casey Clishe
Andy Loch
Johanna Bell

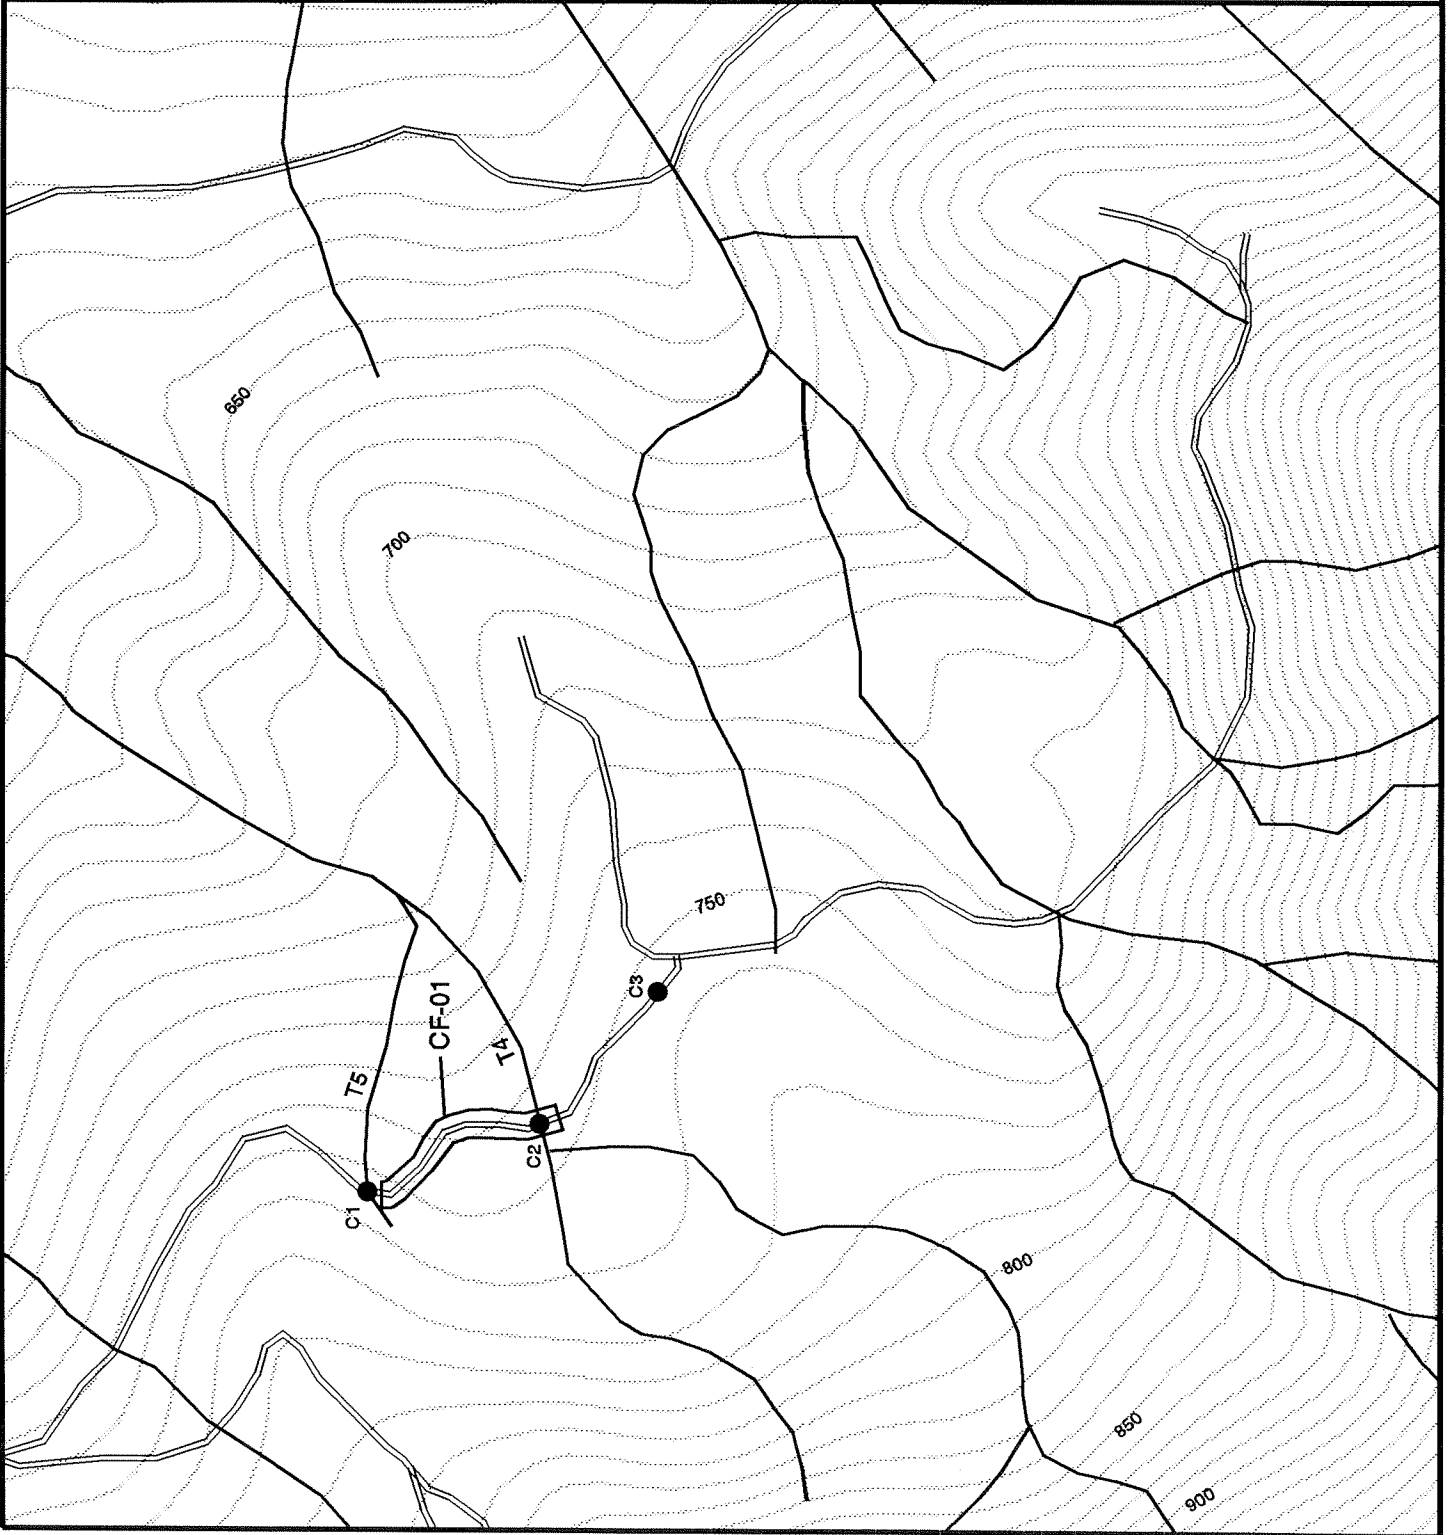
Study Site:	S-02: 8 Road Unit 2 Road - New Road Construction	BMP Effectiveness Ratings			
		Survey Employed	Culvert BMPs	Road Construction BMPs	Fillislopes
		Stream Xings WAC 222-24-040	Relief WAC 222-24-025	Cutslopes WAC 222-24-030	
ASPECT 1: Effectiveness in terms of chronic erosion with delivery to surface waters.		Culvert Condition: CC-01	Partially Effective	Effective	
		Cutbank/Fillislope: CF-01		Not Effective	Effective
Case Narrative:	Culvert fills were adequately stabilized at one of two stream crossings by the second year of surveys (21 months following road construction). This was attributed to effective armoring with rock, including additional rock placed following the initial construction, combined with hydromulch and grass seeding. The relief culvert did not deliver sediment to streams by the second year following road construction, and is rated effective. The overland flow sediment transport distance downslope of the relief outfall was 30 meters. Plugging of the relief culvert following re-grading of the road was noted as a concern during second-year surveys. The fillislopes did not result in delivery of sediment except for the immediate vicinity of the culverts and are rated effective. Cutslope erosion, including gully development, did result in substantial amounts of chronic sediment delivery to the Type 4 stream via drainage ditches, as evidenced by the expanding sediment deposit in the stream. Grass seeding with hydromulch treatment of both cut and fill slopes was partially effective in controlling erosion, except where gullies developed.

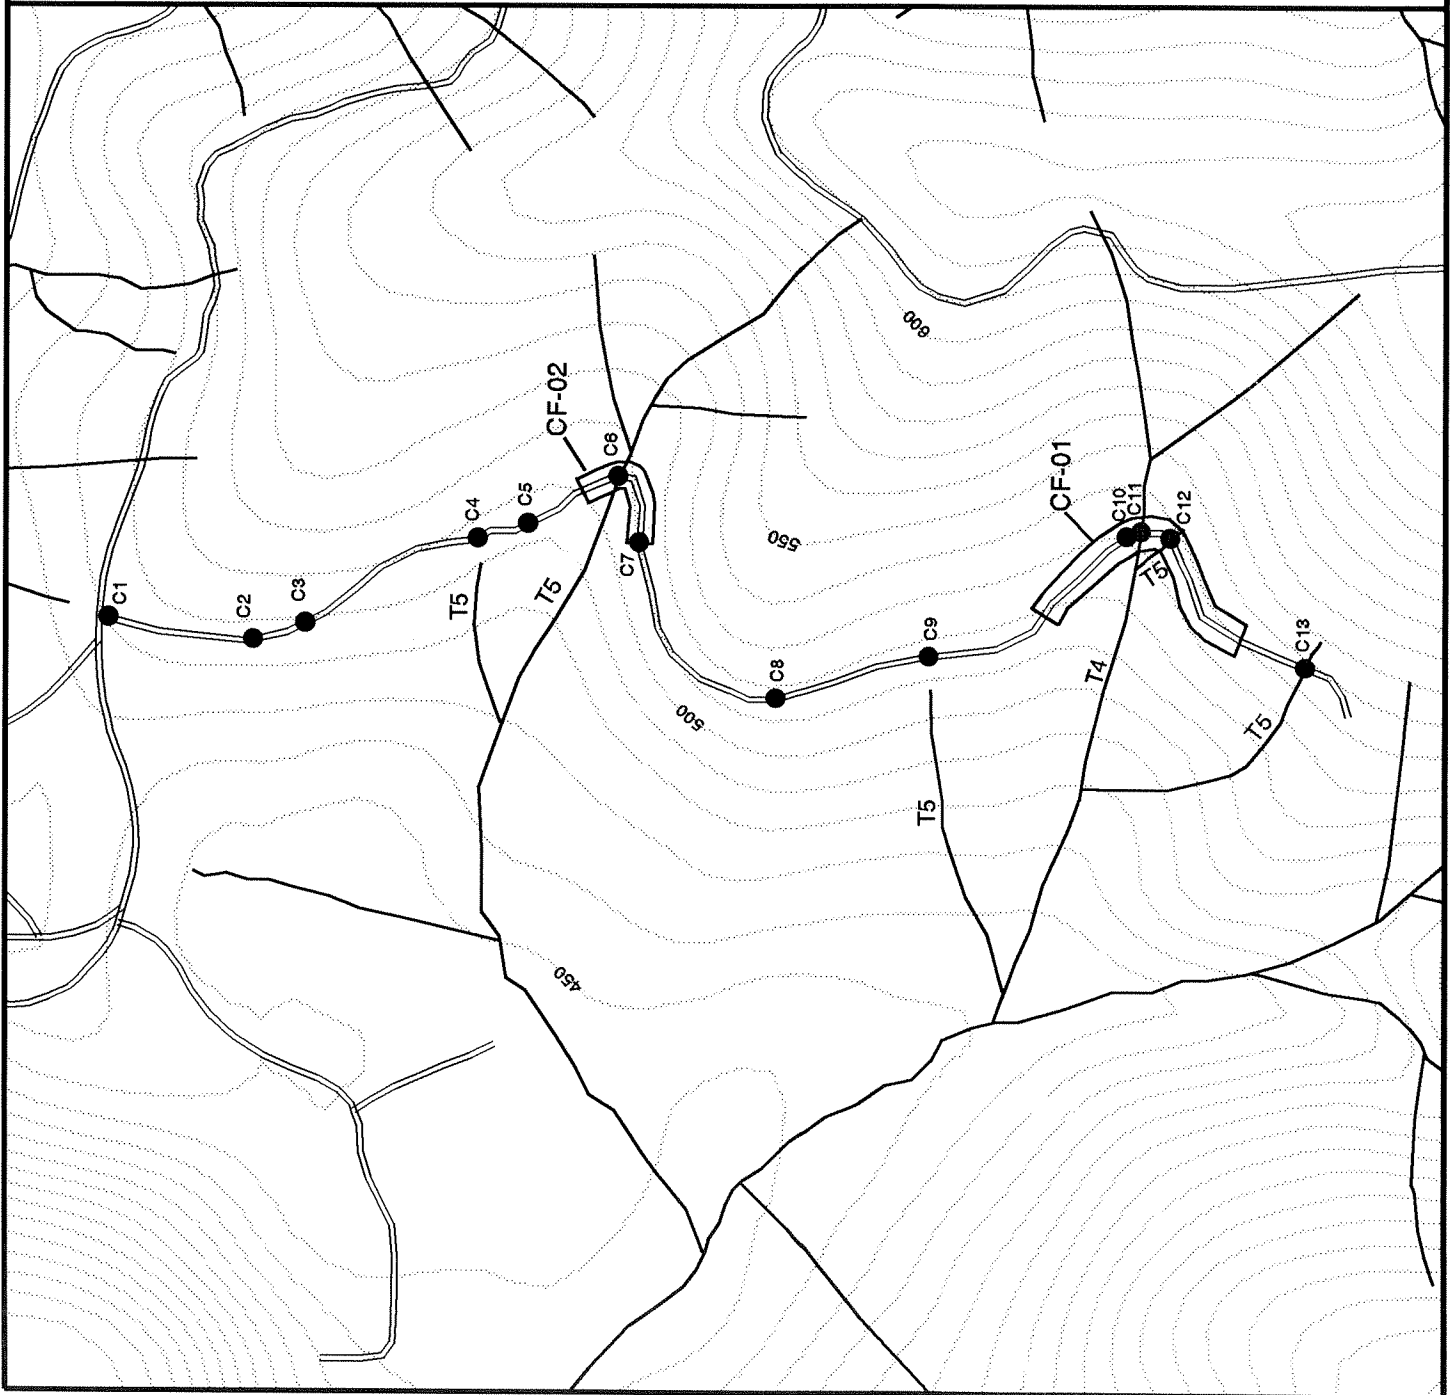
Study Site: S-0: Ohop Blowdown		BMP Effectiveness Ratings	
Survey Employed	Culvert BMPs	Road Construction BMPs	
	Stream Xings WAC 222-24-040	Relief WAC 222-24-025	Cutslopes WAC 222-24-030
Culvert Condition:	Partially Effective	Effective	
ASPECT 1: Effectiveness in terms of chronic erosion with delivery to surface waters.	CC-01		
	CF-01	Not effective	Effective
	CF-02	Effective	Effective
Case Narrative:	Relief culverts did not result in channel initiation (except for one short, 3 meter channel below C2) or delivery of sediment to streams, and are rated effective. Chronic erosion and sediment delivery was documented at all stream crossings, but at three of the four crossings the extent of erosion had decreased to slight levels by the second spring following road construction. Stream crossing practices were effective at these three culverts, which were well-armored with rock riprap to prevent/minimize erosion. At another crossing of a type 5 stream originating at a seep just upslope of the road, culvert fill erosion continued at moderate to severe levels into the second spring, and increased channel development was evident below the crossing. The fillslopes did not result in delivery of sediment except for the immediate vicinity of stream crossings culvert fills, and are rated effective. Cutslope erosion did result in chronic sediment delivery to the Type 4 stream via ditches draining to the crossing at culvert C11 (survey CF-01). Slash and sidecast was also observed in the stream in the vicinity of the crossing in the CF-01 survey. In addition to surface wash and slumping of cutslope material, a seep flowed across and eroded the cutslope between C11 and C12, and cutslope failure at another seep just upslope of C12 produced sediment which was routed down the ditch. In all, seven seeps were observed along the cutslope within the CF-01 survey. In the case of the CF-02 survey, although observations of chronic erosion included minor gullying and slumping along the cutslopes, microtopography associated with a bedrock outcropping and a low-gradient section of ditch functioned effectively as natural sediment trap, which apparently encouraged infiltration of ditch flow, and preventing direct delivery of sediment to the stream. No seeps were noted along the CF-02 road segment, and there was no residual evidence of ditch flows continuing ton the crossing.

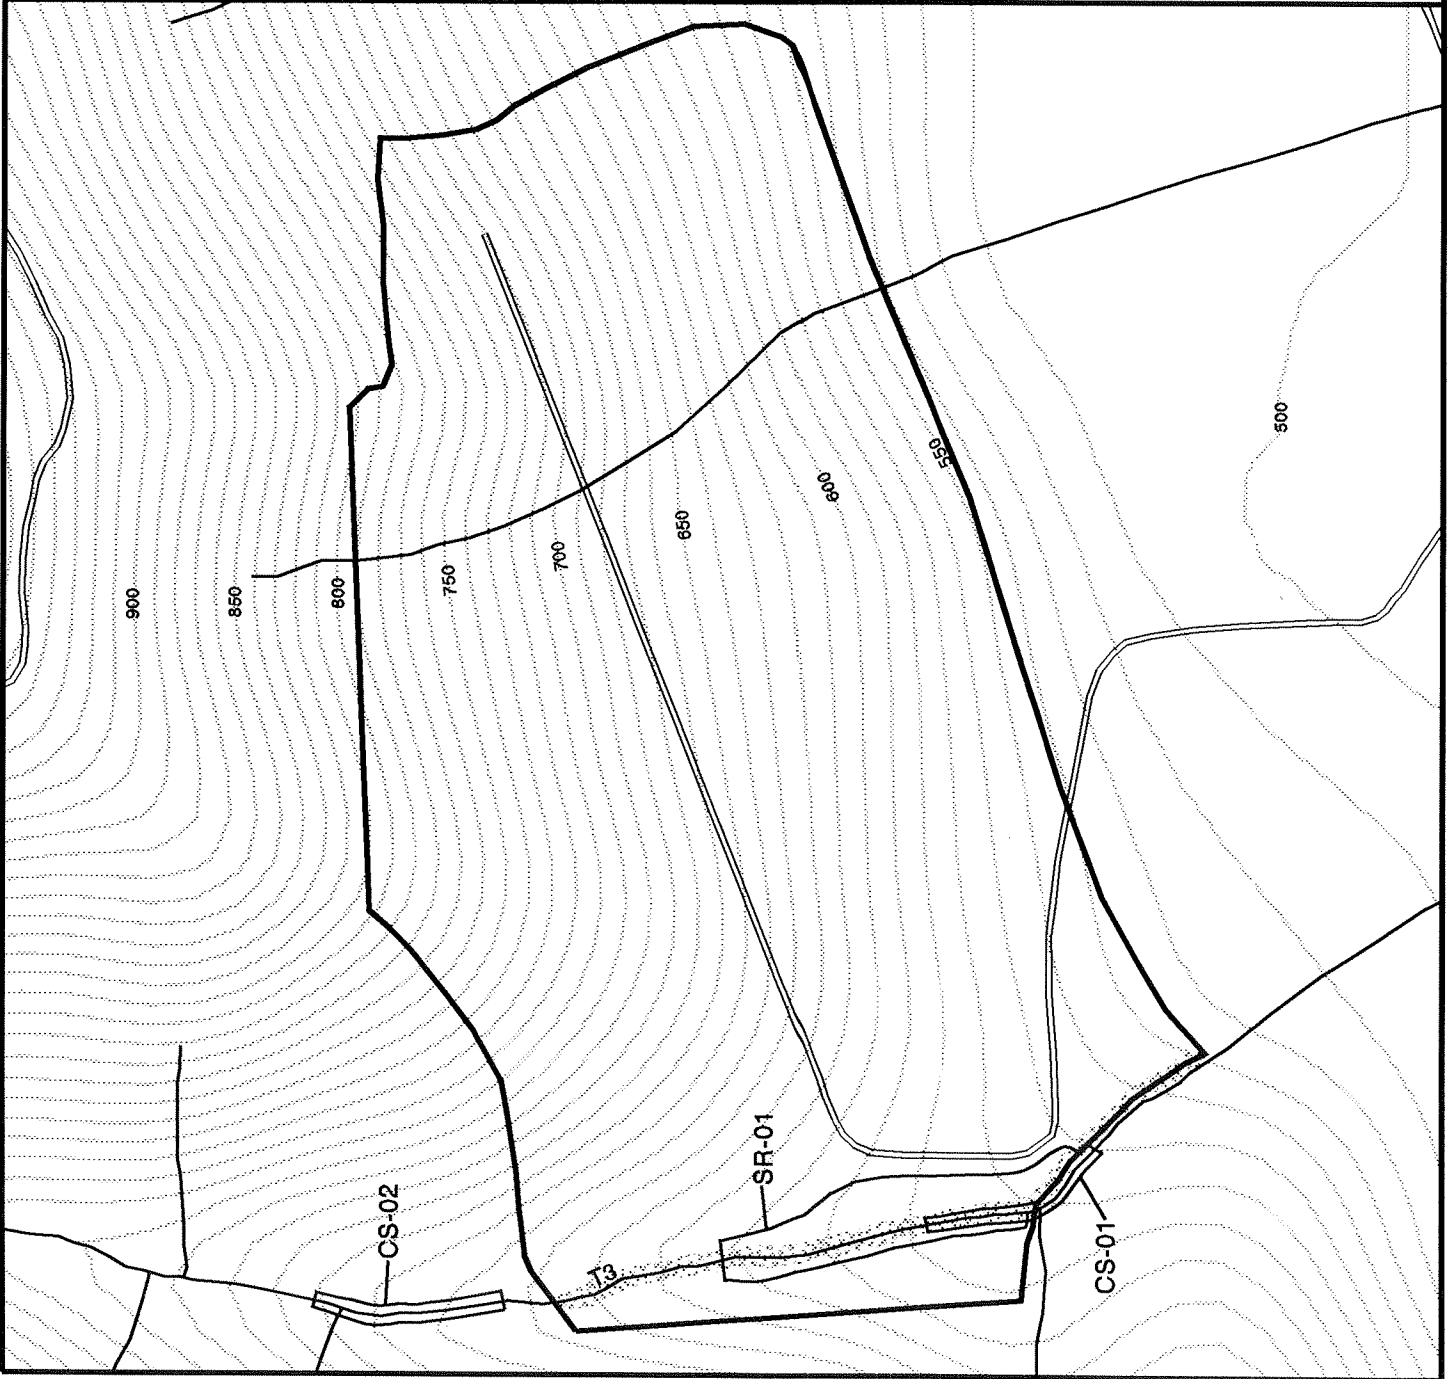
Study Site:	S-04: Friday Creek II - Clearcut harvest with RMZ			
	BMP Effectiveness Ratings			
Survey Employed	Harvest w/ RMZ & Streambank Integrity BMPs (WAC 222-30-020(2-4) & -030 & -040 & 050)	Harvest with no buffers (Type 4 and/or 5 Waters)	Harvest with RLTAs (Type 4 and/or 5 Waters) (WAC 222-30-020(5))	
	Ground-based Yarding WAC 222-30-070	Cable Yarding WAC 222-30-060	Ground-based Yarding WAC 222-30-070	Cable Yarding WAC 222-30-060
ASPECT 1:				
Effectiveness in terms of	Sediment Routing:			
chronic erosion with delivery to surface waters.	SR-01 Not Effective			
Case Narrative:	Soil disturbance produced by cable yarding practices at this site was 18% of the survey area for the first-year survey (5 months following harvest), and 12% for the second-year survey (17 months following harvest). Chronic sediment delivery to the stream buffered by an RMZ was primarily associated with cable yarding routes that crossed the stream and RMZ, which accounted for 72% of the exposed soil associated with erosion features that delivered sediment. Another 26% of the exposed soil from erosion features that delivered sediment was attributed to stream bank erosion not associated with harvest activities, and minor amounts of sediment delivery were attributed to erosion from windthrow and wildlife activities. The RMZ prevented sediment delivery to the type 3 stream where it was not crossed by yarding routes.

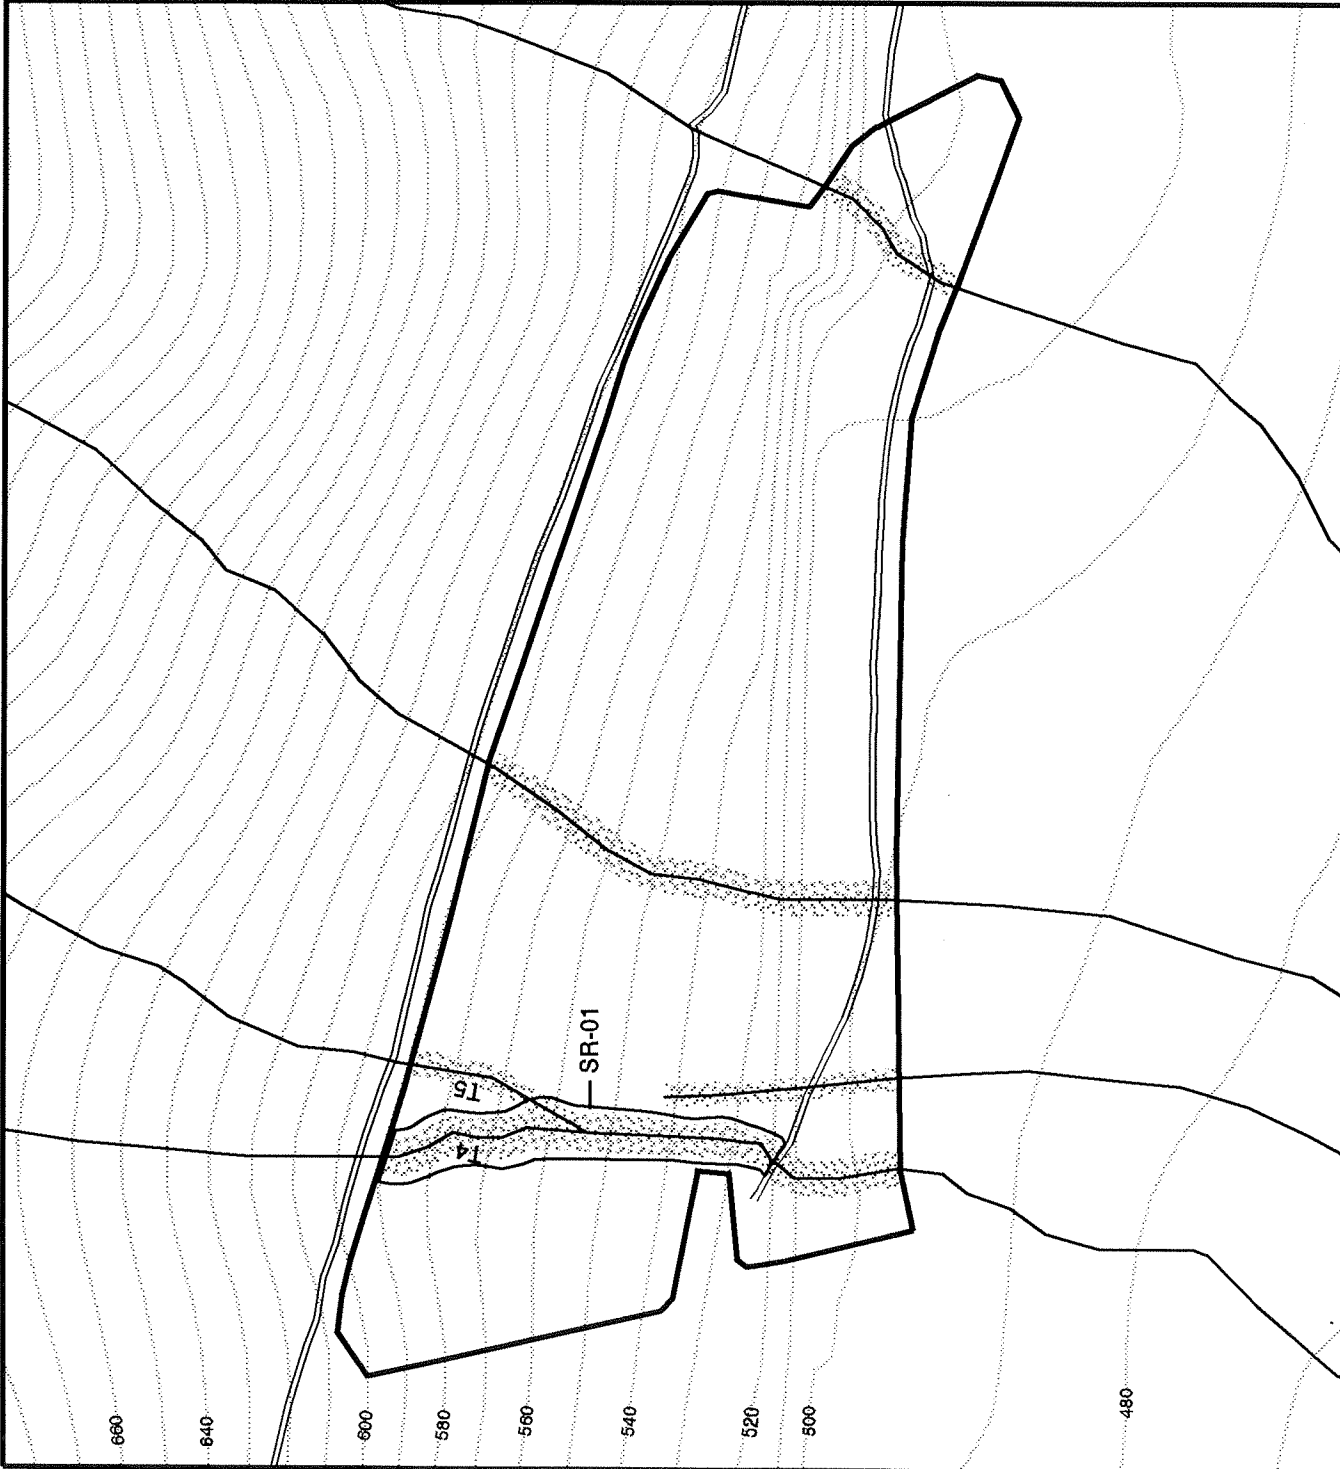
Study Site:	S-05: Sundog - Clearcut harvest with RLTA		BMP Effectiveness Ratings				
	Survey Employed	Harvest w/ RMZ & Streambank Integrity BMPs (WAC 222-30-020(2-4) & -030 & -040 & 050)	Ground-based Yarding WAC 222-30-070	Cable Yarding WAC 222-30-060	Ground-based Yarding WAC 222-30-070	Cable Yarding WAC 222-30-060	Harvest with RLTA's (Type 4 and/or 5 Waters) (WAC 222-30-020(5))
ASPECT 1: Effectiveness in terms of chronic erosion with delivery to surface waters.	Sediment Routing: SR-01						Effective
Case Narrative:	The RLTA was effective at preventing direct sediment delivery to the type 4 stream. Timber was yarded away from the stream on both sides of the RLTA, and there was no yarding across the stream or buffer within the survey area. Sediment delivery documented in the sediment routing surveys was primarily associated with erosion from windthrow, with minor amounts from two erosion features that were attributed to residual yarding scars associated with the logging of the original forest.

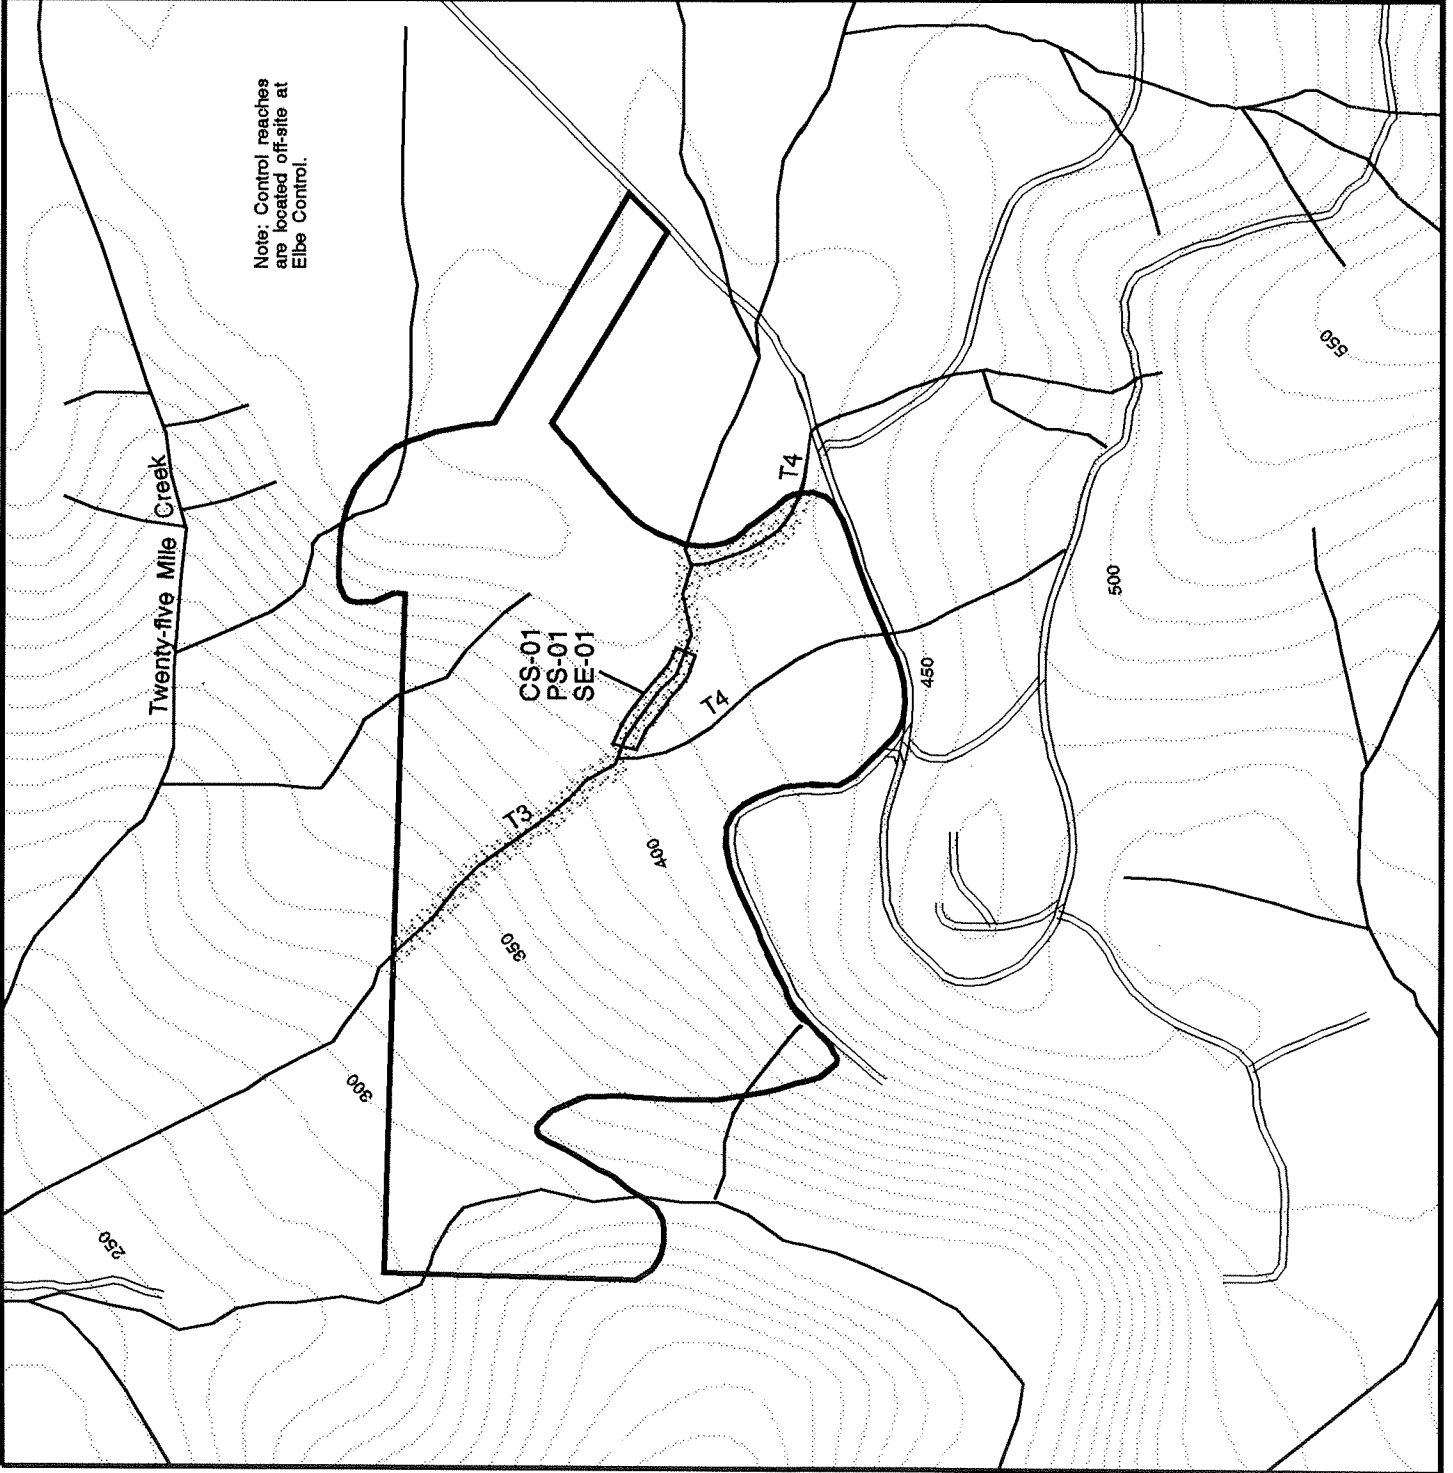
Study Site:	S-08: Kapowsin - Clearcut harvest with RMZ			
	BMP Effectiveness Ratings			
Survey Employed	Harvest w/ RMZ & Streambank Integrity BMPs (WAC 222-30-020(2-4) & -030 & -040 & 050)	Harvest with no buffers (Type 4 and/or 5 Waters)	Harvest with RLTAs (Type 4 and/or 5 Waters) (WAC 222-30-020(5))	
	Ground-based Yarding WAC 222-30-070	Ground-based Yarding WAC 222-30-070	Cable Yarding WAC 222-30-060	Cable Yarding WAC 222-30-060
ASPECT 1: Effectiveness in terms of chronic erosion with delivery to surface waters.	No separate erosion/delivery surveys were conducted.			
Case Narrative:	While no sediment routing or other hillslope erosion/delivery surveys were conducted to evaluate this harvest practice, it was noted in post-harvest stream surveys that minor amounts of sediment delivery were occurring, via travel and runoff, due to valley wall disturbance associated with yarding activity within the RMZ. Although there was a minor amount of harvest and yarding activity within the RMZ, the stream and RMZ were not crossed within the survey areas. The main sediment source observed was windthrow within the RMZ and inner gorge.

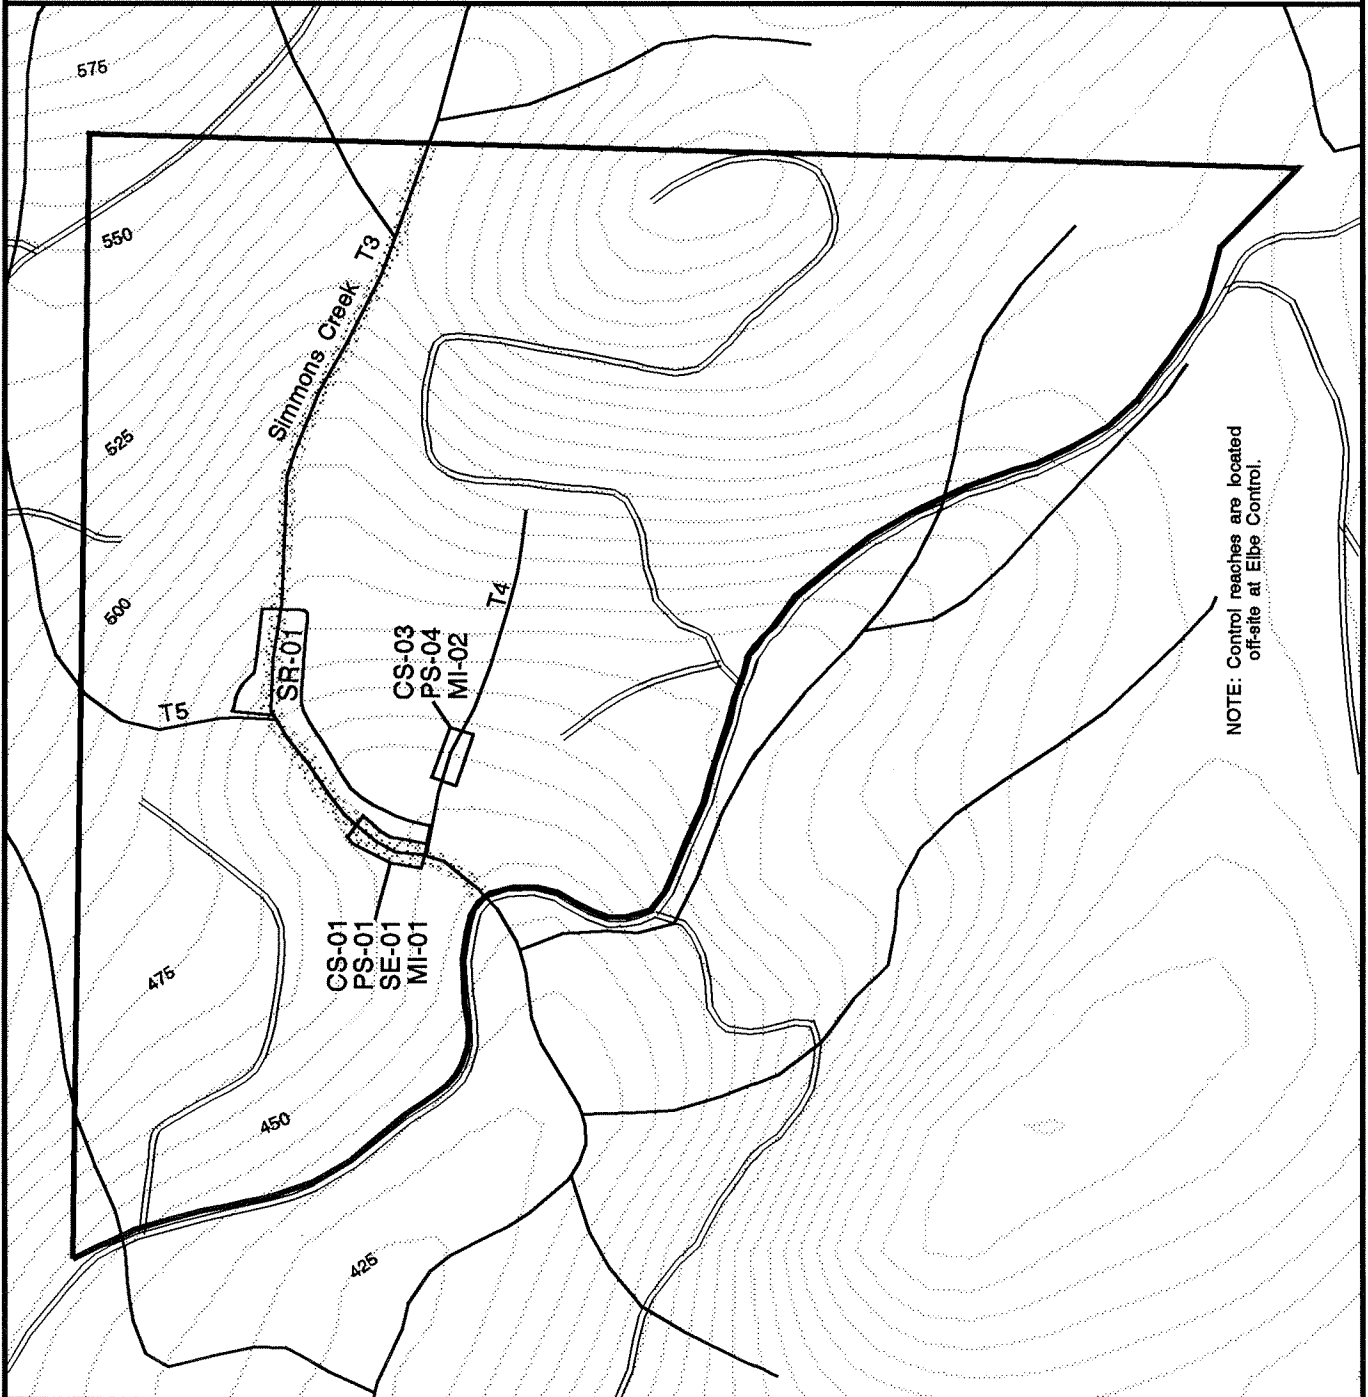
Study Site:	S-09: Simmons Creek - Clearcut harvest, with RMZ and harvest without stream buffers			
Survey Employed	Harvest w/ RMZ & Streambank Integrity BMPs (WAC 222-30-020(2-4) & -030 & -040 & 050)	BMP Effectiveness Ratings		
	Ground-based Yarding WAC 222-30-070	Cable Yarding WAC 222-30-060	Ground-based Yarding WAC 222-30-070	Cable Yarding WAC 222-30-060
	Harvest with no buffers (Type 4 and/or 5 Waters)	Harvest with no buffers (Type 4 and/or 5 Waters)	Harvest with no buffers (Type 4 and/or 5 Waters)	Harvest with RLTA's (Type 4 and/or 5 Waters) (WAC 222-30-020(6))
ASPECT 1: Effectiveness in terms of chronic erosion with delivery to surface waters.	Sediment Routing: SR-01	Effective		
Case Narrative:	The sediment routing survey evaluated sediment delivery from cable yarding in the vicinity of a reach of Simmons Creek buffered by a RMZ. In the first-year survey (7 months following harvest), one yarding feature accounted for just over half of the erosion associated with sediment delivery to the creek, with the remainder attributed to two windthrow features. By the second-year survey conducted 19 months following harvest, the yarding erosion feature had re-vegetated, and the same two windthrow features were continuing to deliver minor amounts of sediment. The RMZ was effective at preventing chronic sediment delivery directly to Simmons Creek from harvest erosion features, although un-buffered tributaries were noted as sources of sediment.
