# The KEYSTONE CANYON

## OVERVIEW

# Prevention Bulletin

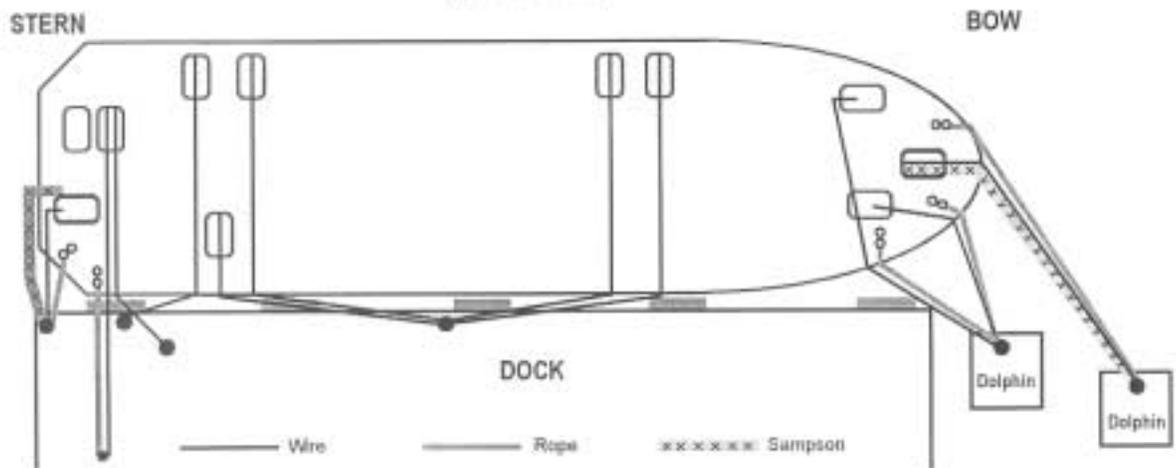
### KEYSTONE CANYON Mooring Configuration

On the day of the incident, the KEYSTONE CANYON was moored with 18 lines – 11 wires and 7 synthetic ropes. Long lines were mixed with short lines, and wires and ropes were paired. The wires and two Sampson ropes were on winches and the other five ropes were on bitts. Statements from the KEYSTONE CANYON deck officers indicated the five ropes on bitts were not properly pre-tensioned. Due to

the difference in elasticity caused by the mixed lines and the imbalance of tension caused by inattention to the 5 synthetic ropes, the 18 lines shared unequal loads against the 60 to 70 mile per hour winds. As increased tension began parting and paying out lines carrying the heaviest loads, fewer lines became available to secure the vessel. This cascading effect ultimately resulted in all lines parting or paying out and the vessel being blown from the dock. [The mooring configuration is shown on Page 1.]

The mooring facilities were not adequate for this size vessel in all weather conditions. The vessel's length in comparison to the available length of pier face caused the stern lines to be nearly perpendicular to the pier, thus assuming a disproportionate share of the load induced by the wind on the side of the ship.

- Develop a plan to limit vessel freeboard during high winds.
- Limit the use of mixed and short mooring lines to the maximum extent possible and ensure each line is equally loaded.
