The NOHO HELE

This bulletin was prepared to share lessons learned with industry and interested public, and to make recommendations to prevent similar occurrences. The company operating the NOHO HELE at the time of the incident was invited to provide comment on this bulletin. They did not provide comment.

OVERVIEW

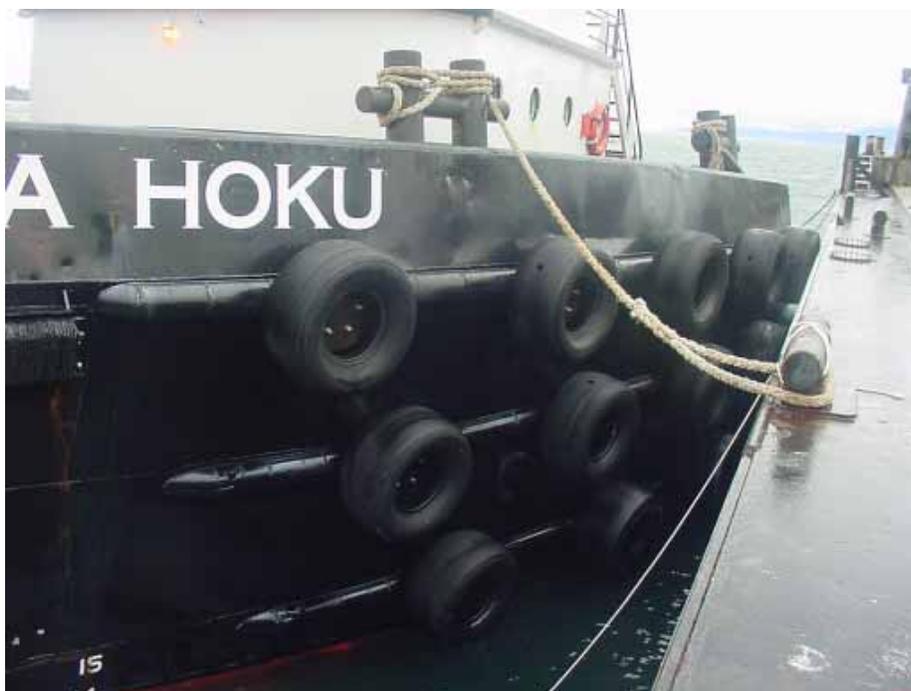
NA HOKU was a 24-year-old twin propeller United States-flagged tugboat of 375 gross tons. Its length was about 32 meters. The NA HOKU was serviced in the shipyard in 2004 where changes were made to the fendering system. The fendering system previously consisted of tires hung on chains over the vessel's side. The system was changed in 2004 to accommodate additional tires by bolting them onto the side of the vessel. This system was based on a design used by another U.S.-West Coast tugboat company.

*Figure 2:
Tug fendering
arrangement.*

- Repaired barge under class approval.
- Cut off the attachment bolts and nuts and the fender retainer is secured by welding alone.
- Provided procedures or amplifying guidance to tug Masters to thoroughly inspect the landing area on the barge after hard contact to ensure no damage was done—including action to shift the tug as necessary to look under fendering points.
- Provided procedures or amplifying guidance to tug Masters to communicate information to the attending tankermen about any hard landings so the PIC can accomplish additional inspections, and so the PIC’s awareness is heightened during barge loading.

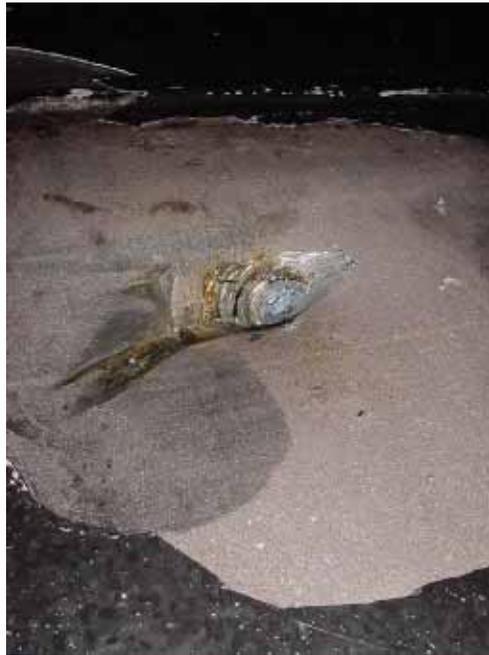
0712 – The tug/barge crew began deploying the onboard containment boom with the barge's response skiff. The skiff was used to inspect the barge hull to try to discover the source of leak. A 3/4-inch crack was discovered in the hull at the waterline between frame 11 and 12, about 7 1/2 feet below the main deck on the port side in the No. 2 port cargo tank.

An examination of the barge revealed a puncture hole in the side of the barge. An estimated 416 gallons of diesel fuel entered the waters of the state.

*Figure 3:
The puncture in
the side of the
NOHO HELE.*

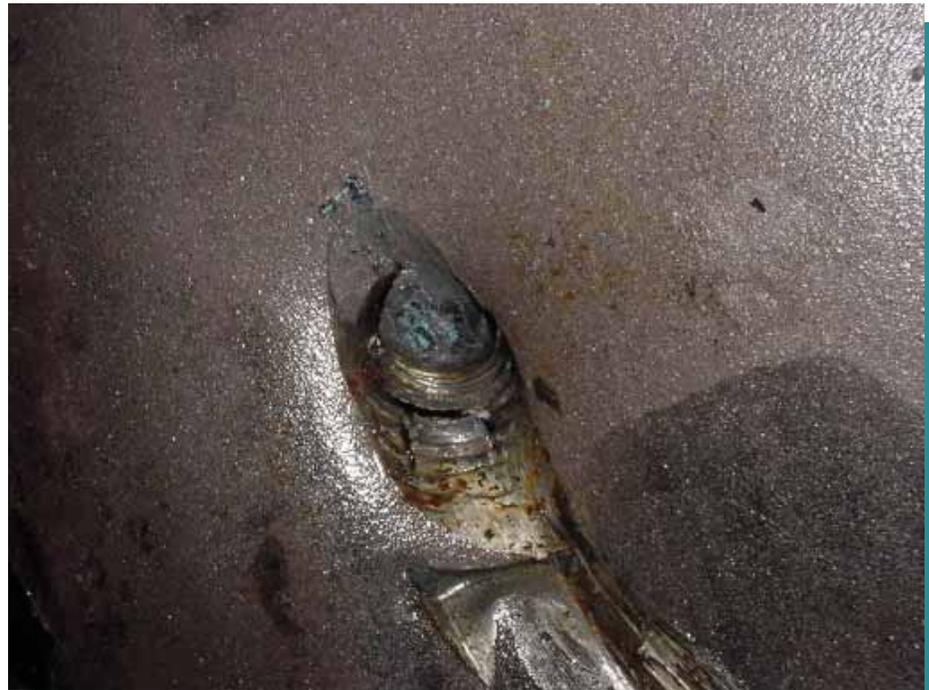
*Figure 4:
The puncture in
the side of the
NOHO HELE.
The small
fracture is
within the
indentation.*

Based on the information gathered, the cause of the spill was a $\frac{3}{4}$ -inch crack in the No. 2 port cargo tank. Factors contributing to the spill included contact between the barge and a bolt in the tug's fendering system, and the design of the fendering system.

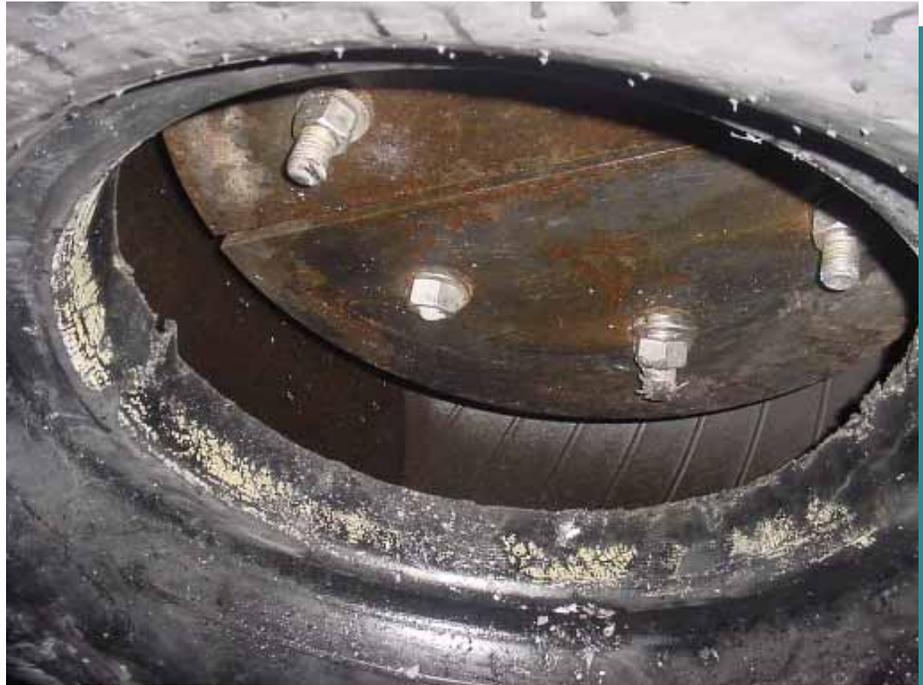
From the Captain’s statement it appeared it was more the angle of contact with the barge rather than the force alone which caused the puncture. The Captain was not aware of the tug having holed the barge and so he took no steps to inform the barge PIC or facility about possible damage to the hull of the barge. The Captain did not make a visual inspection of the area of the barge under the tug fenders.

*Figure 5:
Shows the
damaged bolts
believed
responsible for
piercing the hull
of the NOHO
HELE.*
