The ALLEGIANCE

This bulletin was prepared to share lessons learned with industry and the interested public, and to make recommendations to prevent similar occurrences. The company operating the M/V THE ALLEGIANCE has provided comment.

OVERVIEW

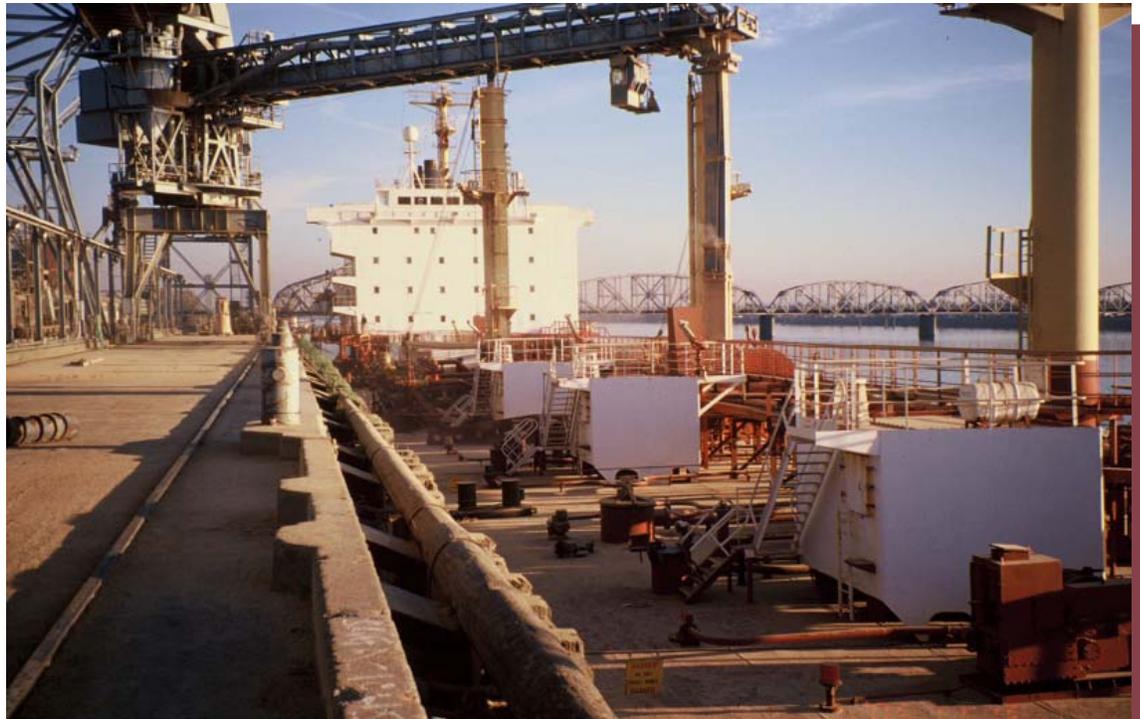
Figure 1. ALLEGIANCE alongside a grain terminal at Vancouver, Washington on November 16, 2005.
