The SONGA HUA

Overview

This bulletin was prepared to share lessons learned with industry and oil spill specialists. Prevention recommendations are also made to prevent similar occurrences. Sharing lessons learned is important if Washington State is to achieve its "zero spills" goal.

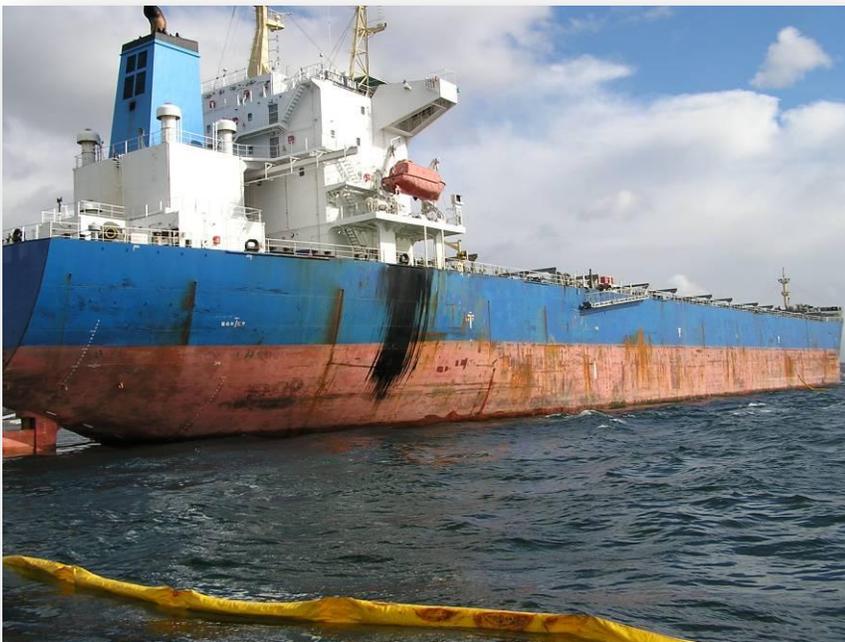
Figure 1 - The SONGA HUA at anchor in Elliot Bay, Seattle, Washington on February 28, 2007, showing an oil stain on its starboard side. [Photograph courtesy of Washington State Department of Fish and Wildlife.]

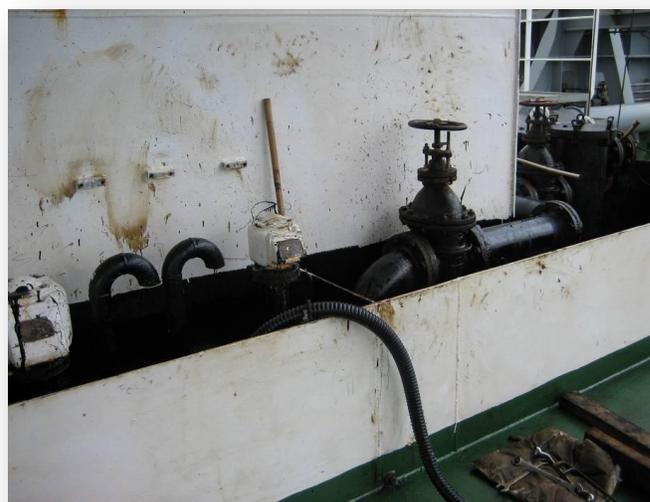
Figure 3 - The No. 4 starboard main deck fuel oil tank valve.

Following the spill and prior to the arrival of Ecology investigators, the ship's crew disassembled the valve under the supervision of the U.S. Coast Guard. They found that the Third Engineer improperly re-installed the indicator on the valve stem following the reconditioning in February 2007. Because the indicator bottomed-out on the stem threads prematurely, it prevented the valve handle from turning any farther. This caused the valve stem to stop turning before the valve could seat fully.

Examination of the valve showed that the stem-mounted valve position indicator on the valve was not positioned to correspond with the actual valve gate position. The valve position indicator could reach the end of the threads before the valve gate could close fully. This caused the valve stem to stop turning, giving the operator a false indication that the valve was fully closed. This likely explains why the Third Engineer did not note a problem when he checked the valve alignment prior to the transfer, and why the No. 4 starboard fuel oil tank was filling despite its being third in the planned filling sequence behind No. 2 and 3 center tanks.

starboard fuel oil to accept 47 percent of the flow. Therefore, the reassembly of the No. 4 starboard fuel oil valve with regard to the positioning of the valve position indicator on the valve stem was significantly in error.

Given the importance of fuel oil valves to safety and the protection of the marine environment, the Chief Engineer should have carefully overseen the Third Engineer's work on the valve. In addition, the ship's bunkering team should have given special attention to the No. 4 starboard fuel oil tank levels during the first bunkering operation following the No. 4 starboard fuel oil tank valve's reassembly.

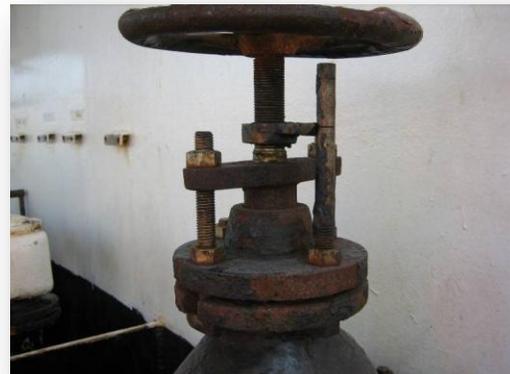
Figure 4. No. 4 starboard main deck fuel oil tank valve. Note the indicator (valve position indicator) mounted on the shaft of the valve stem.

- Examination of the No. 4 starboard fuel oil tank valve showed that the stem-mounted valve position indicator on the valve was not positioned to correspond with the actual valve gate position. The valve position indicator could reach the end of the threads before the valve gate could close fully. This caused the valve stem to stop turning, giving the operator a false indication that the valve was fully closed.

- The reassembly of the No. 4 starboard fuel oil valve with regard to the positioning of the valve position indicator on the valve stem was significantly in error.

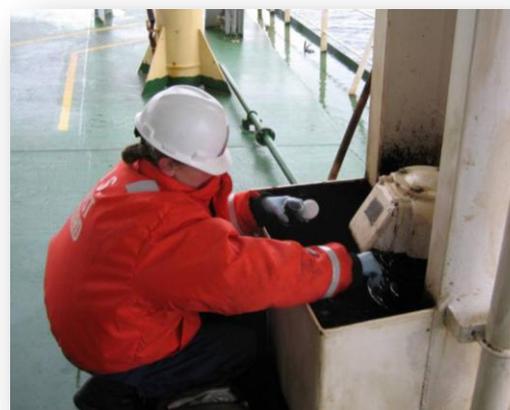
The No. 4 fuel oil tanks were connected to an overflow tank via an eight-inch (20 centimeter) pipe. The overflow tank was equipped with a high-level alarm that sounded in the engine control room. Vents for the No. 4 wing fuel oil tanks were located outboard of the SONGA HUA's house. These vents were equipped with fixed containment (see Figure 5).

Figure 5 - A U.S. Coast Guard (USCG) officer takes a sample from the No. 4 starboard fuel oil vent containment box.
