# The ARCADIA

## PREVENTION BULLETIN 98-01

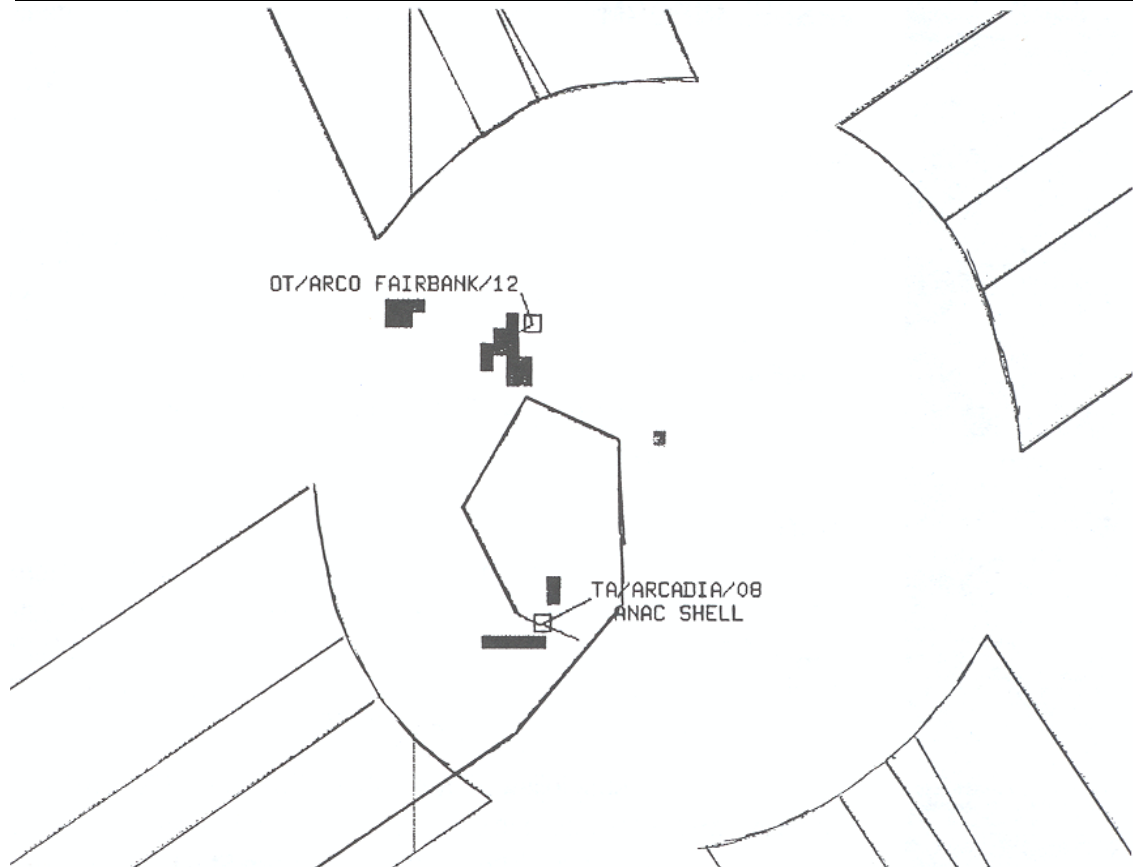
— VTS printout showing ARCADIA's turn. Unlabeled dot at center is Buoy "RA". —

The ARCADIA swung approximately 50 degrees to port before steering control was restored. The Pilot aboard the ARCADIA chose to continue to circle to the left to come back to the intended course. During the turn the ARCADIA's engines remained at full ahead. The ARCADIA's speed (over ground) decreased to about eight knots from about 12.5 knots during the turn. This maneuver took approximately 19 minutes and brought the ARCADIA into the line of the outbound traffic lane-the intended path of the ARCO FAIRBANKS. The VTS printout indicates that the ARCO FAIRBANKS tracked to the right side of the outbound lane. It appears from the VTS printout that the two vessels had a closest point of approach of approximately one mile. Normally, two vessels centered in the inbound and outbound lanes will pass at a distance of approximately 0.8 Nm when following the separation scheme in this area.
