Second Periodic Review

Elliott Tire Center 1 E Lincoln Avenue Yakima, Washington 98902

Facility/Site ID #: 547 Cleanup Site ID #: 1940

December 2013

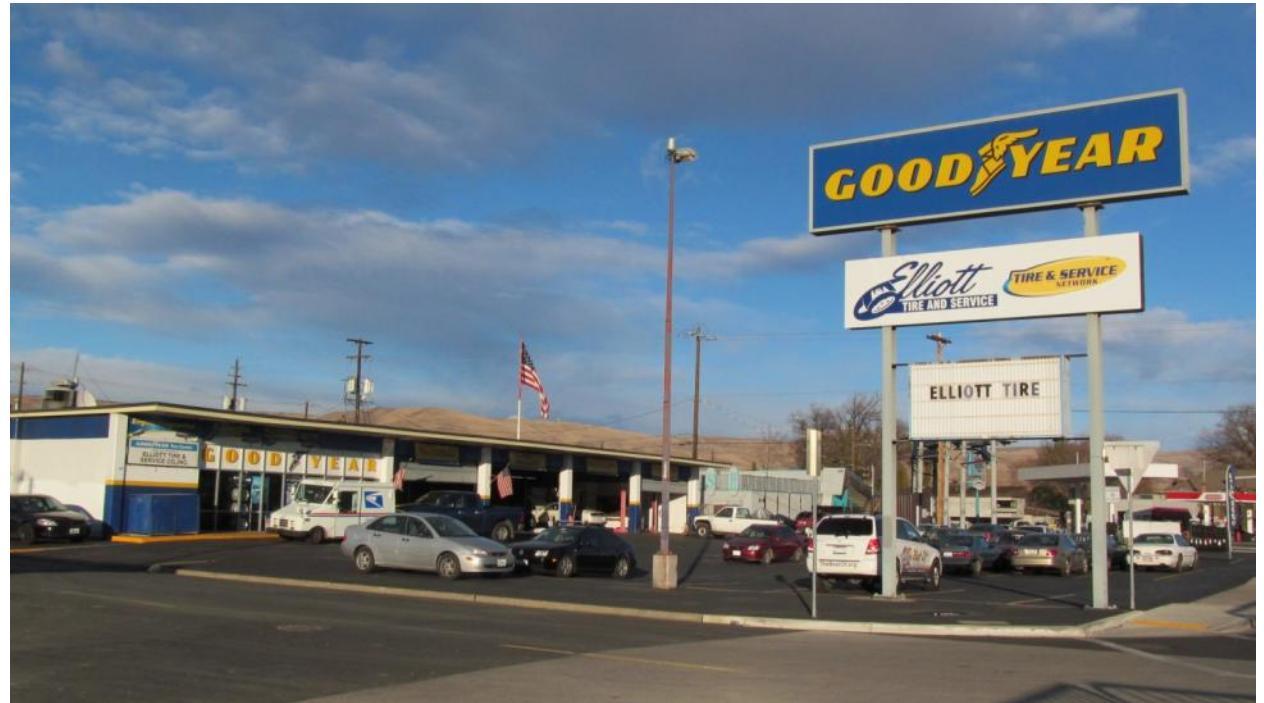
Photo 1: Elliott Tire Center - from the southwest

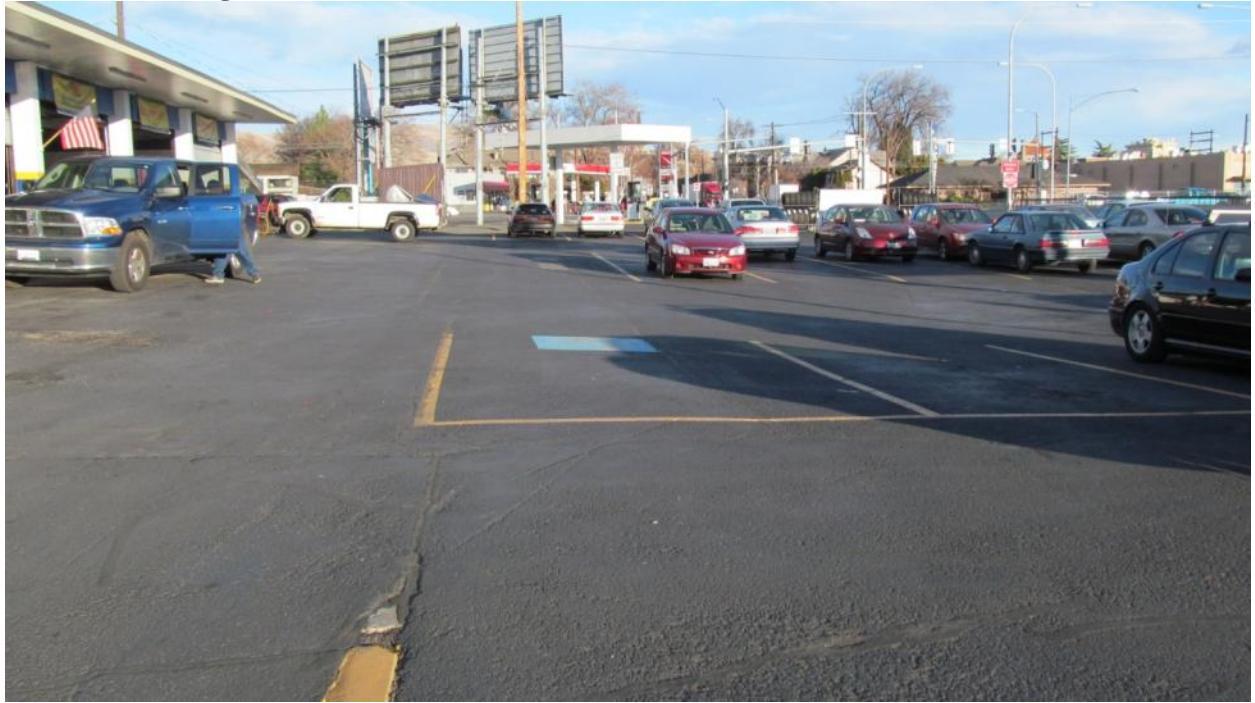
Based upon the Site visit conducted on December 2, 2013, the building and asphalt cover at the Site continue to eliminate exposure pathways (ingestion, contact) to contaminated soils. The asphalt appears in relatively poor condition, with significant cracking; however, it still provides a sufficient barrier to direct contact exposure with contaminated soils. The Site is still operating as a tire service and automotive repair business. A photo log is available as Appendix 6.5.

Photo 2: Parking Lot - from the west

Based on this periodic review, Ecology has determined the restrictions in the restrictive covenant are being observed. No additional remedial actions are required by the property owner. It is the property owner's responsibility to continue to inspect the Site to assure that the integrity of the Site surface is maintained.

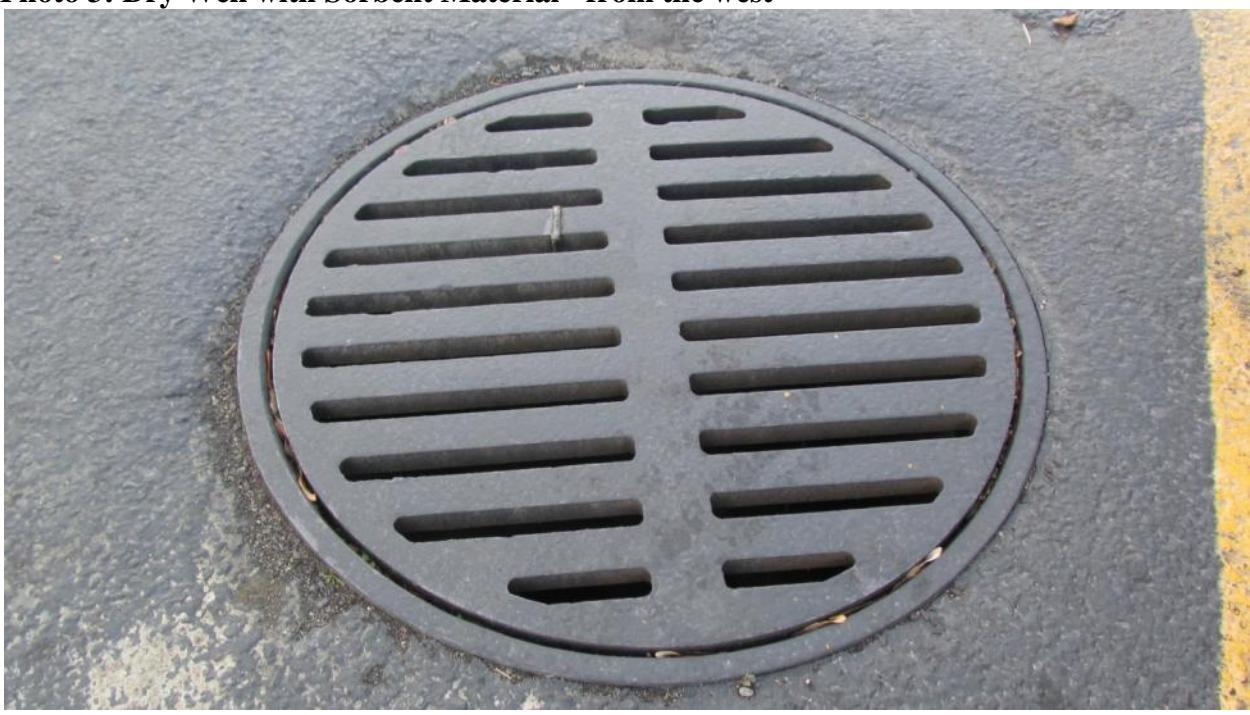
Additionally, the restrictive covenant requires that efforts be maintained to prevent additional soil and groundwater contamination through the Site's catch basin and drywell. At the time of the Site visit, the catch basin and drywell contained a filter and sorbent material, respectively. The store manager was aware of the requirement to protect these storm water infiltration points, and a regular maintenance program was followed.

Photo 3: Dry Well with Sorbent Material - from the west

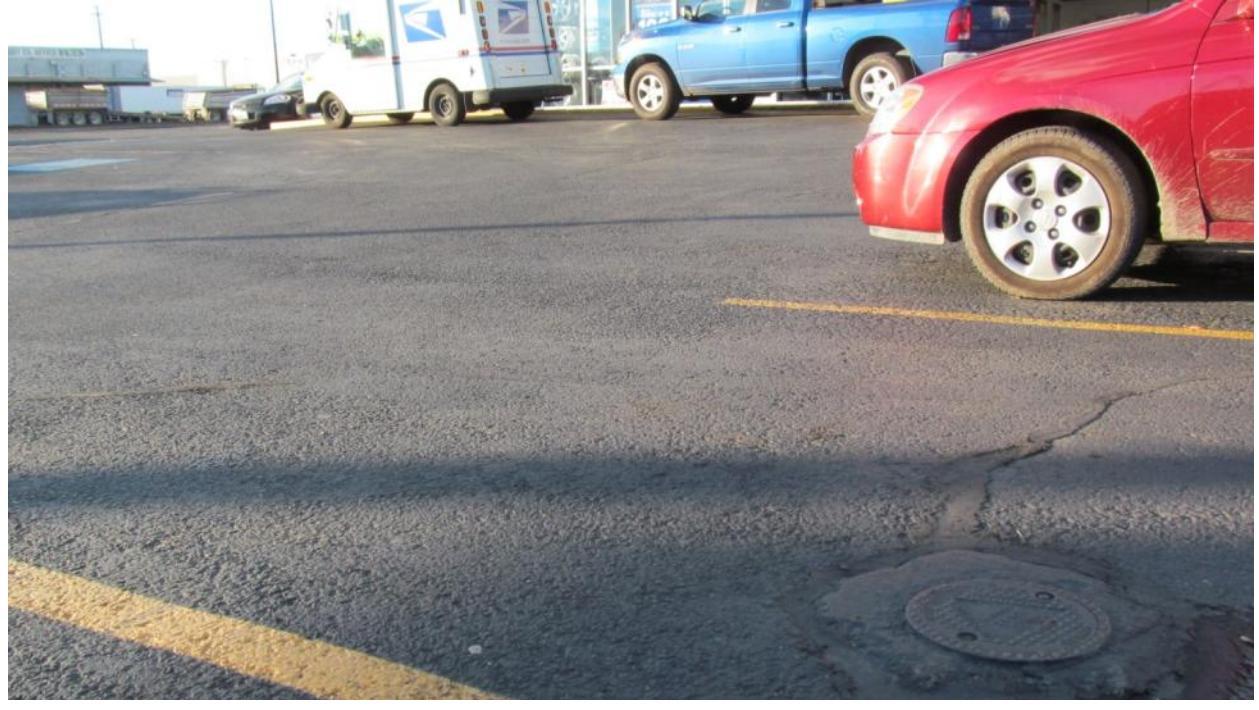
Photo 4: Monitoring Well in Parking Lot – from the southeast
