PERIODIC REVIEW (DRAFT)

WHITTY'S MINI MART 2 SITE

COLVILLE, WA

TOXICS CLEANUP PROGRAM

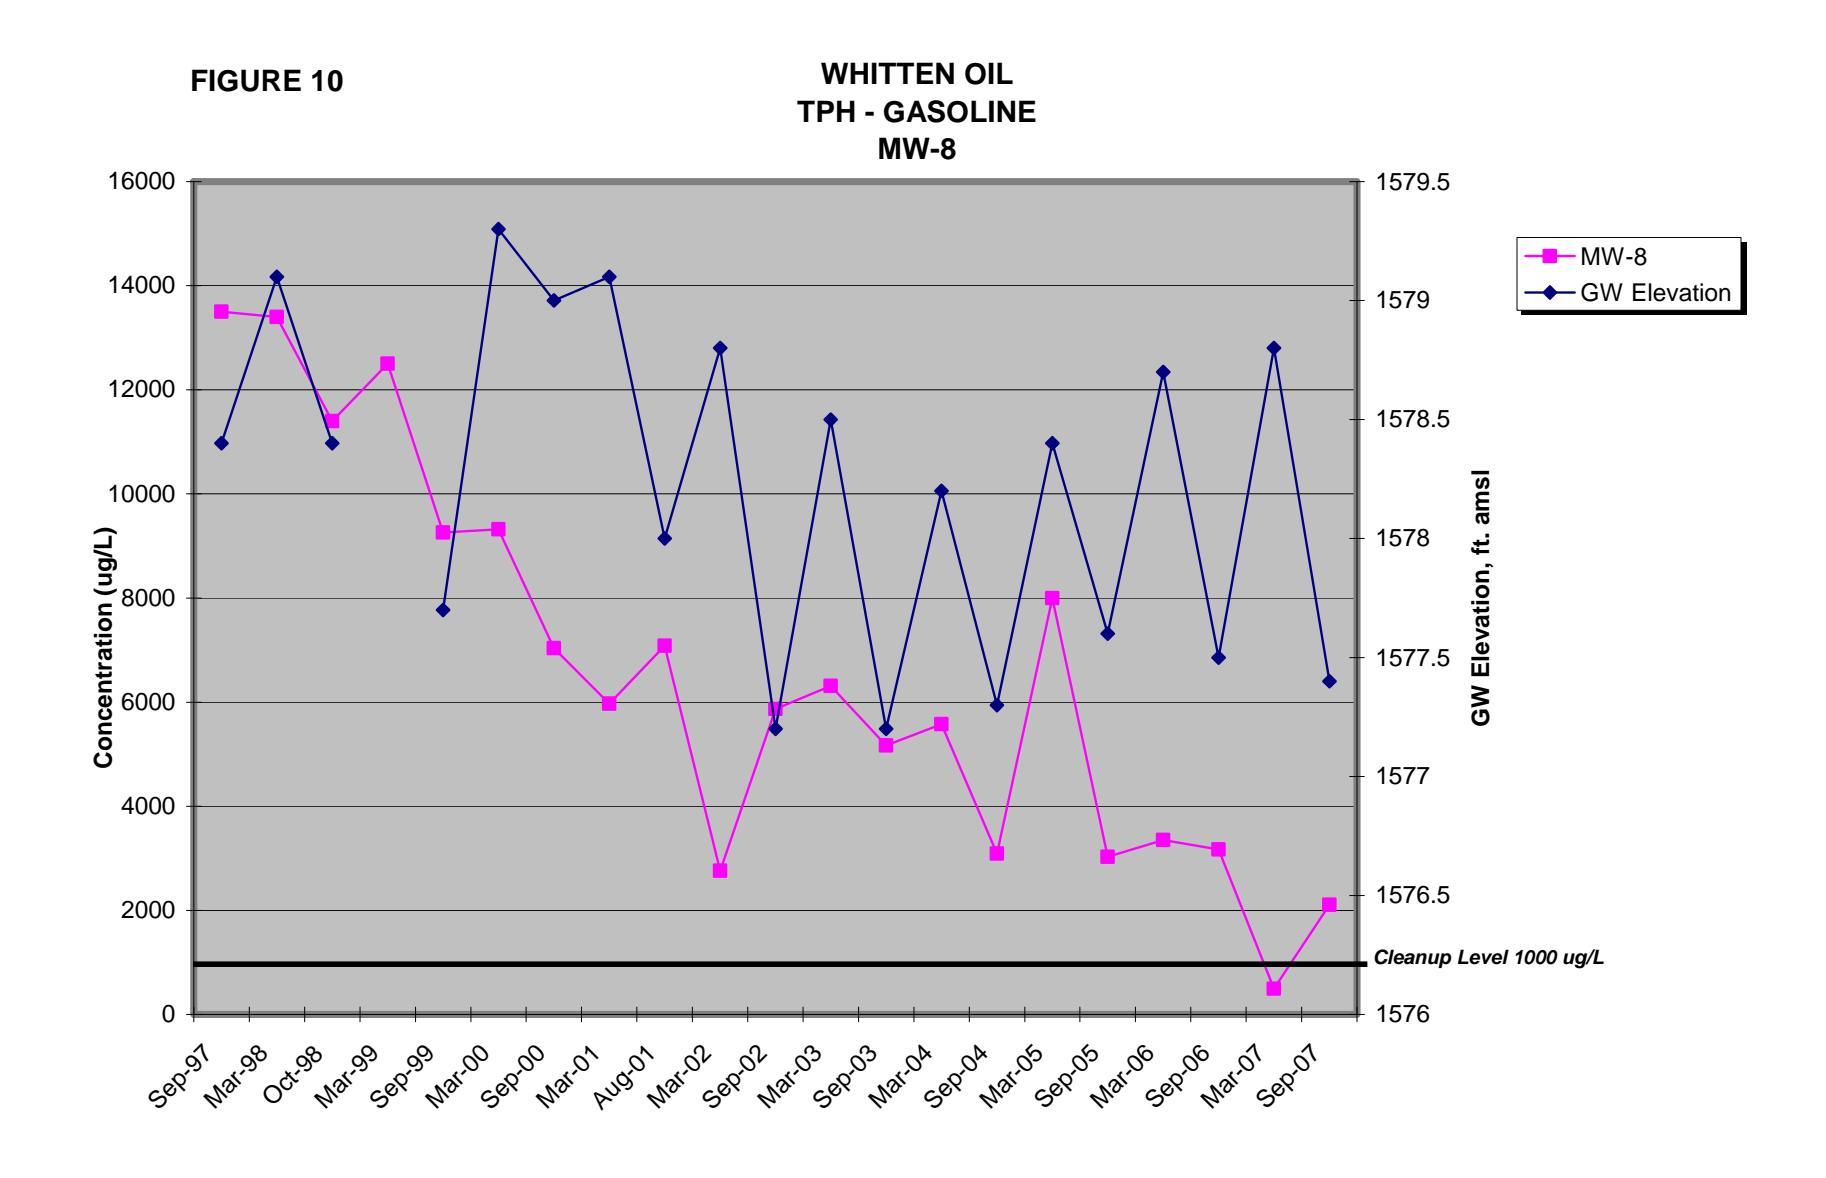
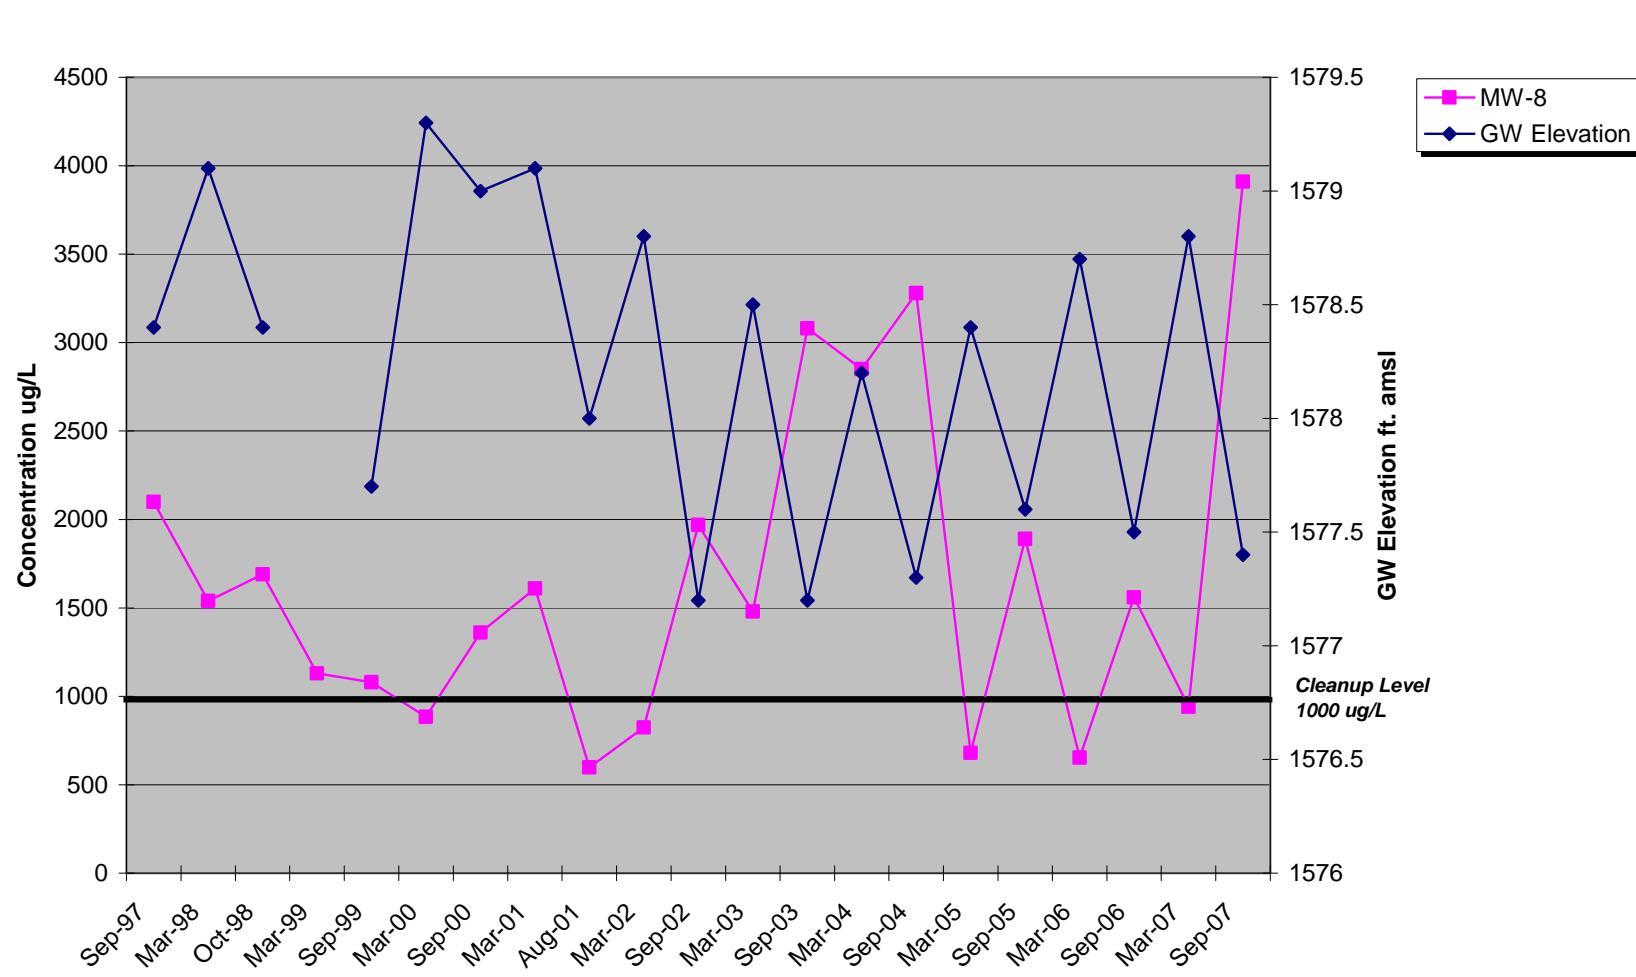
FIGURE 11

MW-8 (Figures 10 & 11)

This compliance well is located closest to the storm water drain and downgradient from MW-7. TPH (G) has decreased approximately 85 % over the review period and over 98% from the highest levels measured prior to cleanup. TPH (D) has been trending downward but continues to have seasonal spikes above the cleanup level. This coincides with the low ground water elevation observed during sampling events in the fall. Diesel and gasoline were below cleanup levels for the first time during the March 2007 sampling event. These levels rebounded above cleanup levels at the time of the September 2007 sampling event. The spike in diesel range contamination was particularly notable.

This wells' proximity to the city's storm water drain may account for the seasonal jump in TPH concentrations. The well is located less than 10 feet from the storm sewer. A 1991 video survey of the storm drain noted gasoline infiltrating through a small breach in the drain in this area. Storm water discharging from this section of the drain would likely impact ground water in the immediate vicinity of MW-8.

WHITTEN OIL TPH - DIESEL MW-8
