Vapor Intrusion Mitigation System Operation and Maintenance Manual

**Edwards On 5th Property
2619 5th Avenue
Seattle, Washington**

August 14, 2018

EPI Project Number: 68301.4

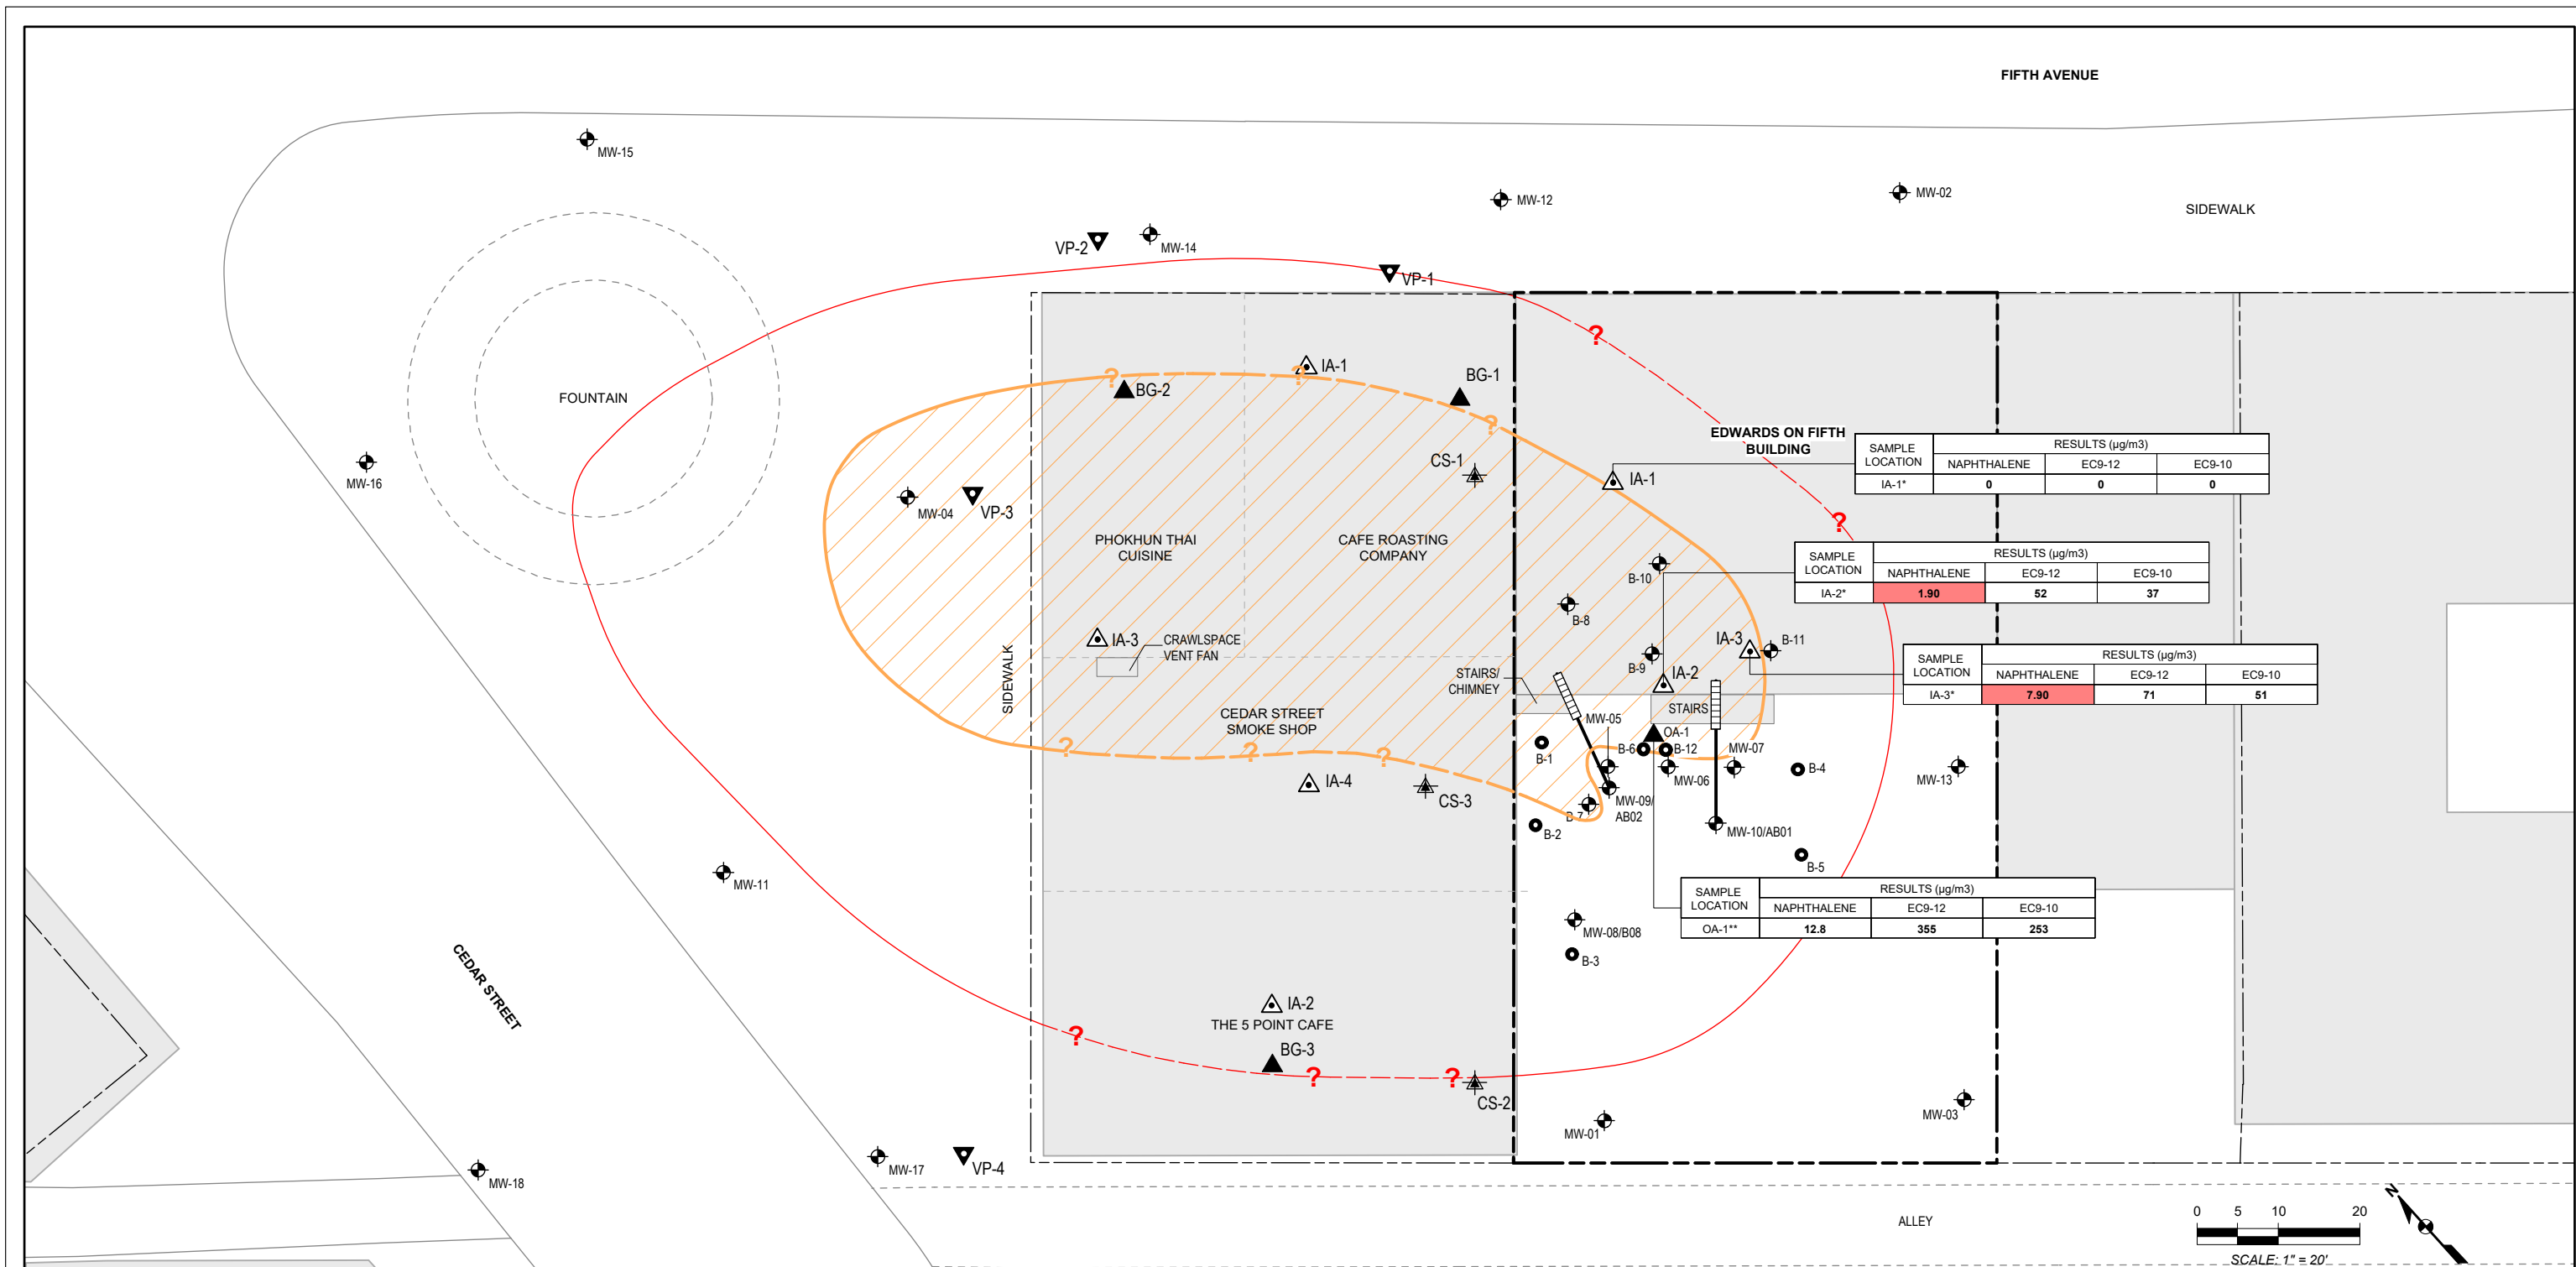
FIGURE 1

EPI mobilized to the subject property on December 16, 2014 to perform an air sampling event at the subject property to evaluate the potential vapor intrusion impacts within the bottom floor of the Edwards Building. A total of three indoor air samples were collected within the basement and one background air sample was collected from outside the building. Sampling locations and analytical data are shown on Figure 1.

An evaluation of the indoor air samples indicated that vapor intrusion of naphthalene may be occurring into the Edwards Building from the former heating oil release. The two indoor air samples collected in the basement nearer the release (IA-2 and IA-3), exhibited concentrations of naphthalene above the cleanup level (CUL). The sample collected further away from the release, to the north (IA-1), exhibited no indications of naphthalene or other DRO-related compounds at concentrations greater than their respective CULs. Aromatic and aliphatic air-phase hydrocarbons (APH) were detected in both indoor air samples IA-2 and IA-3 but were less than their respective Model Toxics Control Act (MTCA) Method B Indoor Air CULs. No APH compounds were detected in IA-1.

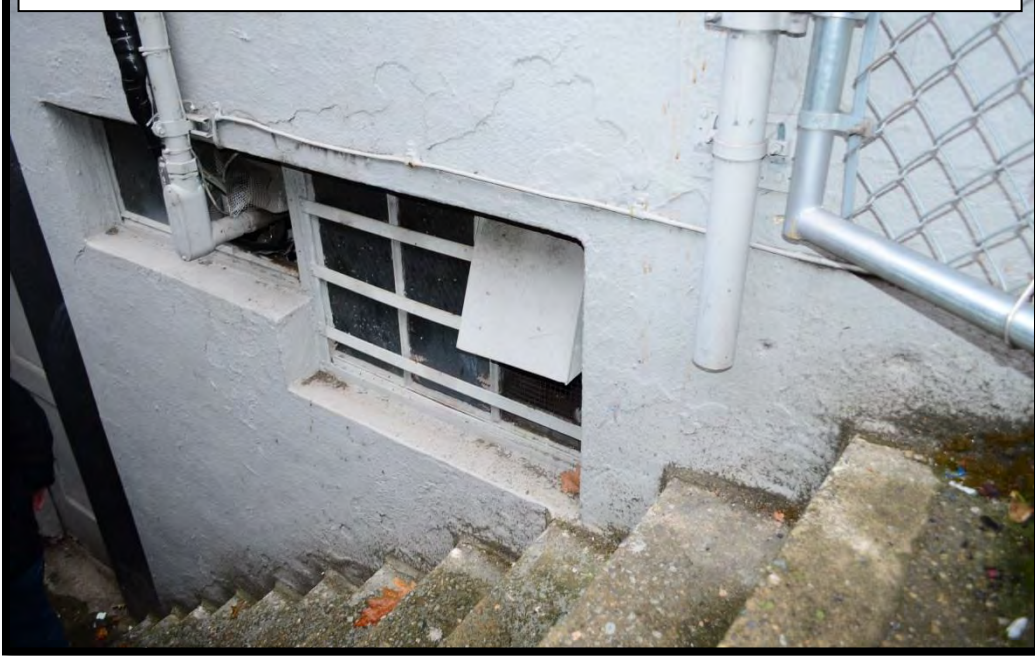
Fig. 1: Stairwell With The Only Significant Exterior Access Point

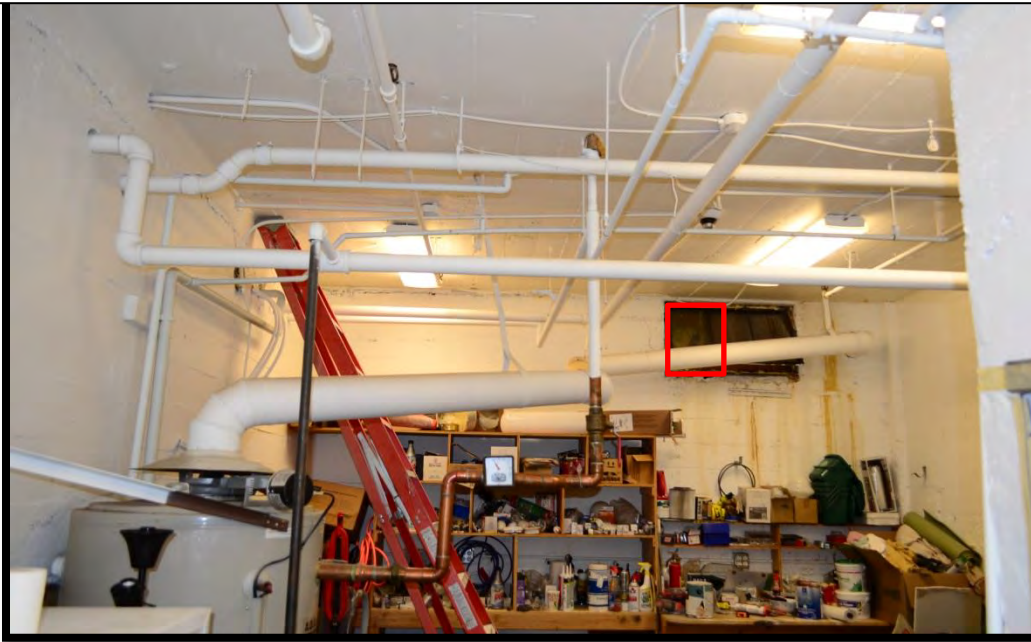
Fig. 3: Location Where Ventilation Access Will Be Installed

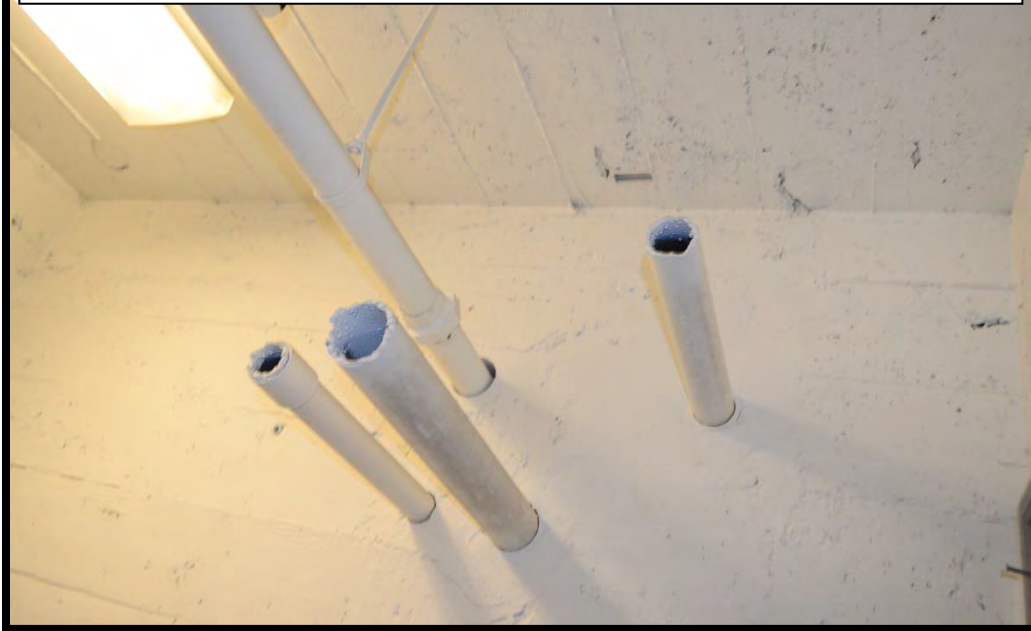
Fig. 4: Numerous Penetrations in Walls Complicates Positive or Negative Pressurization of the Air Spaces.

These units are operated by a 110-Volt power supply and only draw approximately 2 to 3 amperes of current during normal operation. Following installation and prior to startup, gross penetrations and leaks between the basement and the exterior were sealed with expanding polyurethane foam to optimize air pressure confinement.
