Periodic Review Pend Oreille Mine

1382 Pend Oreille Mines Road, Metaline Falls, Pend Oreille County Facility Site ID: 15428546, Cleanup Site ID: 2194

Toxics Cleanup Program, Eastern Region

September 2023

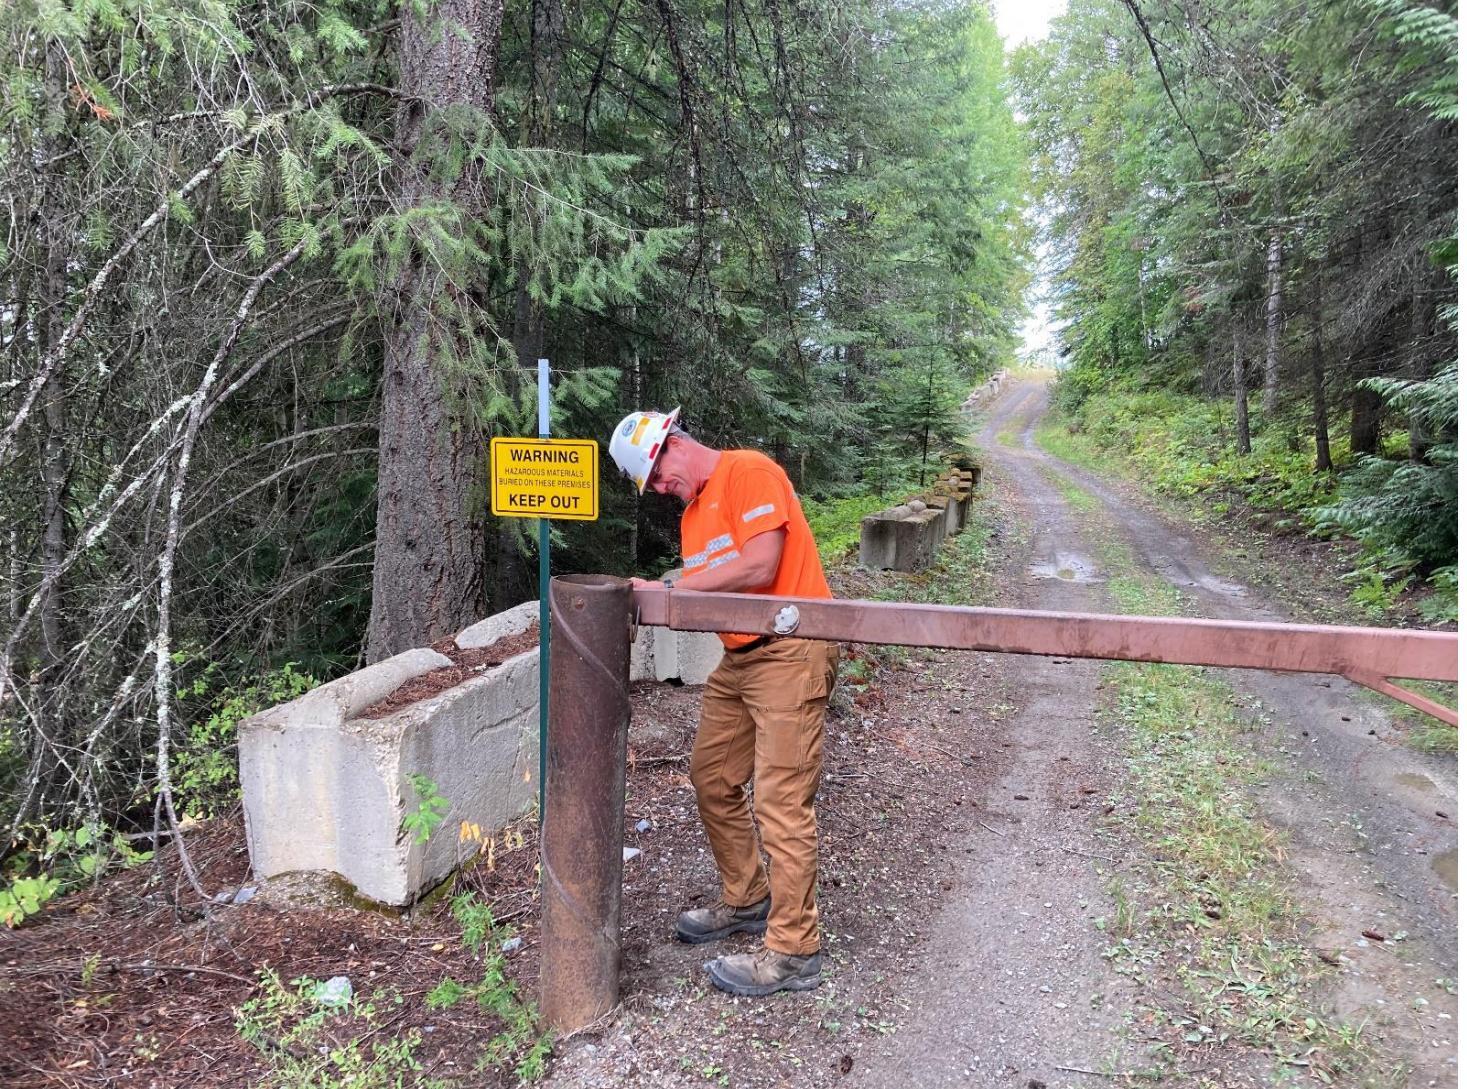
Photo 1: Locked gate and signage on entrance to TDF-1

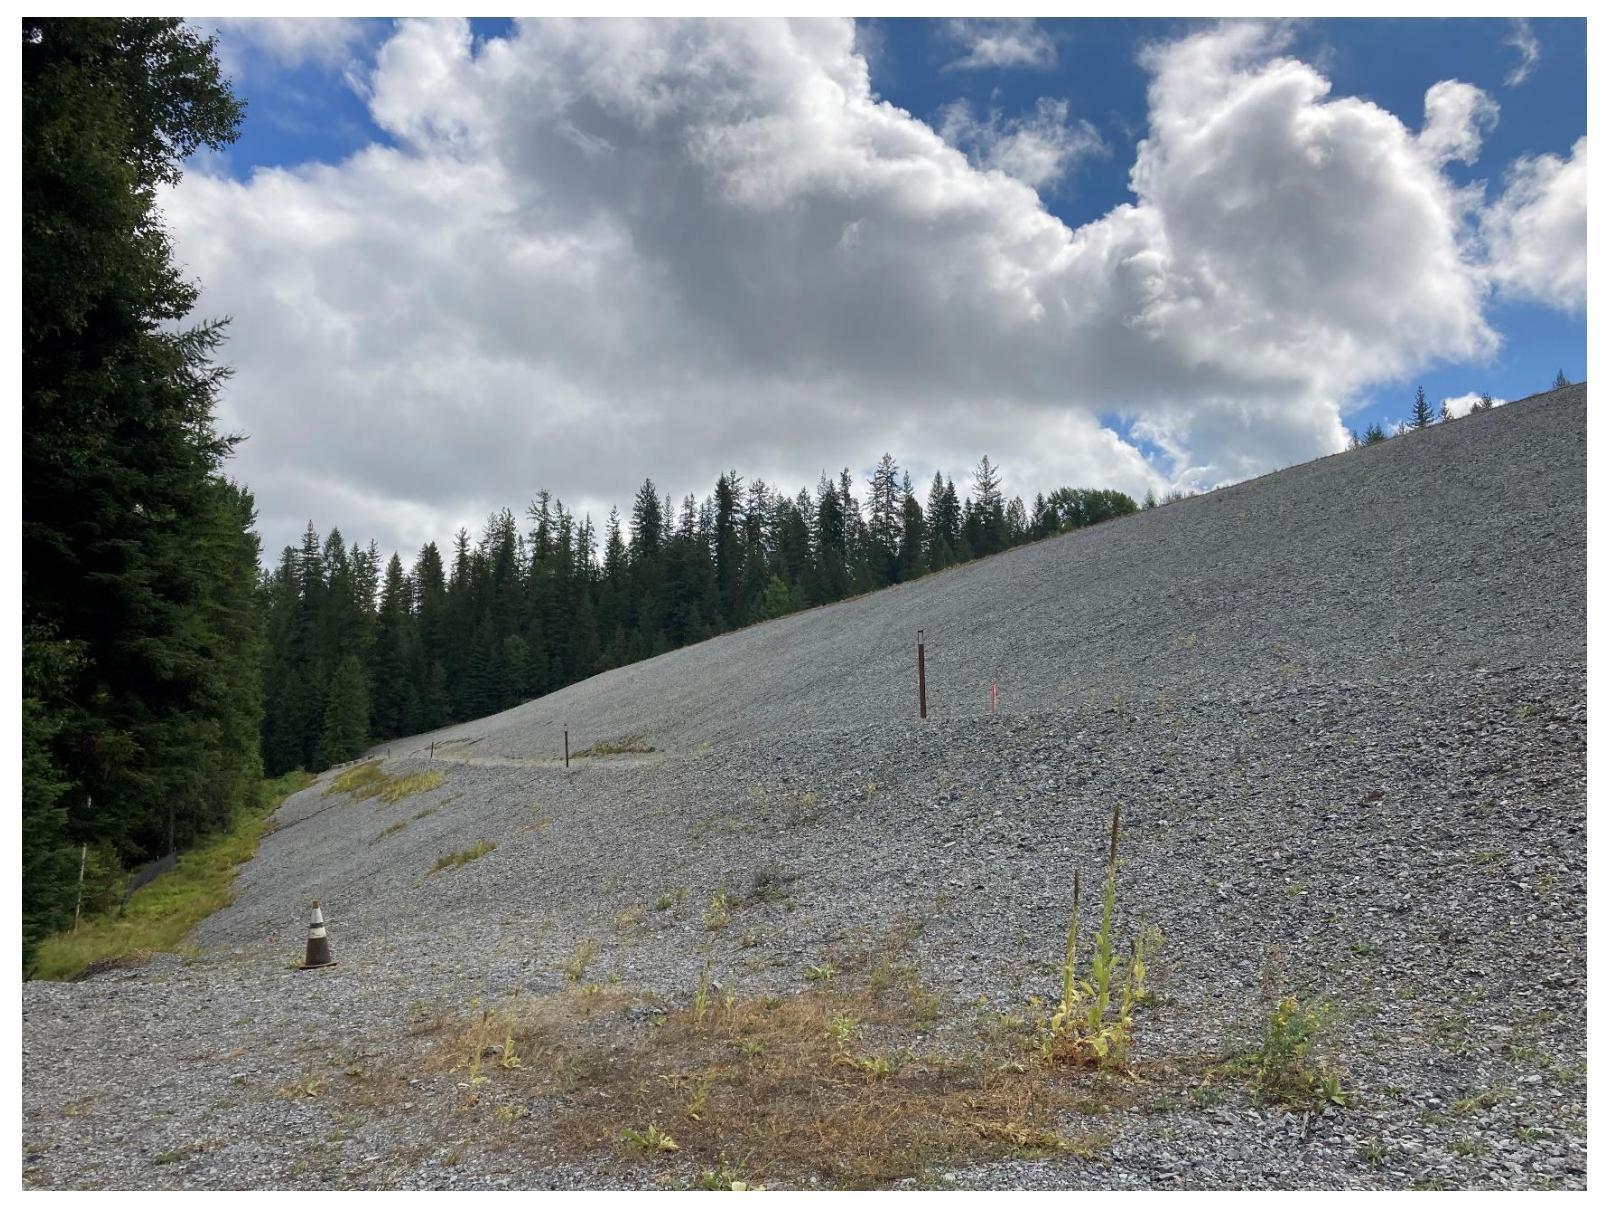
Photo 2: The cap over TDF-1

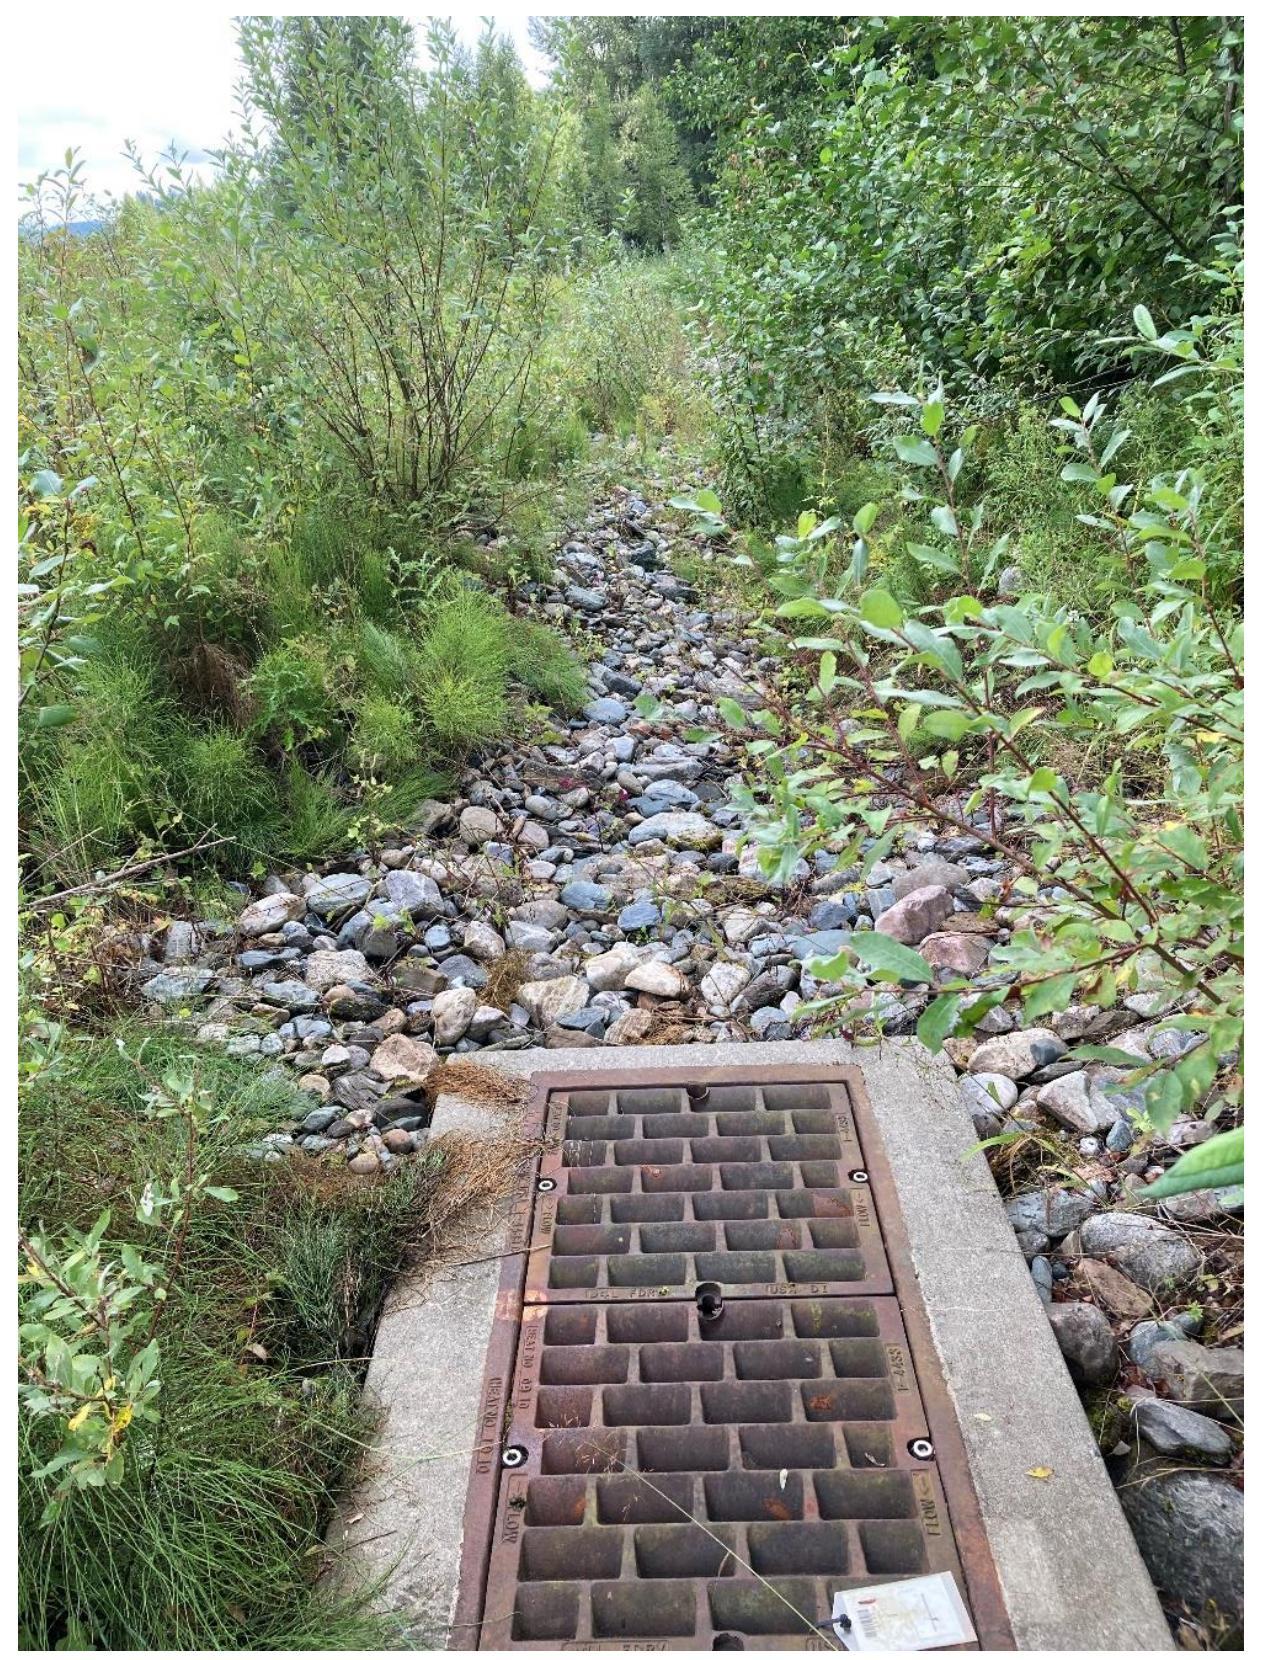
Photo 3: French drain and catch basin on TDF-1

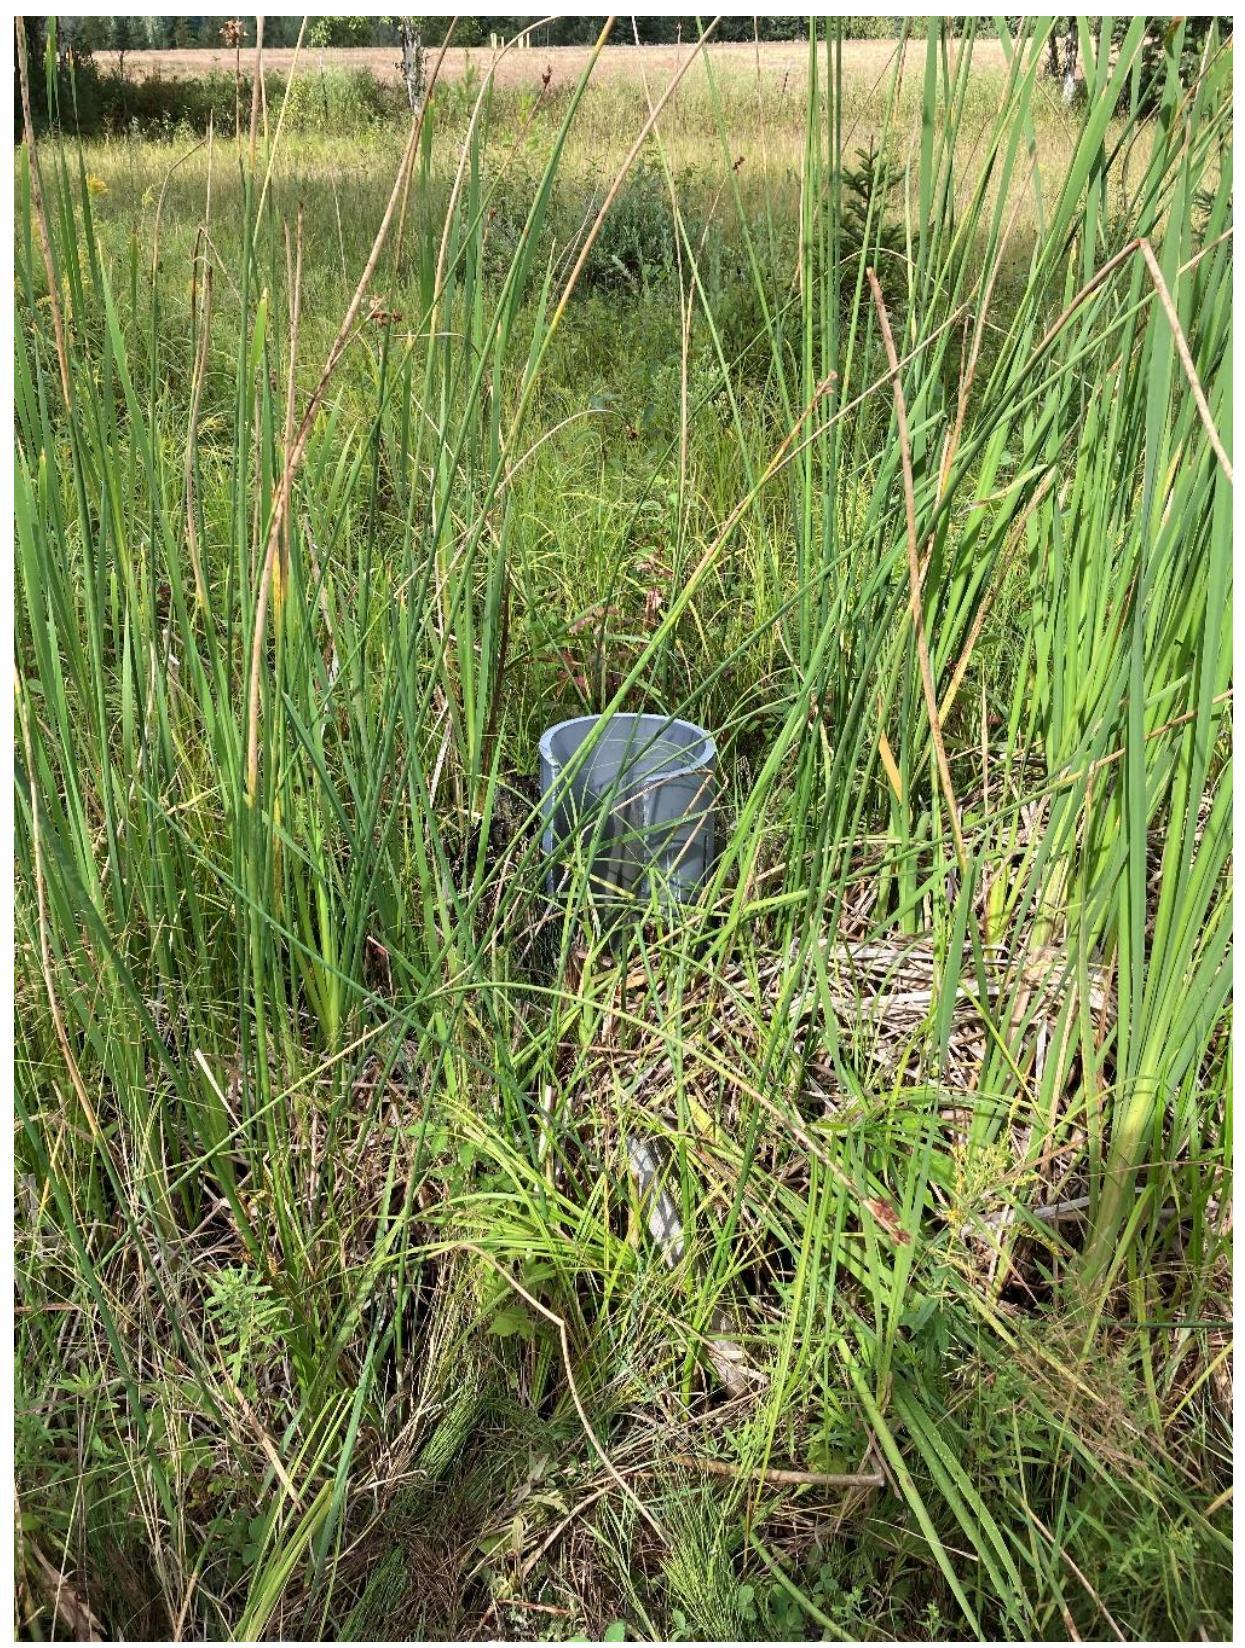
During the Site visit Ecology conducted on August 10, 2023, the cap appeared in good condition, the vegetation appeared healthy, and the Site is actively monitored by Pend Oreille Mine staff. A small wetland area exists on the back side of TDF-1, which is drained year-round by a decant tower. Stormwater runoff from TDF-2 and the hill above TDF-1 is conveyed through a French drain and discharged at the toe of TDF-1. During the site visit, standing water was visible in the northernmost catch basin to the French drain, suggesting that the drain was plugged or blocked.

Photo 4: French drain catch basin with standing water and vegetation

- The water diversion system above TDF-1 should be cleared of any clogs or vegetation to ensure water is being drained from the wetland area and around TDF-1 in the most efficient way possible.

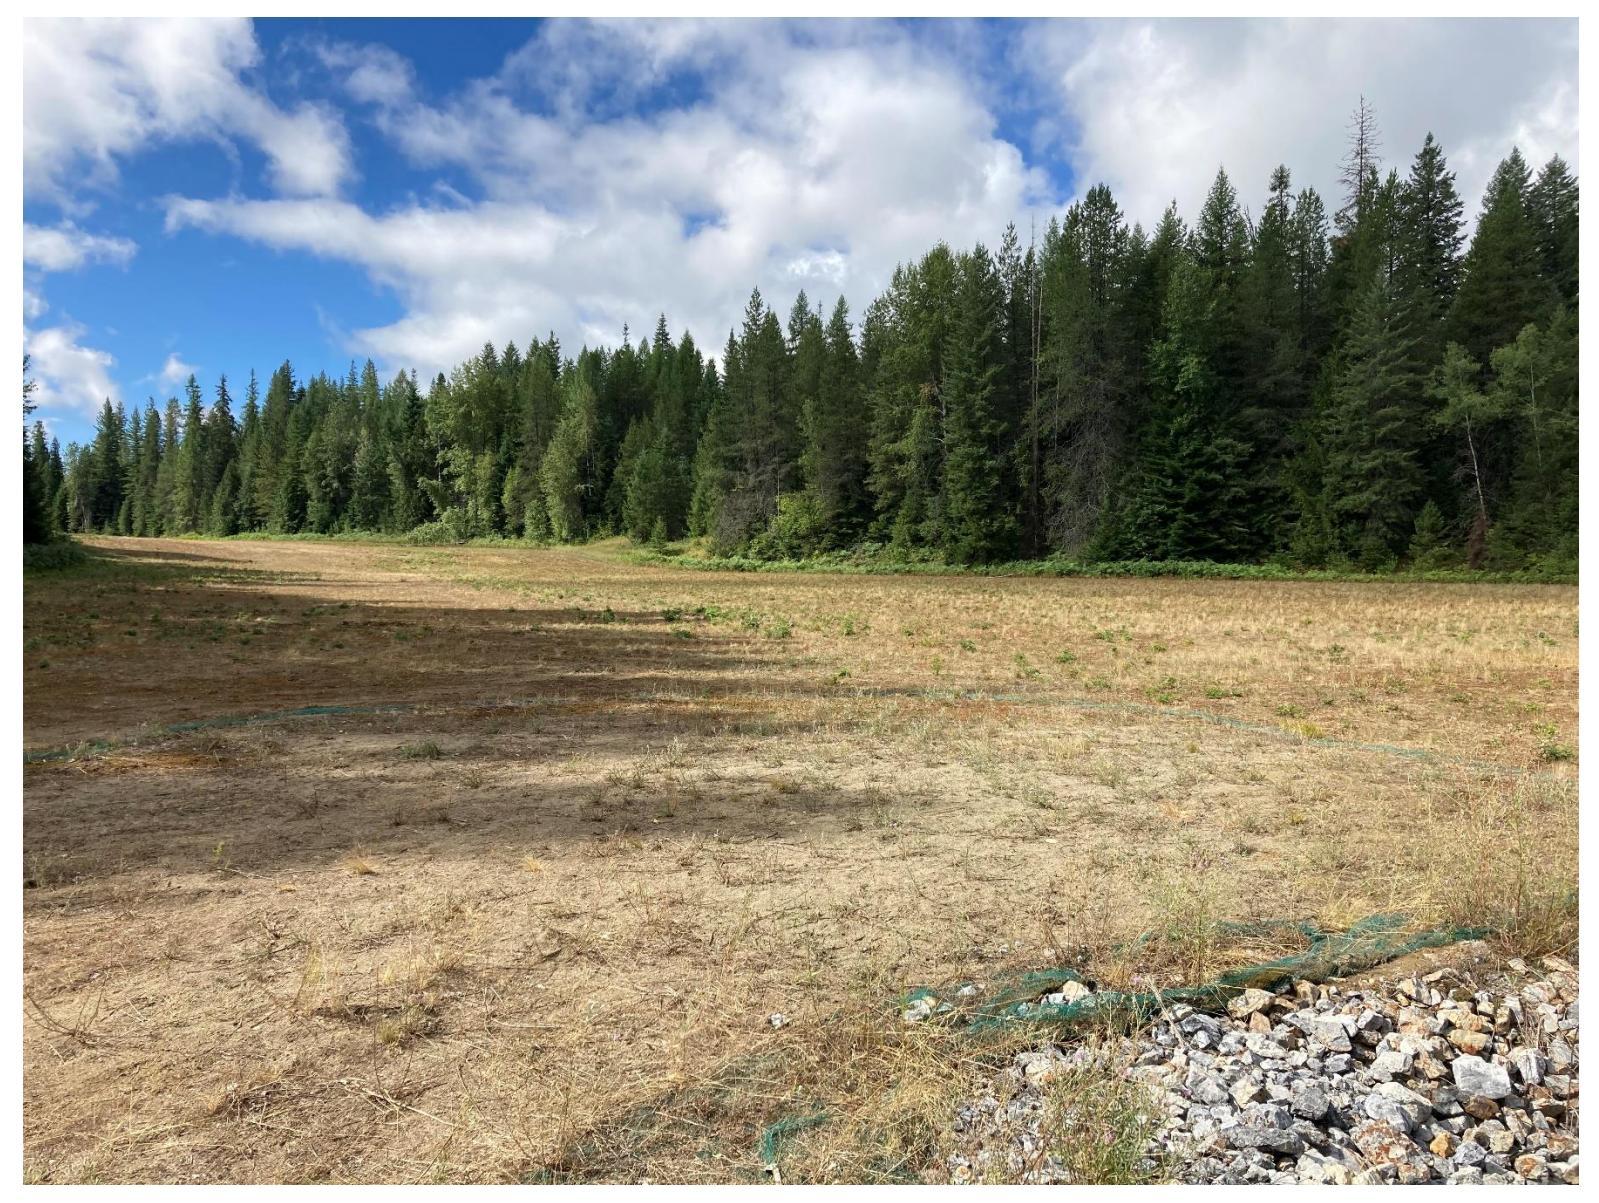
Photo 6: Upper section of TDF-1 with piezometers visible

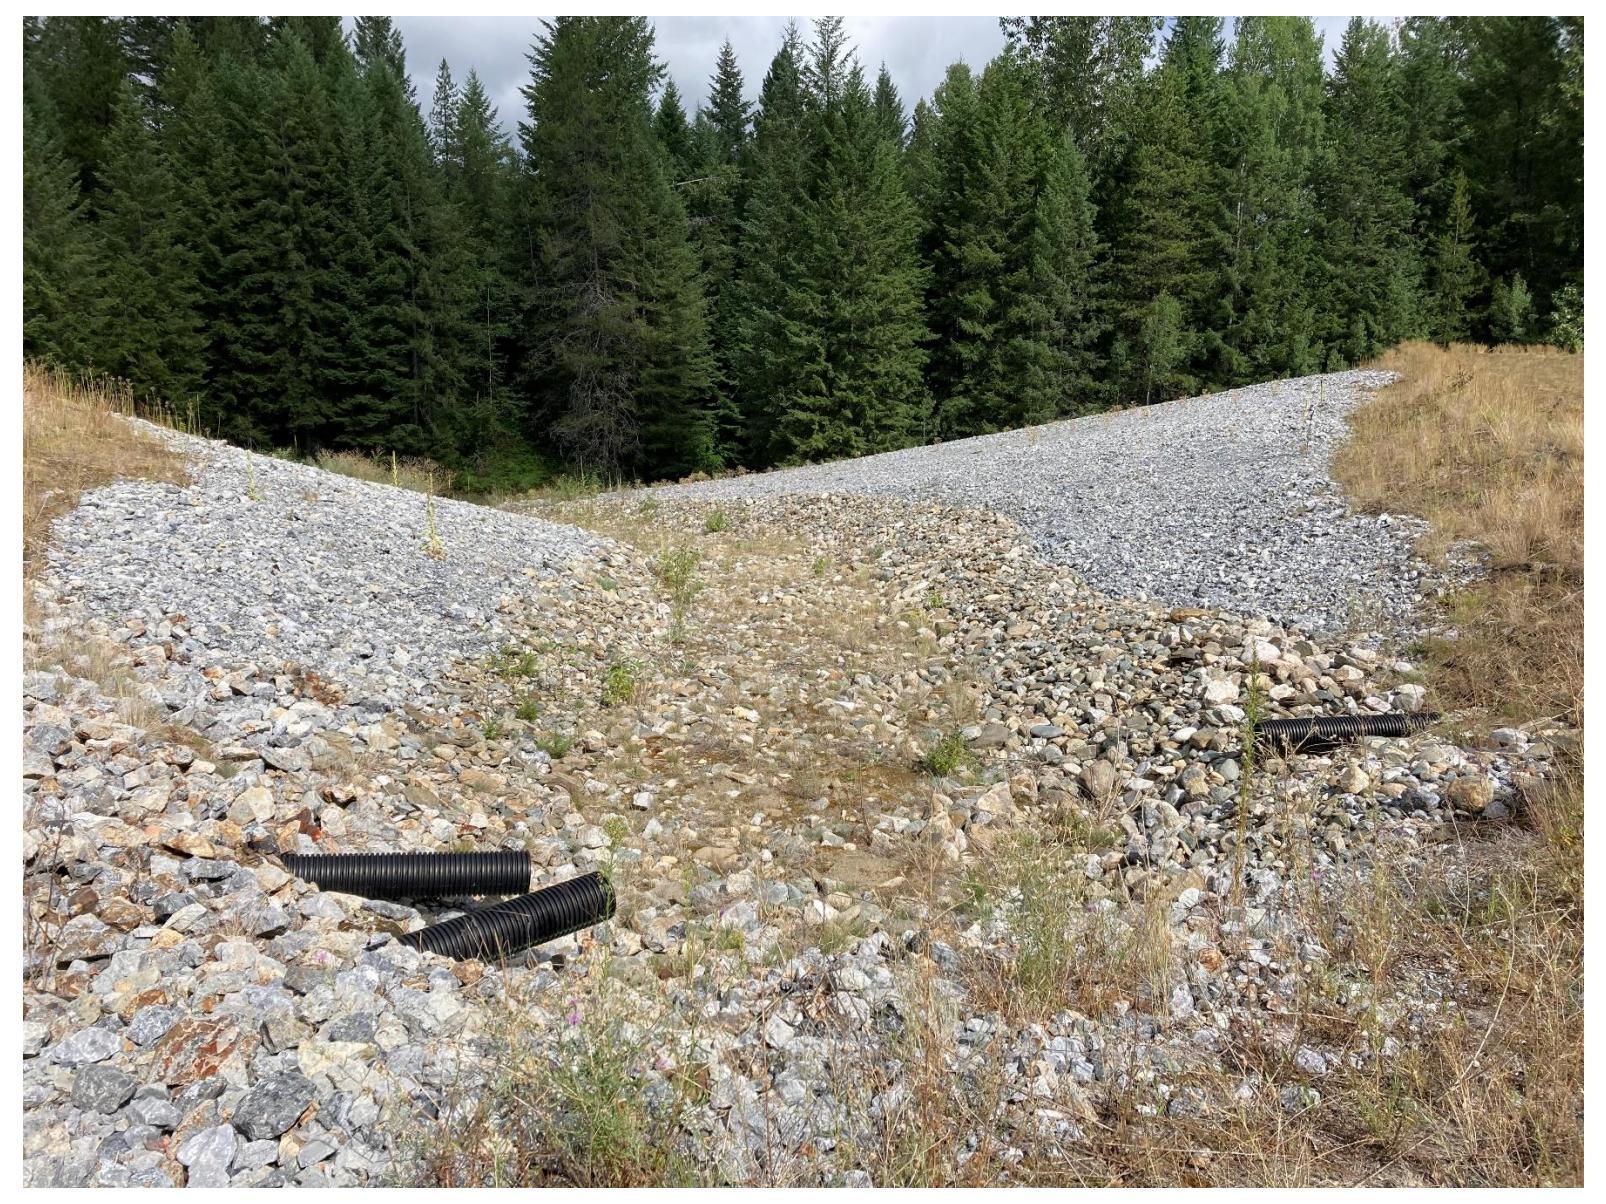
Photo 7: Lower section of the cap on TDF-2
