SOIL MANAGEMENT PLAN

Engineered & Institutional Site Controls

Former Sooper Dry Cleaners Site
Normandy Park Shopping Center
Normandy Park, Washington

May 2003

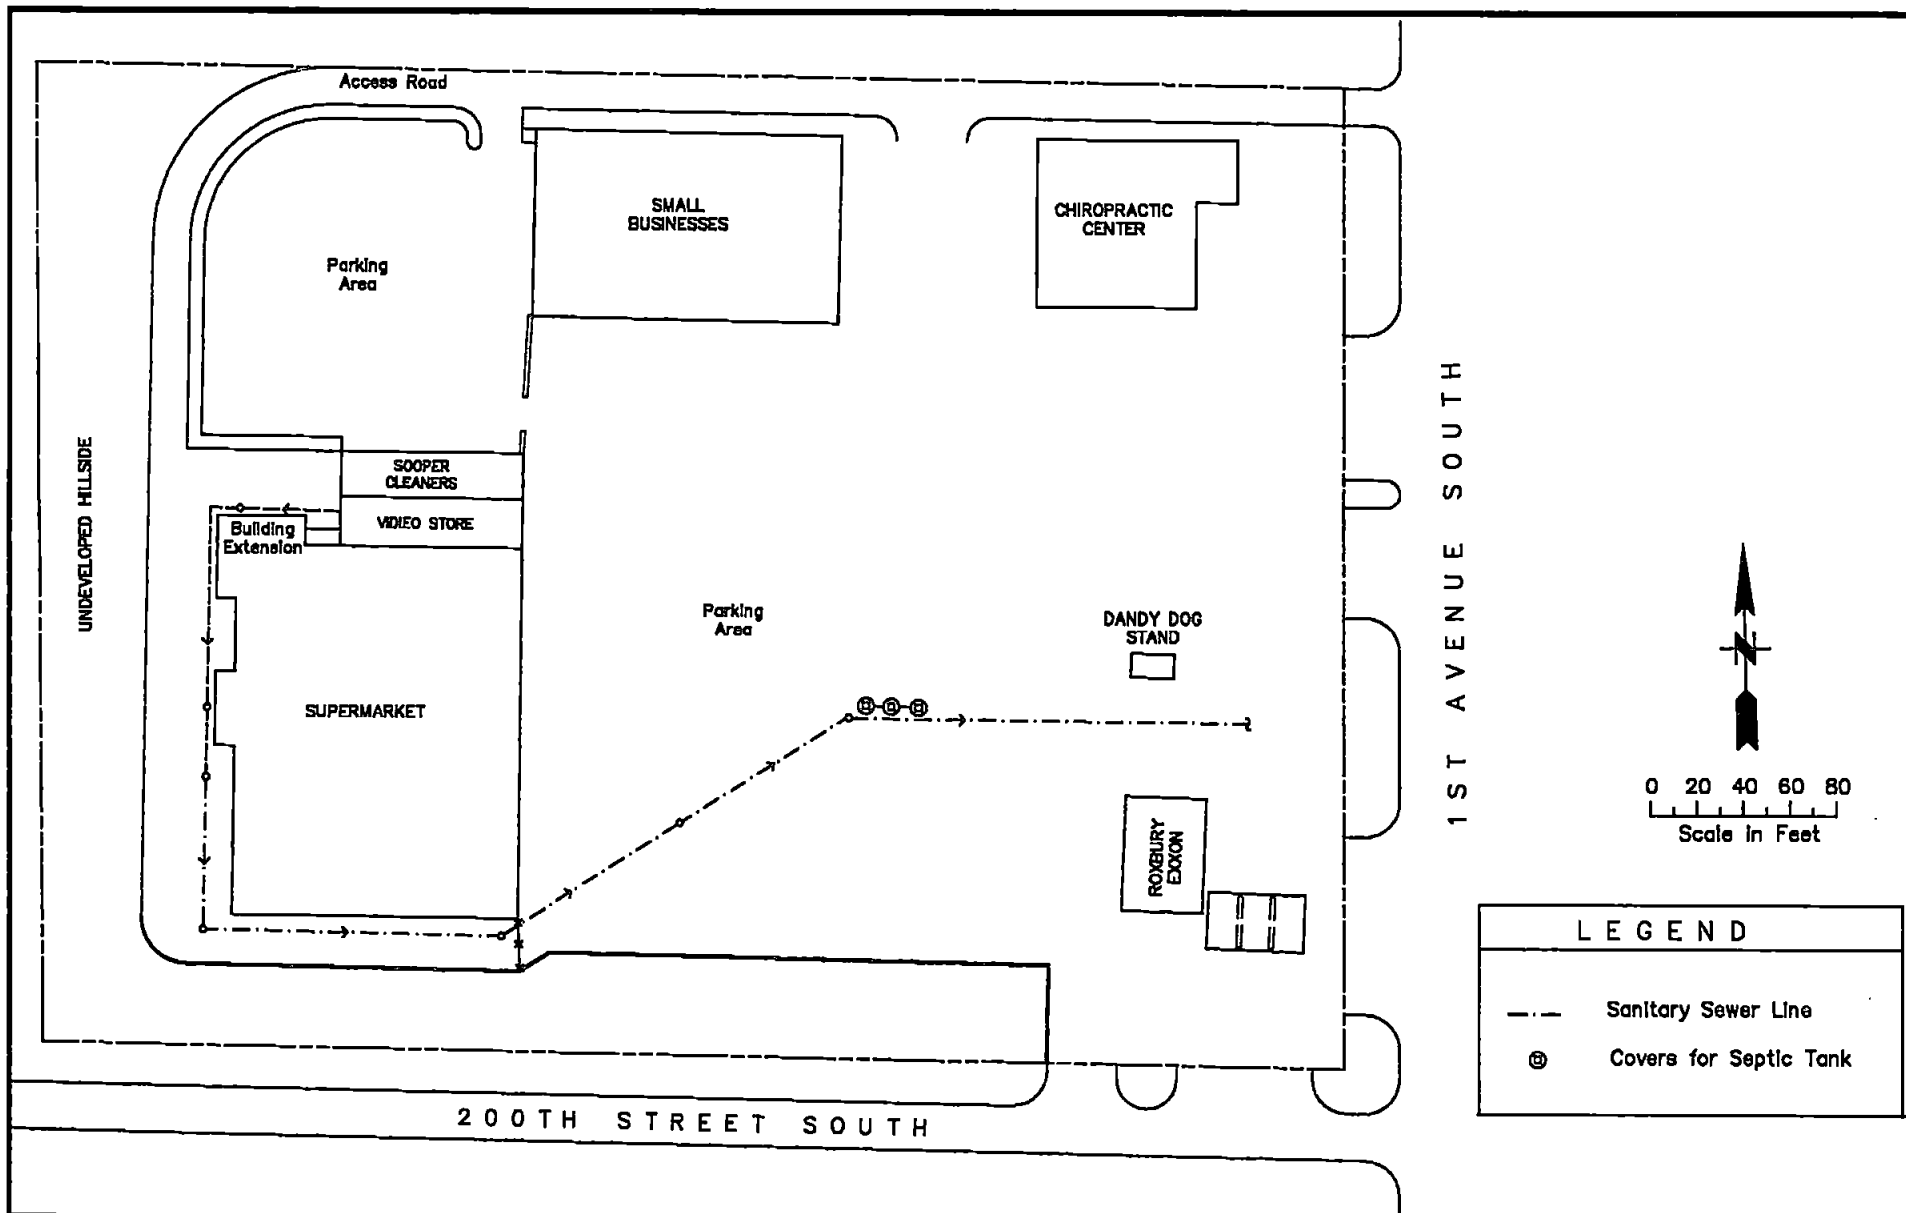
The Sooper Dry Cleaners business was formerly situated in a multi-tenant commercial building on the western end of the Normandy Park Shopping Center at 19935 First Avenue South in Normandy Park, Washington (Figure 1). Various dry cleaning businesses have historically operated within this tenant space since approximately the early 1970's. A generalized site plan illustrating the layout of the Normandy Park, shopping center and the location of the former Sooper Dry Cleaners is provided in Figure 2.

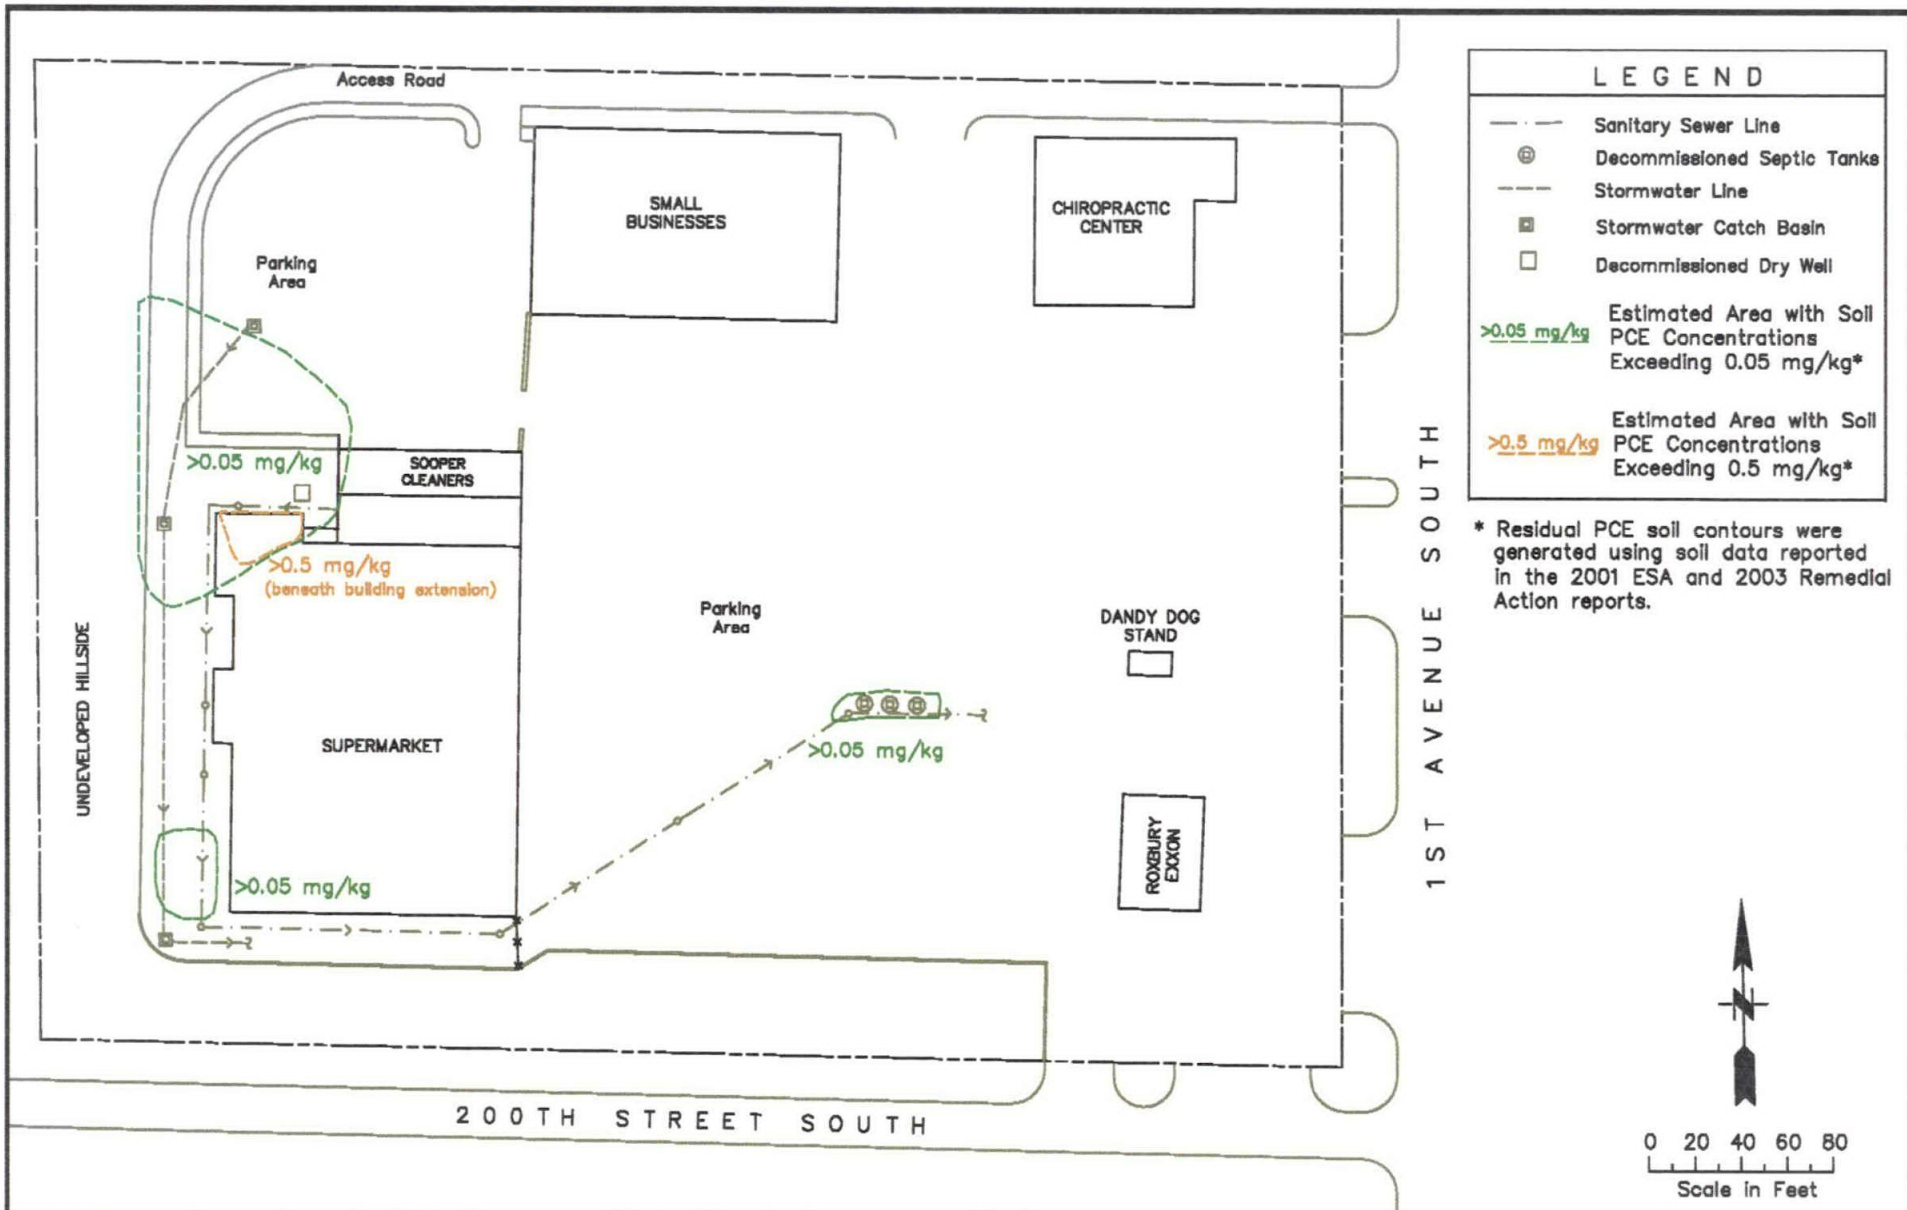
ESTIMATED EXTENT OF
 RESIDUAL PCE SOIL CONTAMINATION
 NORMANDY PARK SHOPPING CENTER

The three zones of residual PCE contamination include the subsurface soils immediately behind the former dry cleaner tenant space, the soils surrounding the stormwater and sanitary sewer corridors near the southwest end of the main building, and the soils immediately beneath the decommissioned septic tank. The estimated areal extent of each of these zones of residual PCE soil contamination are illustrated on Figure 3.

The largest area of residual soil contamination is situated immediately behind the former dry cleaner tenant space. This contamination appears to have originated from the former dry well and from sanitary sewer leakage along the northwest corner of the building. As previously discussed, the majority of the PCE soils removed during the remedial action were excavated from this portion of the site. The area of residual contamination exceeding 0.05 mg/kg is estimated to cover approximately 9,000 square feet. Given that PCE has been detected to the depth of the water table (~40 feet bgs), it is estimated that the volume of residual soil contamination remaining in this area could reach 14,000 cubic yards. However, based on the subsurface data collected during the 2001 ESA, most of the PCE contamination in this area (especially along the north and west perimeter of this zone) appears to occur at depths greater than 10 feet bgs.

The second general area of residual soil contamination is located in the subsurface soils immediately surrounding the sanitary sewer and stormwater utilities near the southwest corner of the main building. PCE soil concentrations detected during the pipe replacement in this area ranged between 0.06 and 0.09 mg/kg. These detections occurred at a depth of approximately 5 feet bgs. This area extends over approximately 900 square feet, and is estimated to contain less than 100 cubic yards of residual soil contamination exceeding 0.05 mg/kg PCE (Figure 3).

The final area containing residual PCE levels exceeding 0.05 mg/kg occurs in the subsurface soils in the vicinity of the decommissioned septic tank. These soils occur at depths ranging between 5 and 18 feet bgs, with PCE concentrations ranging from 0.06 to 0.24 mg/kg. Confirmation sampling conducted immediately after the removal of the old septic tank reported PCE soil concentrations ranging between "not detected" and 0.09 mg/kg. As illustrated on Figure 3, this area covers approximately 500 square feet, and is estimated to contain on the order of 200 cubic yards of residual soil contamination exceeding 0.05 mg/kg PCE.

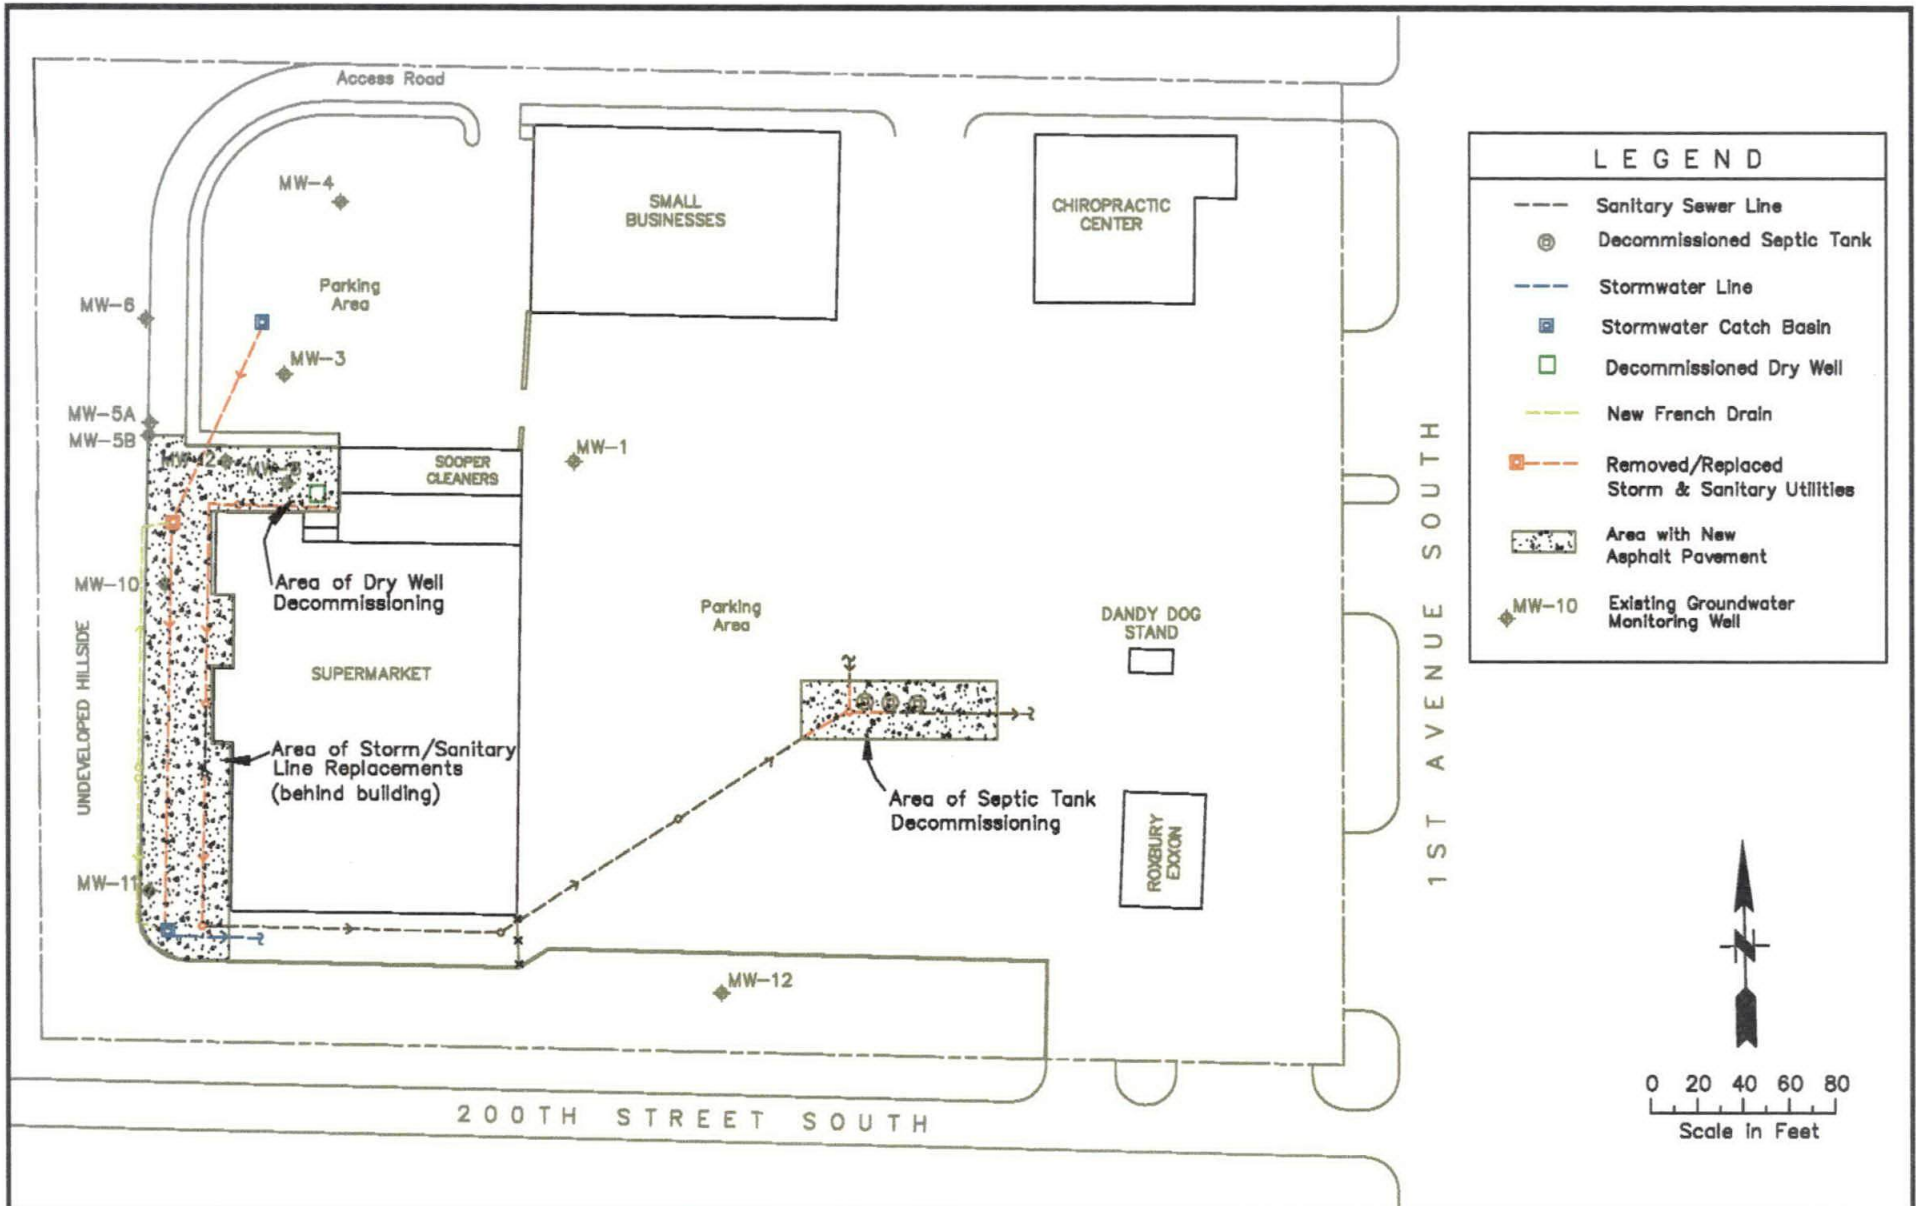
Due to the presence of PCE contaminated groundwater beneath the western portions of the shopping center, Ecology has mandated that the soil remedy include one year of quarterly groundwater monitoring at the site. As illustrated in Figure 4, a total of 11 groundwater monitoring wells (MW-1, MW-2, MW-3, MW-4, MW-5A, MW-5B, MW-6, MW-8, MW-10, MW-11 and MW-12) remain present on the property. Two of the groundwater wells (MW-7 and MW-9) installed during the environmental assessment were decommissioned during the closure of the dry well and the sanitary sewer replacements.

To keep the sewer and stormwater site controls functioning properly and in good repair, the following routine maintenance and BMPs are recommended:

- All the stormwater catch basins located on the shopping center should be cleaned of any accumulated sediment at least annually.
- The french drain system should be periodical inspected (minimum of once per year) during a storm event to ensure it continues to collect and divert surface runoff. The drain rock surface that parallels the western edge of the alley behind the main building must be kept clear of vegetation and/or debris that could block infiltration into the system.
