# PORT OF EVERETT: WEYERHAEUSER MILL A CLEANUP PROJECT

## BASELINE EELGRASS AND SHORELINE HABITAT SURVEY

FEBRUARY 3, 2023

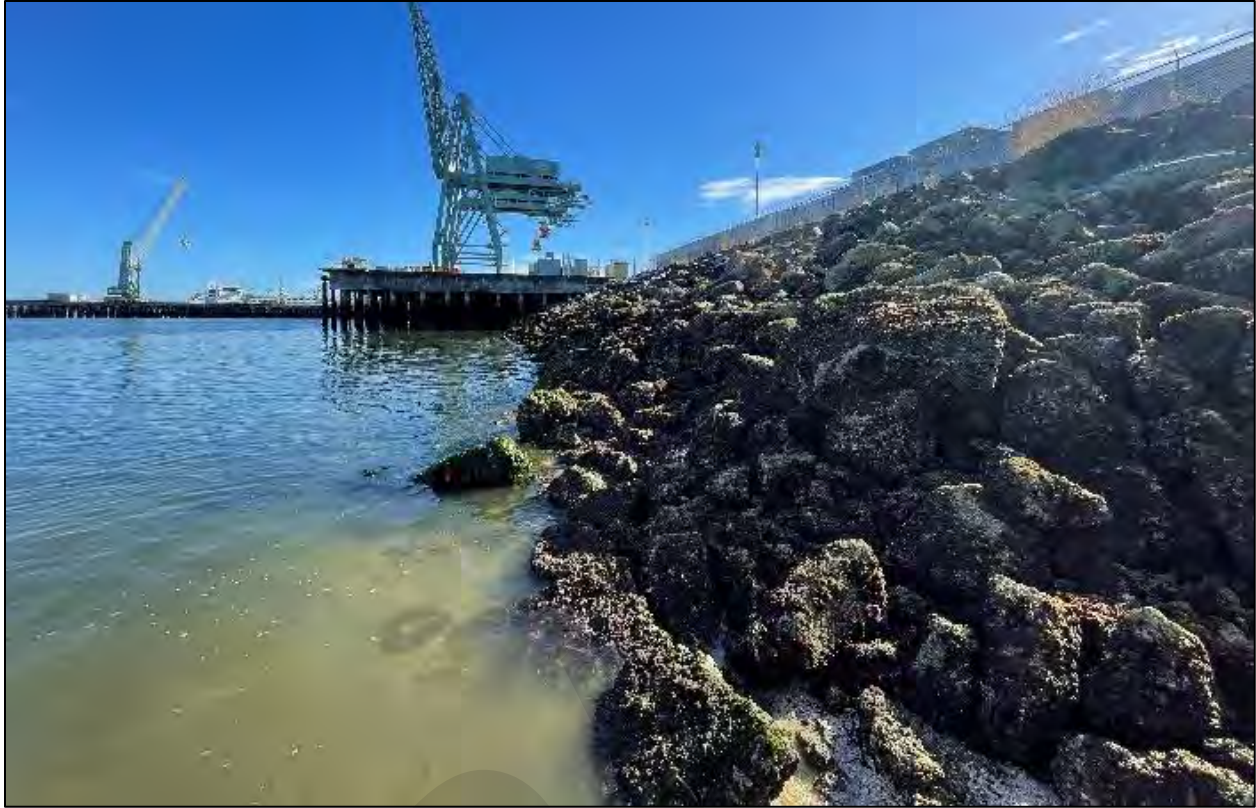
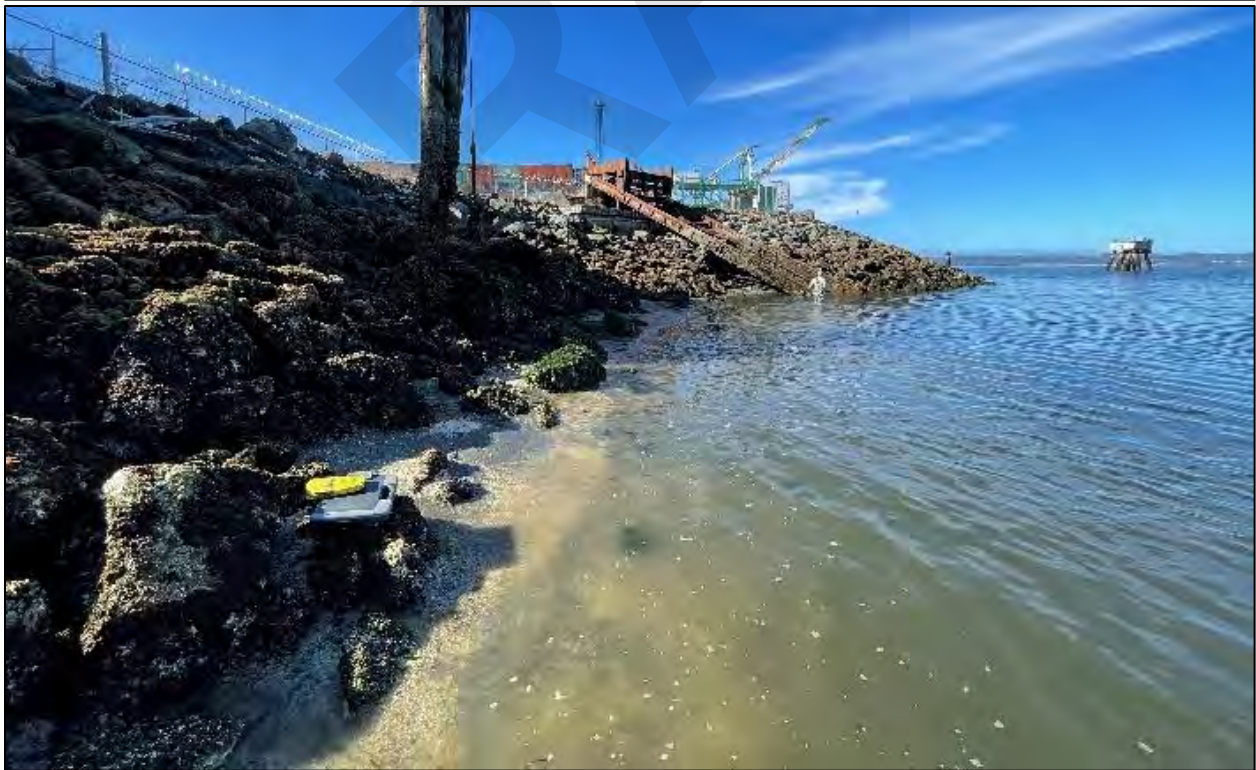
Photographs 1 and 2), the majority of the riprap slopes were 45%, with a break in slopes observed near 0 ft MLLW. At this break, slopes became more gradual and materials typically transitioned to smaller sediments like sand and shell hash. Subdominant materials within the large riprap included small angular rock (diameter 2-12 in).

**Photographs 1 & 2. Photo Point 1 in Area 1 of the Northern shoreline** facing northeast (above) towards the Pacific Terminal, and southwest (below) towards the South Terminal; typical conditions. (See Figure 3 for approximate location.)

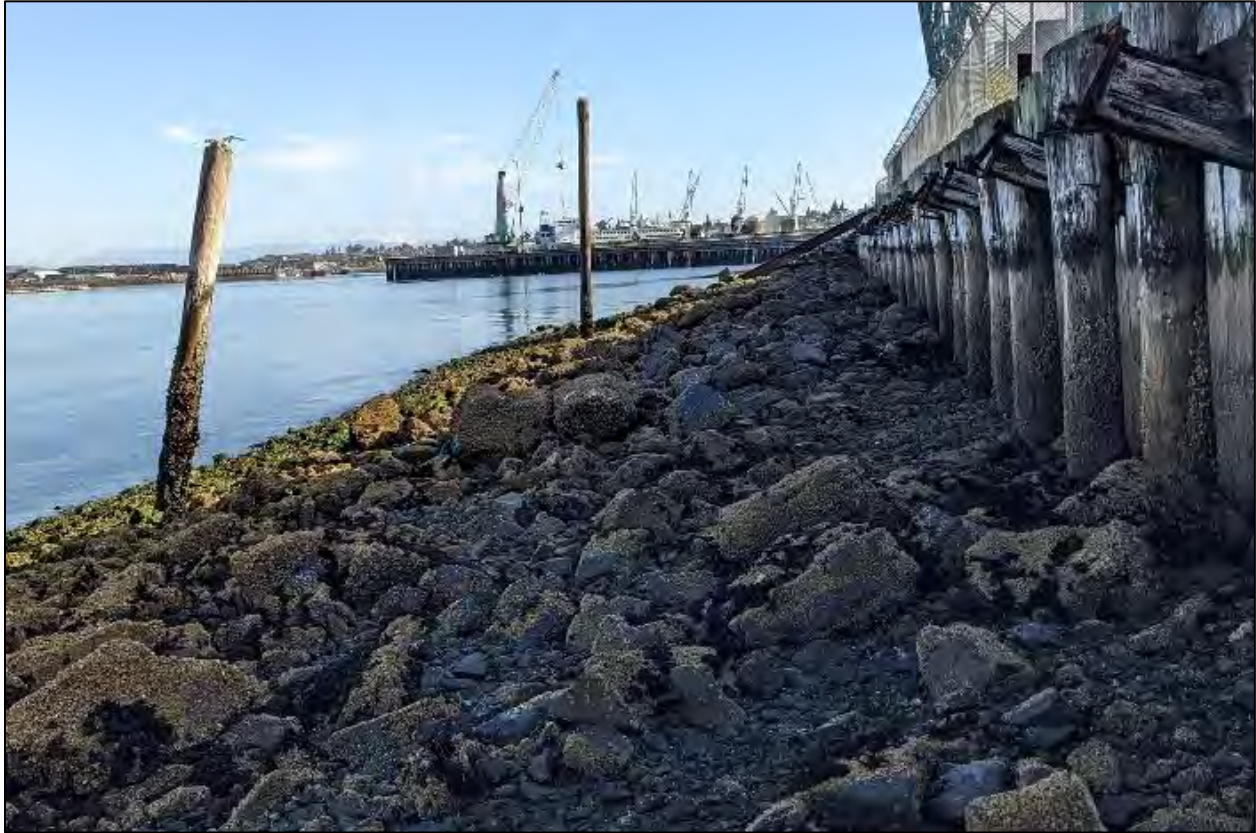
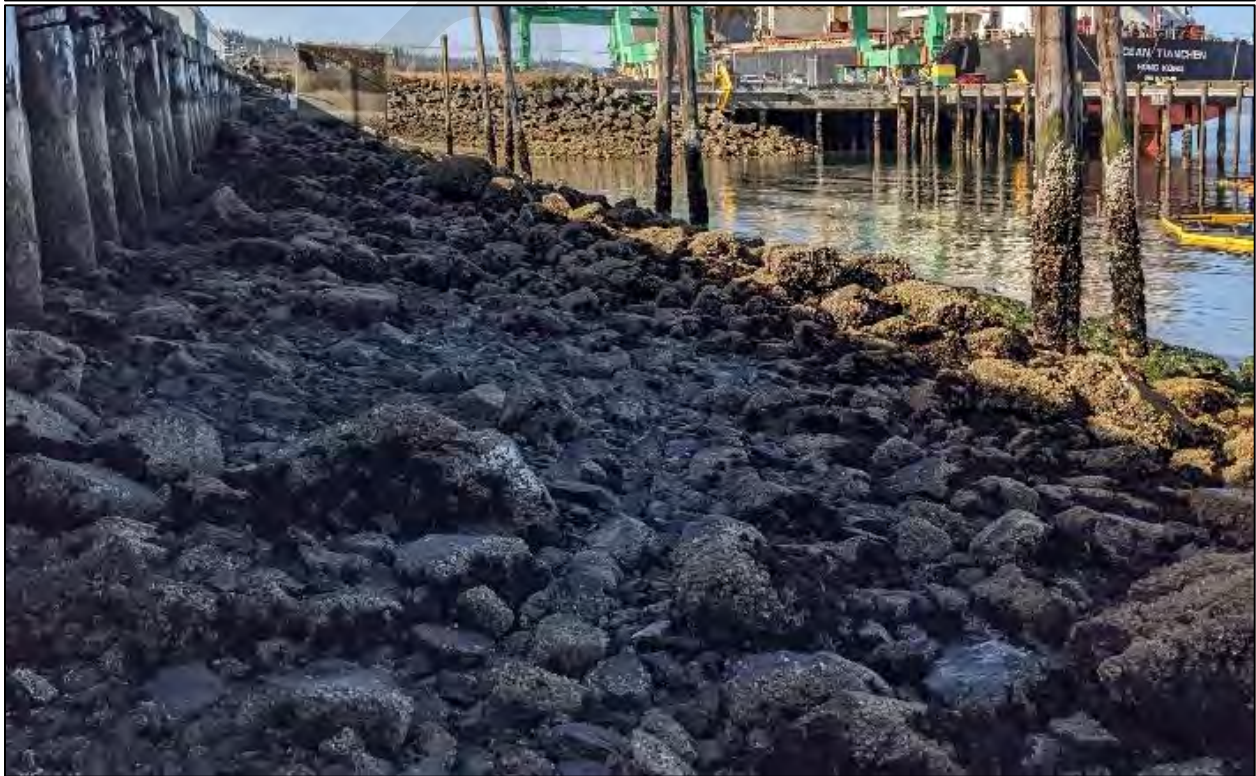
The slopes within Area 2 (Figure 3; Photographs 3 and 4) were less steep than in Areas 1 and 3, ranging from 5% to 25%, likely due to the presence of the vertical bulkhead in these areas. The substrate within Area 2 is also generally smaller material than observed in 1 and 3, consisting of an assorted mix of angular rock and quarry spalls. Dominant and subdominant materials range in size from 1 to 48 inches in diameter. A break in slopes and substrates are also present in Area 2 near 0 ft MLLW, where slopes become more gradual and consist of sand mixed with shell hash. Watermarks on the timber bulkhead (visible in Photographs 3 and 4) also indicate that during high tides, this portion of the shoreline is completely inundated.

**Photographs 3 & 4. Photo Point 2 in Area 2 of the Northern shoreline** facing northeast (above) towards the Pacific Terminal, and southwest (below) towards the South Terminal. (See Figure 3 for approximate location.)

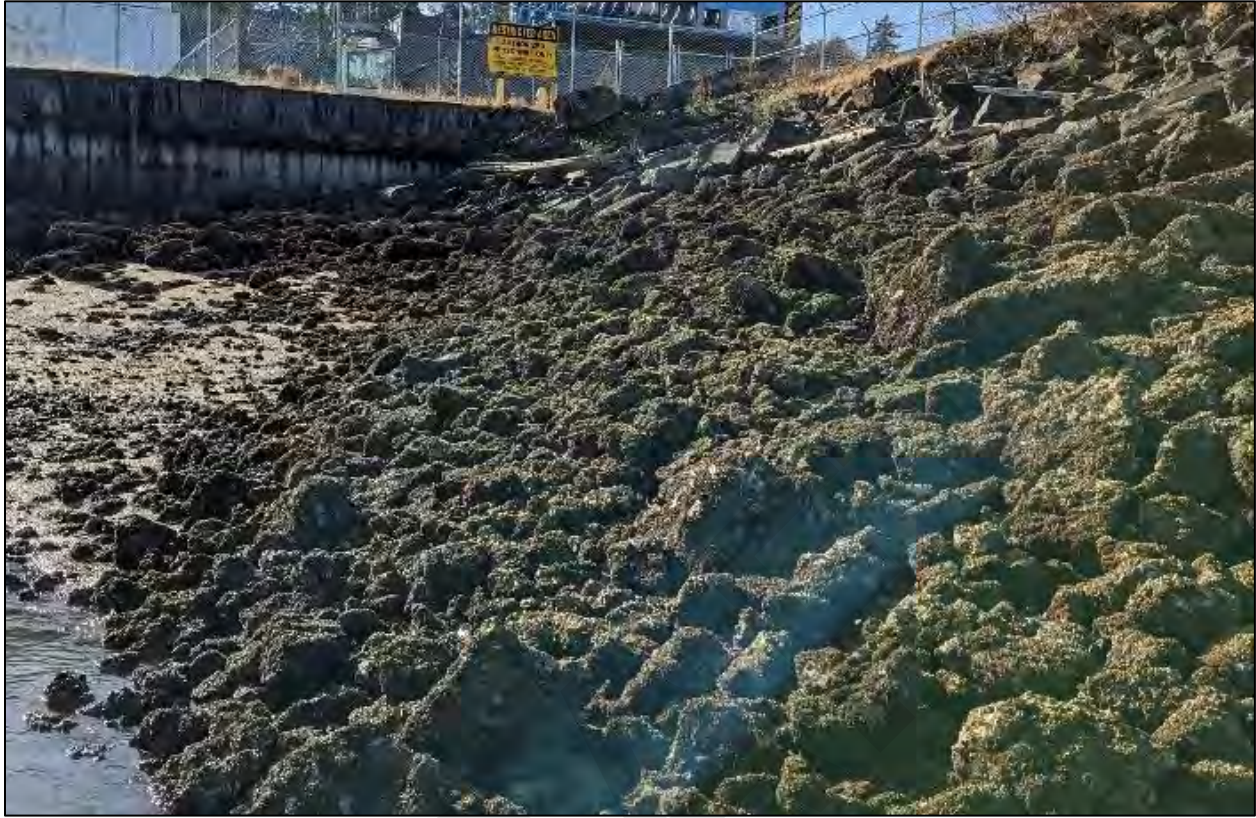
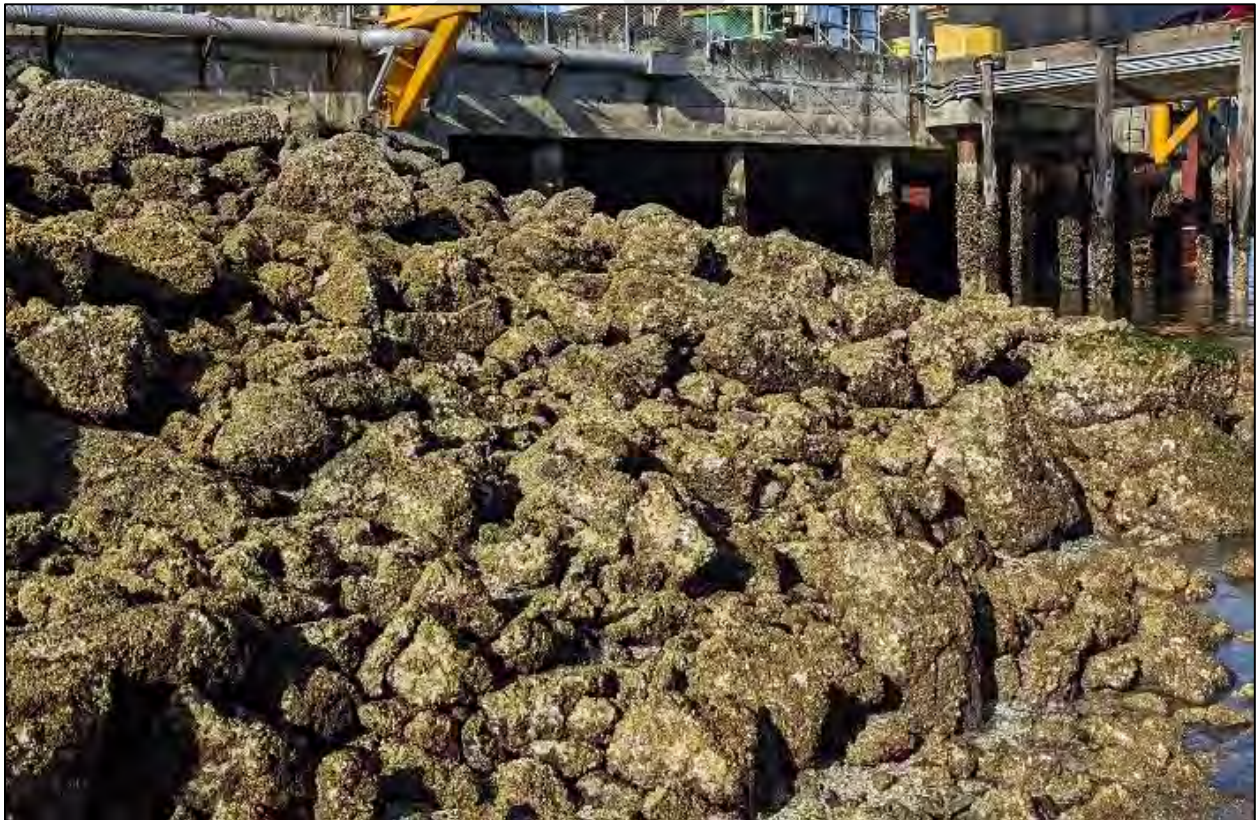
In Area 3 (Photographs 5 and 6), slopes range from 30% to 50%. The substrate primarily consists of large riprap (ranging from 1 to 6 feet diameter), with subdominant materials including cobble and small angular rock (6 to 24 inches in diameter), and gravel. The break in slope is less evident in Area 3 versus Areas 1 and 2; the rocky slope appears to continue below 0 ft MLLW, and no toe of slope was visible at the time of the Site visit.

**Photographs 5 & 6. Photo Point 3 in Area 3 of the Northern shoreline** facing southeast (above) northwest (below) adjacent to the South Terminal. (See Figure 3 for approximate location.)

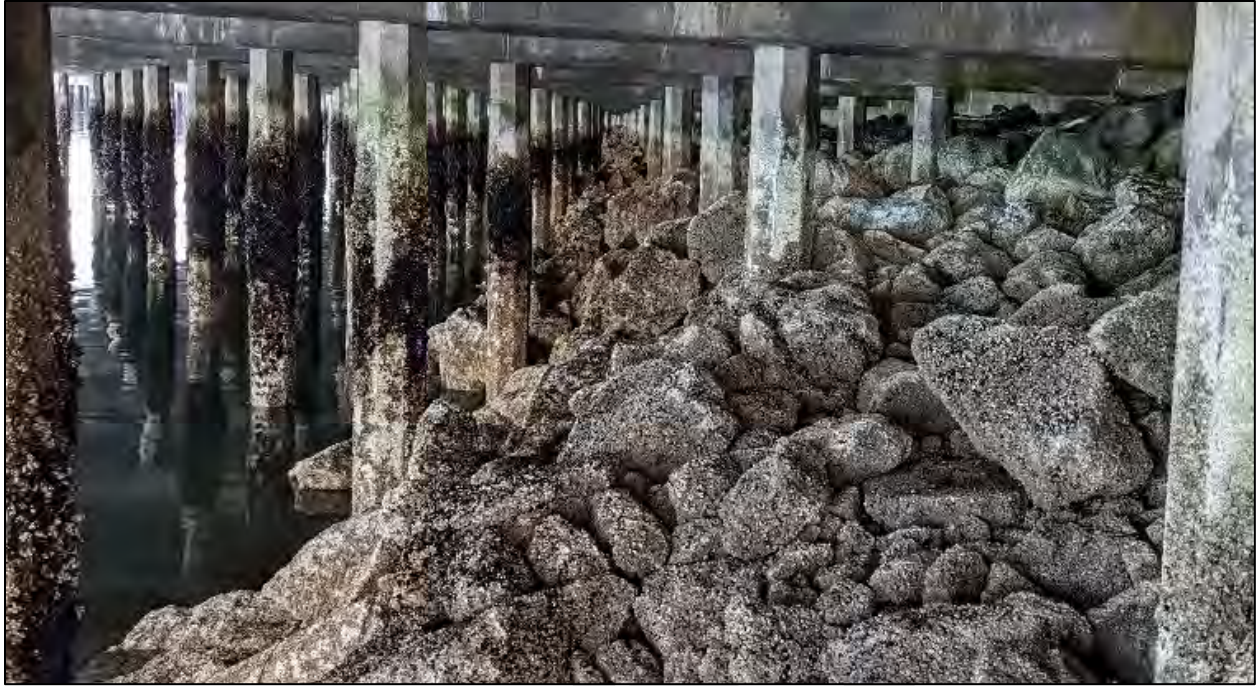
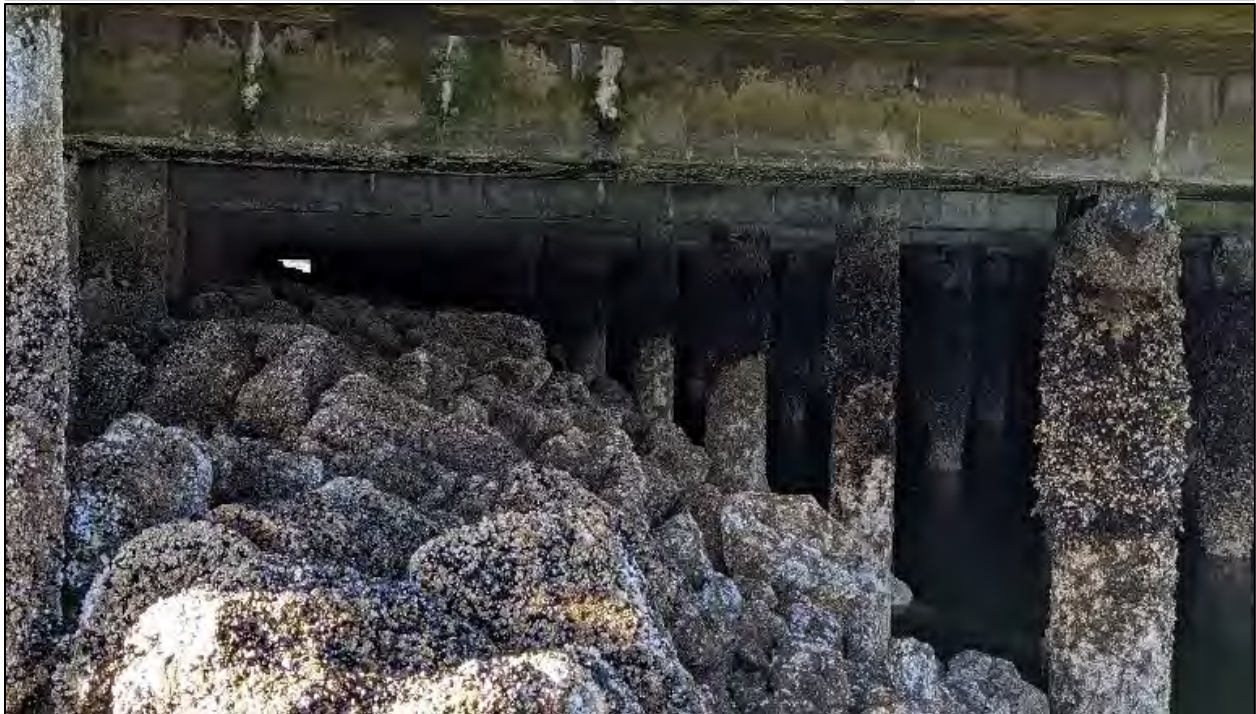
The total linear distance of the Central shoreline is approximately 708 feet. This portion of the armored shoreline consists entirely of a steep riprap slope of large angular rock (ranging from 4 feet to 4 inches in diameter; Photographs 7 and 8). The riprap is almost completely covered in barnacles and mussels, in addition to a large portion of the piles. The steep riprap slope (approximately 50%) continues below 0 feet MLLW. From what is visible, this portion of the shoreline is completely void of eelgrass, macroalgae, and upland vegetation due to decreased light availability from the wharf and frequent traffic from large vessels.

**Photographs 7 & 8. Photo Point 5 in the Southern Shoreline. Central shoreline beneath the South Terminal wharf.** Photographs of the riprap slope beneath the southern edge of the wharf facing North (above), and riprap slope beneath the northern edge of the wharf facing South (below).

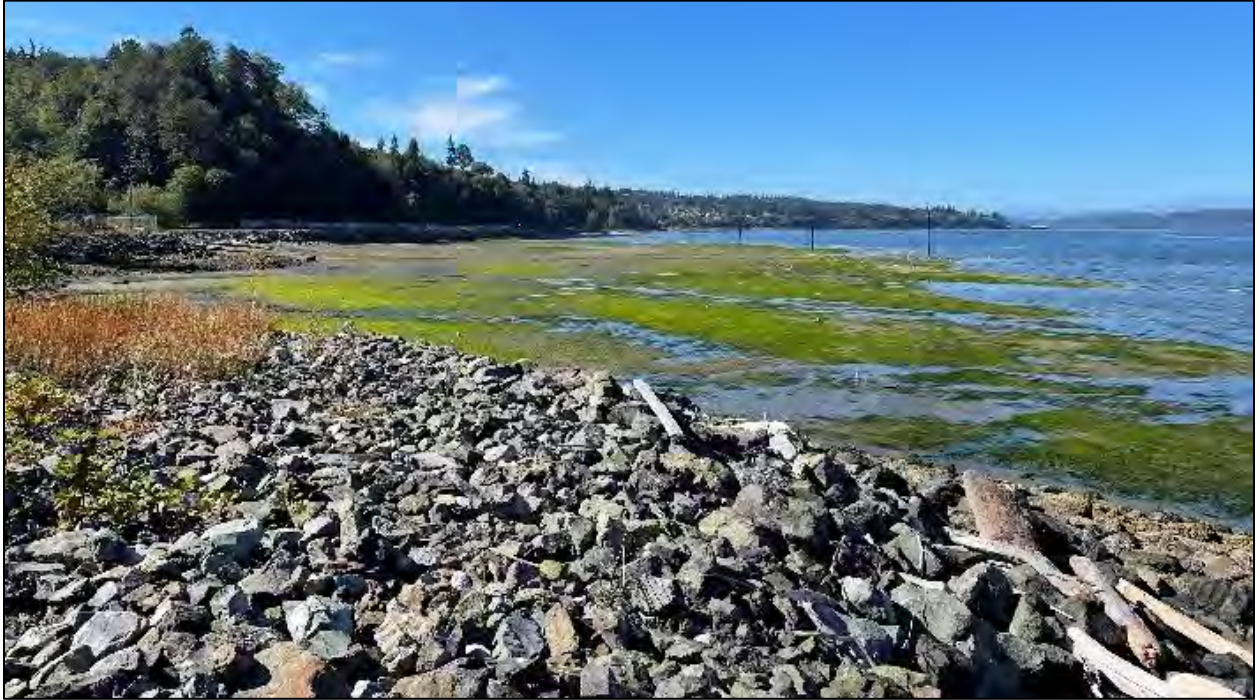
**Photograph 9. Photo Point 4 in the Southern Shoreline.** Photograph taken facing southwest.

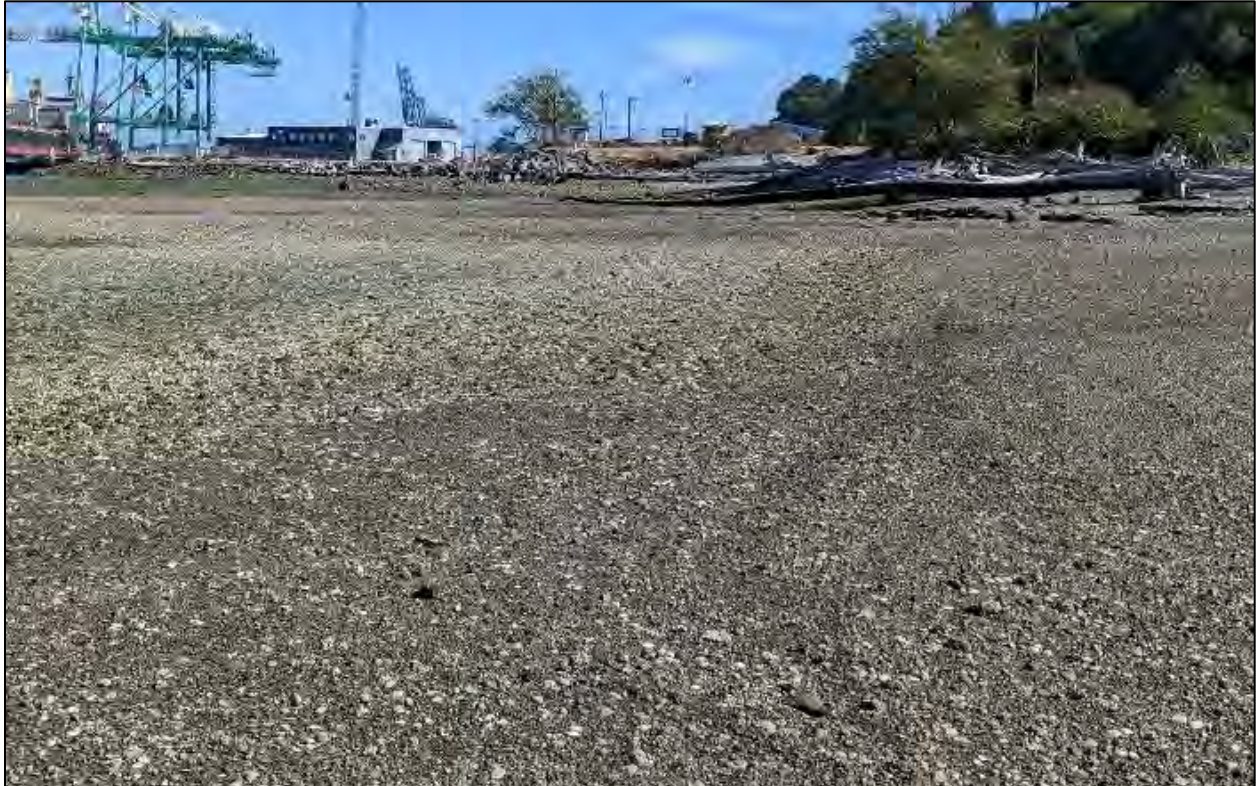
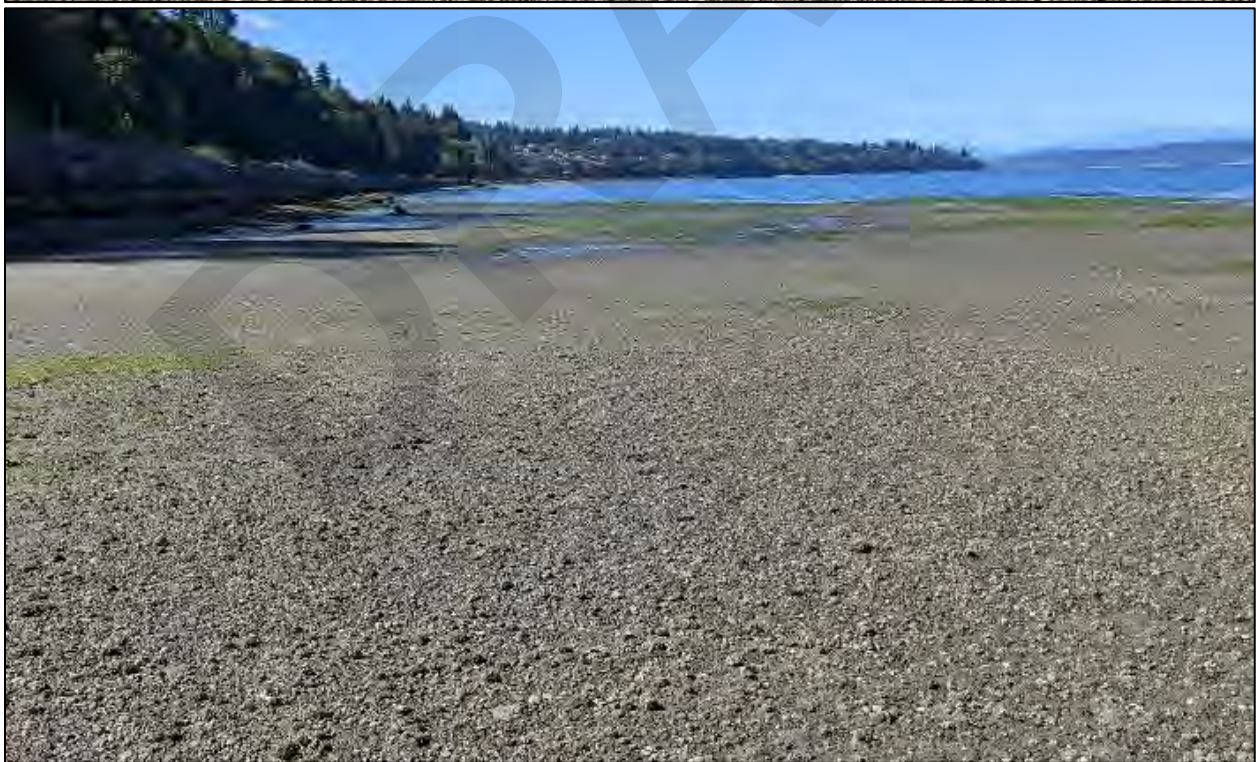
**Photographs 10 & 11. Photo Point 5 in the Southern Shoreline.** Photographs taken facing northeast (above) and southwest (below).

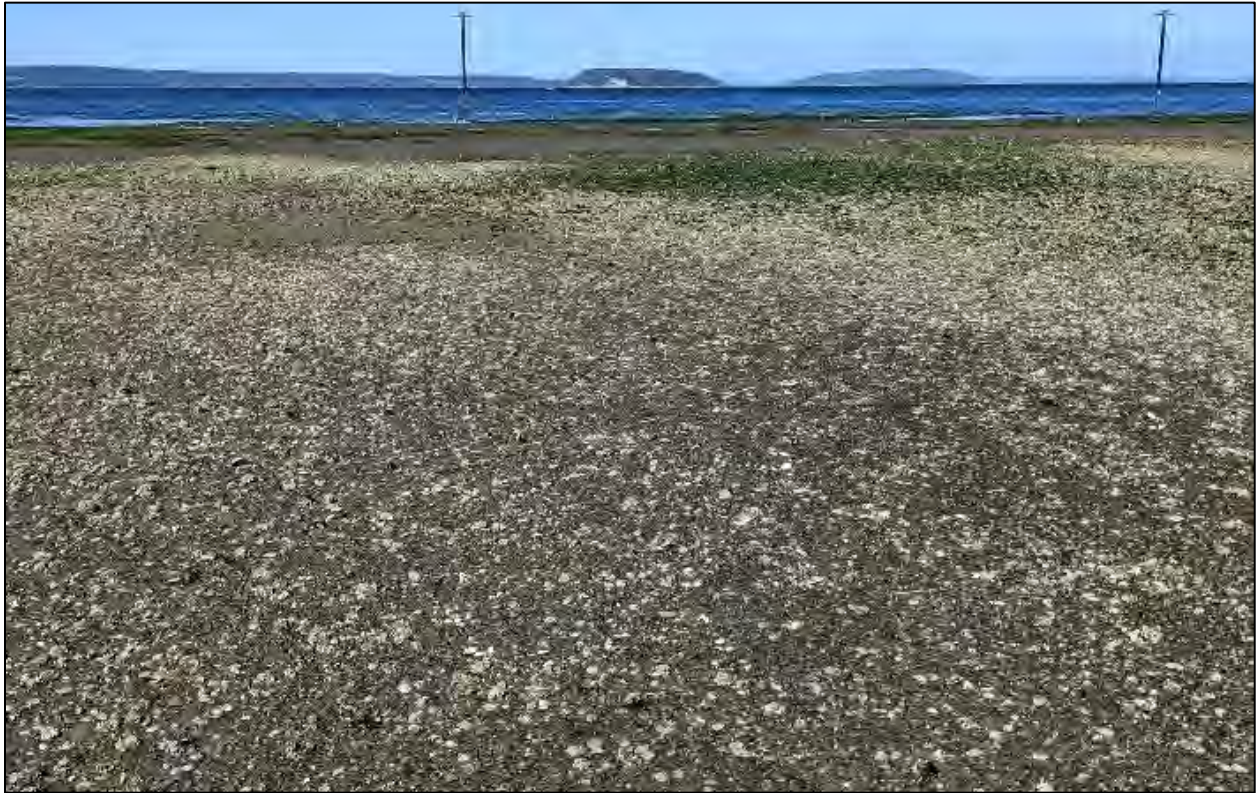
**Photograph 12 . Photo Point 5 in the Southern Shoreline.** Photograph taken facing northwest.

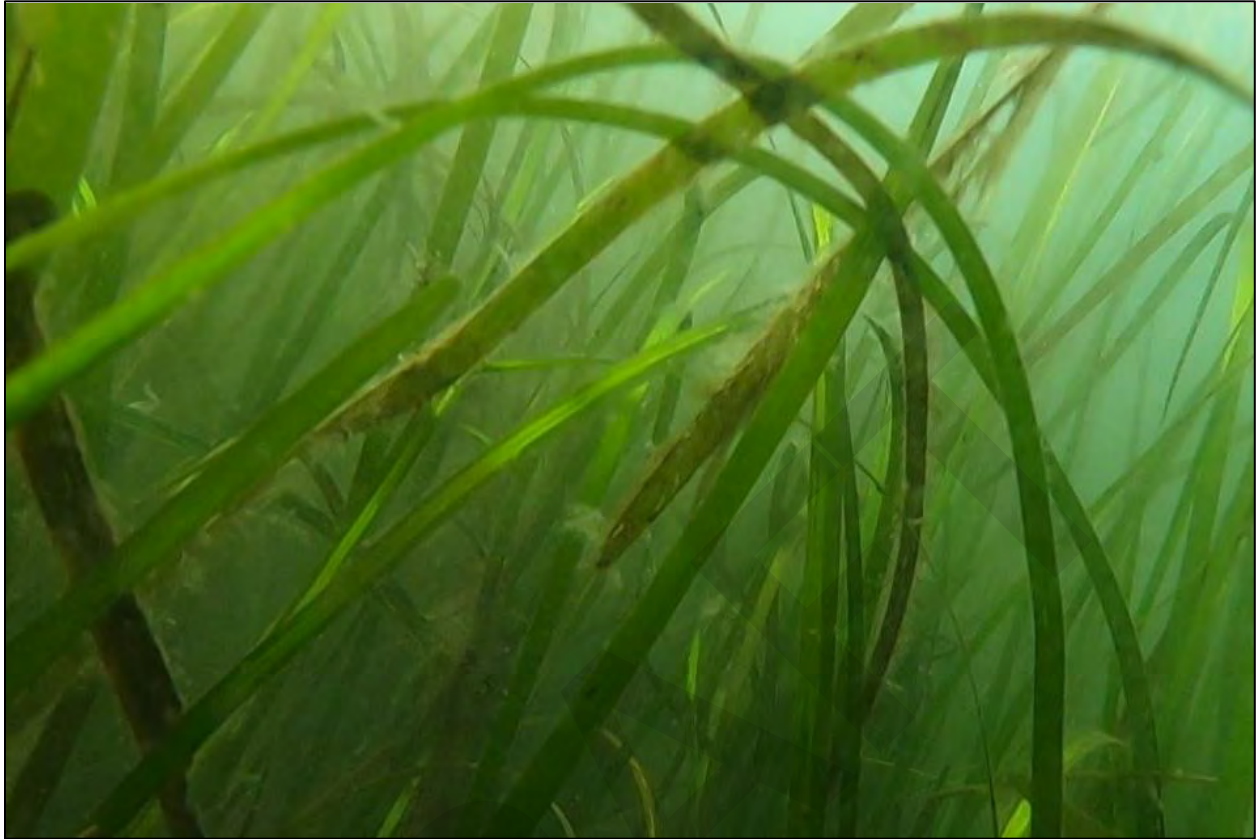
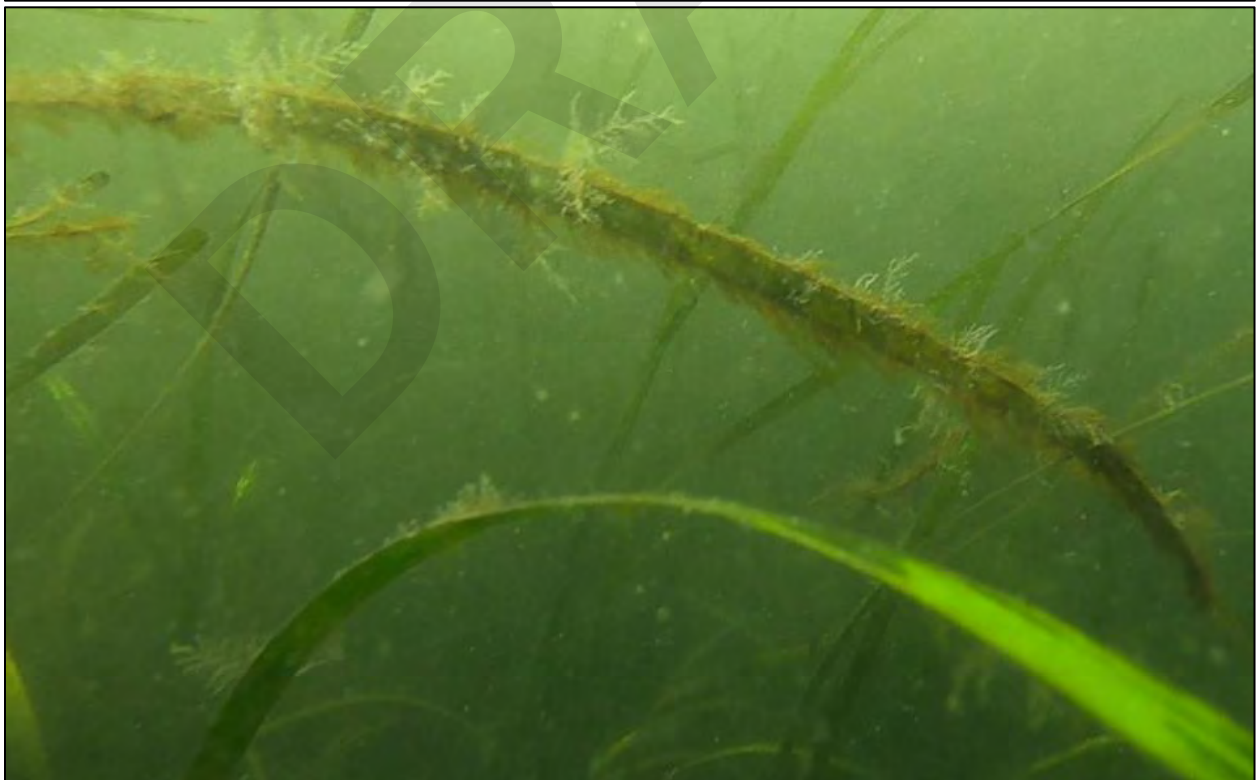
Overall, the eelgrass beds on Site appear healthy, with blades approximately 6 feet long, occasionally covered in epiphytes (Photographs 34 and 35). The eelgrass beds within the Northern and Southern Zones of the Site contain a dense, continuous community of eelgrass existing within elevations from approximately -3 to -13 ft MLLW. As mentioned previously, the eelgrass beds within the Southern Zone are smaller but more dense than beds observed in the Northern Zone (Tables 2 and 3). Due to inaccessible conditions, the Central Zone was not surveyed for eelgrass. However, eelgrass presence within this portion of the Site is extremely unlikely. The wharf of the South Terminal has created low light conditions likely not suitable for eelgrass proliferation. Bathymetry data also indicate that riprap beneath the wharf ends at approximately -35 ft MLLW, which is deeper than where eelgrass is observed in the Northern and Southern Zones of the Site. Large vessels mooring at the wharf also provide continual disturbance which could affect eelgrass presence.

**Photographs 13 & 14. Eelgrass observed on Site (typical conditions)** with an example of a dense patch of eelgrass (above), and eelgrass blades with epiphytes (below).

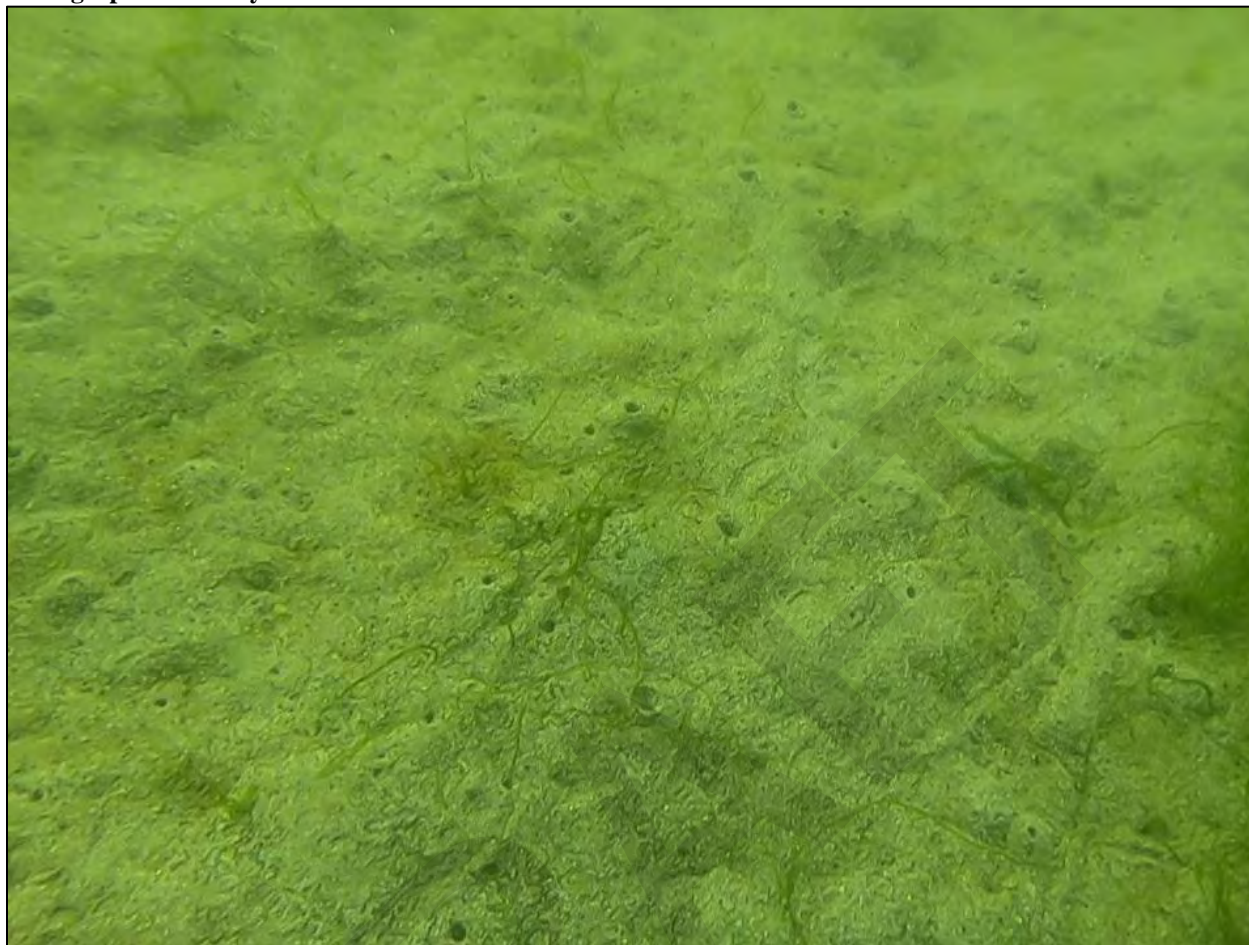
Similar to conditions observed in the Southern Zone during the Shoreline survey, some areas contain sandy sediments with holes leading to burrowed invertebrates (Photograph 15).

**Photograph 15. Sandy substrates with invertebrate burrows.**

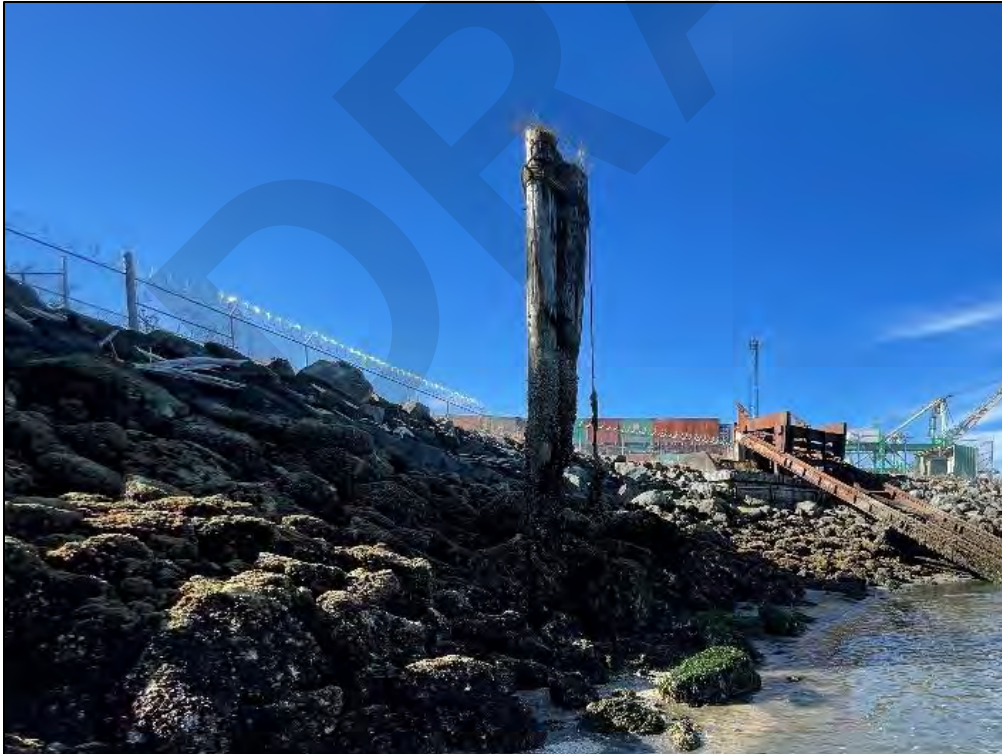
Various types of debris are present along the Northern shoreline, including: derelict creosote timber piles, rusted metal rails, LWD, and assorted trash. The derelict piles are standing upright in Areas 1 and 2 (Photograph 27 and Photograph 28; Appendix E). LWD is commonly scattered on the upper slopes within Areas 1 and 3 (Photograph 29 and Photograph 30; Appendix E); the gradual slopes of Area 2 are void of LWD. Two sets of metal rails are also present within Area 1 (see locations in Figure 3, and one set of metal rails in Photograph 27; Appendix E).

**Photograph 27. Derelict piles along the Northern shoreline of Area 1. Facing southwest near the Pacific Terminal.**

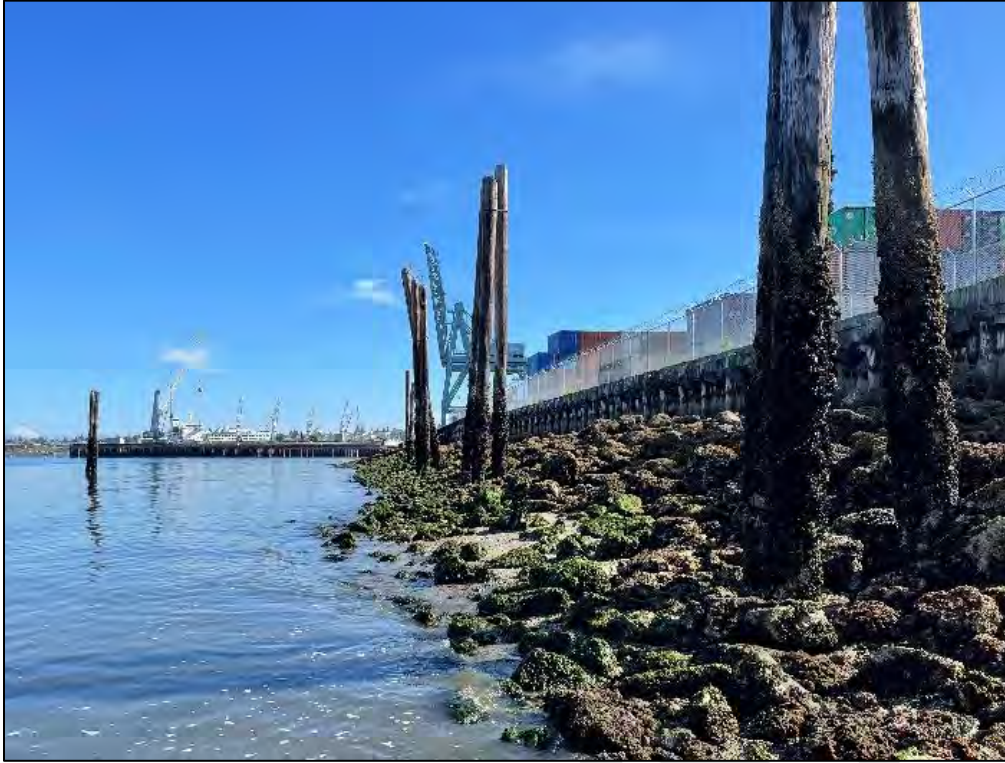
**Photograph 28. Derelict piles along the Northern shoreline of Area 2. Facing northeast.**

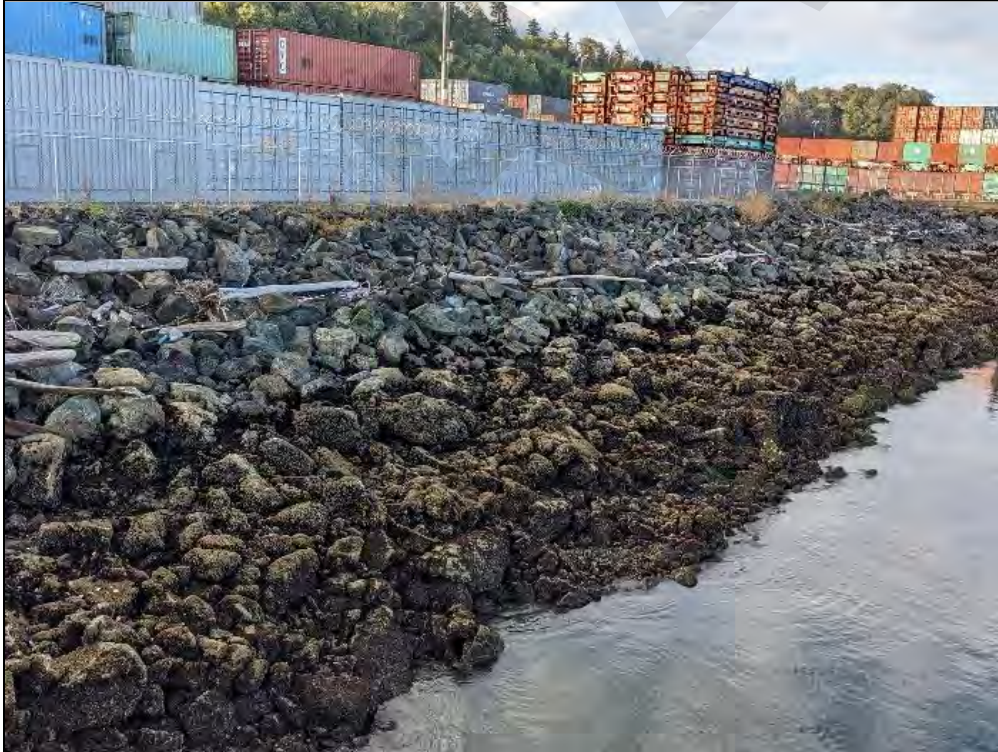
**Photograph 29. LWD along the Northern shoreline of Area 1, taken from the Pacific terminal facing southwest.**

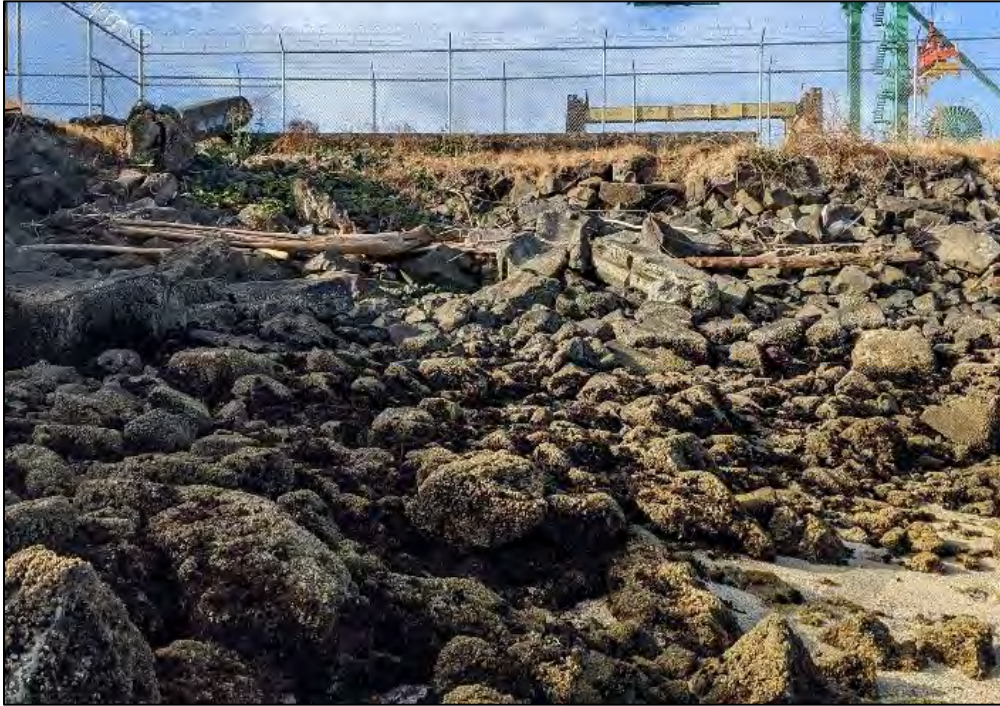
**Photograph 30. LWD along the Northern shoreline of Area 1 (above) and Area 3 (below), taken adjacent to the northern edge of the South Terminal facing southwest.**

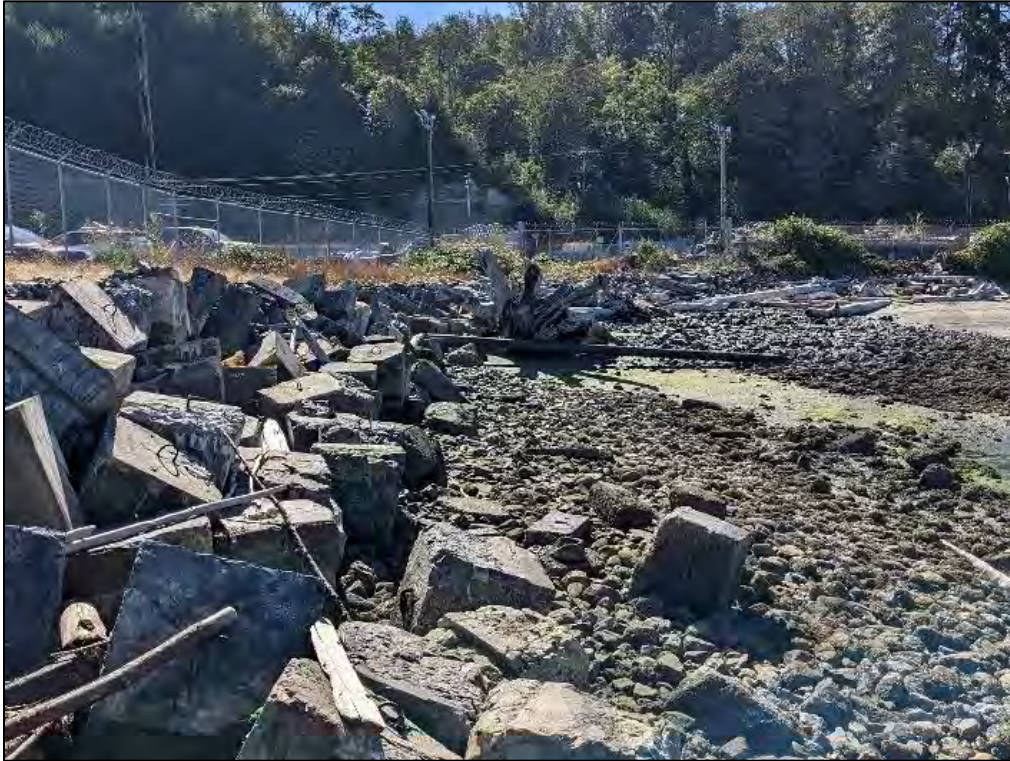
Continuing south down the shoreline, the armoring transitions into large concrete blocks (approximately 4x4x4 ft) (Photograph 32; Appendix E), with a mix of cobble and small angular rock/gravel further down the slope. Armoring within Area A is covered in *Ulva* spp. typically from +2 to +3 ft MLLW. Barnacles and mussels also cover slopes from +2 to +6 ft MLLW, at coverages of 85% and 10% respectively.

**Photograph 32. Armored slopes of the southern shoreline in Area A north of Pigeon Creek.** Large concrete blocks facing South.

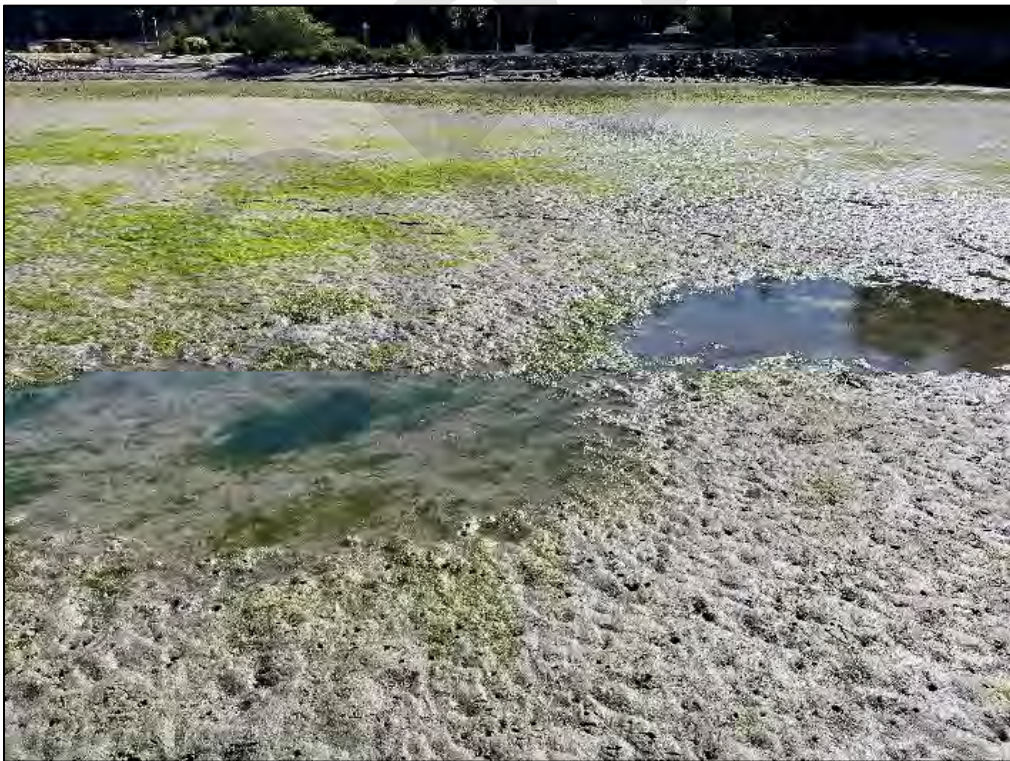
Occasional pools of shallow, standing water are present on Site in addition to many holes from burrowing invertebrates (Photograph 33; Appendix E). Nearly 50% of all substrates in the mudflat are covered in *Ulva* spp (Photograph 34; Appendix E). Empty valves of hardshell clams (e.g., varnish clams) are also common.

**Photograph 33. Mudflat conditions within the Southern shoreline; typical.** Occasional standing pools of water and invertebrate burrows.

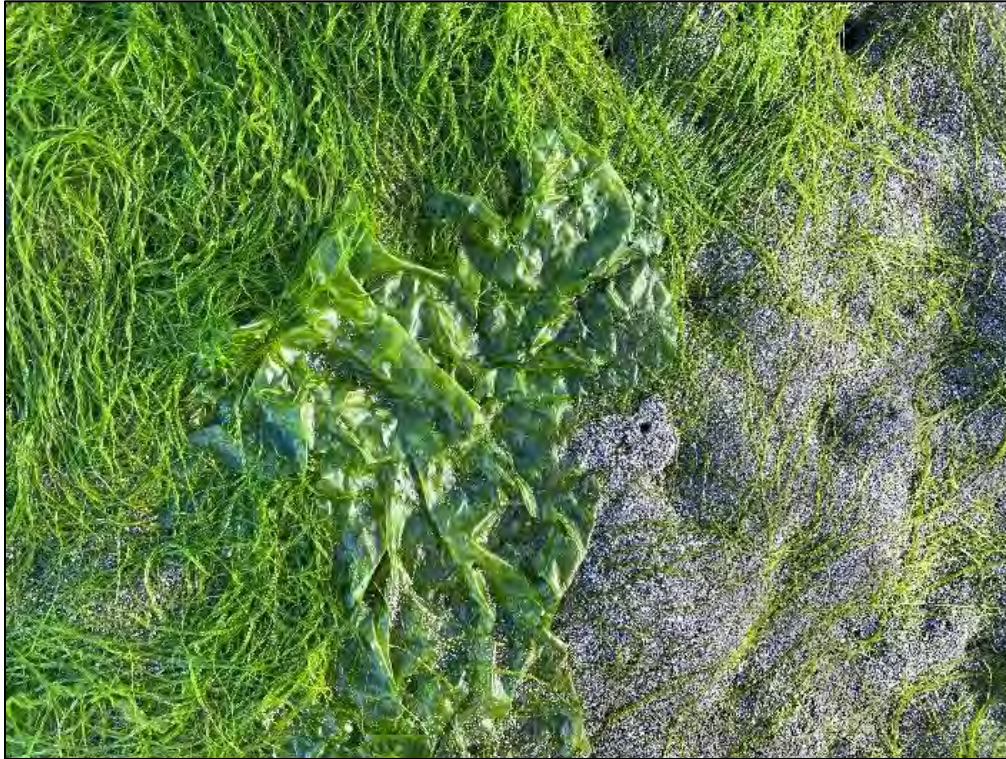
Site observations indicate there is no aquatic vegetation within the mudflat of the southern shoreline. Macroalgae (*Ulva* sp.) is abundant (Photograph 34; Appendix E) throughout the entire southern shoreline, covering approximately 50% of the mudflat. As mentioned above, *Ulva* also covers lower portions of the armored shoreline. Additional information on macroalgae present at lower elevations is in Section 3.

**Photograph 34. Mudflat conditions within the Southern shoreline; typical. *Ulva* spp. (below) commonly covering mudflat sediments.**

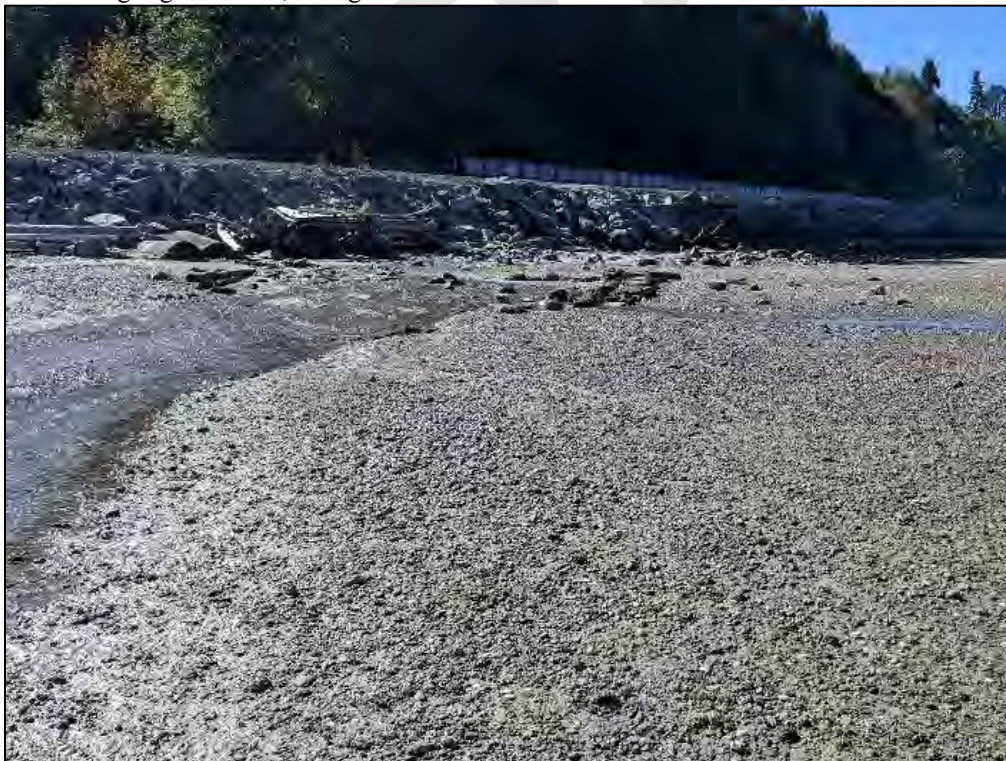
Sediments within the mudflat change surrounding the Pigeon Creek mouth. Mixed with the soft sand and silt substrates is rounded gravel, and smaller pea gravel, likely deposited from Pigeon

**Photograph 35. Southern shoreline conditions near Pigeon Creek in Area B; typical. Gravel substrates surrounding Pigeon Creek, facing South.**
