# PORT OF EVERETT: WEYERHAEUSER MILL A CLEANUP PROJECT

## BASELINE EELGRASS AND SHORELINE HABITAT SURVEY

FEBRUARY 3, 2023

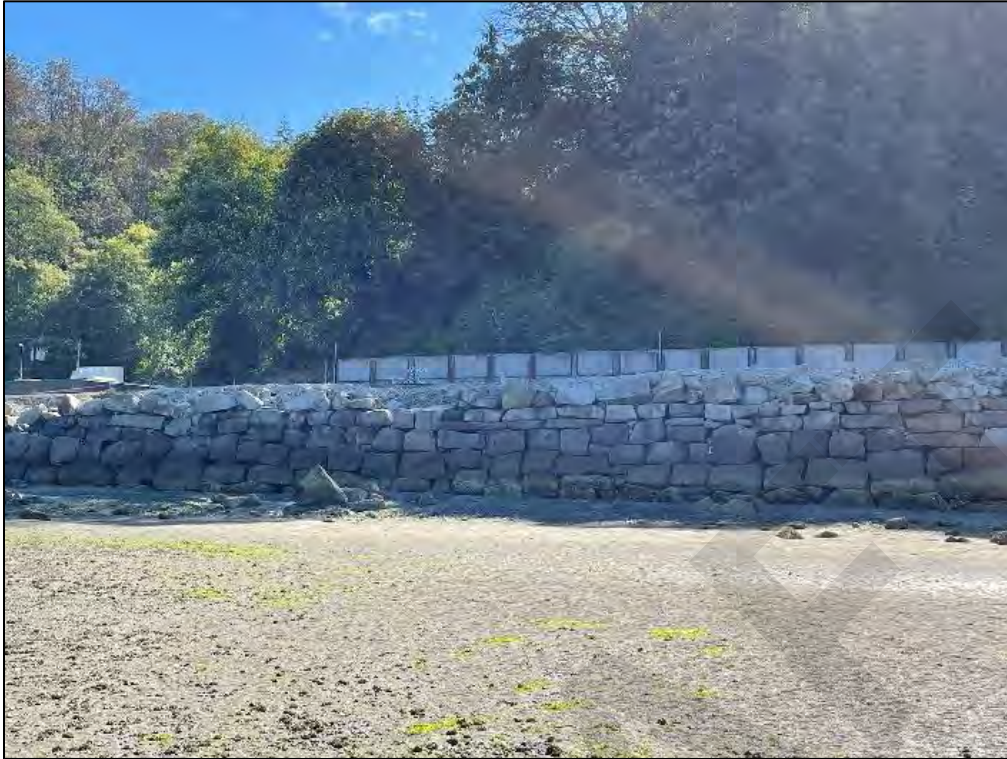
Creek (Photograph 35; Appendix E). The shoreline is still armored within Area B; however, it primarily consists of a vertical rock wall that supports the railroad which runs directly adjacent to the shore (Photograph 36; Appendix E).

**Photograph 36. Southern shoreline conditions near Pigeon Creek in Area B; typical.** Vertical rock wall supporting the adjacent railroad tracks, facing South.
