PORT OF EVERETT: WEYERHAEUSER MILL A CLEANUP PROJECT

BASELINE EELGRASS AND SHORELINE HABITAT SURVEY

FEBRUARY 3, 2023

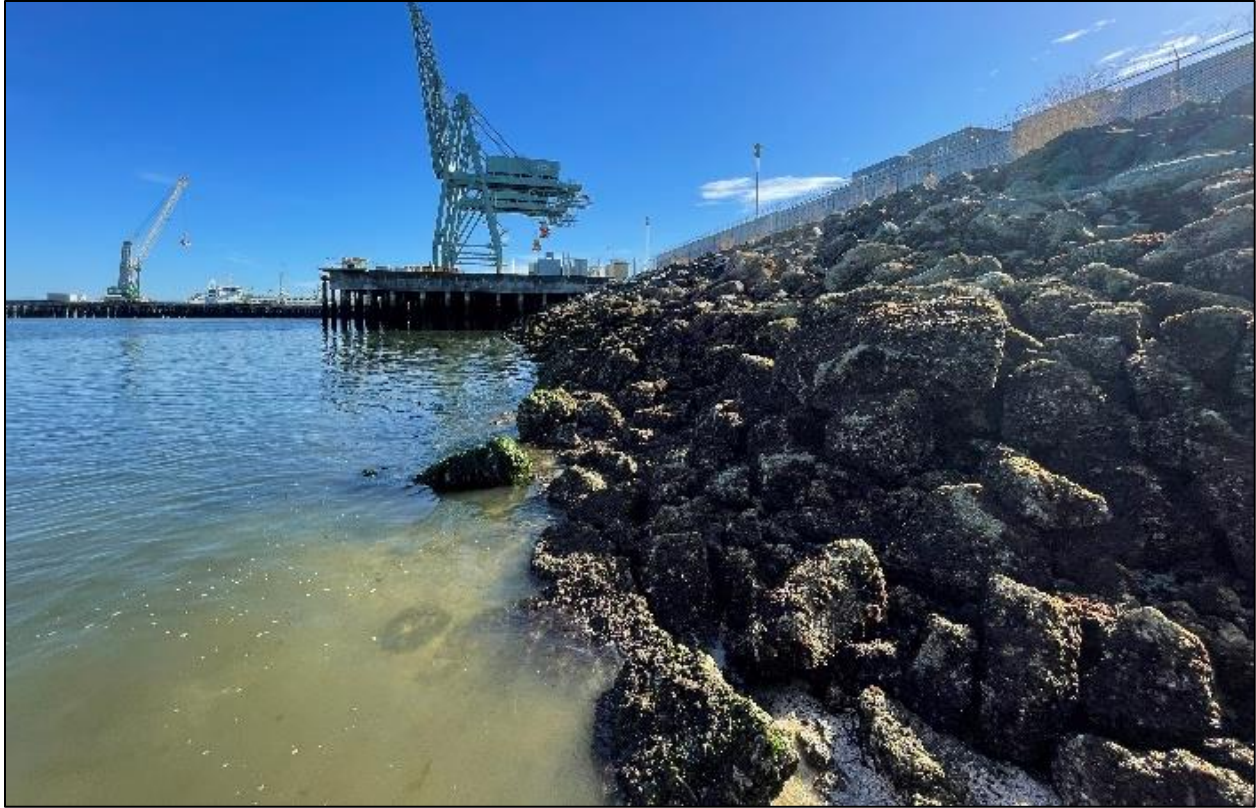
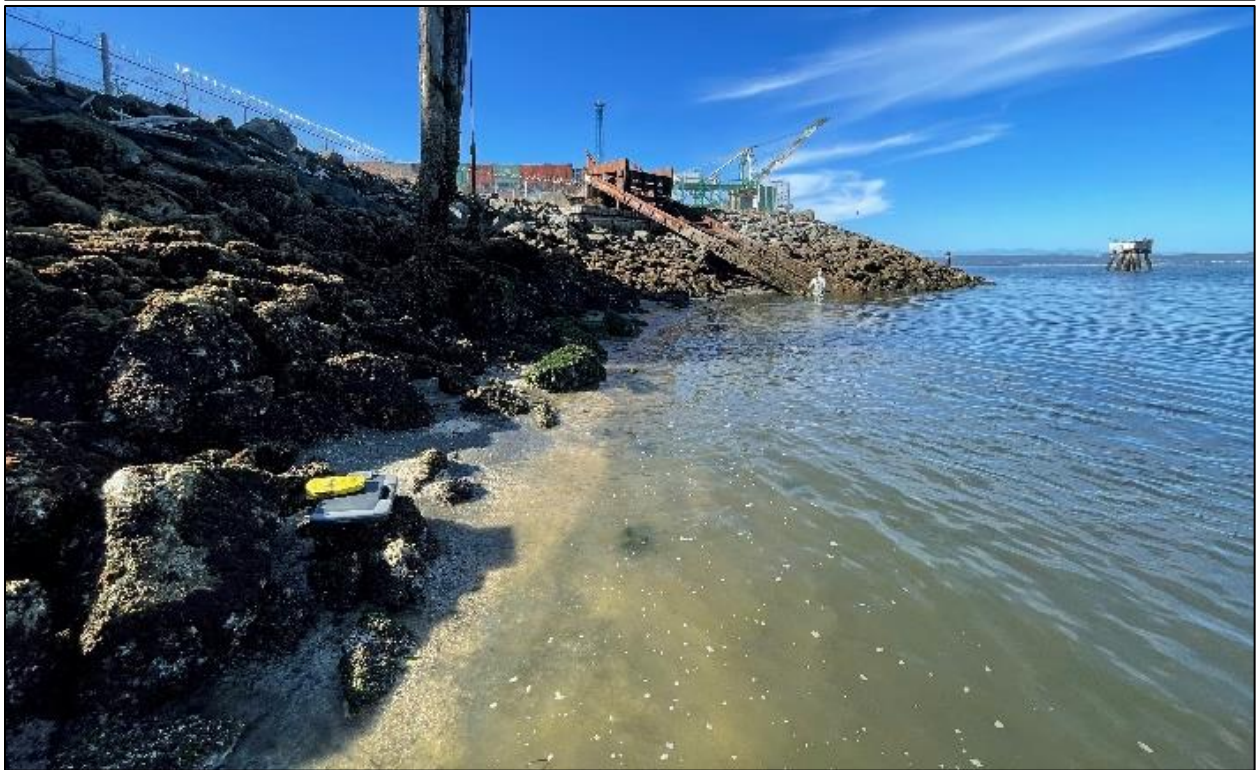
Photographs 1 and 2), the majority of the riprap slopes were 45%, with a break in slopes observed near 0 ft MLLW. At this break, slopes became more gradual and materials typically transitioned to smaller sediments like sand and shell hash. Subdominant materials within the large riprap included small angular rock (diameter 2-12 in).

Photographs 1 & 2. Photo Point 1 in Area 1 of the Northern shoreline facing northeast (above) towards the Pacific Terminal, and southwest (below) towards the South Terminal; typical conditions. (See Figure 3 for approximate location.)

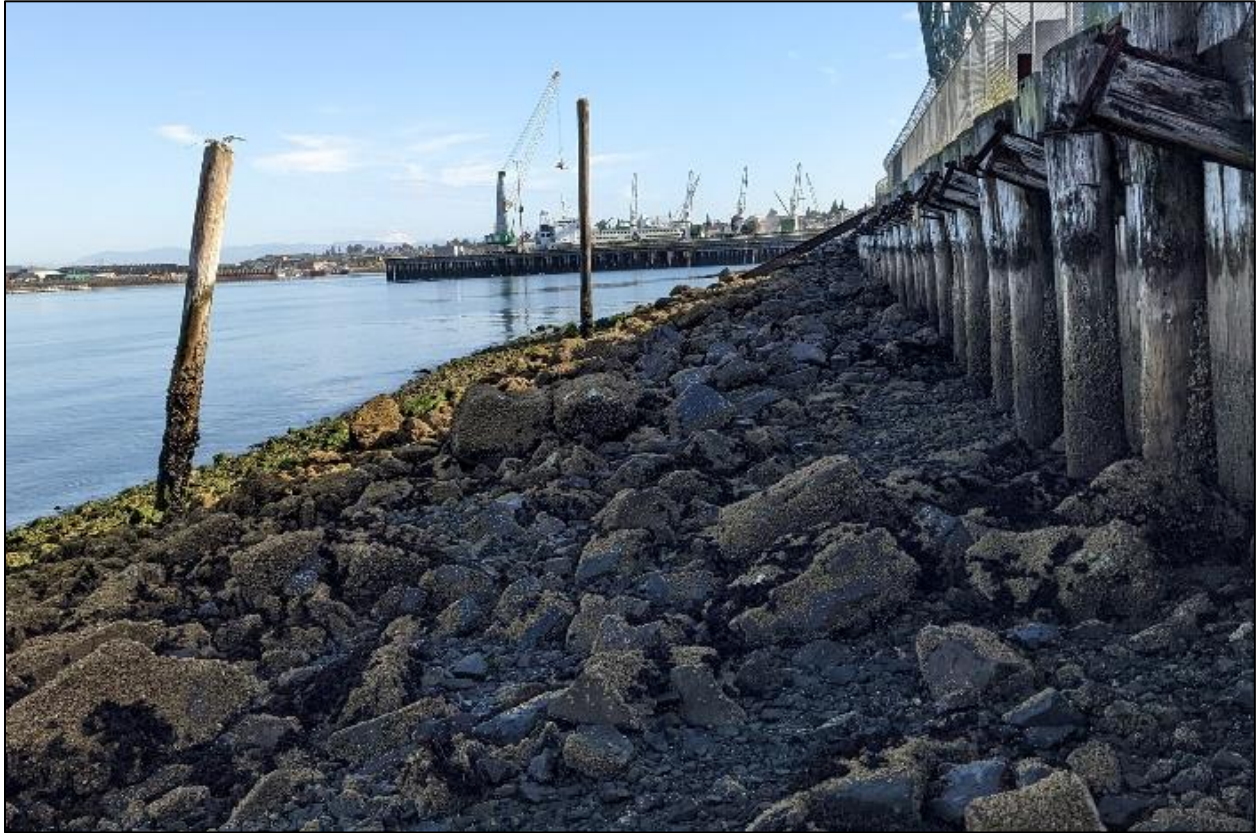
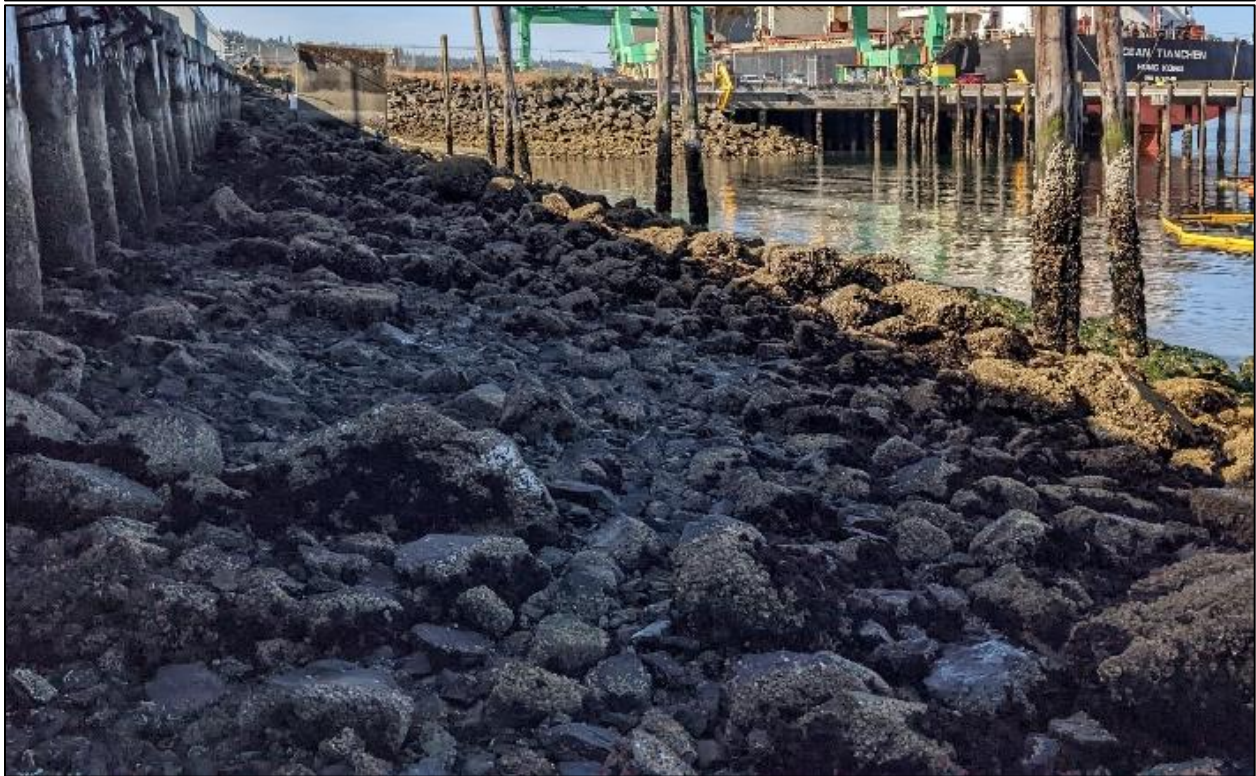
The slopes within Area 2 (Figure 3; Photographs 3 and 4) were less steep than in Areas 1 and 3, ranging from 5% to 25%, likely due to the presence of the vertical bulkhead in these areas. The substrate within Area 2 is also generally smaller material than observed in 1 and 3, consisting of an assorted mix of angular rock and quarry spalls. Dominant and subdominant materials range in size from 1 to 48 inches in diameter. A break in slopes and substrates are also present in Area 2 near 0 ft MLLW, where slopes become more gradual and consist of sand mixed with shell hash. Watermarks on the timber bulkhead (visible in Photographs 3 and 4) also indicate that during high tides, this portion of the shoreline is completely inundated.

Photographs 3 & 4. Photo Point 2 in Area 2 of the Northern shoreline facing northeast (above) towards the Pacific Terminal, and southwest (below) towards the South Terminal. (See Figure 3 for approximate location.)

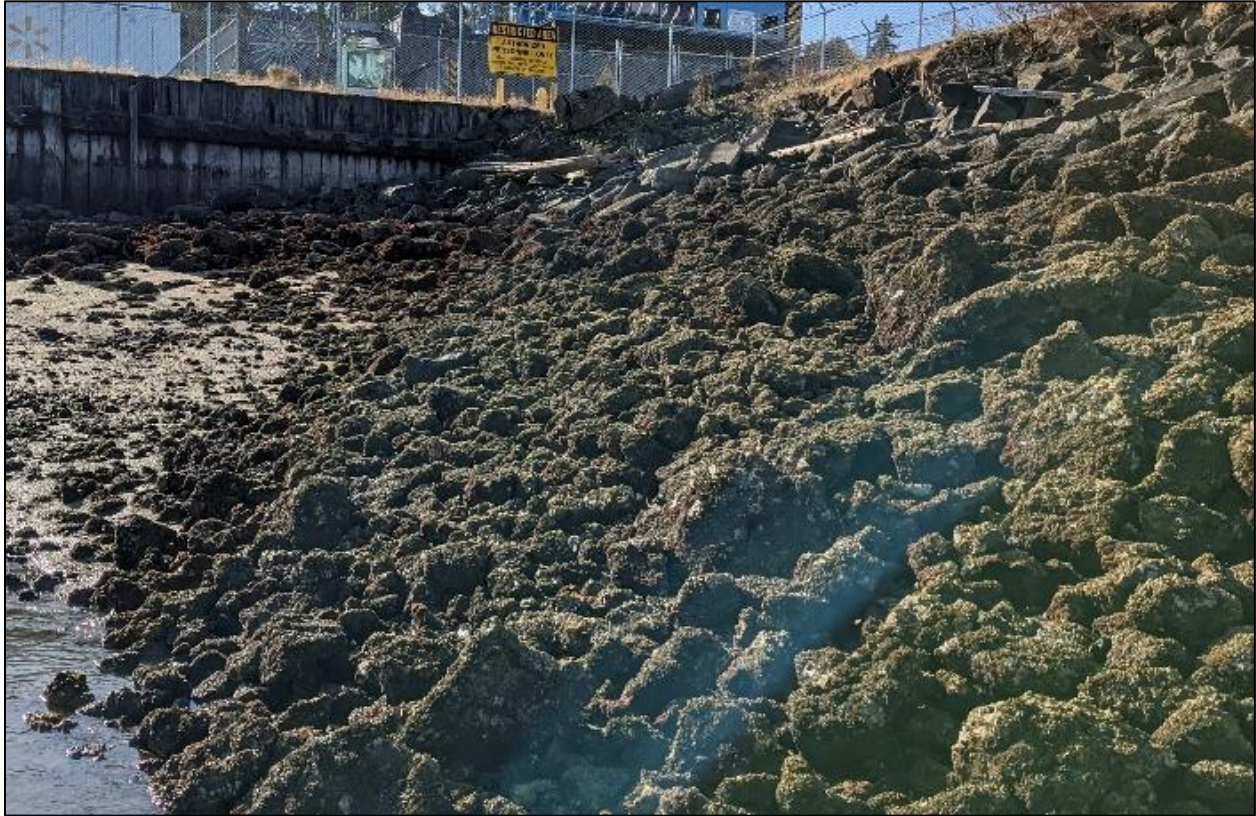
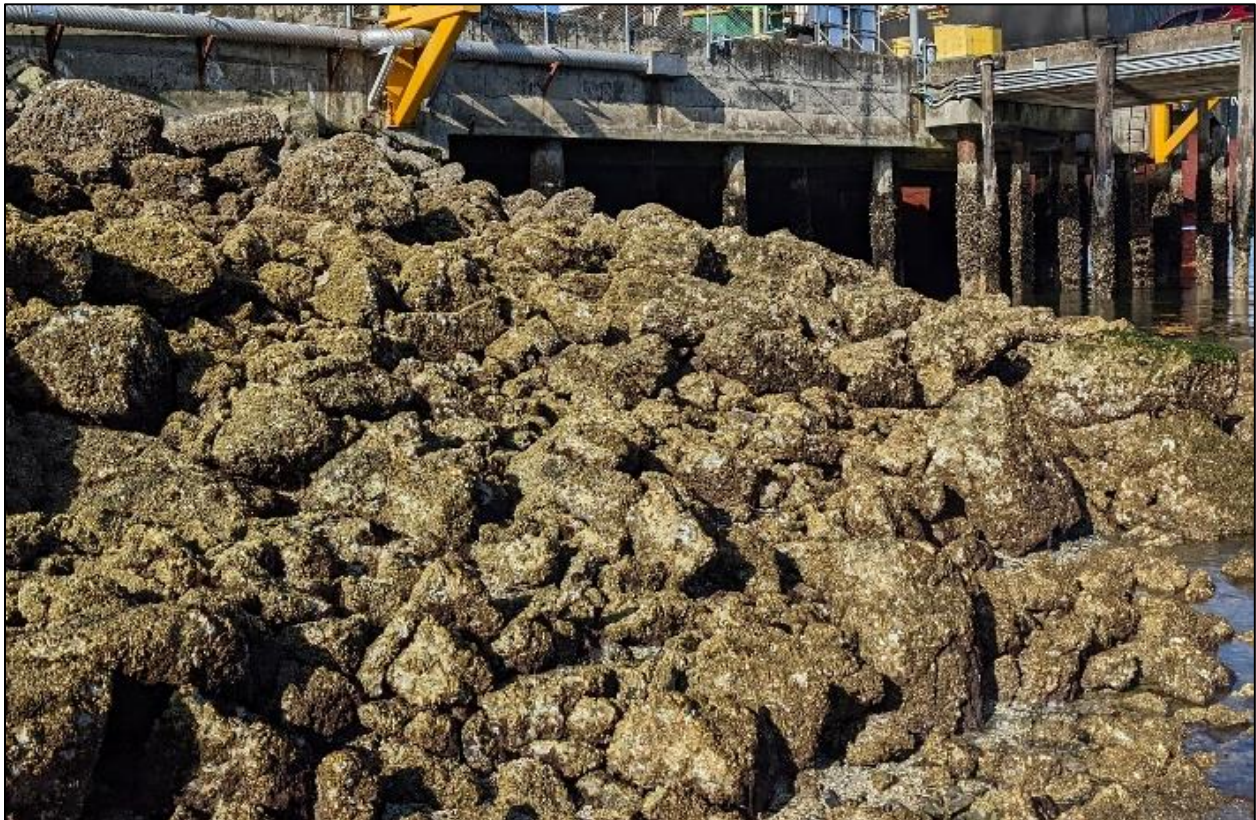
In Area 3 (Photographs 5 and 6), slopes range from 30% to 50%. The substrate primarily consists of large riprap (ranging from 1 to 6 feet diameter), with subdominant materials including cobble and small angular rock (6 to 24 inches in diameter), and gravel. The break in slope is less evident in Area 3 versus Areas 1 and 2; the rocky slope appears to continue below 0 ft MLLW, and no toe of slope was visible at the time of the Site visit.

Photographs 5 & 6. Photo Point 3 in Area 3 of the Northern shoreline facing southeast (above) northwest (below) adjacent to the South Terminal. (See Figure 3 for approximate location.)

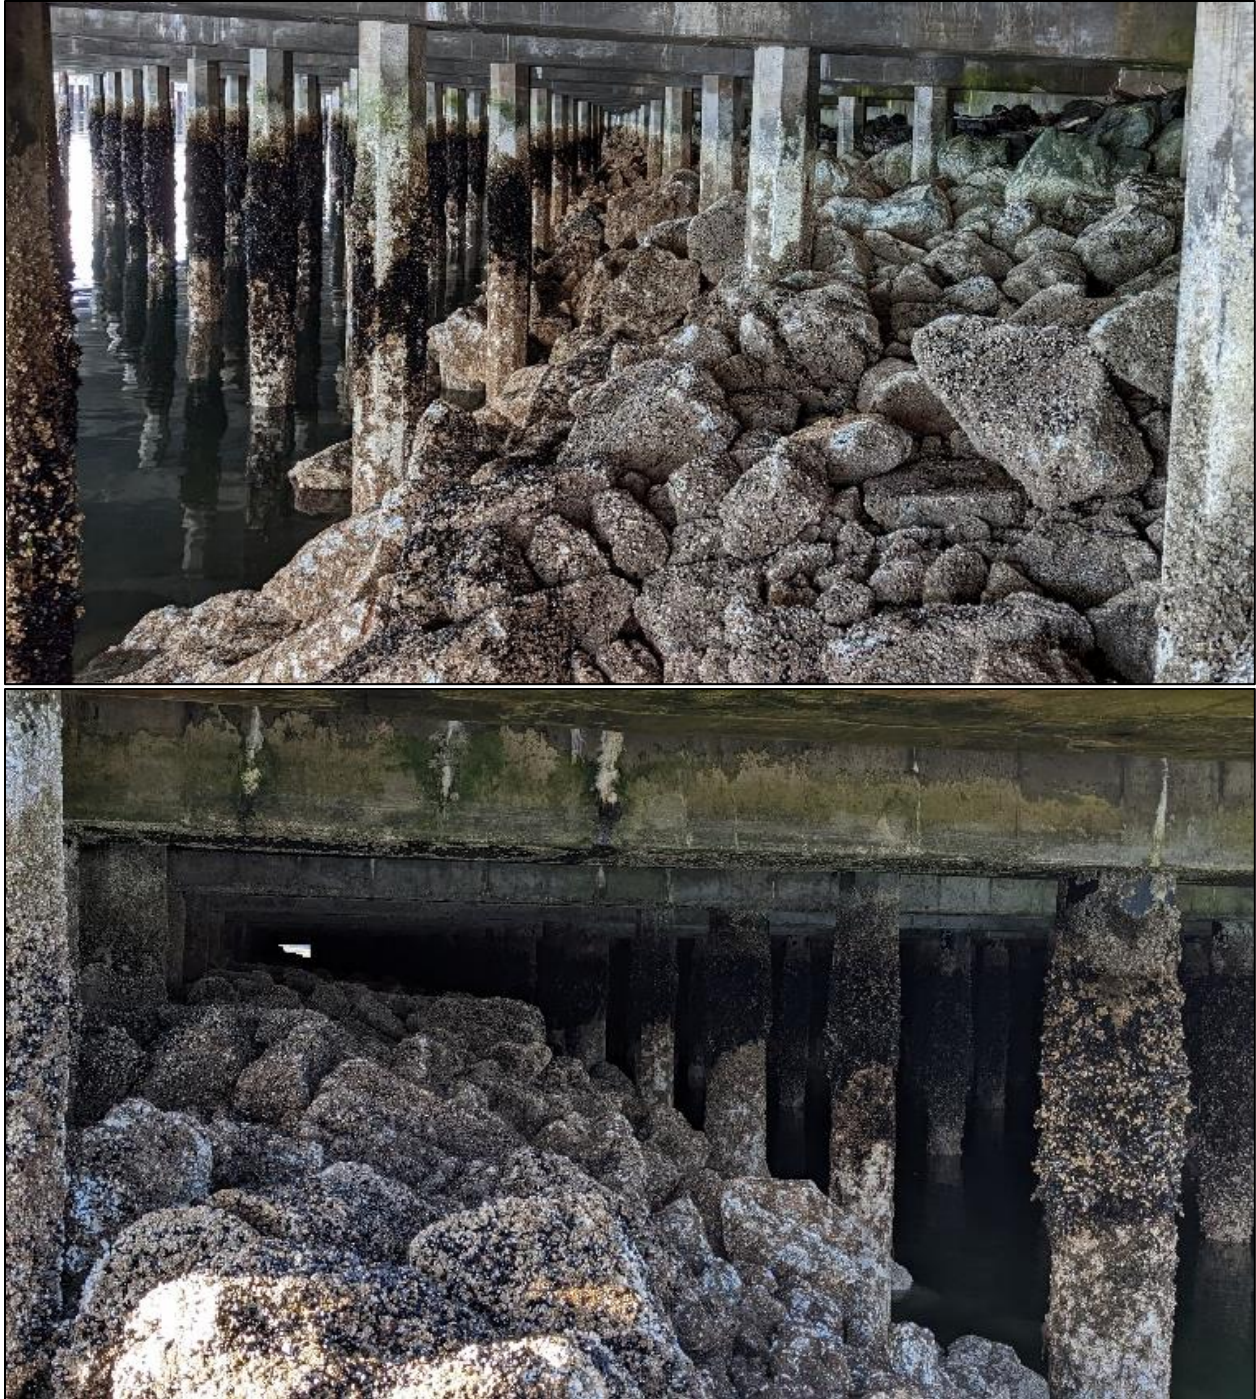
The total linear distance of the Central shoreline is approximately 708 feet. This portion of the armored shoreline consists entirely of a steep riprap slope of large angular rock (ranging from 4 feet to 4 inches in diameter; Photographs 7 and 8). The riprap is almost completely covered in barnacles and mussels, in addition to a large portion of the piles. The steep riprap slope (approximately 50%) continues below 0 feet MLLW. From what is visible, this portion of the shoreline is completely void of eelgrass, macroalgae, and upland vegetation due to decreased light availability from the wharf and frequent traffic from large vessels.

Photographs 7 & 8. Photo Point 5 in the Southern Shoreline. Central shoreline beneath the South Terminal wharf. Photographs of the riprap slope beneath the southern edge of the wharf facing North (above), and riprap slope beneath the northern edge of the wharf facing South (below).

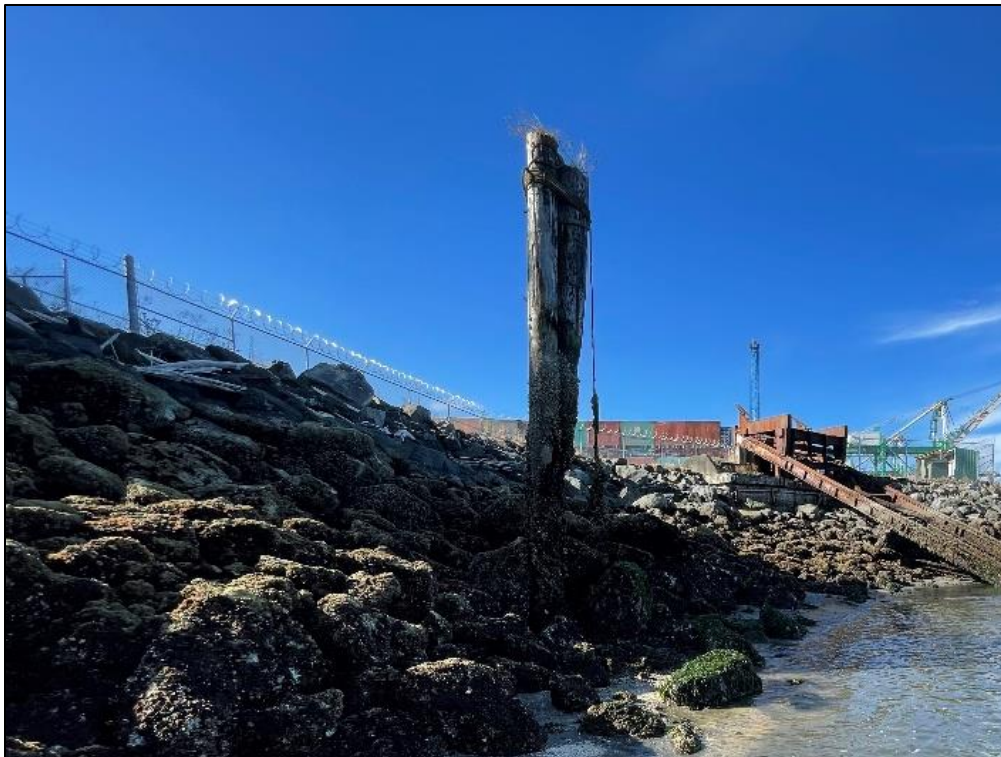
Various types of debris are present along the Northern shoreline, including: derelict creosote timber piles, rusted metal rails, LWD, and assorted trash. The derelict piles are standing upright in Areas 1 and 2 (Photograph 27 and Photograph 28; Appendix E). LWD is commonly scattered on the upper slopes within Areas 1 and 3 (Photograph 29 and Photograph 30; Appendix E); the gradual slopes of Area 2 are void of LWD. Two sets of metal rails are also present within Area 1 (see locations in Figure 3, and one set of metal rails in Photograph 27; Appendix E).

Photograph 27. Derelict piles along the Northern shoreline of Area 1. Facing southwest near the Pacific Terminal.

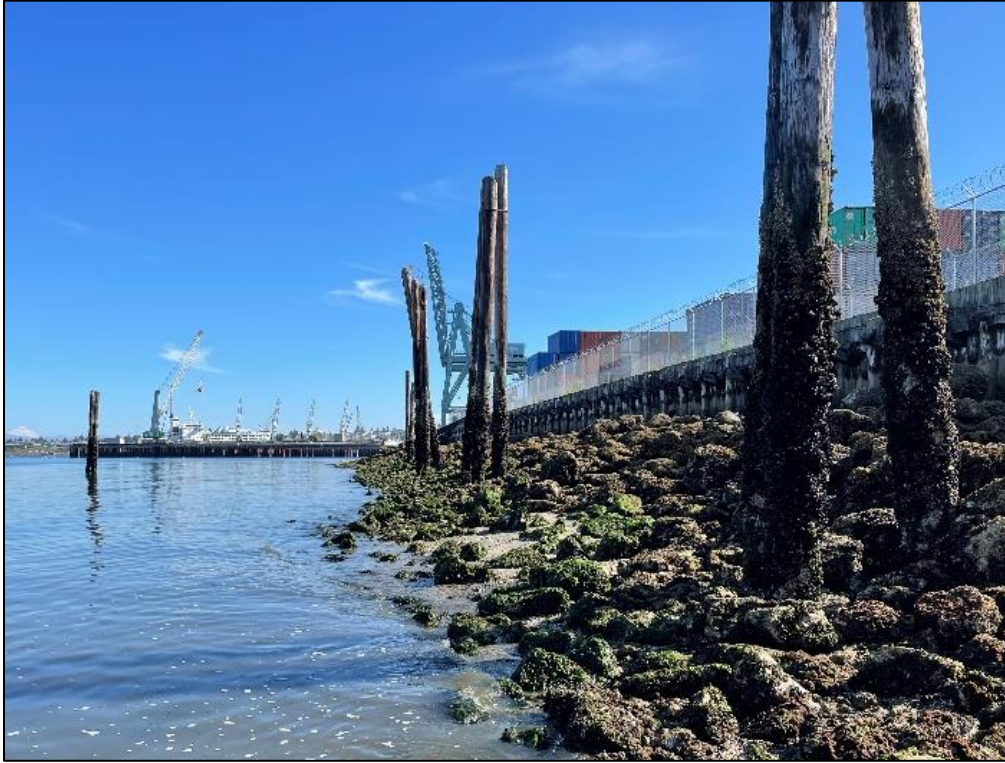
Photograph 28. Derelict piles along the Northern shoreline of Area 2. Facing northeast.

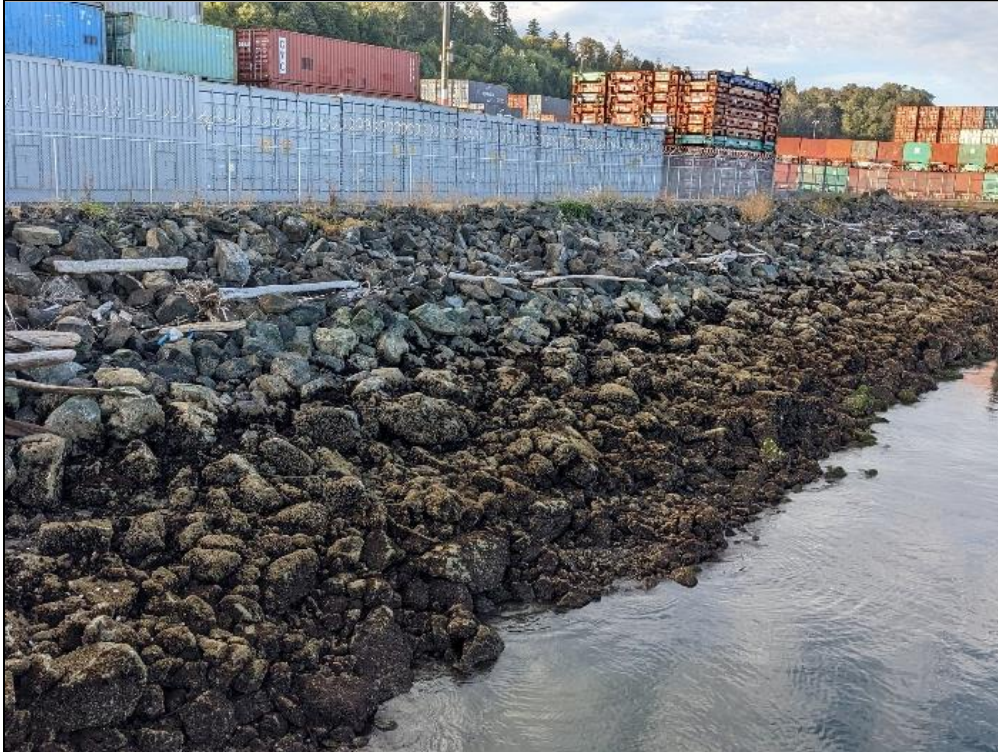
Photograph 29. LWD along the Northern shoreline of Area 1, taken from the Pacific terminal facing southwest.

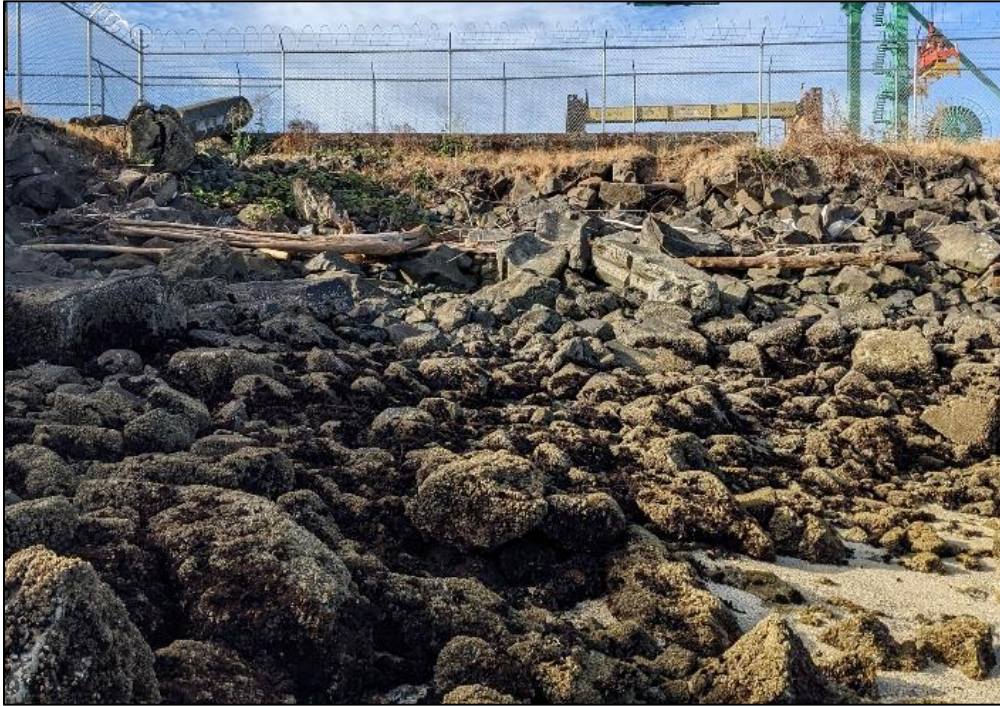
Photograph 30. LWD along the Northern shoreline of Area 1 (above) and Area 3 (below), taken adjacent to the northern edge of the South Terminal facing southwest.

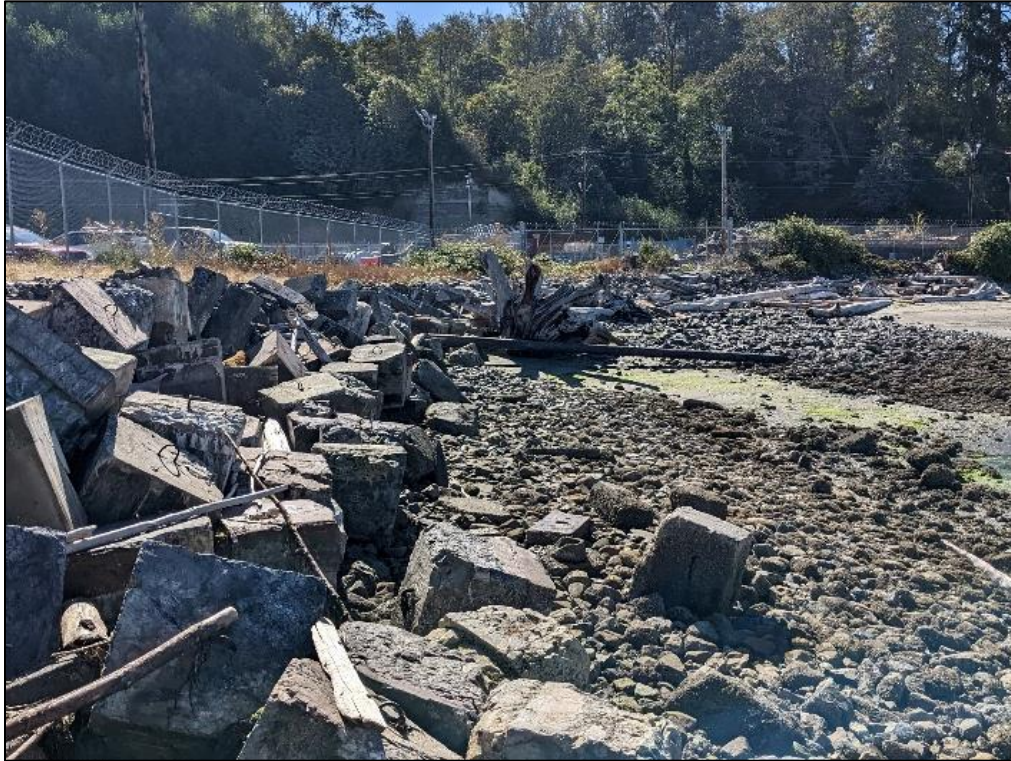
Continuing south down the shoreline, the armoring transitions into large concrete blocks (approximately 4x4x4 ft) (Photograph 32; Appendix E), with a mix of cobble and small angular rock/gravel further down the slope. Armoring within Area A is covered in *Ulva* spp. typically from +2 to +3 ft MLLW. Barnacles and mussels also cover slopes from +2 to +6 ft MLLW, at coverages of 85% and 10% respectively.

Photograph 32. Armored slopes of the southern shoreline in Area A north of Pigeon Creek. Large concrete blocks facing South.

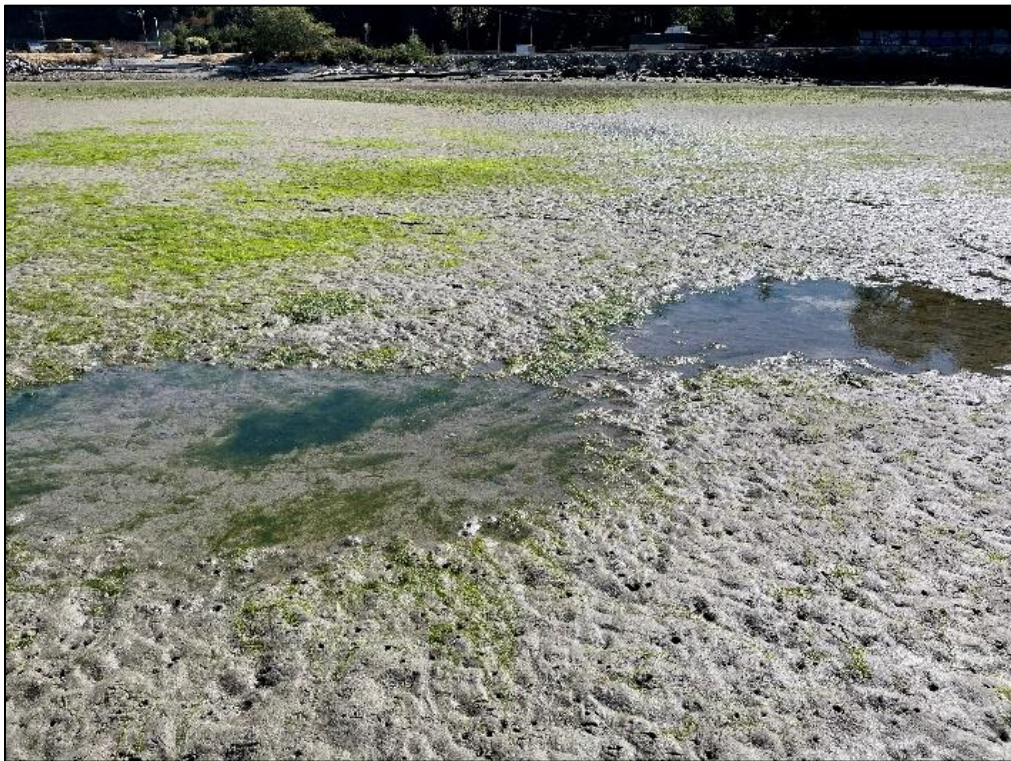
Occasional pools of shallow, standing water are present on Site in addition to many holes from burrowing invertebrates (Photograph 33; Appendix E). Nearly 50% of all substrates in the mudflat are covered in *Ulva* spp (Photograph 34; Appendix E). Empty valves of hardshell clams (e.g., varnish clams) are also common.

Photograph 33. Mudflat conditions within the Southern shoreline; typical. Occasional standing pools of water and invertebrate burrows.

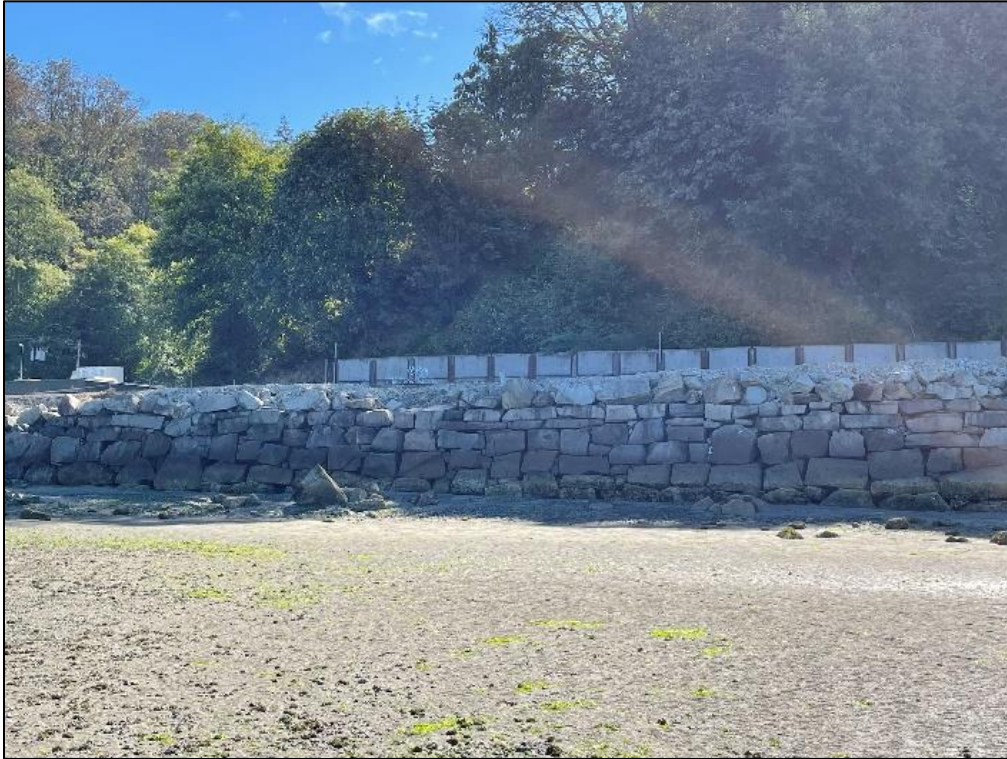
Creek (Photograph 35; Appendix E). The shoreline is still armored within Area B; however, it primarily consists of a vertical rock wall that supports the railroad which runs directly adjacent to the shore (Photograph 36; Appendix E).

Photograph 36. Southern shoreline conditions near Pigeon Creek in Area B; typical. Vertical rock wall supporting the adjacent railroad tracks, facing South.
