TECHNICAL MEMORANDUM

File No.: 260.002

- Prepared for: ATTN: Jing Liu Toxics Cleanup Program Washington State Department of Ecology PO Box 47600 Olympia, WA 98504-7600
- Re: Cornet Bay Marina Model Toxic Control Act (MTCA) Cleanup Mitigation Plan: 2021 (Year 7) Vegetation Monitoring Results

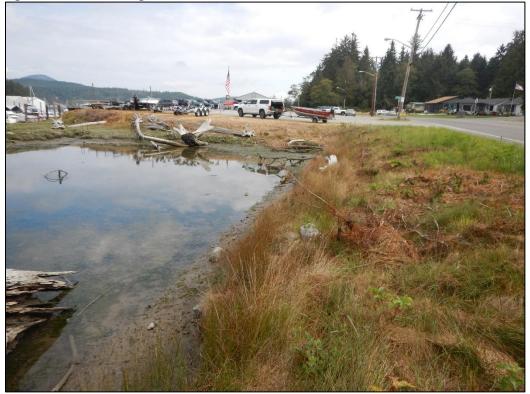
There is no performance standard for emergent vegetation within the planted area; however, a general assessment of the emergent vegetation was completed to determine the overall health and success of the plantings. The emergent area predominantly consists of seashore saltgrass (*Distichlis spicata*), Lyngby's sedge (*Carex lyngbyei*), saltmarsh bulrush (*Schoenoplectus maritimus*), and pickleweed (*Salicornia virginica*). Based on visual observations, the planted emergent area has approximately 80 percent aerial coverage.

Figure 7. Planted emergent area.
