TECHNICAL MEMORANDUM

October 9, 2024

Re: Cornet Bay Marina Model Toxic Control Act (MTCA) Cleanup Mitigation Plan: 2024
(Year 10) Vegetation Monitoring Results

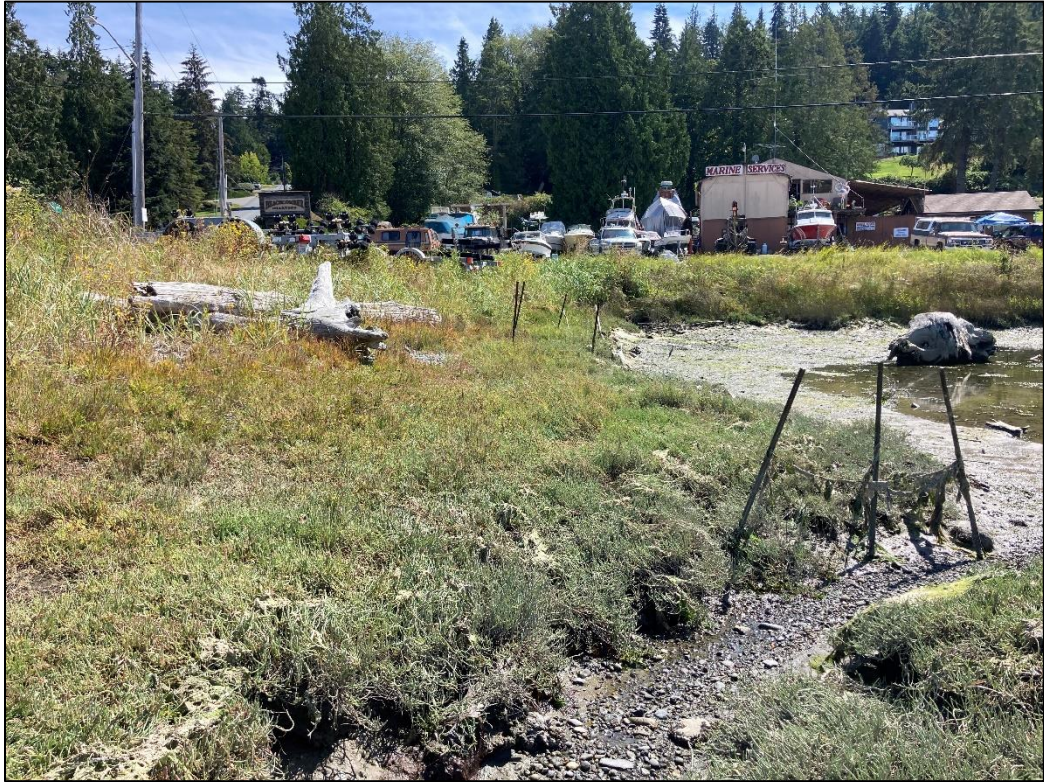
Photo point 7. Planted emergent area.

There is no performance standard for emergent vegetation within the planted area; however, a general assessment of the emergent vegetation was completed to determine the overall health and success of the plantings. The emergent area predominantly consists of seashore saltgrass (*Distichlis spicata*), Lyngby's sedge (*Carex lyngbyei*), beach plantain (*Plantago maritima*), fleshy jaumea (*Jaumea carnosa*), Puget Sound gumweed (*Grindelia integrifolia*) and pickleweed (*Salicornia pacifica*). Based on visual observations, the planted emergent area has approximately 75 percent aerial coverage.
