Former Cascade Timber #1 Site, Tacoma, Washington: 2024 Annual Operations & Maintenance Report

Date: March 3, 2025

PHOTOGRAPHIC LOG – NOVEMBER 2024 INSPECTION

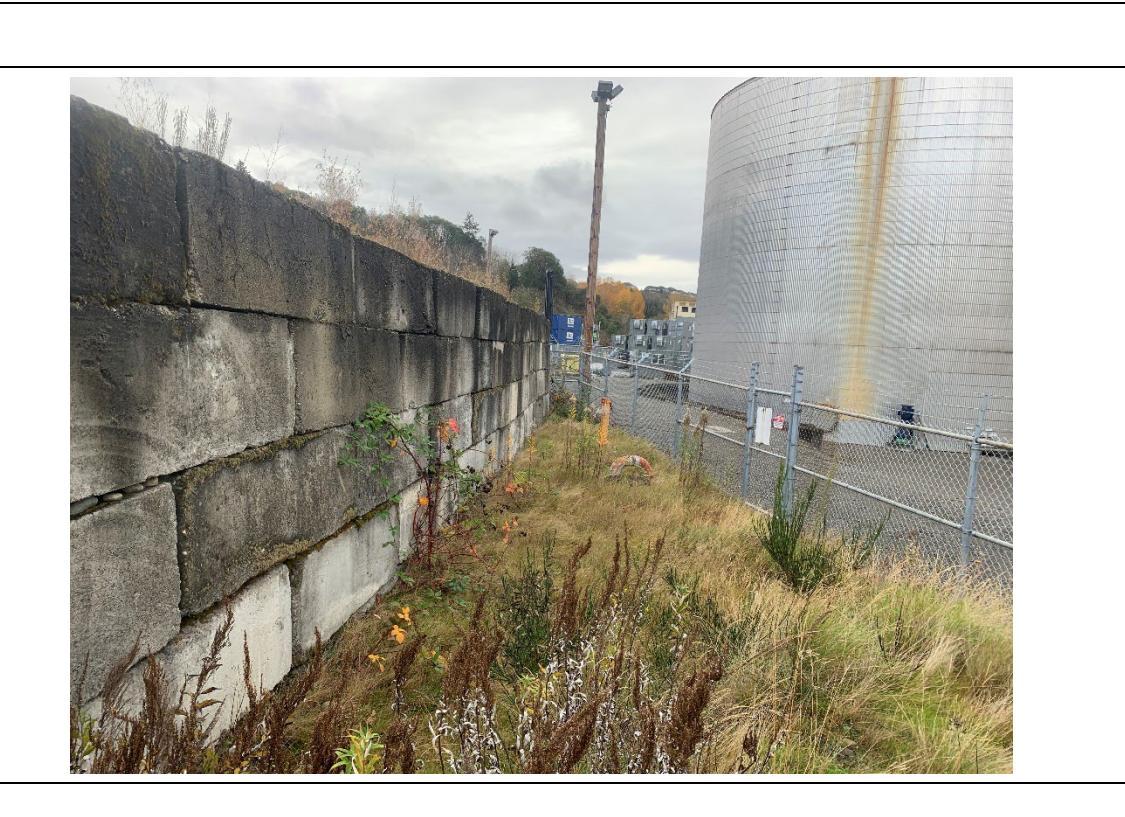
Photo 3: View of the south side of the containment cell and the south gate (facing east).

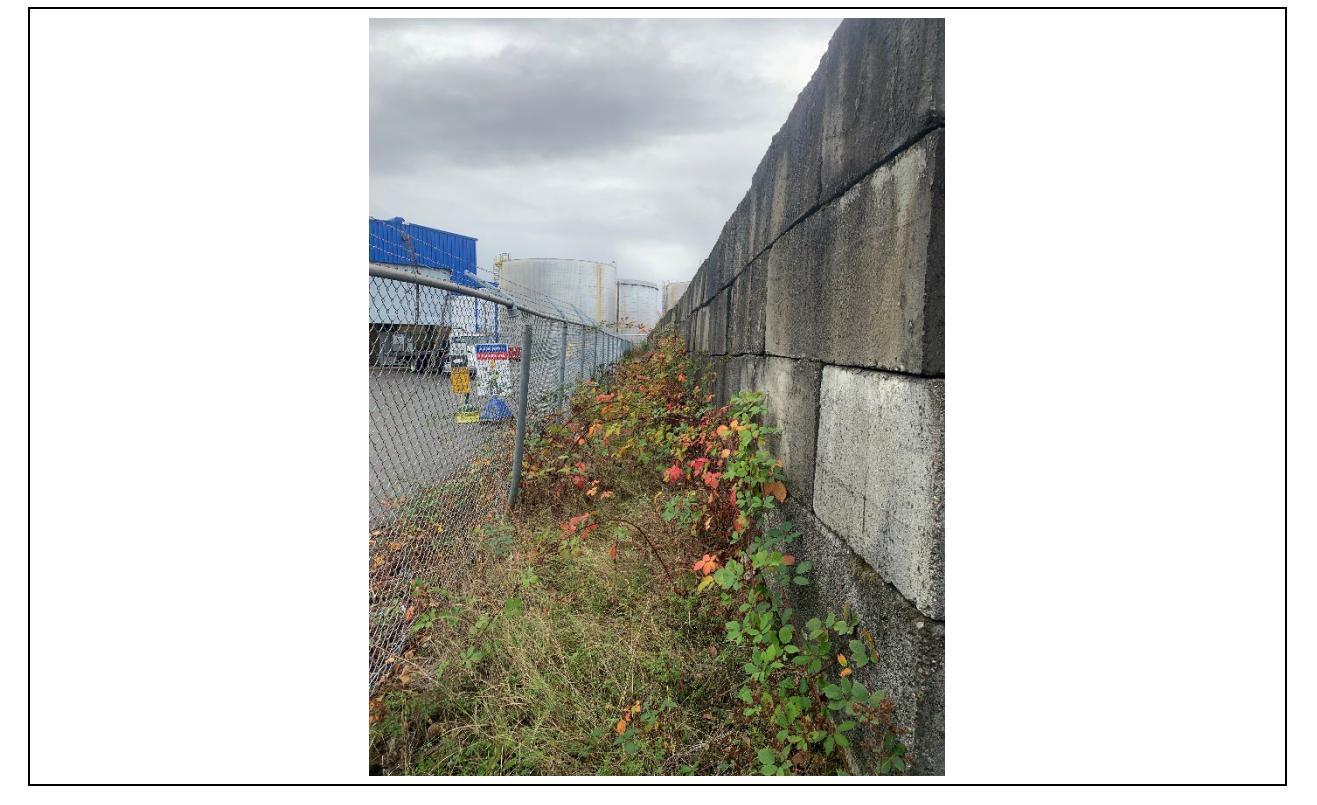
Photo 4: View of the east side of the containment cell and associated weed growth (facing south).

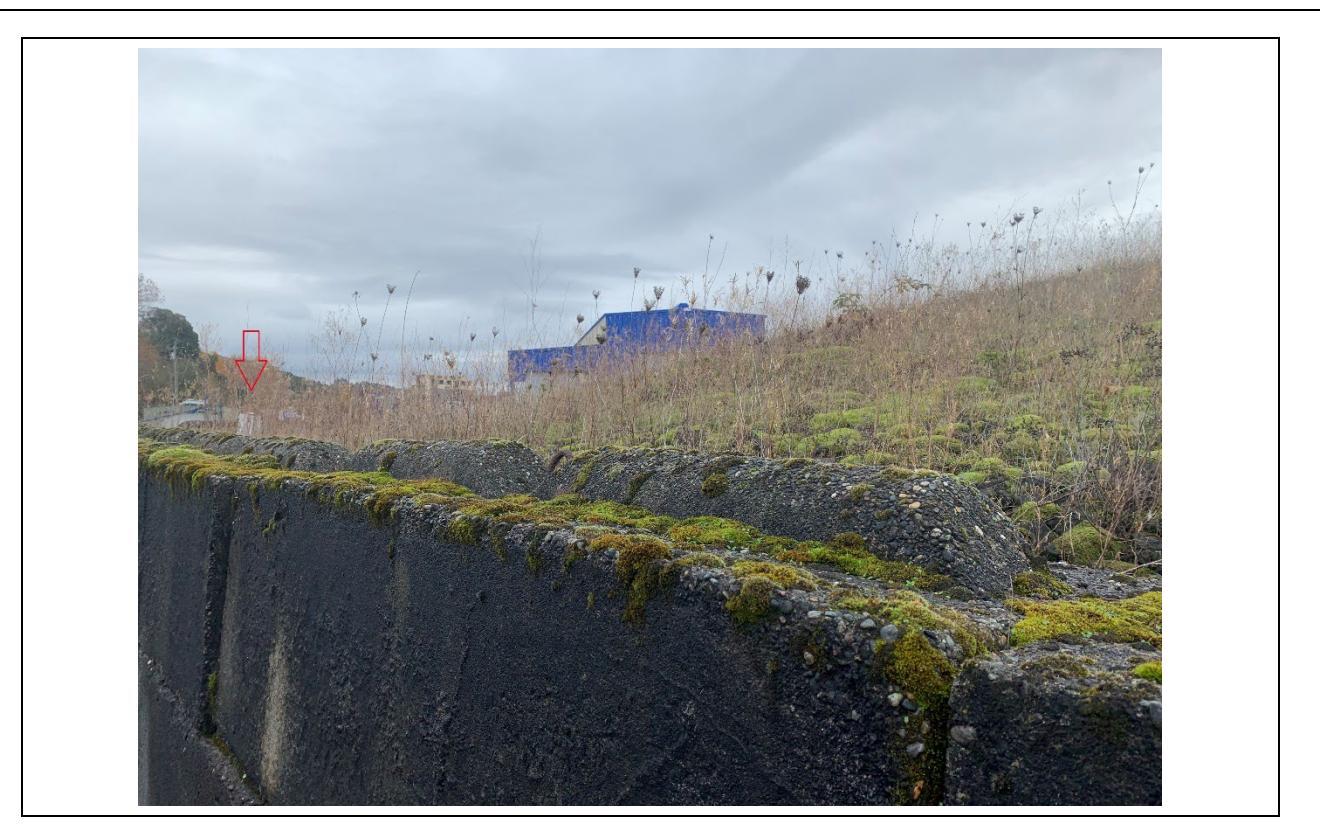
Photo 6: View of the northwest corner containment cell cap with vent pipe visible (facing east).

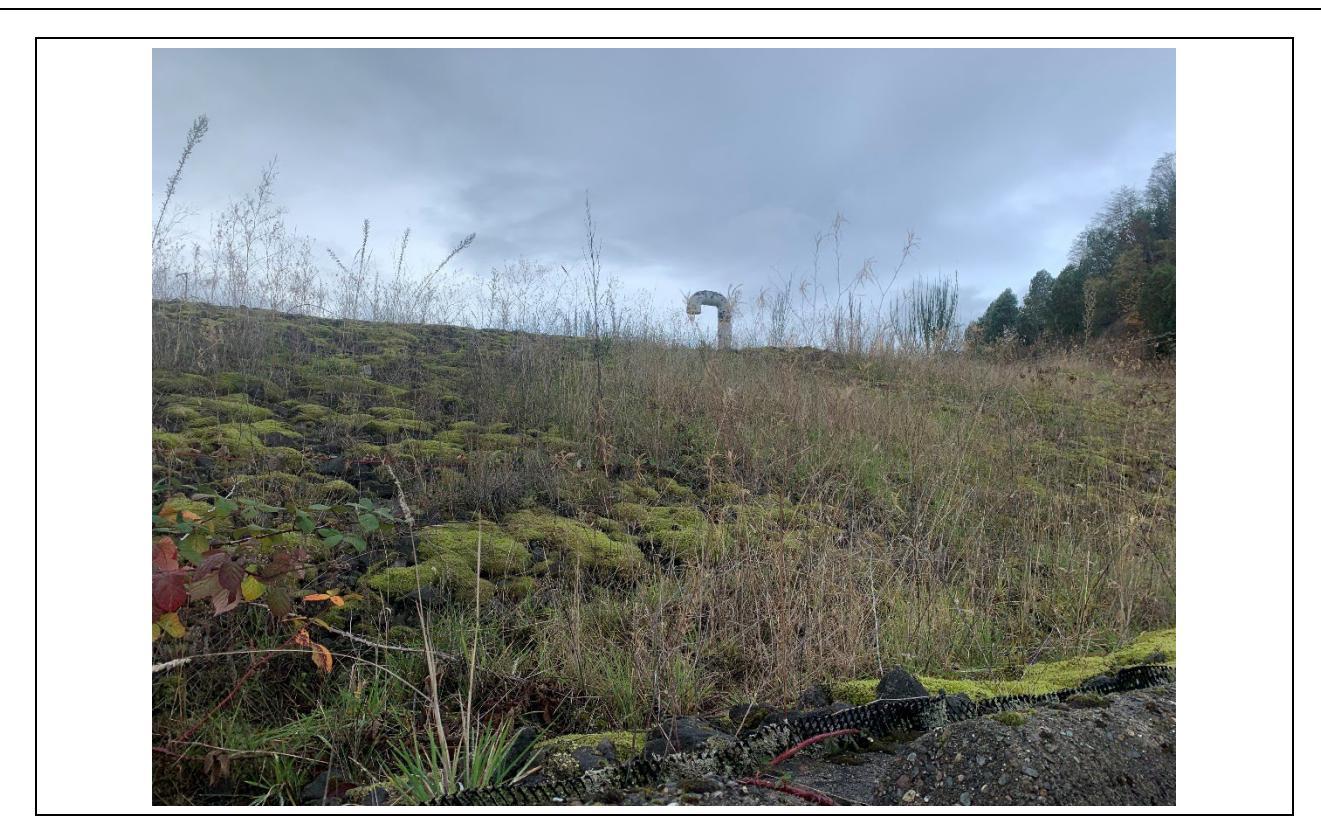
Photo 8: View of the center of containment cell cap and vent pipe (facing west).

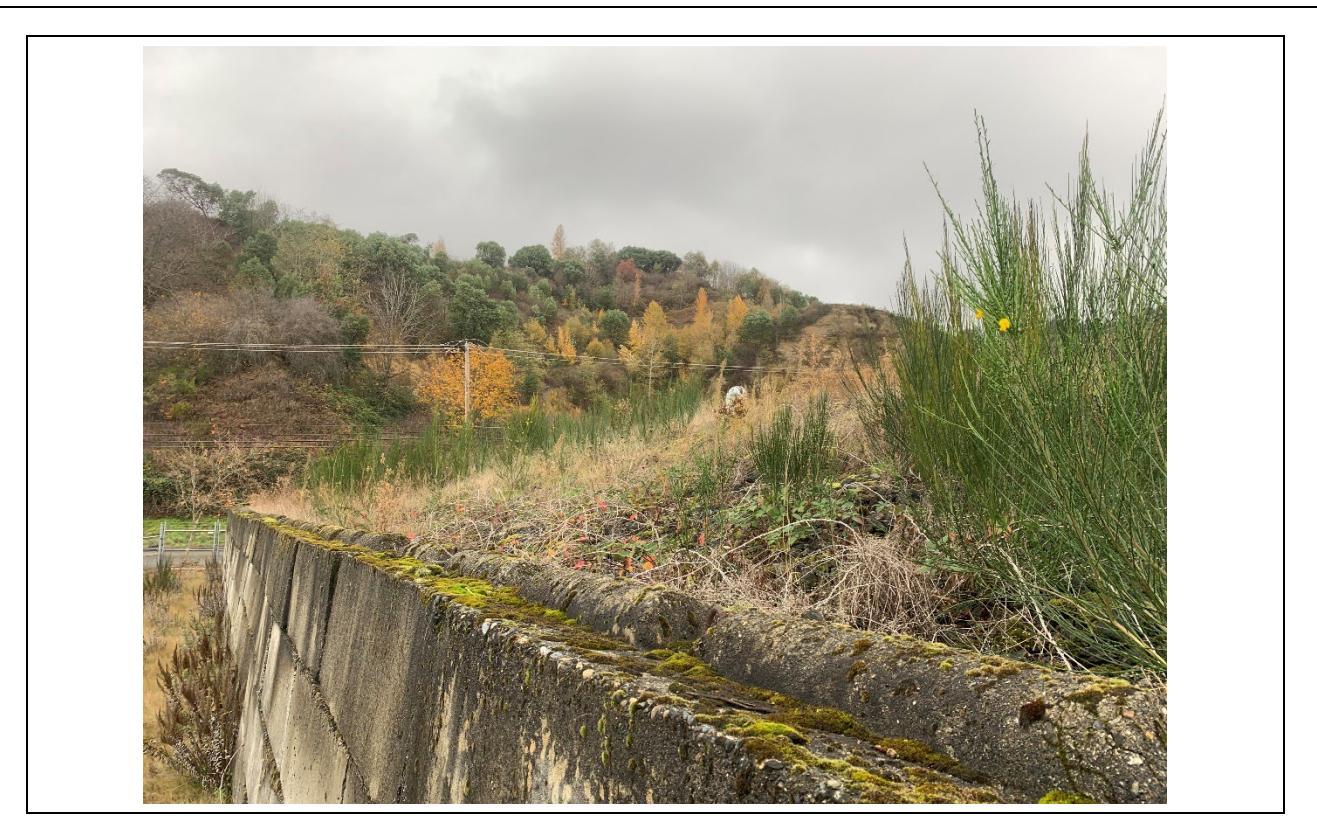
Photo 10: View of the west side of containment cell cap (facing north).

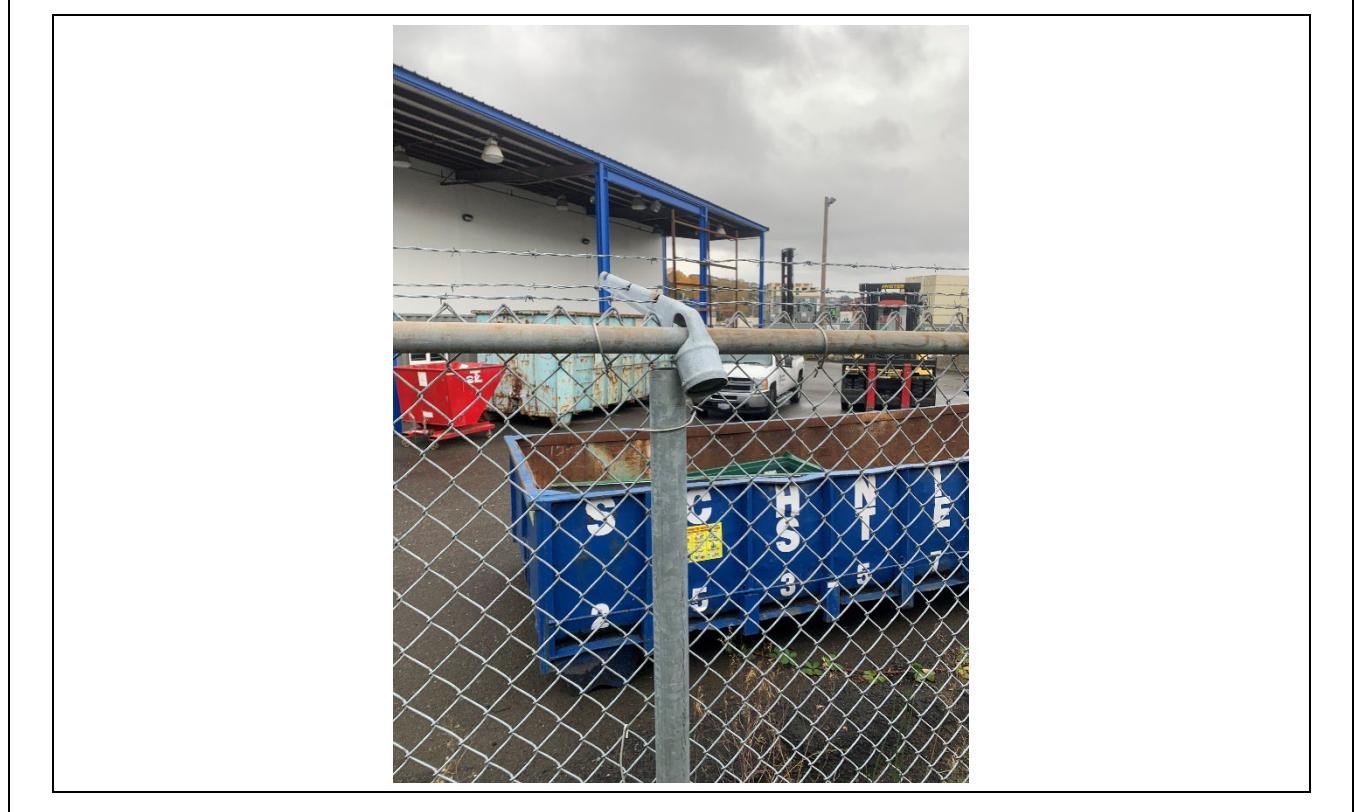
Based on the condition of the vegetative cover observed during the Site visit, Ramboll concludes that the O&M activities have been adequate in preventing erosion and maintaining the overall integrity of the containment cell. Although a barbed wire support arm (southeastern portion of fence) requires reattachment to ensure longevity, the Site was observed to be secure in the near term, and no conditions warranting immediate further action were identified. On behalf of the Trust, Ramboll will conduct a maintenance event in Spring 2025 to 1) trim and remove extraneous vegetation on and around the containment cell, 2) reattach the fence support arm, 3) replace well and gate locks, and 4) fill the pest hole identified in the exterior of the containment cell. Ramboll will also continue inspection of the condition of the Site cap and fencing on an annual basis in accordance with the O&M Plan during 2025.

Photo 12: View of a barbed wire disconnected from fence post along the east side fence line.

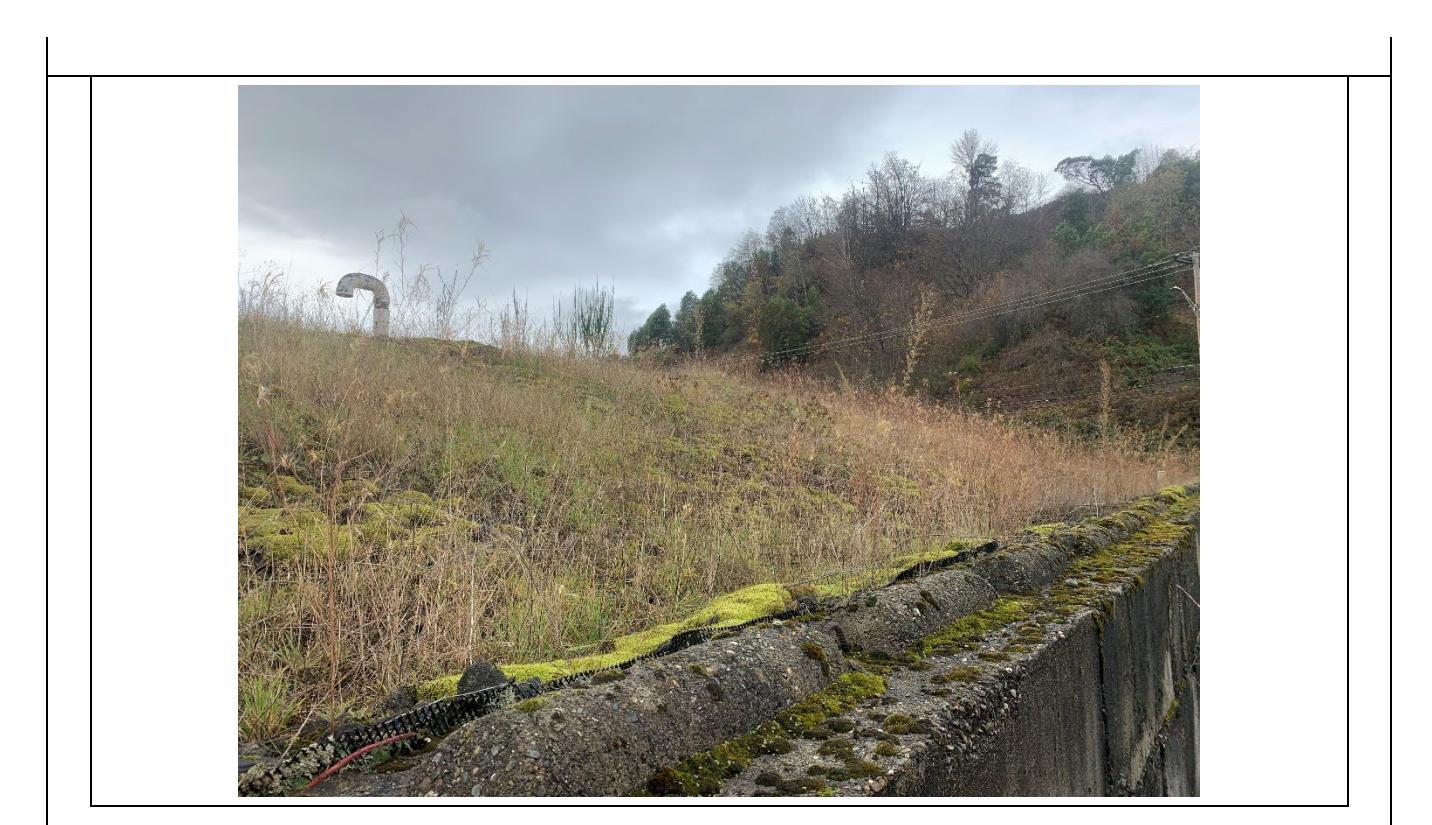
Photo 13: View of the east side of containment cell cap (facing north).

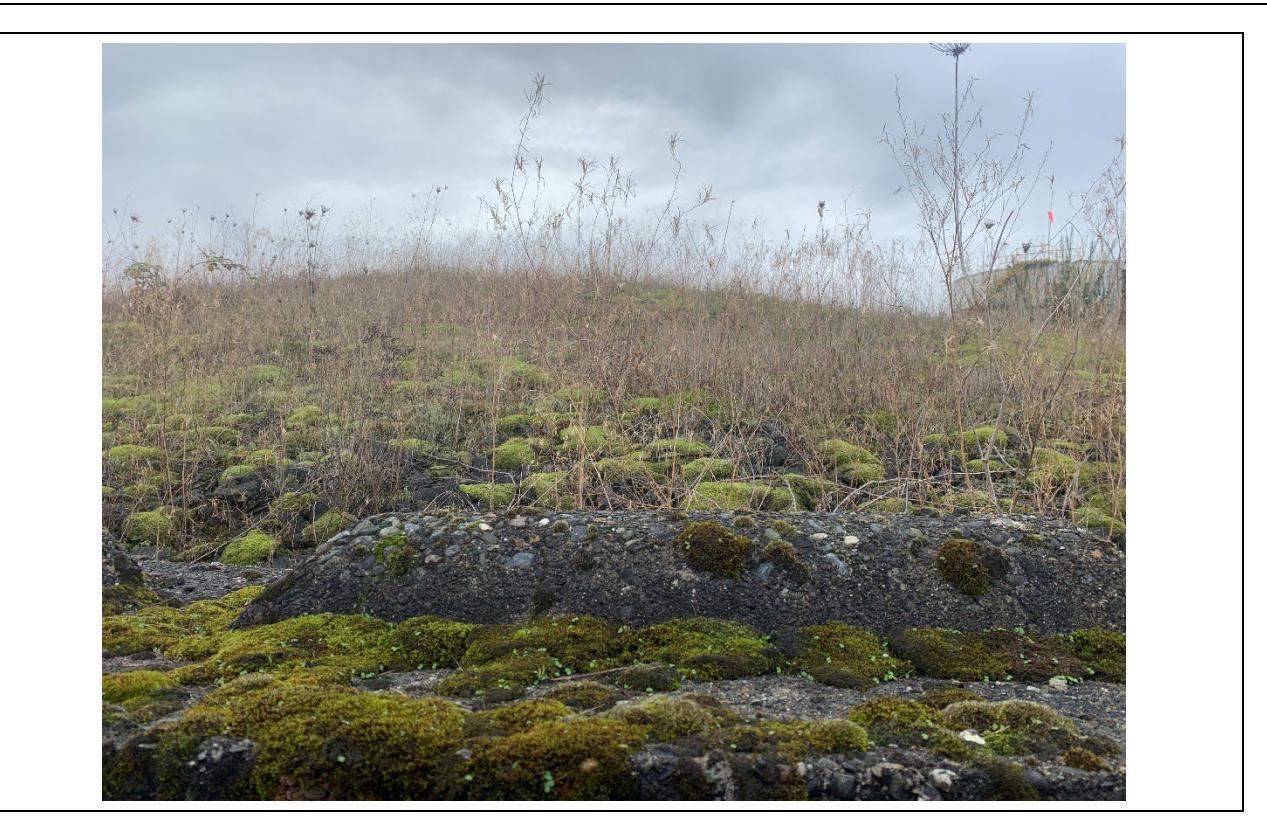
Photo 14: View of the center of containment cell cap (facing south).

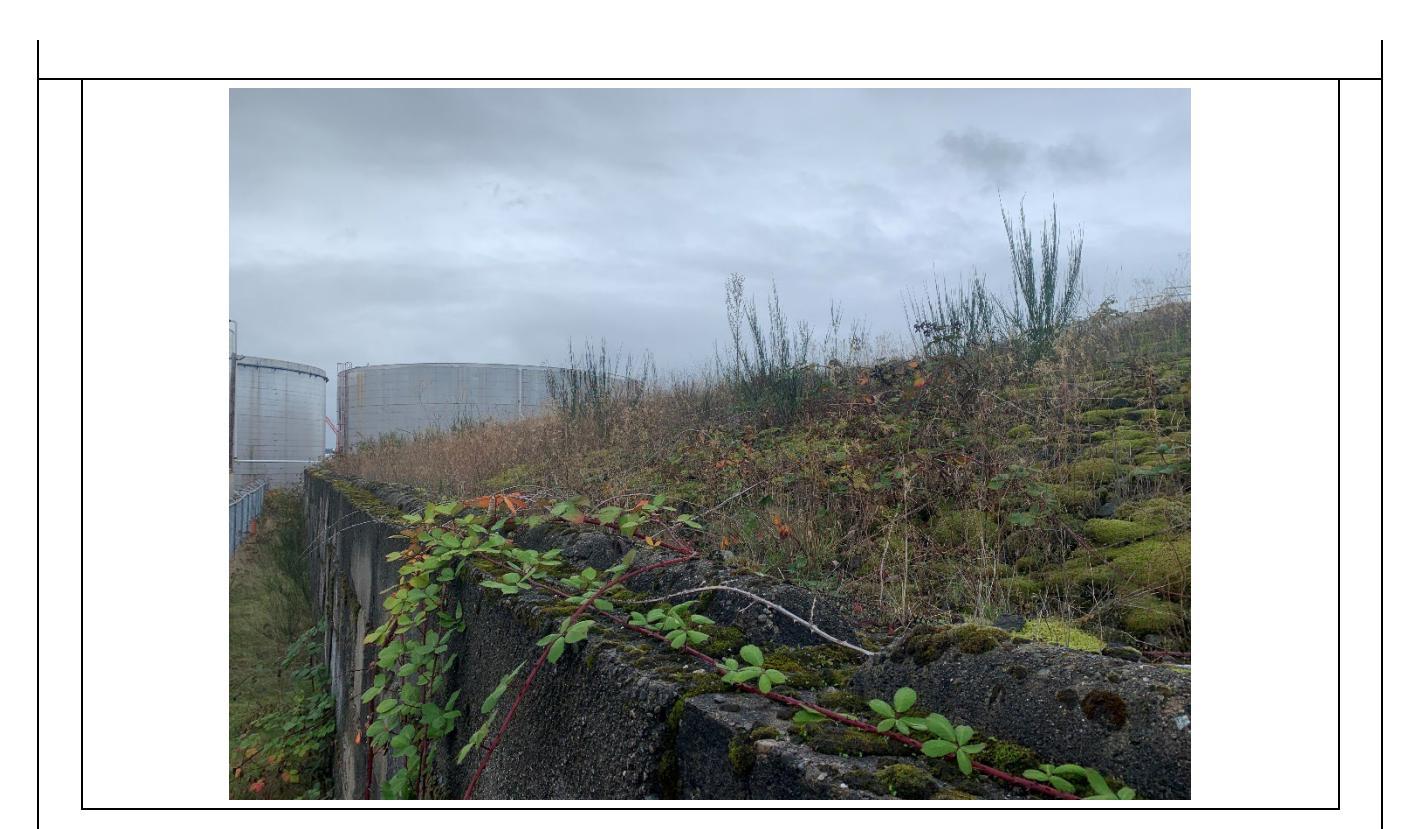
Photo 15: View of the east side of containment cell cap (facing south).

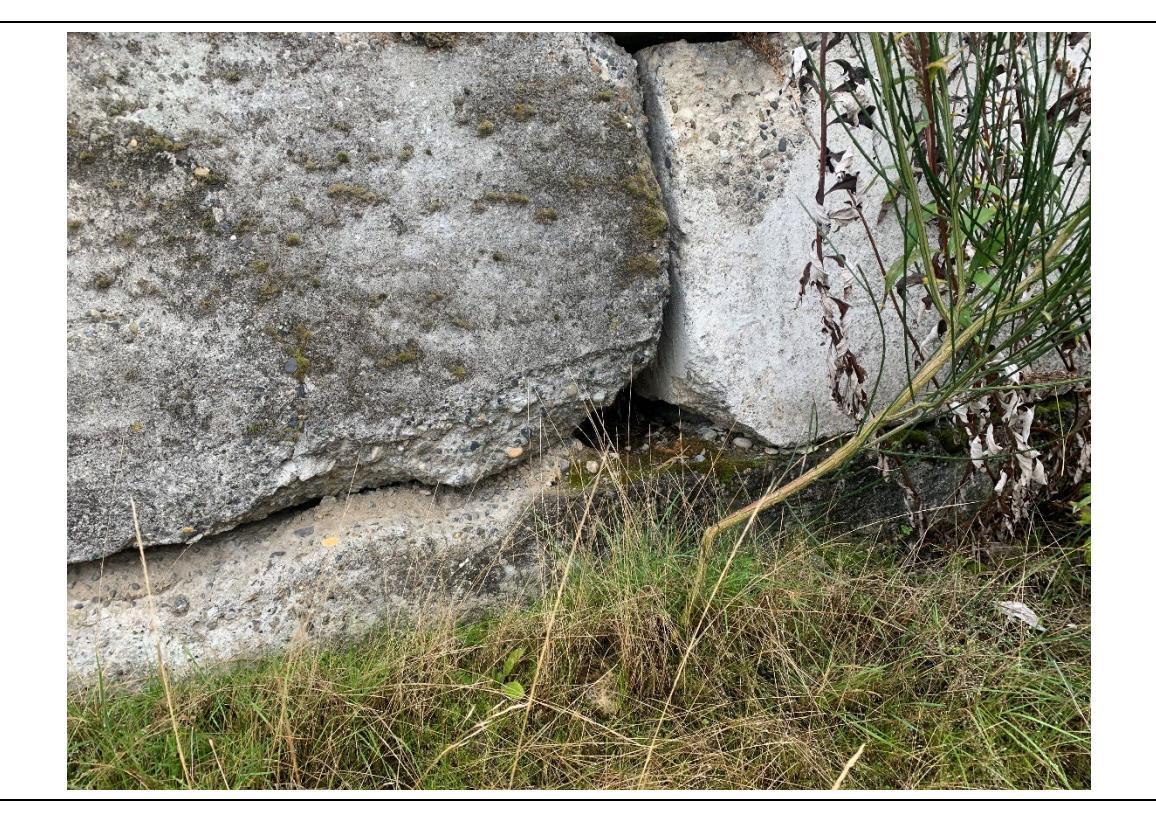
Photo 16: View of a hole on west side (field mouse was observed entering hole).

Containment Cell Inspection		
Cap vegetation (e.g., weed growth, distress, dead, inadequate)	No disturbance of earth, erosion, cracks, or mounds was observed from cell perimeter. Adequate vegetative cover was observed on the containment cell (as viewed from cell perimeter). Minor weeds were observed on the western section of the cap and near vent pipes; the presence and nature of the weeds does not appear to have resulted in an erosion issue or damage to the cap.	
Erosion (e.g., rills or depressions)	The cell cap cover consisted of rock covering, grass, and vegetation. Evidence of erosion was not observed.	
FML condition (e.g., subsidence, bulging)	Small portions of liner were visible from the cell perimeter on the northwest corner. No bulging/subsidence observed.	
Pest or vegetation intrusion (potential impacts to FML)	Small hole was observed along the base of the western wall, and a mouse was observed running into the hole (See Photo 16). Blackberry bushes were observed along the eastern side.

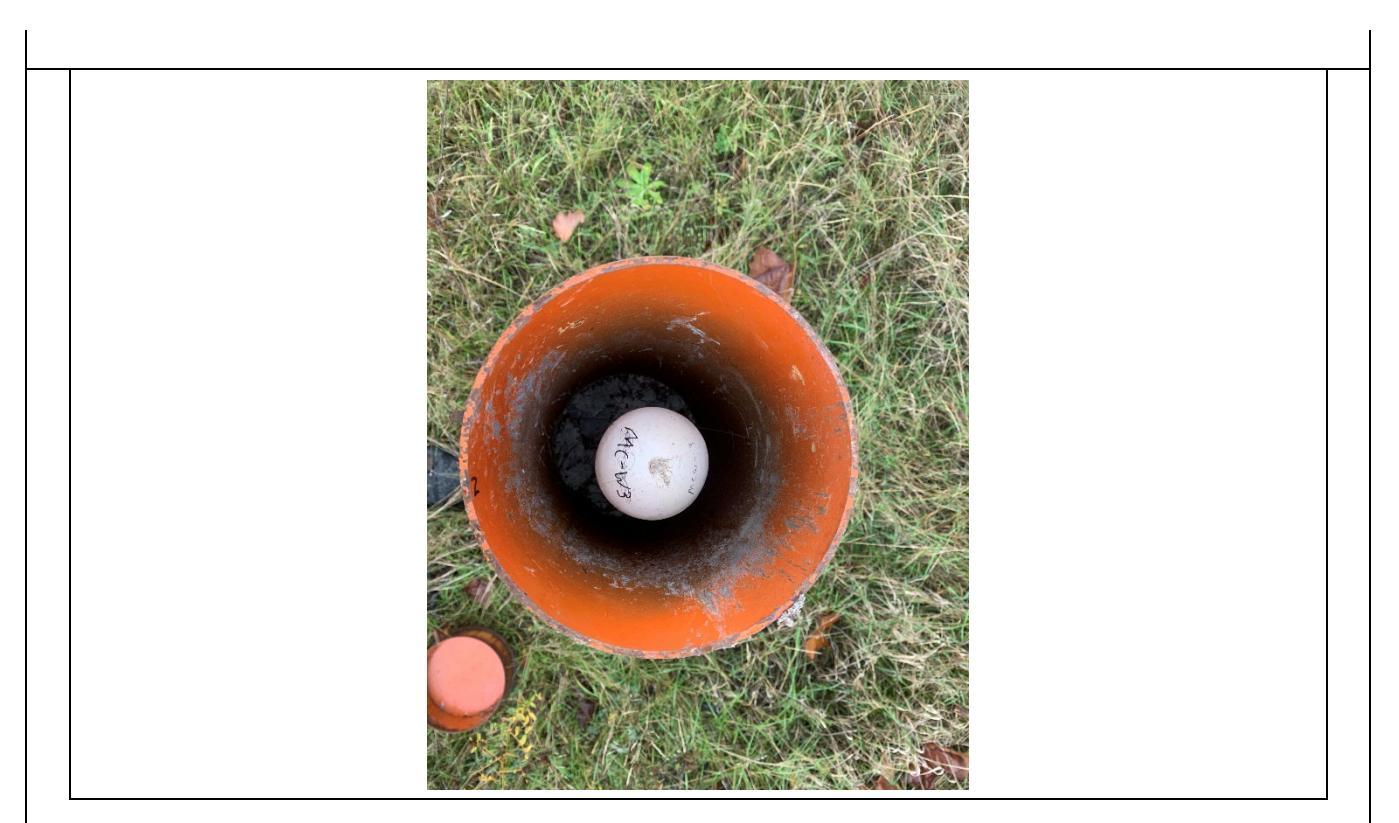
Photo 17: View of monitoring well (MCW-3) with inner cap visible.

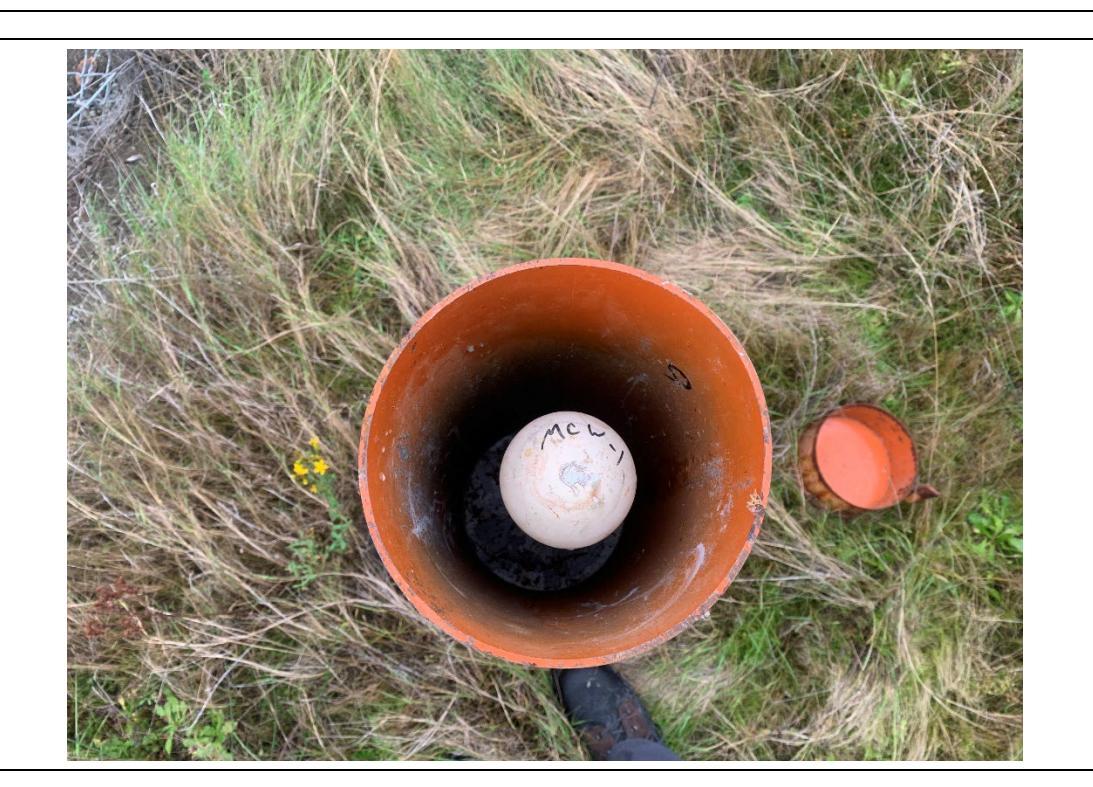
Photo 19:View of monitoring well (MCW-1) with inner cap visible.

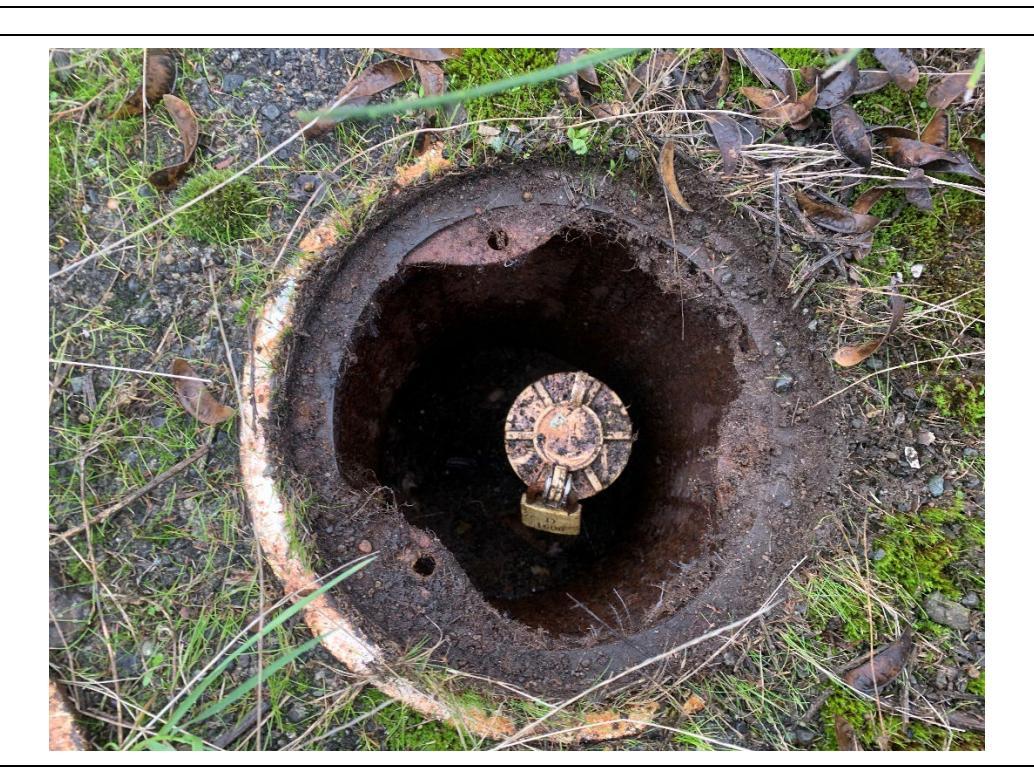
Photo 23: View of the monitoring well (MCW-2) with inner cap visible.

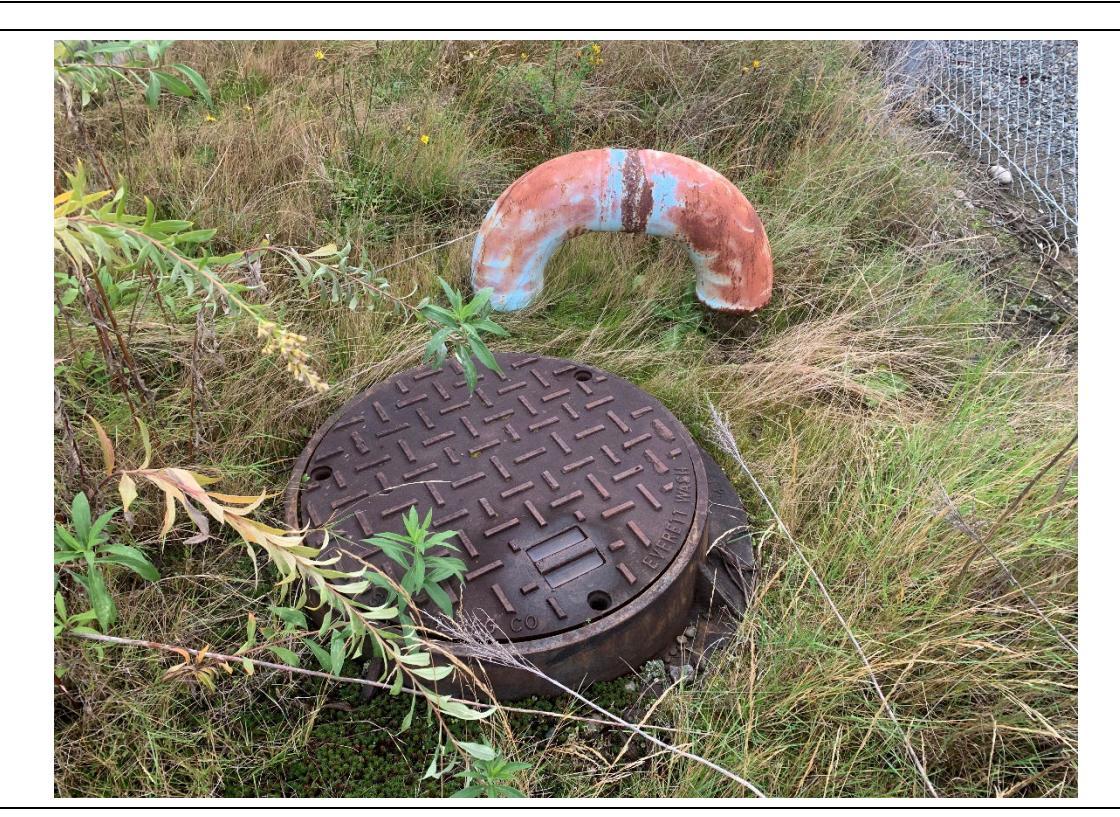
Photo 24: View of manhole and vent pipe located south of the containment cell.

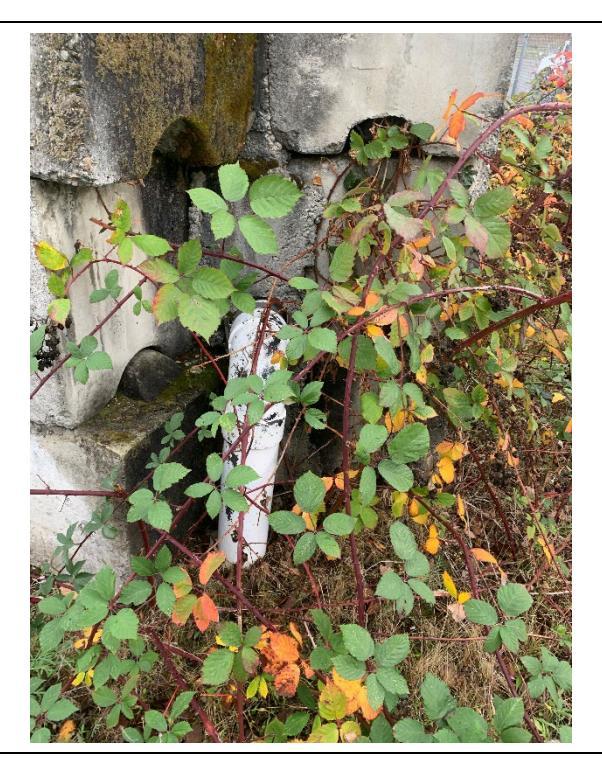
Photo 25: View of the drainpipe in the southeast corner of the containment cell.

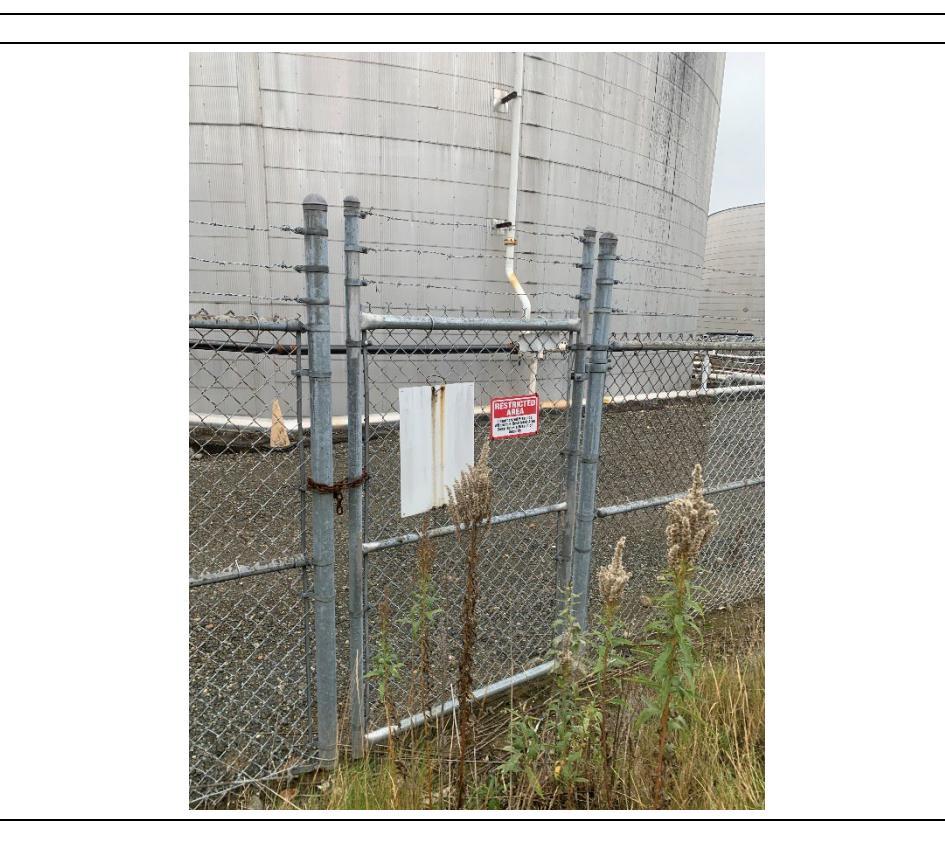
Photo 26: View of the south gate (facing south).
