Subj: 2022 Pentennial MMR Report: Former Josephine Mill No. 1

Stimson employees Wade Pierce (Area Woodlands Manager) and Steven Petrin (Environmental Manager) completed an annual spring site inspection on May 5, 2022 pursuant to the Post Removal Site Control Plan (PRSCP) found in Appendix E to the Final Removal Action Report (RAR) dated February 10, 2012. The PRSCP outlines the long-term maintenance and monitoring obligations to ensure the continuous protection, integrity and stability of the mine waste repository constructed at the former Josephine Mill No. 1 in Pend Oreille County, Washington. Your letter of 7 July 2017 extended the inspection frequency period to five years (pentennial) from the previous requirement of annually. This letter serves as the 2022 pentennial spring Monitoring Maintenance and Repairs (MMR) report.

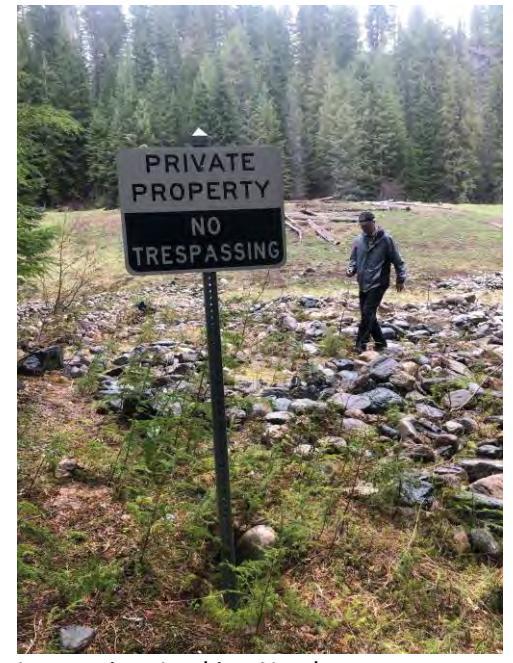
- All 3 warning signs remain upright and in place, were undamaged, and are readily visible.

Lower sign: Looking North

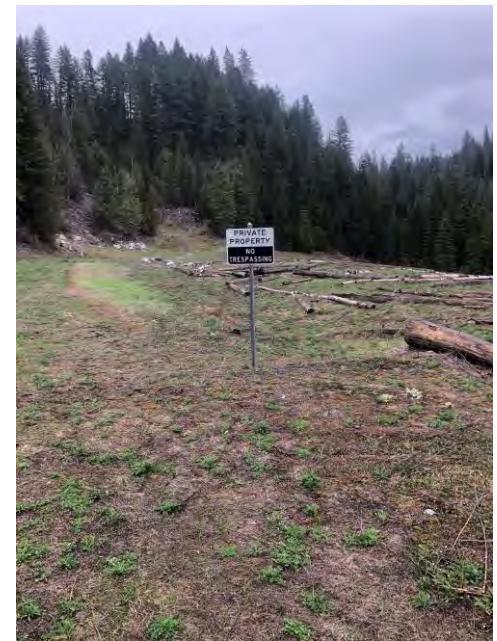
Upper sign: Looking East

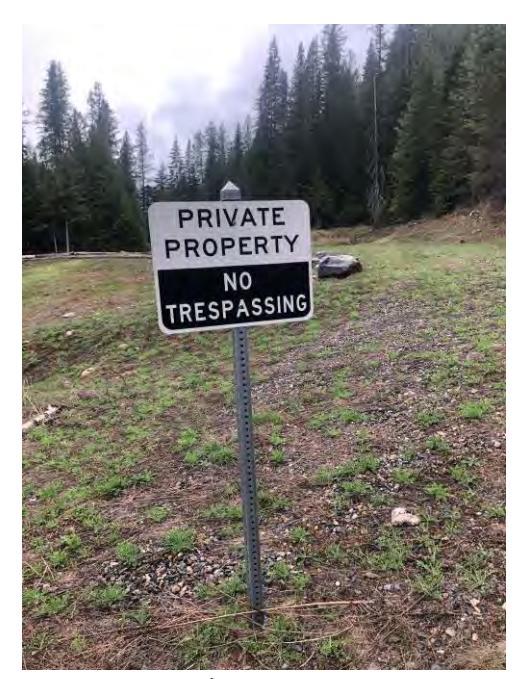
Upper sign: Looking Eest

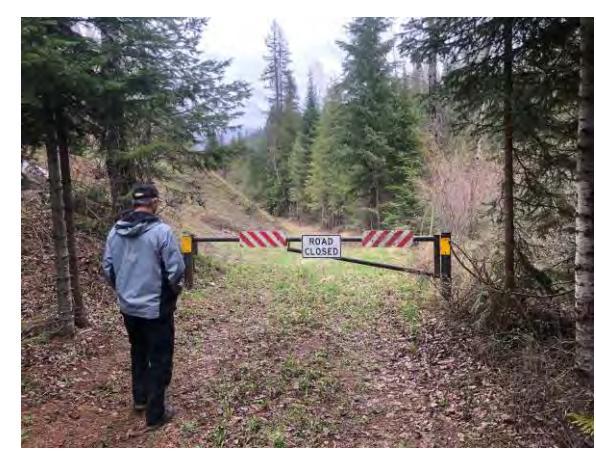
- The gate was closed and in good working order with an intact lock. Boulders and other structures designed to restrict vehicular entry remain in place and were undamaged. The evidence of sporadic ATV access referenced in the 2017 Inspection Report appears to have waned over the years. We noted the disturbed area referenced had not seen entry for quite some time.

- Gate fully functional. Now also has BLM lock.

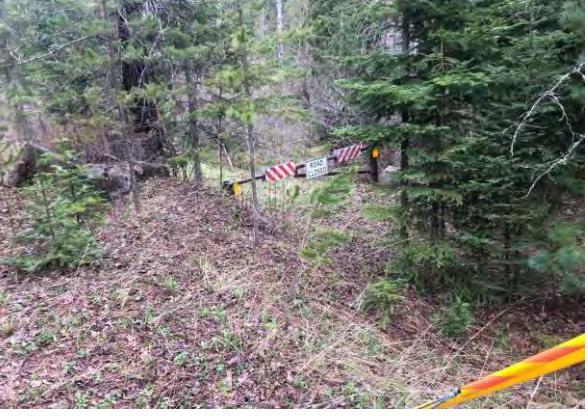
Peripheral access control working as planned.

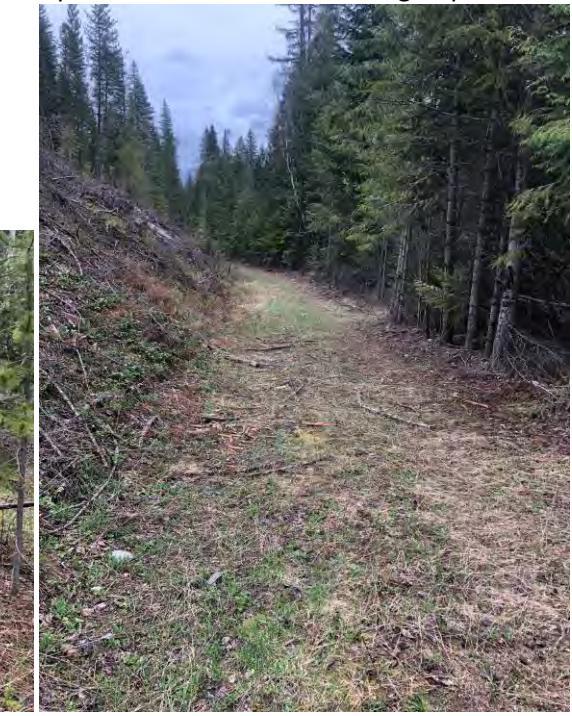
Peripheral access control effective.

Road fully vegetated.

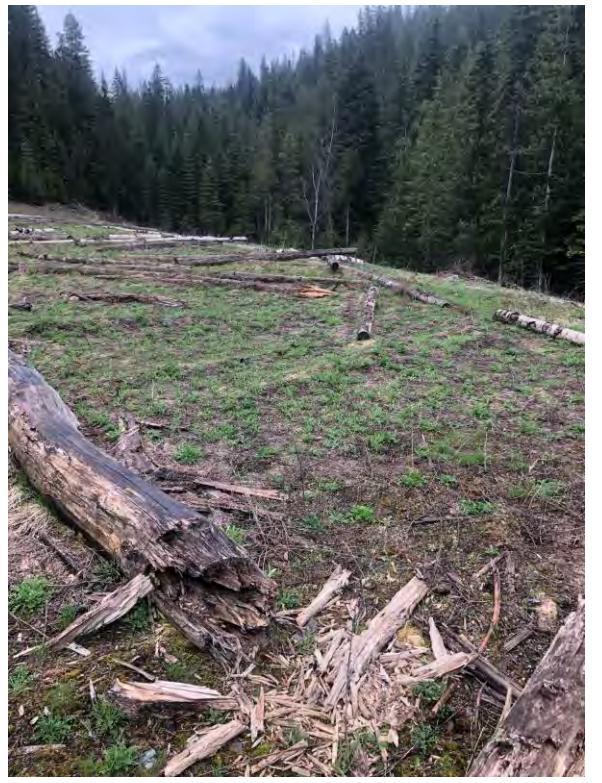
- The repository cap appears stable and has a good vegetative cover dominated by grasses. The logs distributed on the cap to discourage entry are in good physical condition and have not been disturbed since original placement. No erosion or areas with exposed liner were visible, and there was no evidence of mass movement. We did note recent gopher activity on cap and in surrounding area. After lengthy discussion, it was agreed that allowing natural processes to control gopher activity is more favorable than traditional means which would increase the potential to disturb the cap and liner.

Condition of cap, looking east.

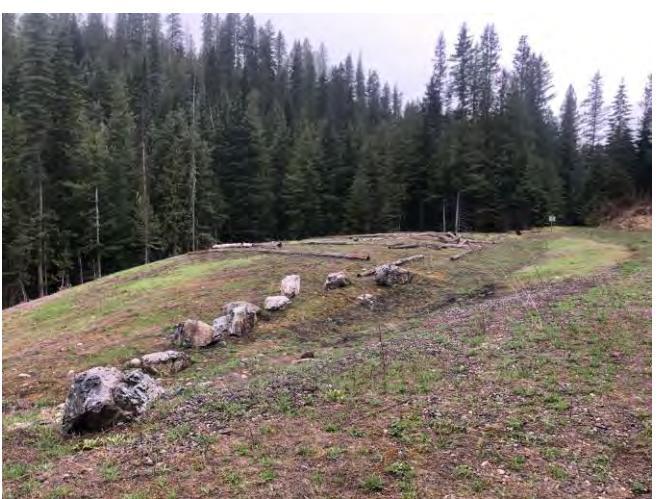
Condition of cap, looking west.

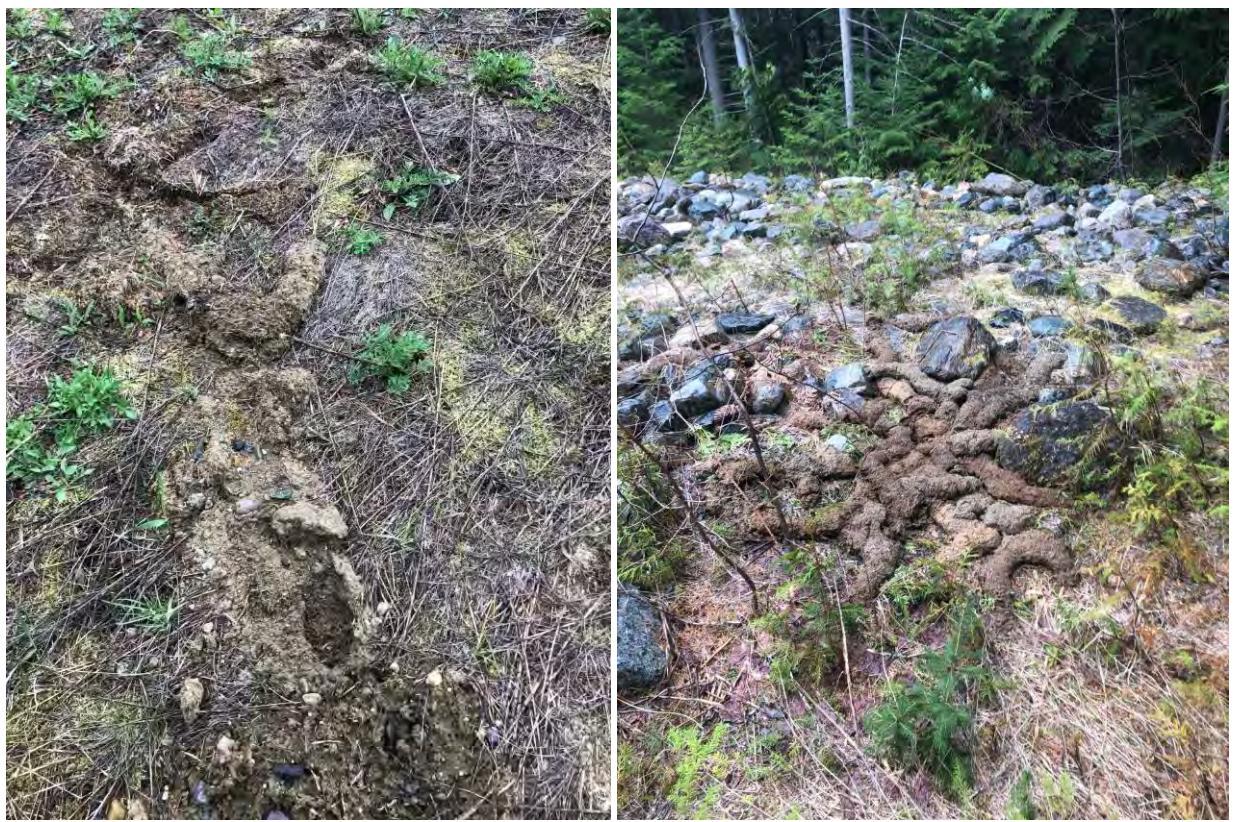
Recent gopher activity on cap.

Recent gopher activity. Bottom of cap.

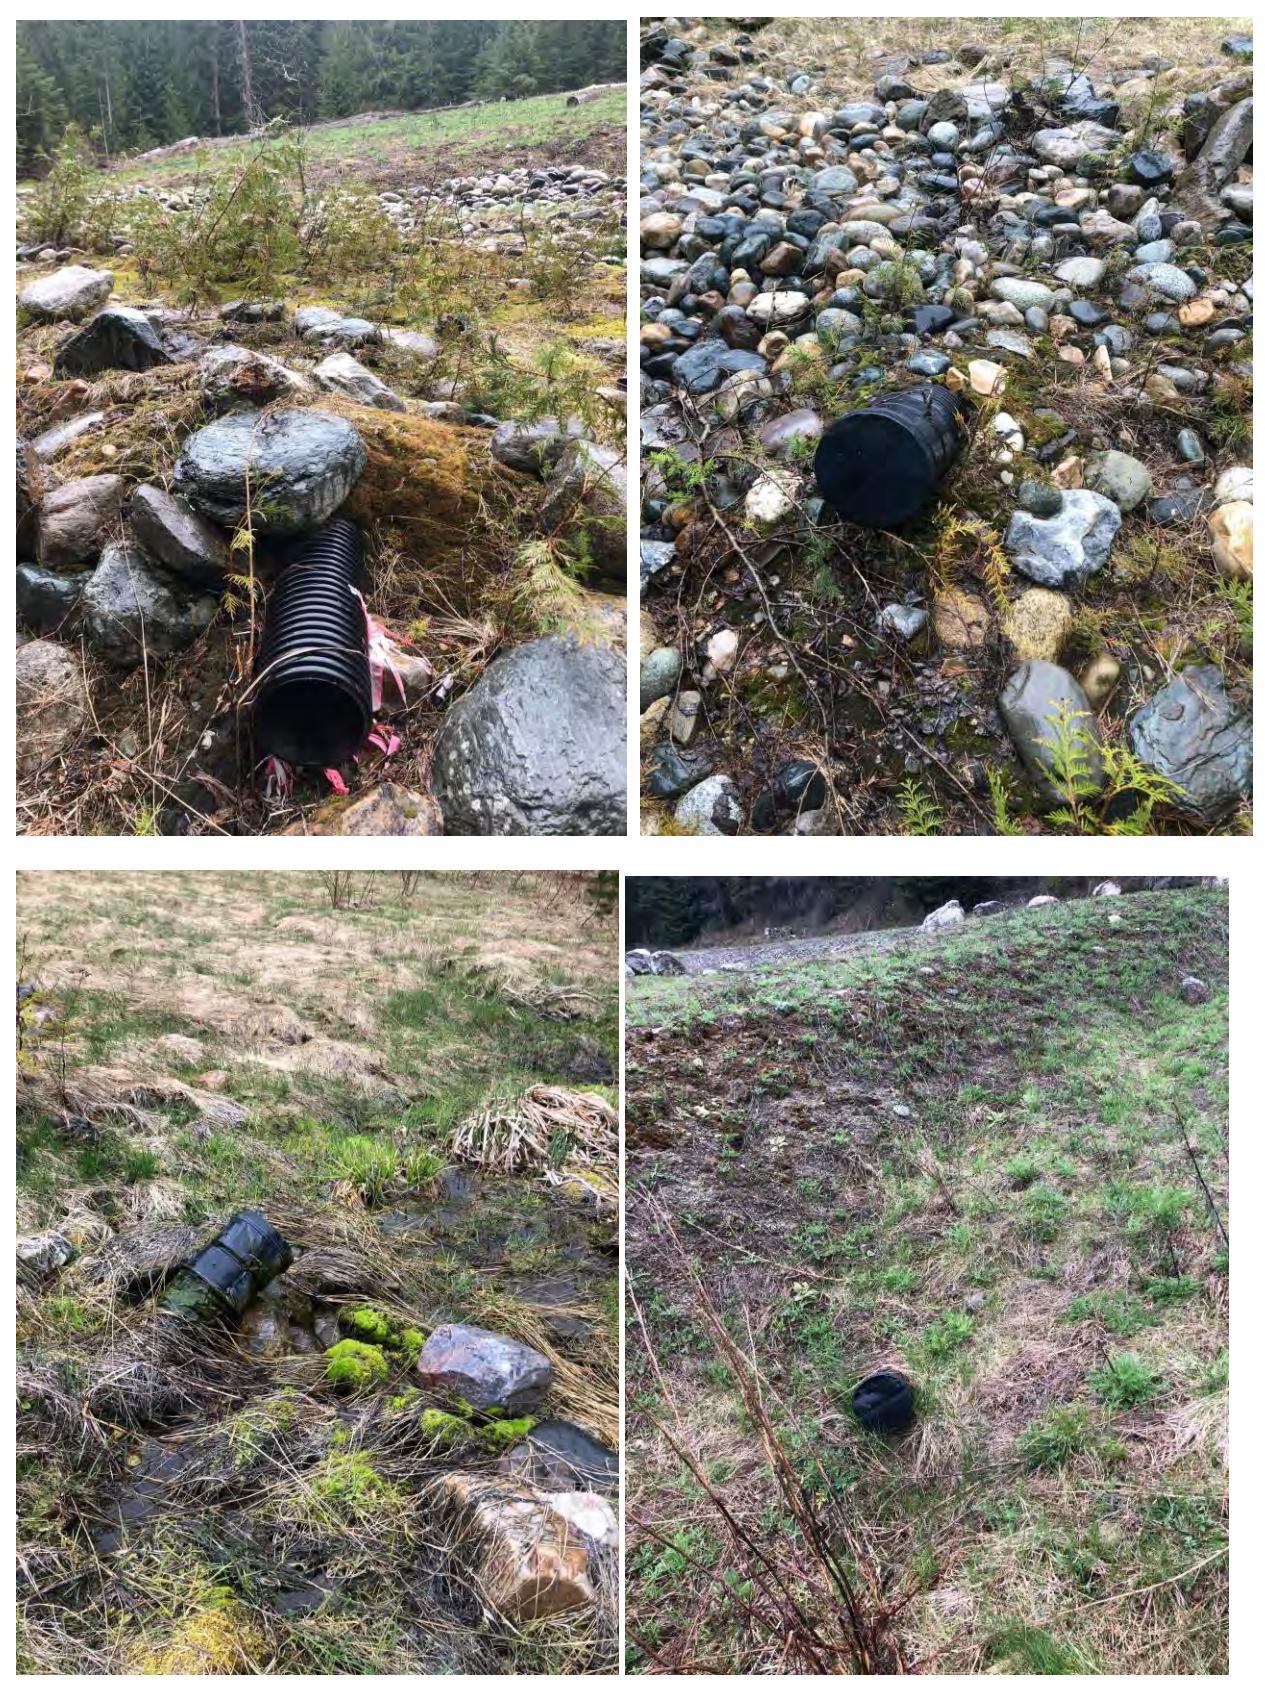
- The underdrain system appeared to be functioning as engineered, and all cleanouts were clear of debris.

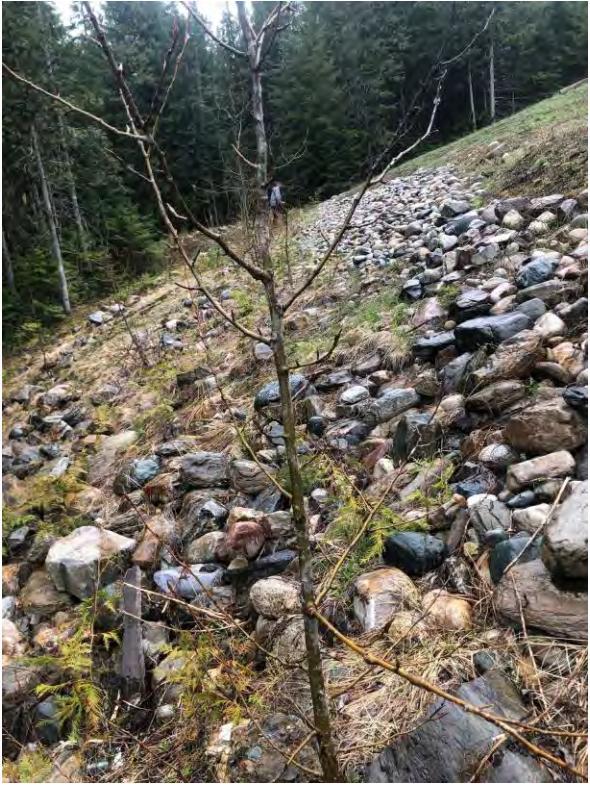
- No visual damage to the system was evident. There continues to be ingrowth of both hardwood and conifer trees and brush in the rip-rap area between repository cap and stream.

Rip-rap area below cap stable and revegetating.

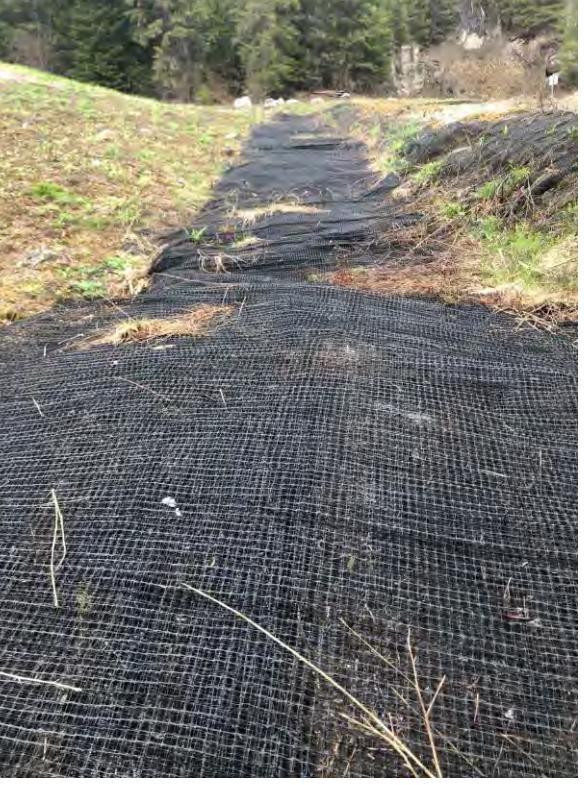
Woven textile on east edge of cap in good condition.

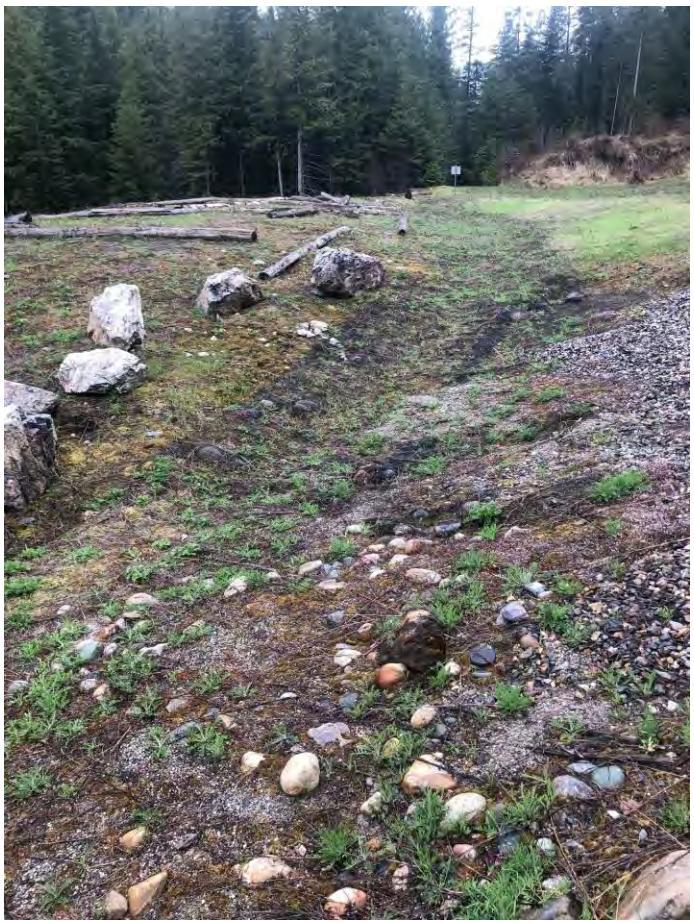
Drainage feature above cap in stable condition, no rutting.
