2024 ANNUAL PROGRESS REPORT SWMU-1 OILY WATER SEWER

HF SINCLAIR PUGET SOUND REFINING LLC

March 2025

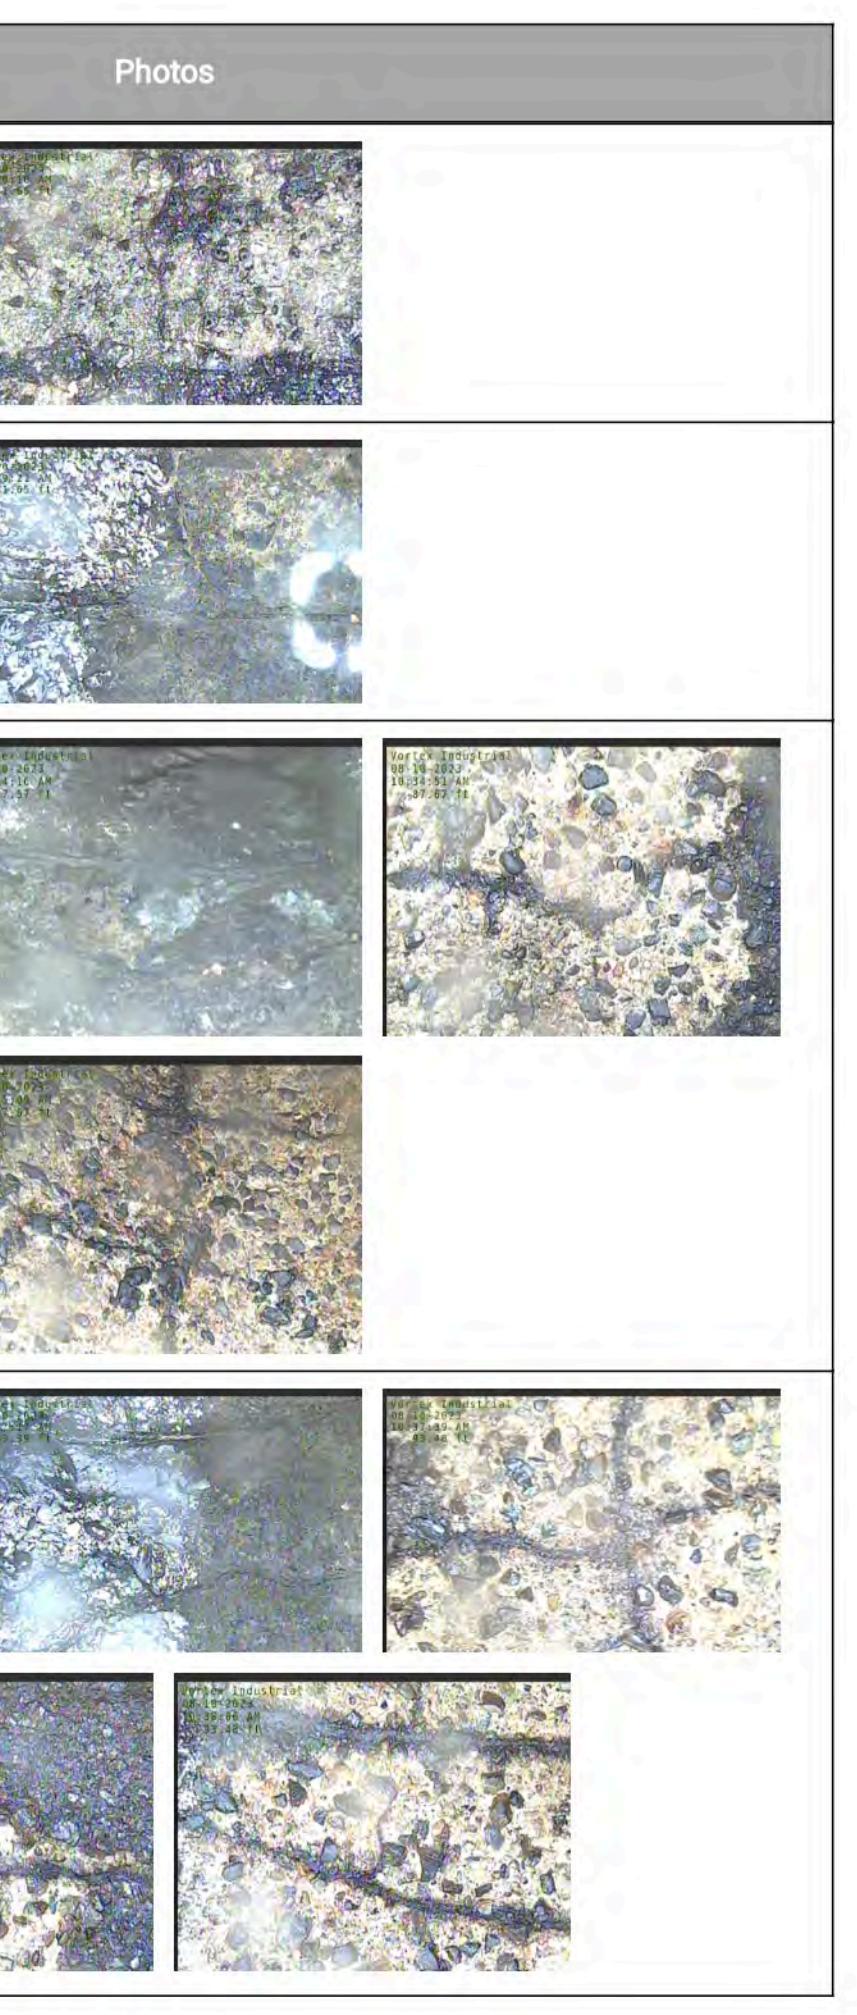
Description	Spatial Type	Distance (ft)	Туре	Percent	Clock	SR	O&M	С	PR	Remarks	
Crack Multiple	Point	99.5	Structural	0	12- 12	3	0	0	2	Crack Multiple	
Crack Multiple	Point	103.7	Structural	0	12- 12	3	0	0	2	Crack Multiple	Image: state stat

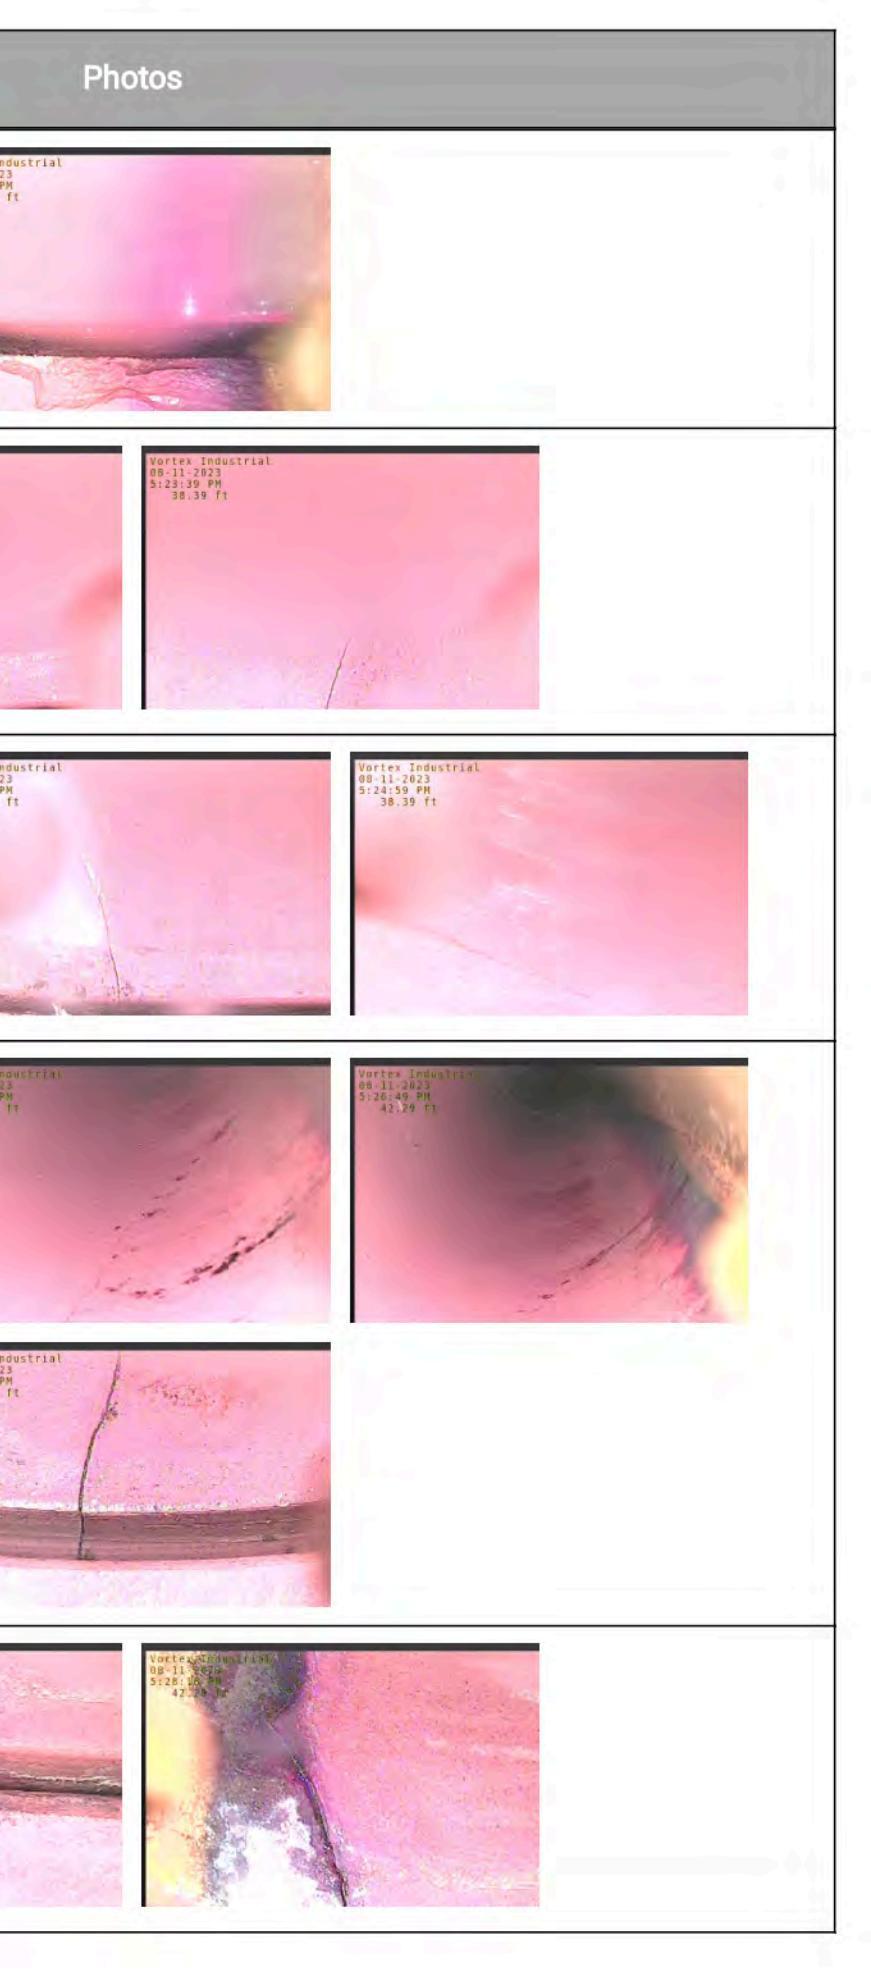
Description	Spatial Type	Distance (ft)	Туре	Percent	Clock	SR	O&M	С	PR	Remarks	
Crack Multiple	Point	46.3	Structural	0	12- 12	3	0	0	2	Crack Multiple	Vortex Industrial 08:11:2023 51:29:27 PN 43:40 Tt Vortex Industrial 08:11:20 44:43 Vortex Industrial 09:11:20 Vortex Industrial 10:11:20 Vortex Industrial 10:11:20
Crack Multiple	Point	50.4	Structural	0	12- 12	3	0	0	2	Crack Multiple	Vortex, Industrial 08-11-203 S13009 PM S0-31 TI S0-31 TI S0-31 TI S0-31 S0-32
Crack Spiral	Point	54	Structural	0	12-5	2	0	0	2	Crack Spiral	Vortex 1 98-11-20 5:38:10 50.70

2023-11	B-1:B-3	50.4	12-12	2	Crack Multiple	over lifetime Normal degradation of pipe	Liner Installed	August-2024	-
2023-11	B-1:B-3	54	12-5	2	Crack Spiral	over lifetime	Liner Installed	August-2024	-

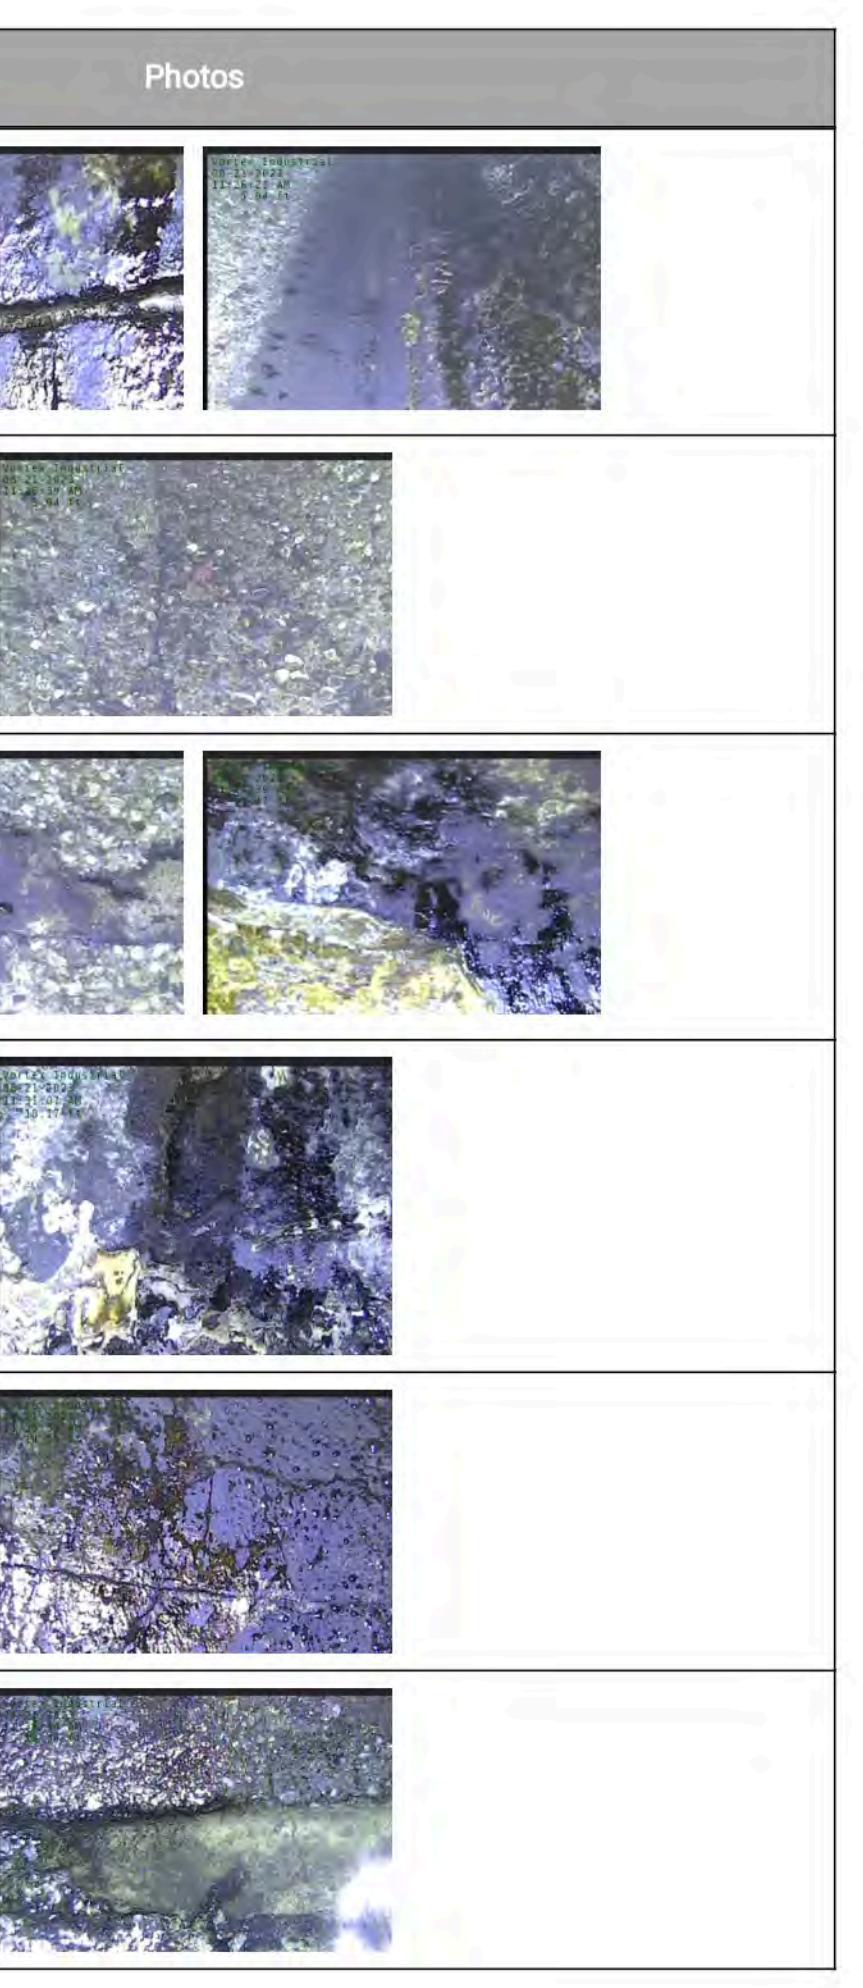
Description	Spatial Type	Distance (ft)	Туре	Percent	Clock	SR	0&M	с	PR	Remarks	
Crack Longitudinal	Point	18.3	Structural	0	8	2	0	0	1	Crack Longitudinal	
Crack Longitudinal	Point	21.5	Structural	0	11	2	0	0	1	Crack Longitudinal	
Surface Damage Reinforcement Visible	Point	25.9	Structural	0	12	4	0	0	2	Surface Damage Reinforcement Visible	
Miscellaneous Water Level	Point	26	Miscellaneous	10		0	0	0	0	Miscellaneous Water Level	
Crack Spiral	Point	35.3	Structural	0	6-7	2	0	0	2	Crack Spiral	
Surface Damage Reinforcement Visible	Point	35.4	Structural	0	10	4	0	0	2	Surface Damage Reinforcement Visible

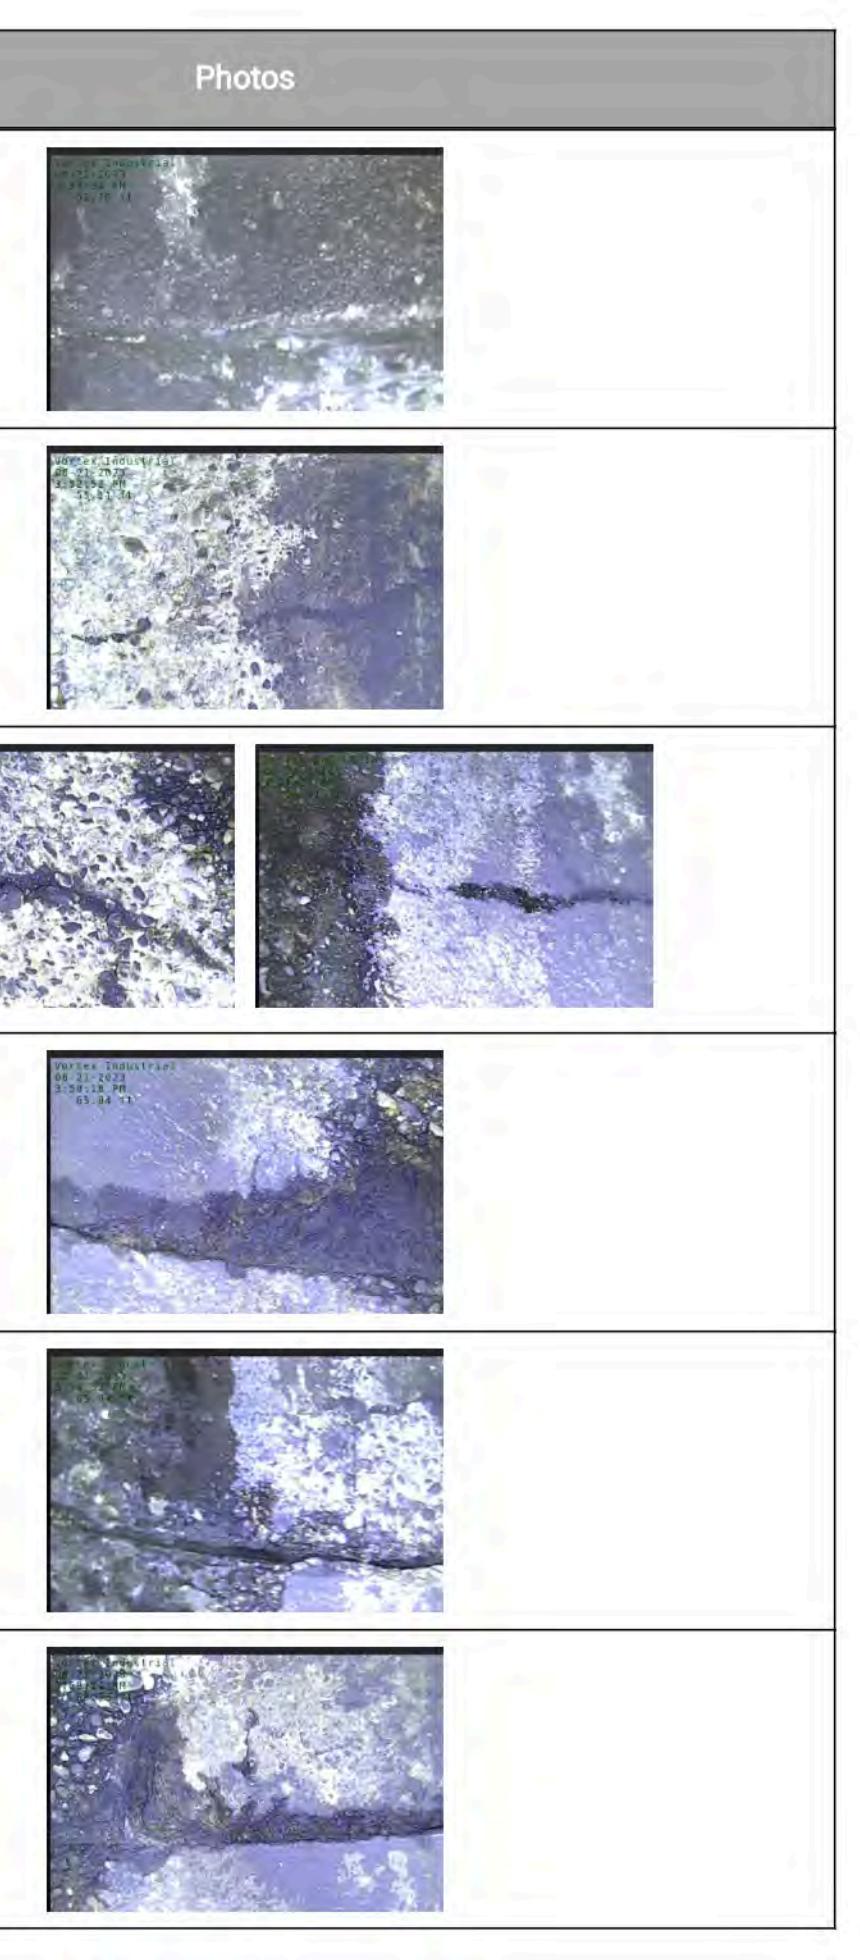
Description	Spatial Type	Distance (ft)	Туре	Percent	Clock	SR	0&M	С	PR	Remarks	
Surface Damage Reinforcement Visible	Point	73.1	Structural	0	10	4	0	0	2	Surface Damage Reinforcement Visible	
Miscellaneous Water Level	Point	73.1	Miscellaneous	10		0	0	0	0	Miscellaneous Water Level	
Crack Circumferential	Point	77.3	Structural	0	5-6	1	0	0	2	Crack Circumferential	947144 204021-13. 88.83742023 87.84.85 90 27.22 **
Crack Longitudinal	Point	77.3	Structural	0	4	2	0	0	1	Crack Longitudinal	
Crack Longitudinal	Point	81.3	Structural	0	8	2	0	0	1	Crack Longitudinal

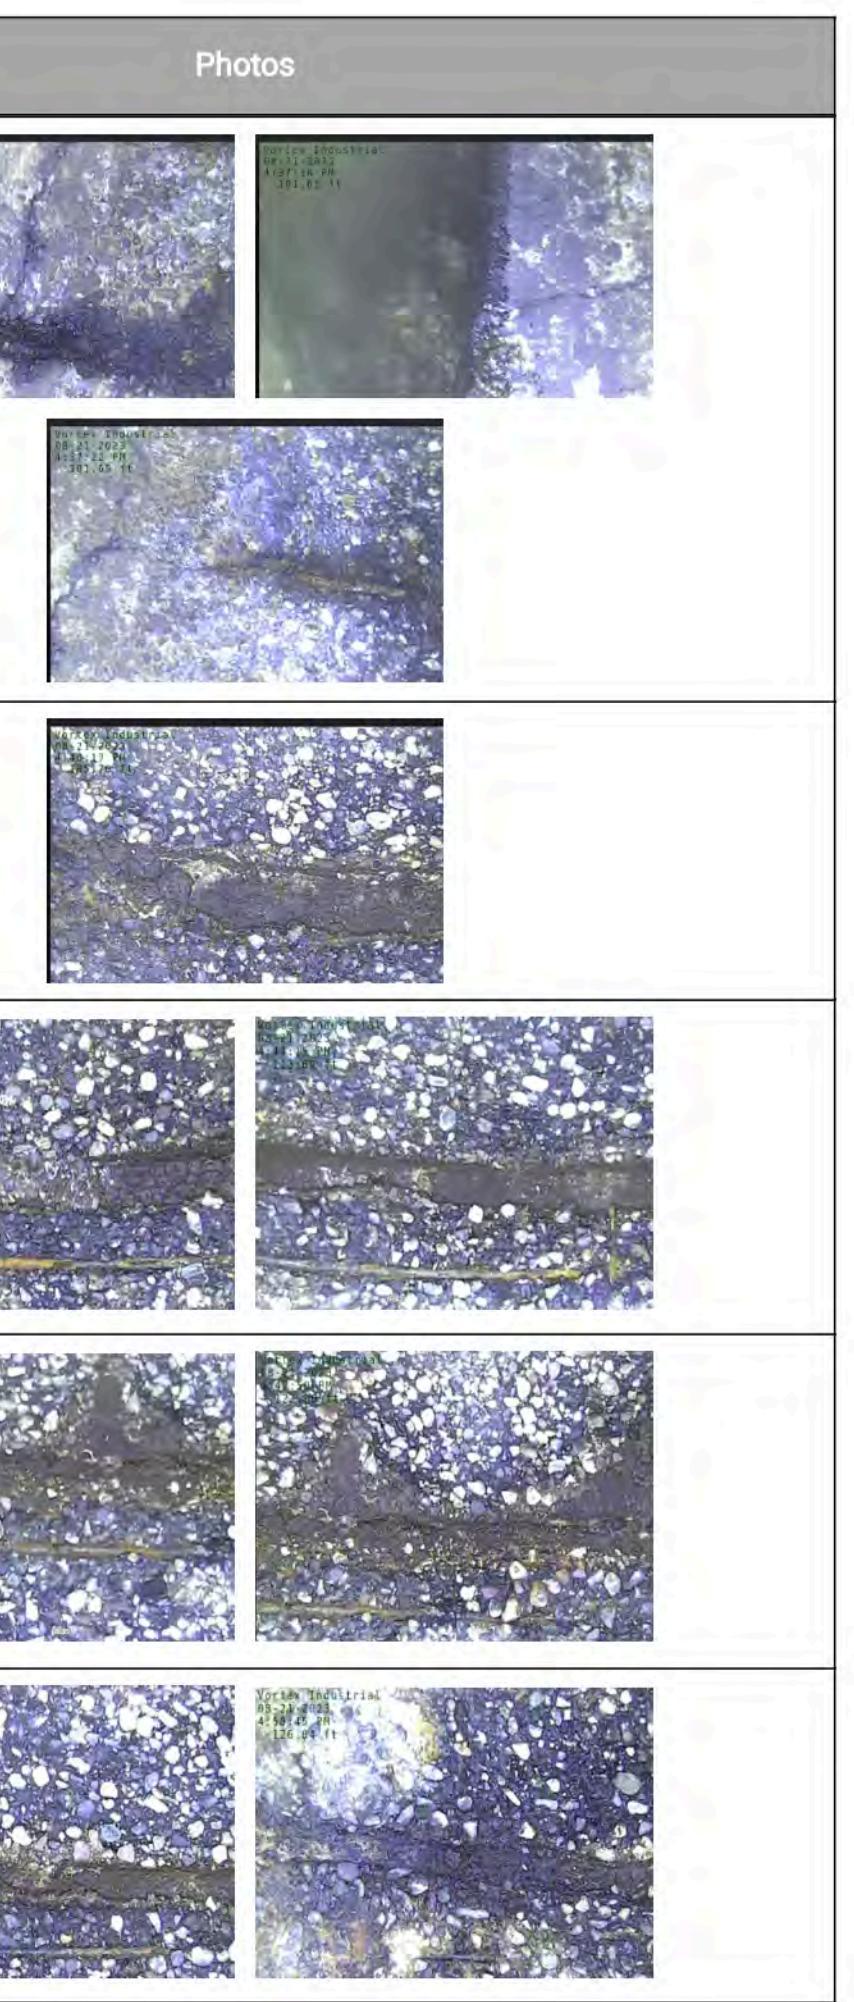
Description	Spatial Type	Distance (ft)	Туре	Percent	Clock	SR	O&M	С	PR	Remarks	Saa
Surface Damage Reinforcement Visible	Point	130.1	Structural	0	5-7	4	0	0	2	Surface Damage Reinforcement Visible	
Surface Damage Reinforcement Visible	Point	134.2	Structural	0	1-4	4	0	0	2	Surface Damage Reinforcement Visible	
Surface Damage Reinforcement Visible	Point	138.3	Structural	0	2-4	4	0	0	2	Surface Damage Reinforcement Visible	
Crack Longitudinal	Point	146.4	Structural	0	2	2	0	0	2	Crack Longitudinal

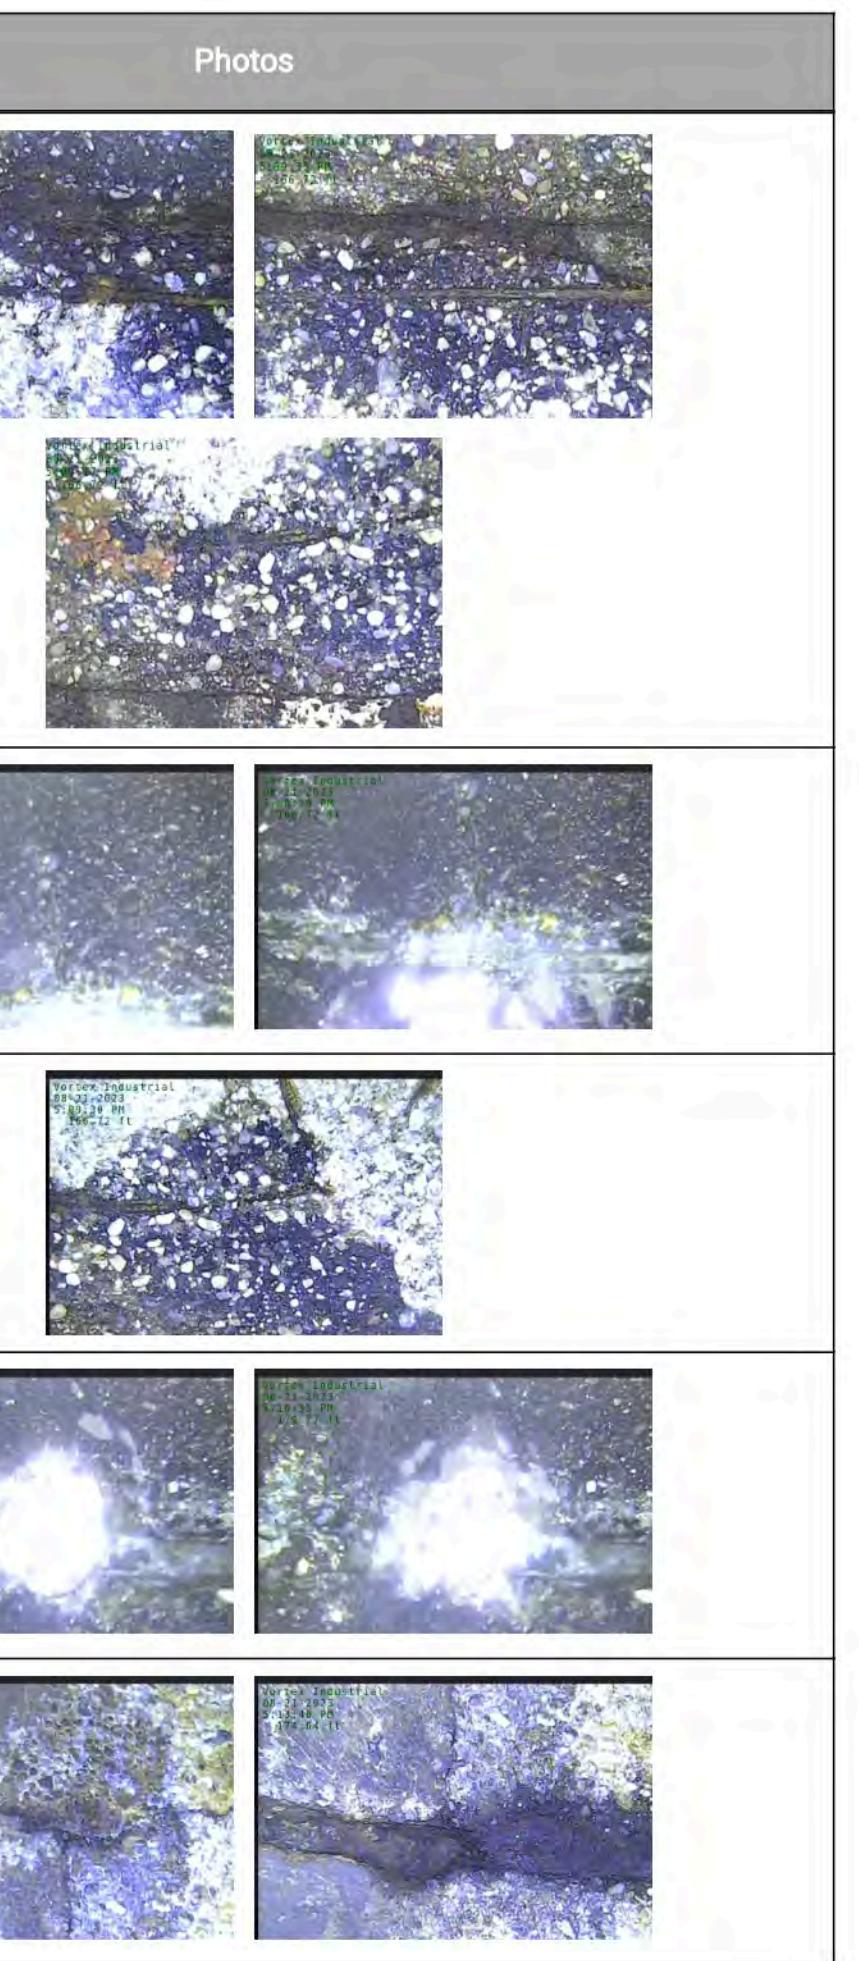
Description	Spatial Type	Distance (ft)	Туре	Percent	Clock	SR	O&M	С	PR	Remarks	
Surface Damage Reinforcement Visible	Point	178.8	Structural	0	7-10	4	0	0	2	Surface Damage Reinforcement Visible	
Crack Multiple	Point	182.9	Structural	0	4-5	3	0	0	2	Crack Multiple	
Crack Longitudinal	Point	187	Structural	0	4	2	0	0	1	Crack Longitudinal	
Crack Circumferential	Point	187	Structural	0	3-4	1	0	0	1	Crack Circumferential	
Surface Damage Reinforcement Visible	Point	191	Structural	0	7-10	4	0	0	2	Surface Damage Reinforcement Visible

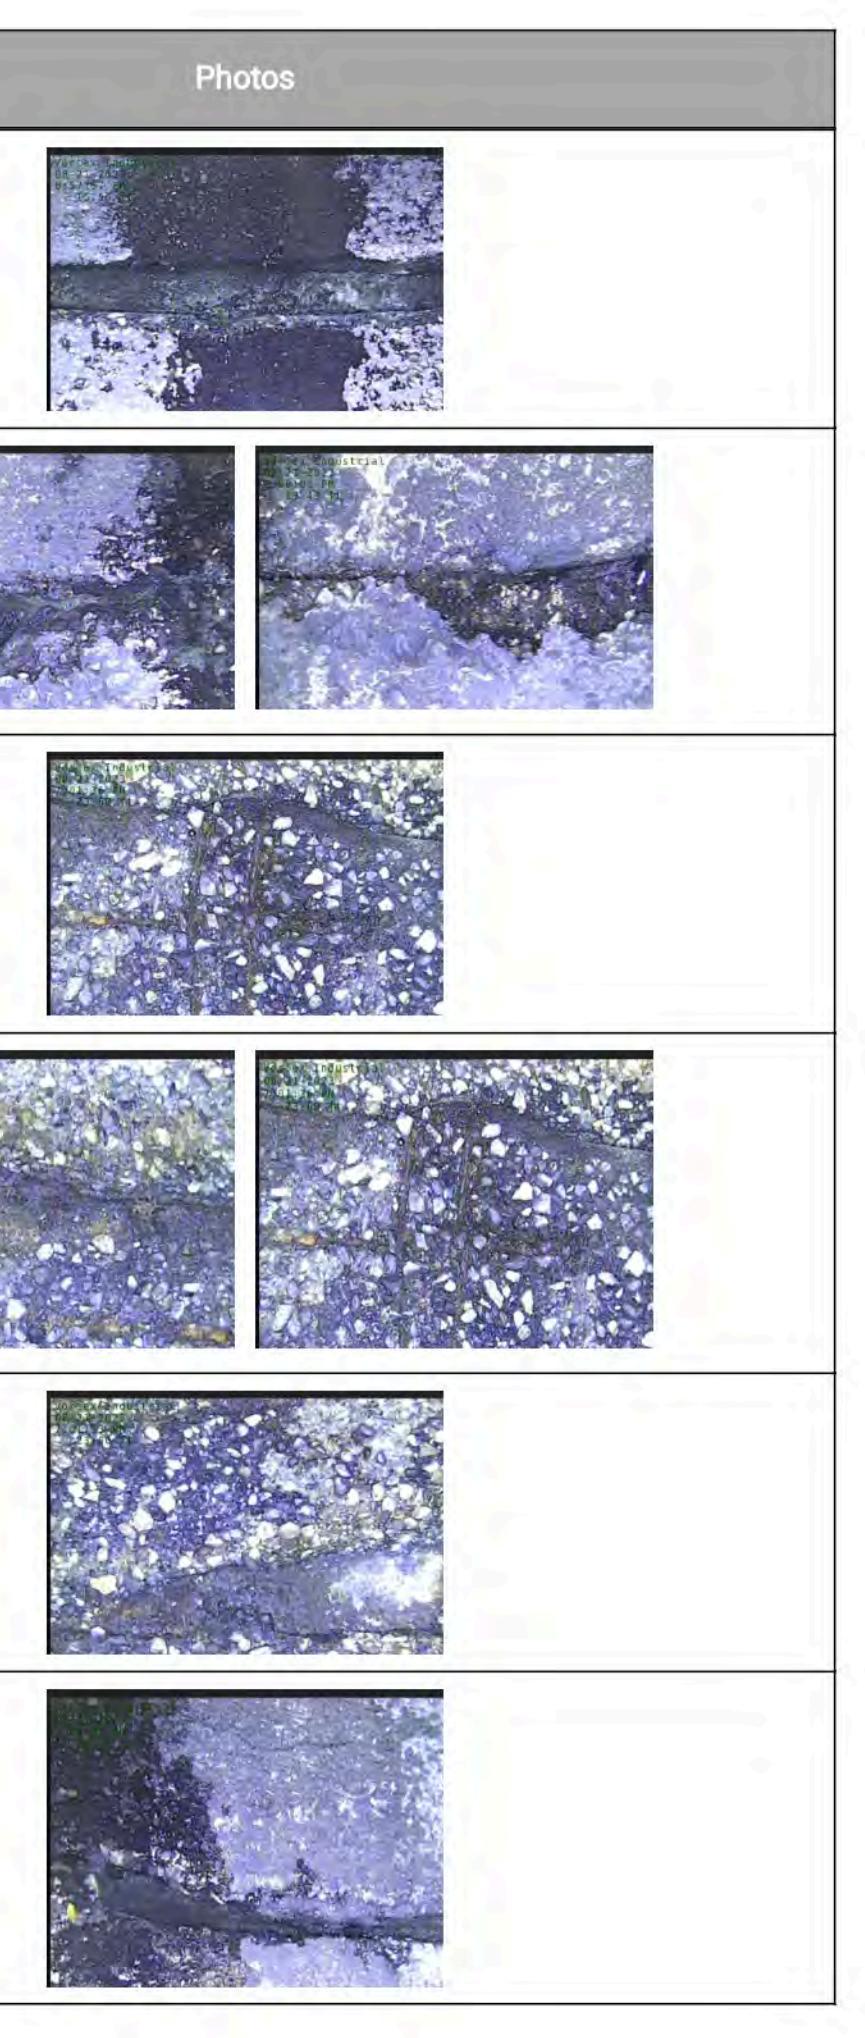
Description	Spatial Type	Distance (ft)	Туре	Percent	Clock	SR	O&M	С	PR	Remarks	
Fracture Circumferential	Point	26.2	Structural	0	2-3	2	0	0	2	Fracture Circumferential	
Surface Damage Reinforcement Visible	Point	38.4	Structural	0	8	4	0	0	2	Surface Damage Reinforcement Visible	
Crack Longitudinal	Point	43.2	Structural	0	6	2	0	0	2	Crack Longitudinal	
Miscellaneous Water Level	Point	47.5	Miscellaneous	10		0	0	0	0	Miscellaneous Water Level	
Surface Damage Reinforcement Visible	Point	48.2	Structural	0	4	4	0	0	2	Surface Damage Reinforcement Visible	
Crack Circumferential	Point	51.3	Structural	0	3-5	1	0	0	1	Crack Circumferential	100-00 1000/0010 99-00-00 97-014-00 51-20-50

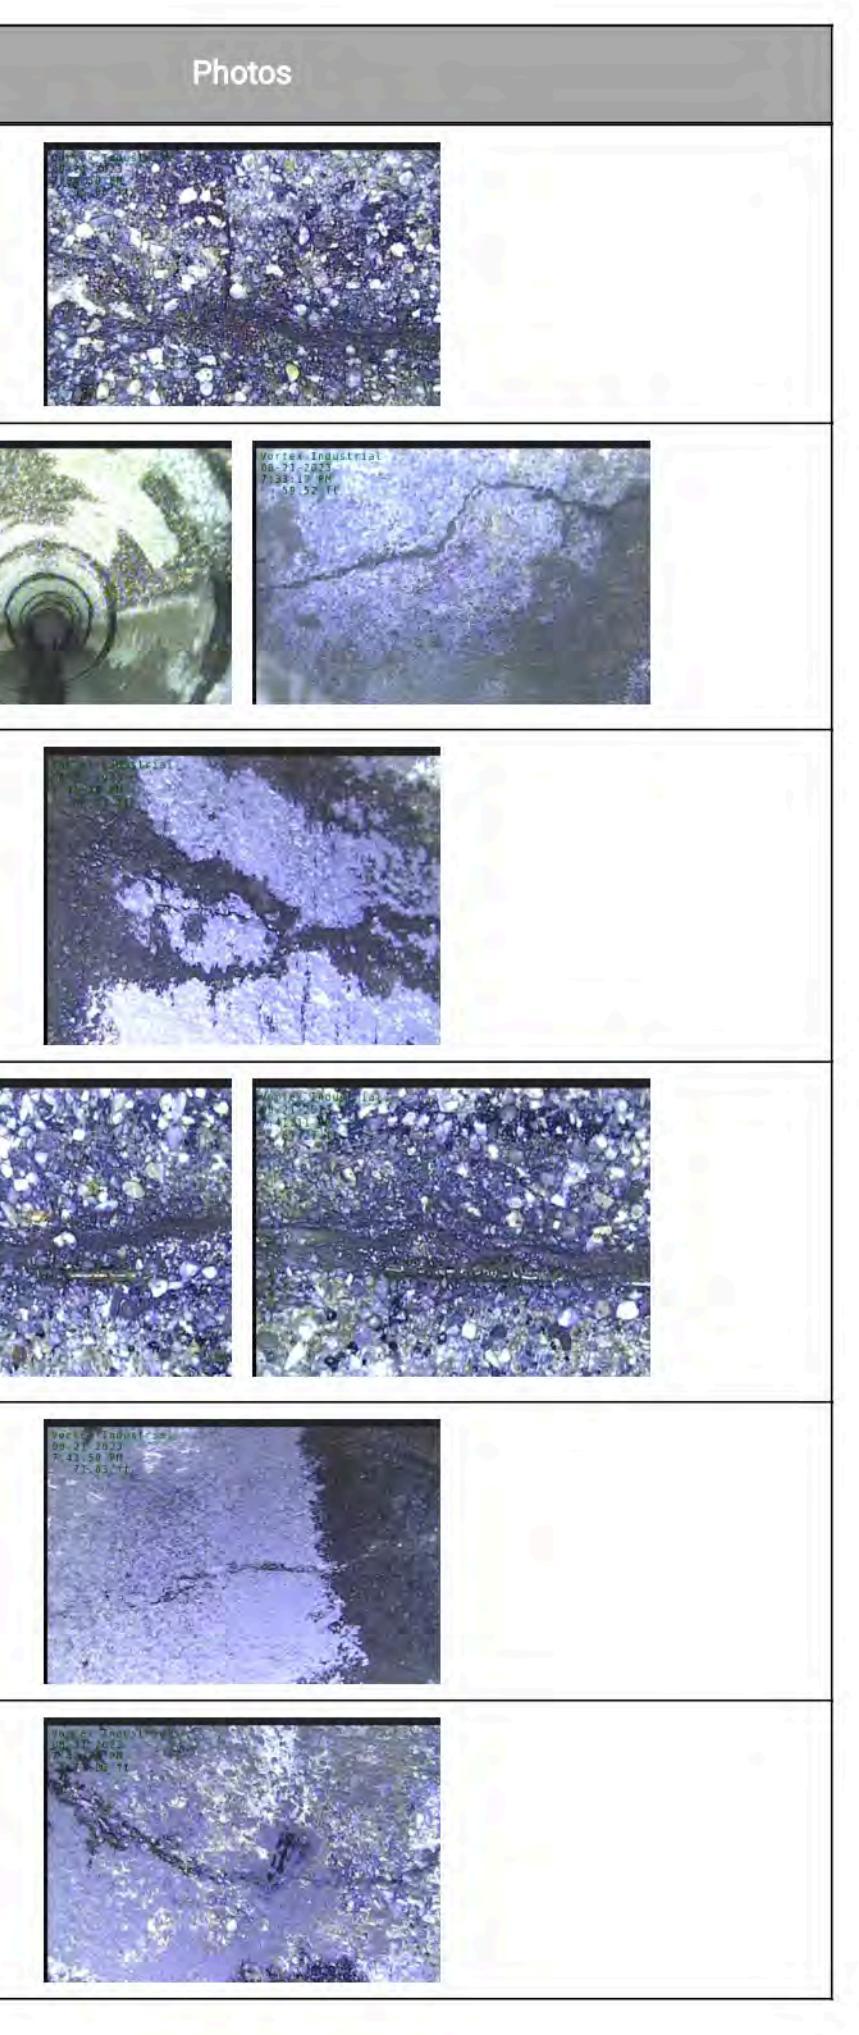
Description	Spatial Type	Distance (ft)	Туре	Percent	Clock	SR	O&M	С	PR	Remarks	
Surface Damage Reinforcement Visible	Point	71.8	Structural	0	3	4	0	0	2	Surface Damage Reinforcement Visible	
Surface Damage Reinforcement Visible	Point	79.5	Structural	0	2-4	4	0	0	2	Surface Damage Reinforcement Visible	
Surface Damage Reinforcement Visible	Point	87.9	Structural	0	10	4	0	0	2	Surface Damage Reinforcement Visible	
Manhole	Point	89.5	Constructional	0		0	0	0	0	5-E

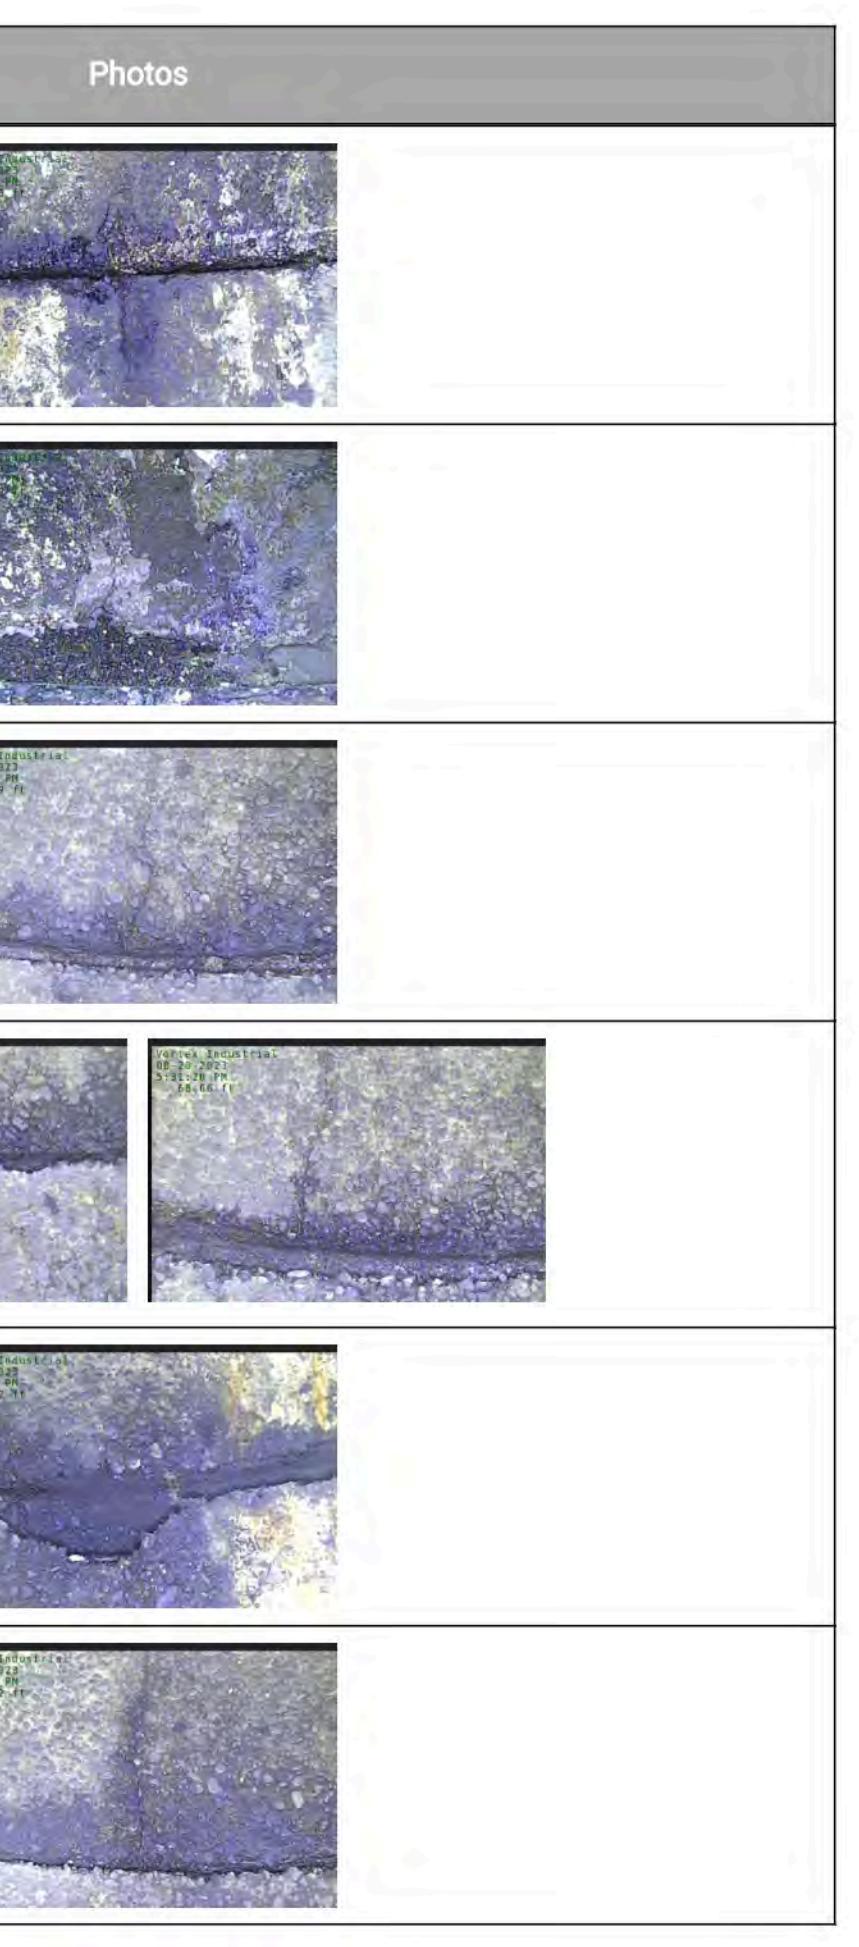
Description	Spatial Type	Distance (ft)	Туре	Percent	Clock	SR	O&M	С	PR	Remarks	
Crack Longitudinal	Point	72.6	Structural	0	2	2	0	0	2	Crack Longitudinal	
Crack Circumferential	Point	73	Structural	0	3-9	1	0	0	2	Crack Circumferential	
Crack Longitudinal	Point	76.7	Structural	0	12	2	0	0	1	Crack Longitudinal	00-fte 4 08-34: 3-7 76- 3-7 76
Crack Circumferential	Point	76.7	Structural	0	6-9	1	0	0	2	Crack Circumferential	
Fracture Circumferential	Point	80.7	Structural	0	4-5	2	0	0	2	Fracture Circumferential

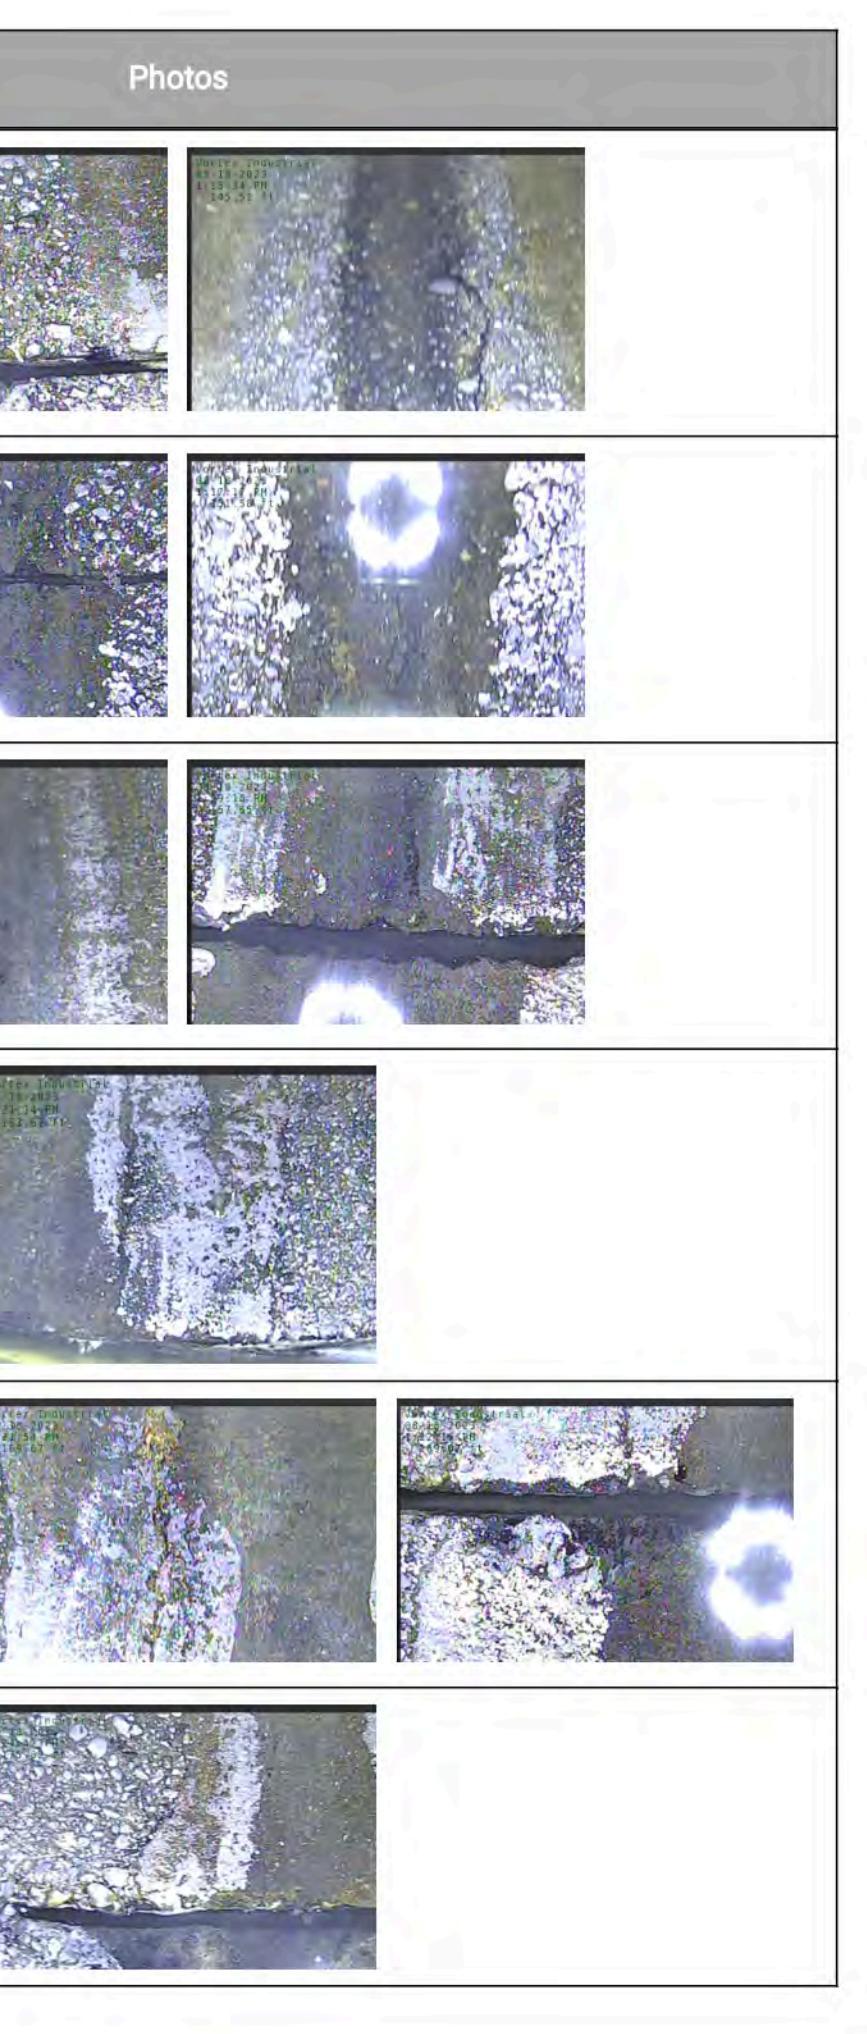
Description	Spatial Type	Distance (ft)	Туре	Percent	Clock	SR	O&M	С	PR	Remarks	
Fracture Circumferential	Point	175.6	Structural	0	6-7	2	0	0	2	Fracture Circumferential	
Crack Circumferential	Point	188	Structural	0	5-7	1	0	0	1	Crack Circumferential	
Crack Longitudinal	Point	199.9	Structural	0	6	2	0	0	1	Crack Longitudinal	
Crack Multiple	Point	224	Structural	0	6-7	3	0	0	1	Crack Multiple	Worther ID Guist CLAI WART ID GUIST CLAI No LLA ST AN AD LLA ST AN AD LLA ST AN AD LLA ST AN AD LLA ST AN AD
Crack Longitudinal	Point	225.5	Structural	0	6	2	0	0	2	Crack Longitudinal	June fene Junuit, sed nyf. Bergerige 1932 fan sjer 1935 fa
Crack Longitudinal	Point	229.9	Structural	0	6	2	0	0	1	Crack Longitudinal
