Aladdin Plating Site Groundwater Monitoring Results, 2024: Data Summary Report

Environmental Assessment Program

Publication 25-03-022

December 2025

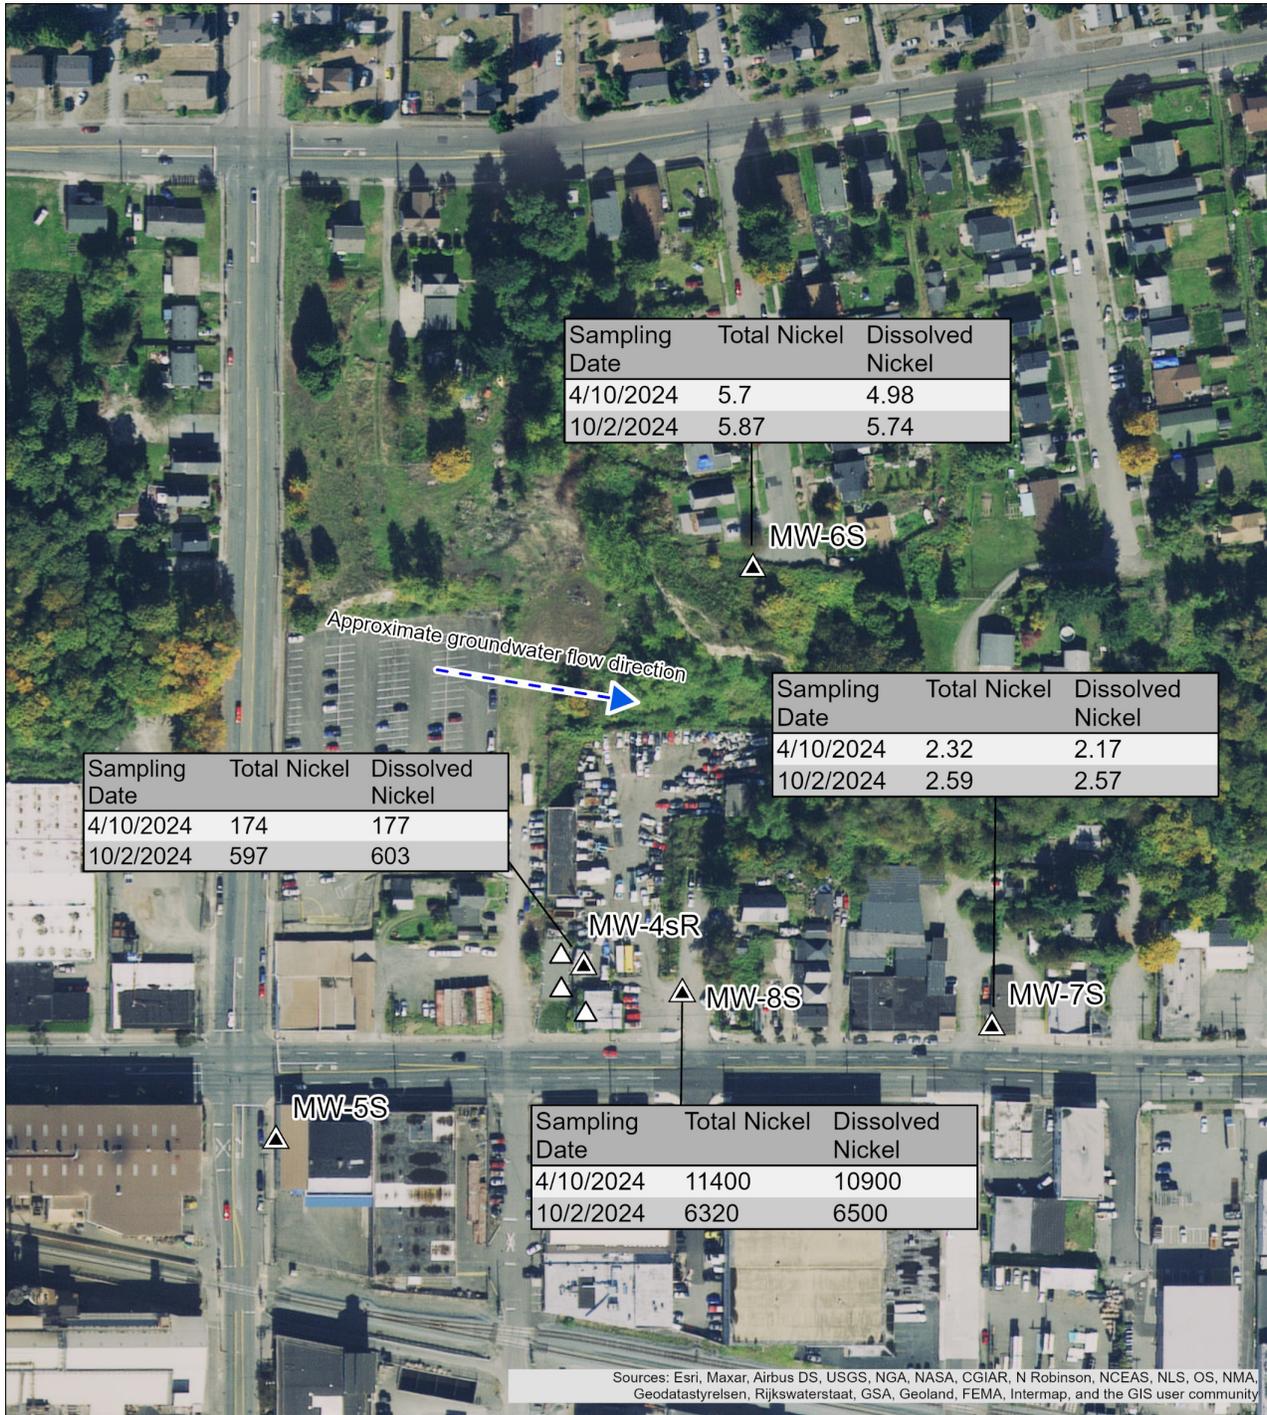
Figure 4. Total and Dissolved Nickel Concentrations (µg/L) in 2024

Analytical data from samples collected during April and October 2024 indicate that the near-surface aquifer at the former Aladdin Plating site continues to be impacted by nickel contamination far above the 320 µg/L MTCA cleanup level (WAC 173-340-720). Total and dissolved nickel concentrations in wells MW-4sR and MW-8s are higher than (not meeting) applicable cleanup levels, representing near-source and downgradient contamination, respectively.

- Semi-annual groundwater monitoring events should continue as scheduled due to nickel concentrations which continue to exceed (not meet) established cleanup levels. Analytical results from these sampling events indicate that source removal of impacted soil onsite has reduced concentrations of chromium and nickel in the near-surface aquifer, however, further semi-annual monitoring is necessary to confirm that these concentrations continue to naturally attenuate towards cleanup goals.

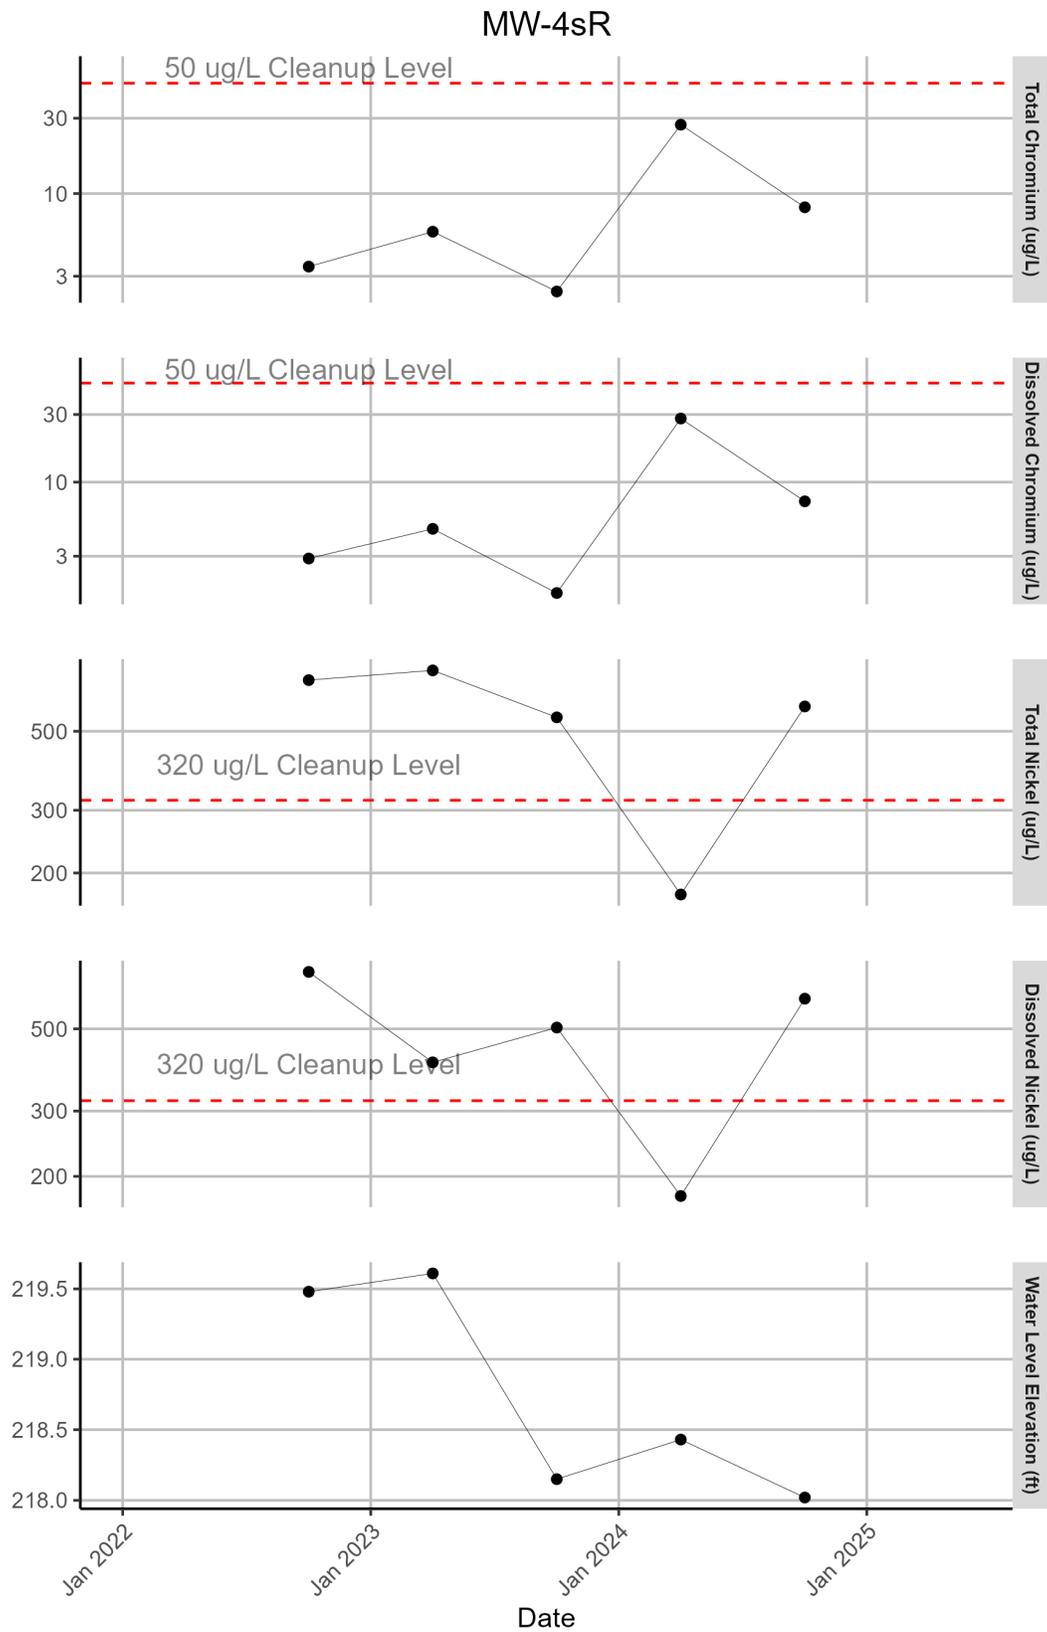
Figure 5. MW-4sR contaminant concentrations (log scale) and groundwater elevations (ft NVGD29) for 2022 – 2024

Well MW-4sR is in the footprint of the 2018 excavation and placed near the former location of wells MW-4s and MW-4d. Concentrations of total and dissolved nickel in this well during April 2024 were below the applicable cleanup levels of 320 µg/L as specified in the CAP (GeoEngineers 2014b, WAC 173-340-740). Total and dissolved nickel exceeded the cleanup level during October 2024, with reported concentrations of 597 µg/L and 603 µg/L, respectively. Nickel results in MW-4sR indicate a decrease in concentrations following the 2018 soil excavation, where initial post-excavation nickel concentrations were reported as high as 2,700 µg/L. Recent nickel concentrations are within the range of reported concentrations during Ecology's monitoring at the site (Figure 5). Chromium concentrations in well MW-4sR were below the cleanup levels of 50 µg/L during both sampling events in 2024. There is an apparent seasonal trend in chromium concentrations in MW-4sR, with concentrations higher in the spring than in fall (Figure 5).

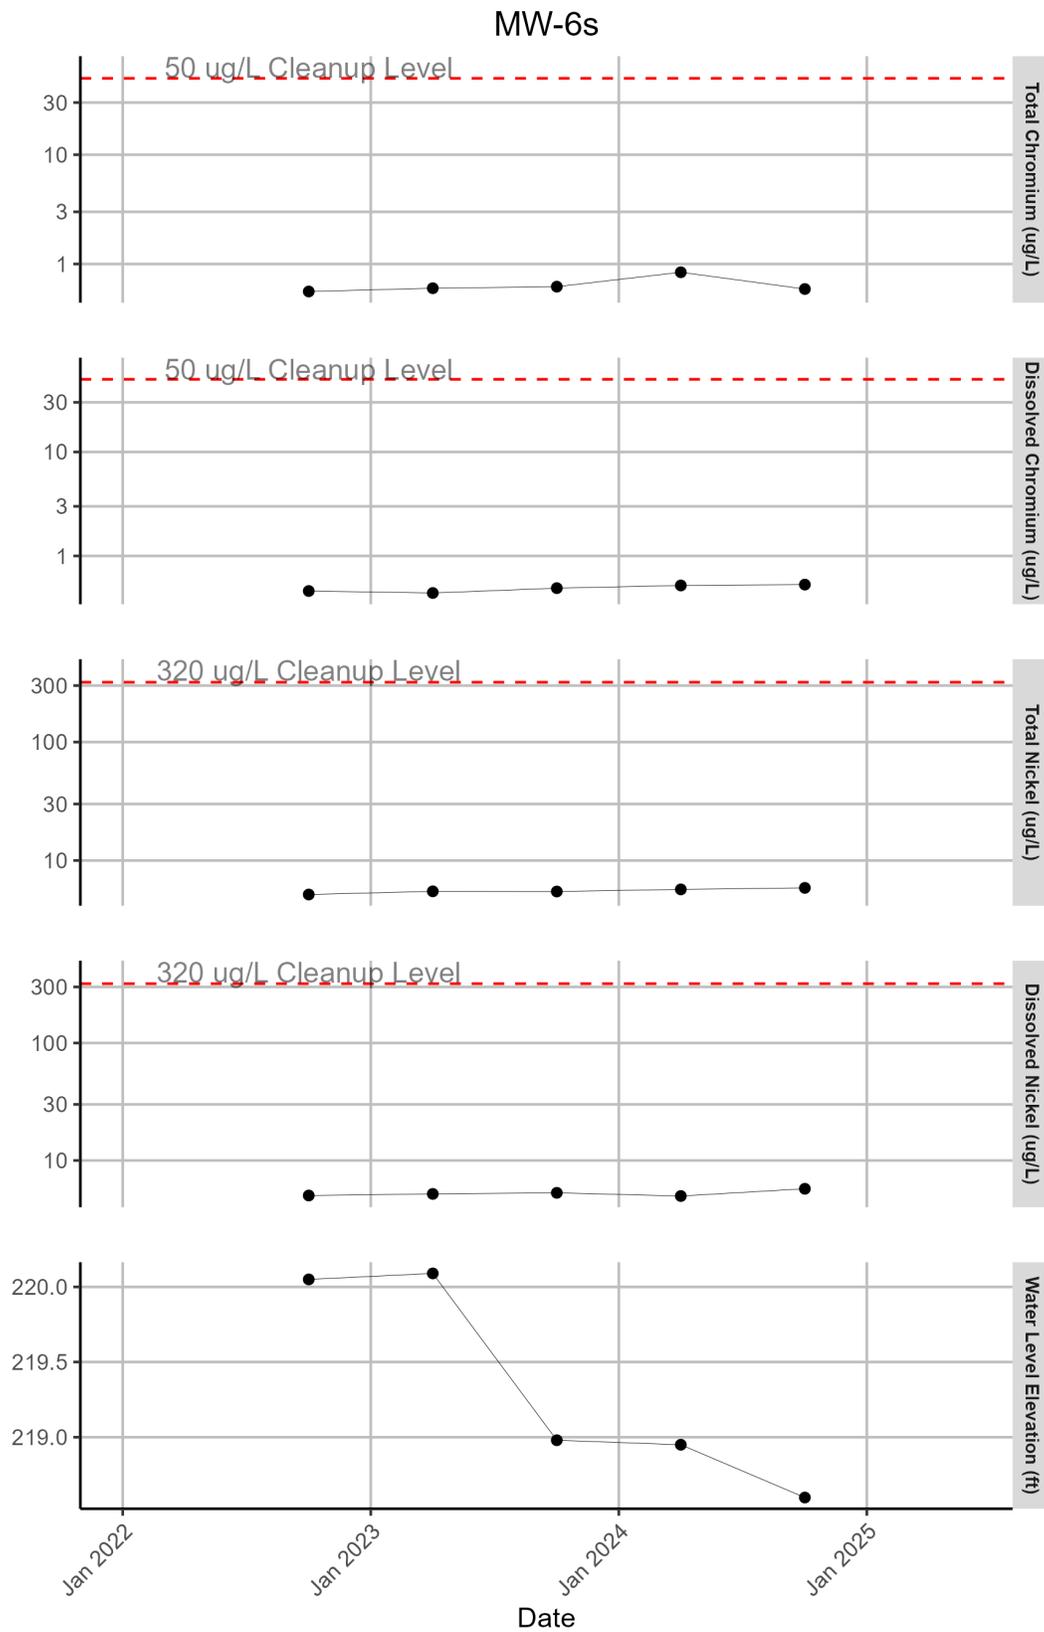
Figure 6. MW-6s contaminant concentrations (log scale) and groundwater elevations (ft NVGD29) for 2022 – 2024

Well MW-6s is located atop a bluff approximately 470 feet from and crossgradient to well MW-4sR. Chromium and nickel concentrations in well MW-6s were far below their respective cleanup levels during all sampling events. Contaminant concentrations in MW-6s have been relatively stable throughout Ecology's monitoring at the site (Figure 6).

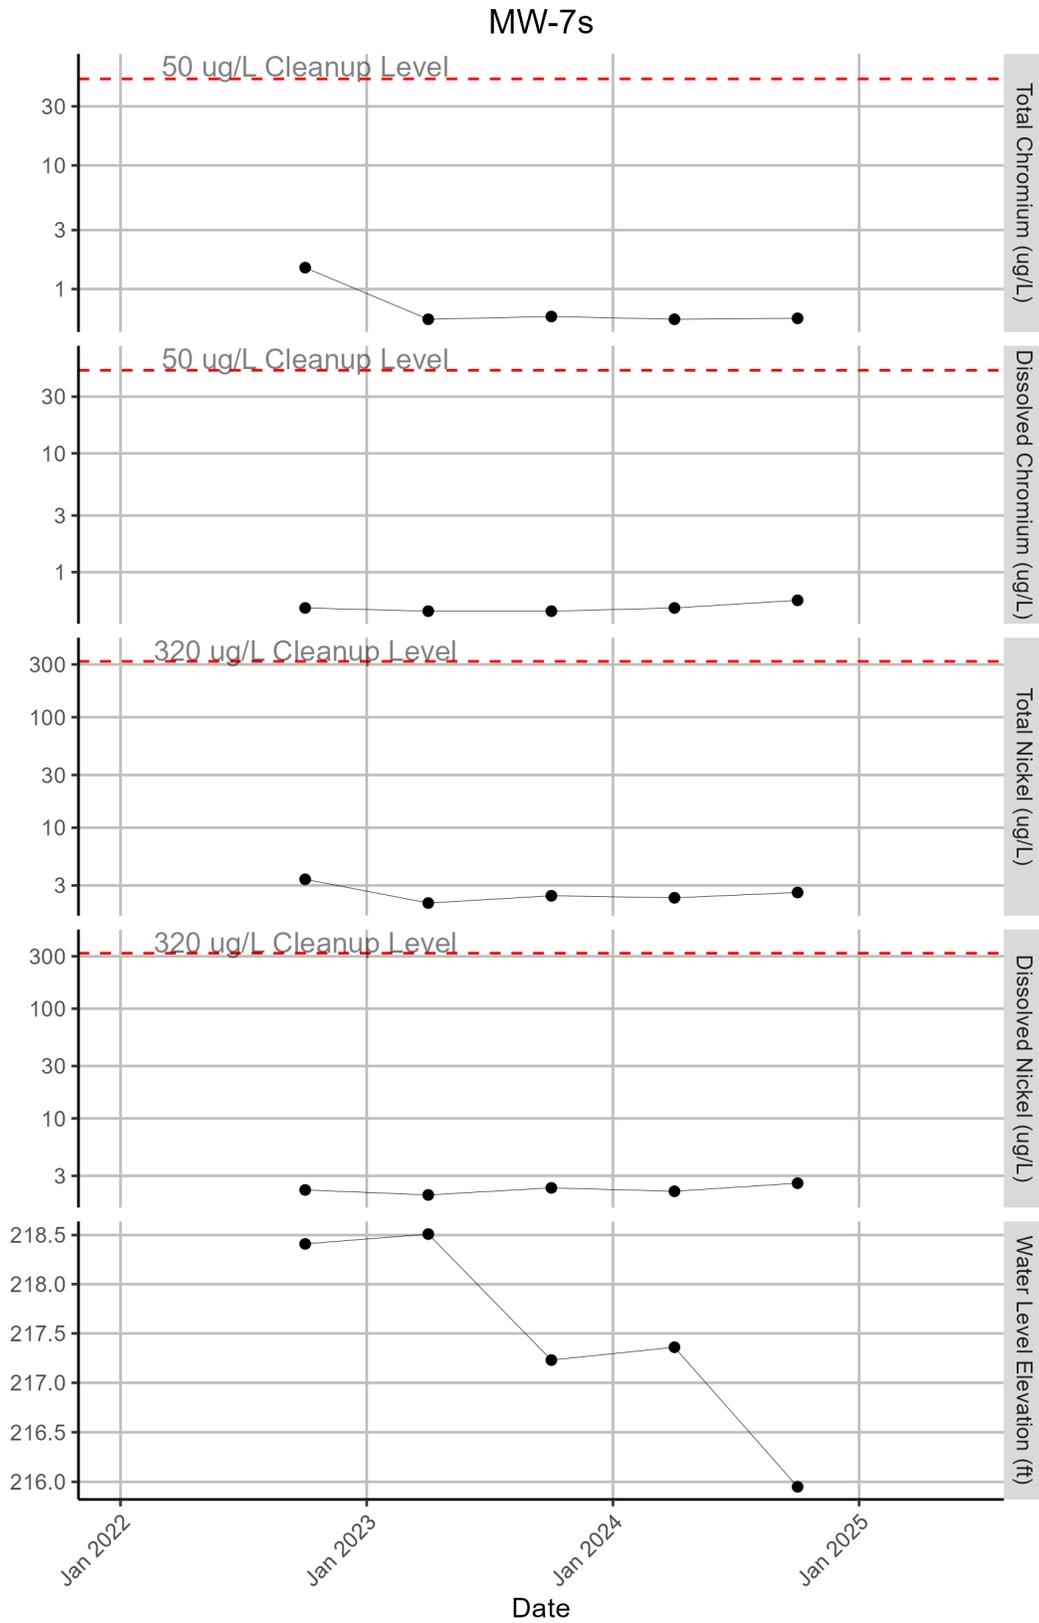
Figure 7. MW-7s contaminant concentrations (log scale) and groundwater elevations (ft NVGD29) for 2022 – 2024

Well MW-7s is located approximately 450 feet downgradient of well MW-4sR. Well construction details are similar to MW-4sR and MW-8s, however, MW-7s is screened three feet deeper (Table 1). Chromium and nickel concentrations in samples collected from well MW-7s during all sampling events were far below their respective cleanup levels. Contaminant levels in MW-7s have remained relatively stable throughout Ecology's monitoring at the site (Figure 7).

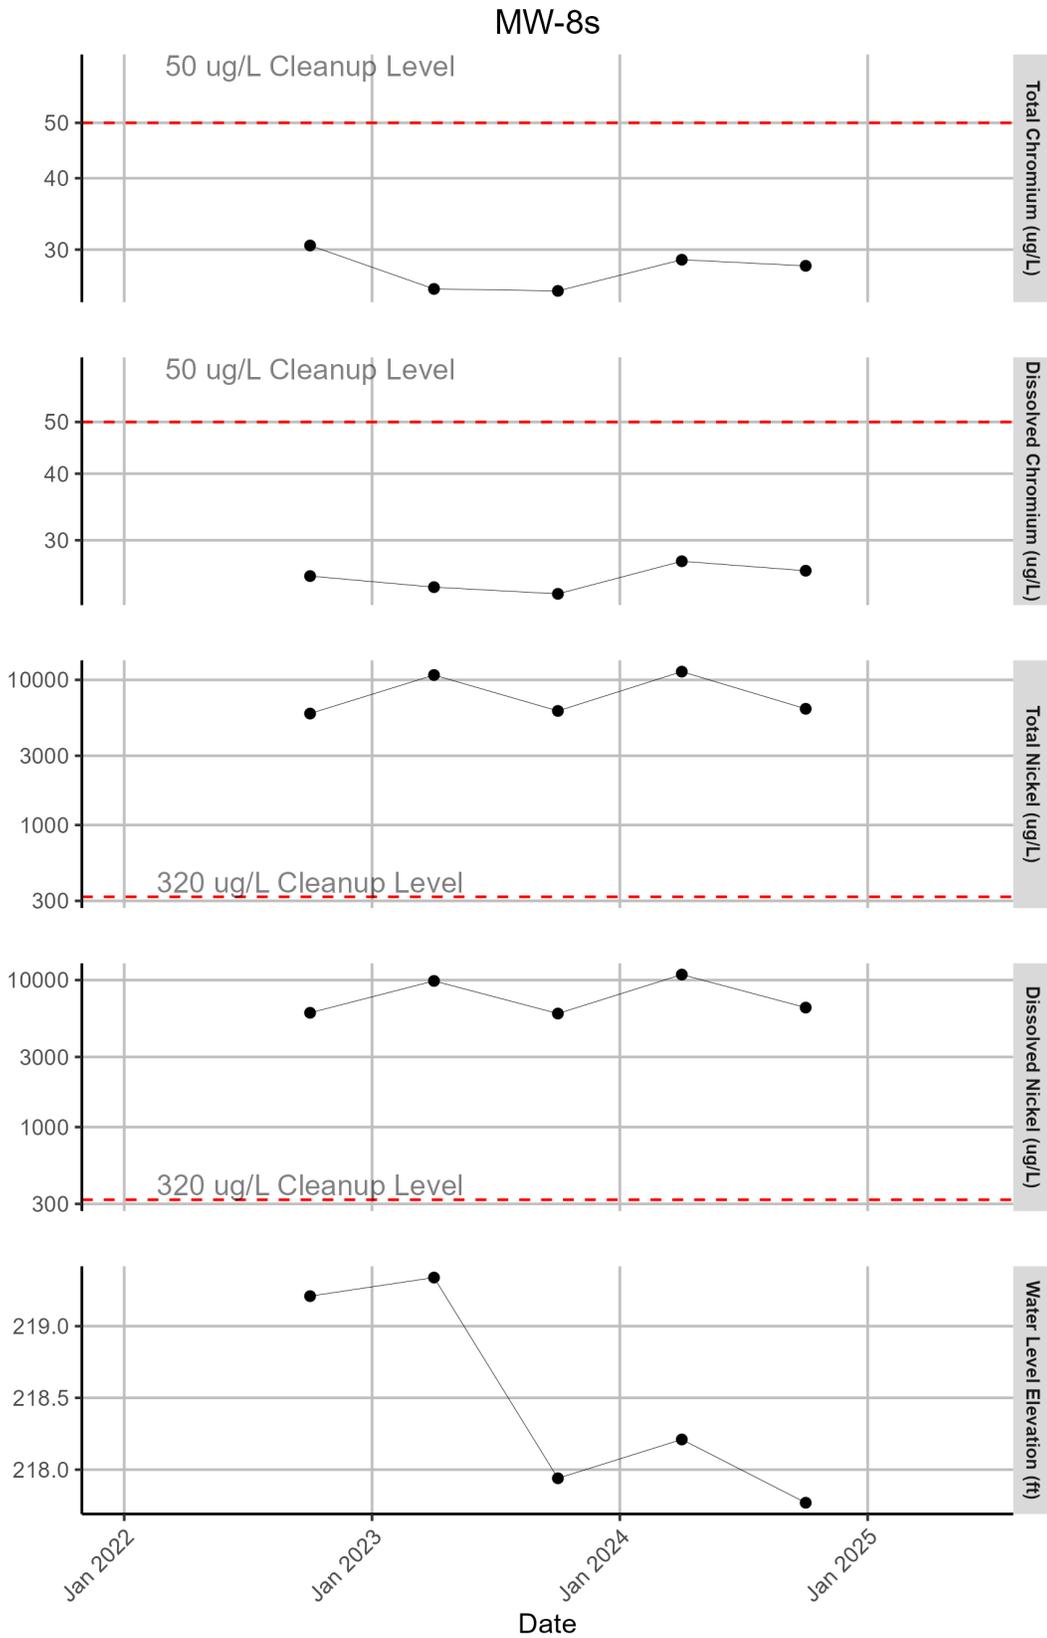
Figure 8. MW-8s contaminant concentrations (log scale) and groundwater elevations (ft NVGD29) for 2022 – 2024

Well MW-8s is located approximately 110 feet downgradient of well MW-4sR. Both wells share similar construction depths and screened intervals (Table 1). Concentrations of total and dissolved nickel in well MW-8s continue to far exceed (not meet) the applicable cleanup levels. Well MW-8s had the highest nickel concentrations of all wells sampled in 2024, with total nickel ranging from 6,320 µg/L to 11,400 µg/L and dissolved nickel ranging from 6,500 µg/L to 10,900 µg/L (Figure 4). Nickel concentrations in MW-8s were the highest in the April 2024 sampling event, however, these results indicate concentrations have decreased since post-excavation sampling in 2019 when concentrations were reported as 13,000 µg/L (Appendix A). There is an apparent seasonal trend to total and dissolved nickel concentration in MW-8s, with concentrations higher in the spring than in fall (Figure 8). Chromium concentrations in MW-8s were below the cleanup levels during all sampling events and are within the range of concentrations reported throughout Ecology's monitoring at the site (Figure 8).
