**SUBJECT: STORMWATER MANAGEMENT RECOMMENDATIONS FOR FORMER JELD-WEN SITE  
PROPERTIES  
WW-Everett  
Everett, Washington**

# FIELD REPORT

| Project: | <b>W&amp;W Everett Stormwater Project Field Report</b> | Others Present: | <b>Kristin Anderson (FS), Amy Booth (FS), Jason Cornetta (Anchor QEA), Chris Kramer (SLR), Ron Woolworth.</b> |

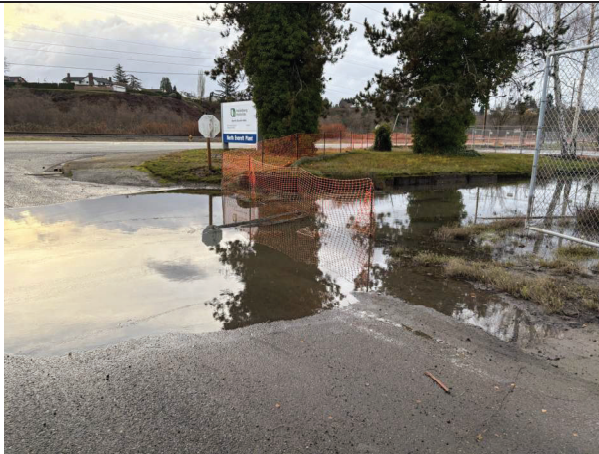
Stormwater that collects in the North Truck Bay is actively pumped to maintain trucking access in the north driveway. Based on SLR's observations and previous site photos, run-on flow from the north-adjacent Baywood facility is likely contributing to the ponding at the North Truck Bay. After demolition, water in the North Truck Bay was being pumped to the western portion of the main manufacturing building concrete pad, where it was allowed to sheet flow for a short distance to collect in catch basin DS-7 before discharging to Outfall OF-2. A catch basin owned by the City of Everett (City) is located at the northern driveway entrance from W Marine View Drive and appears to be nonfunctional because the street is not properly sloped to direct stormwater toward the catch basin. The drainage basin for the nonfunctional catch basin, where street runoff flows on to the property, is delineated by flanking catch basins within the gutter in the driveway returns that appear to be functional.

***Photo 1: North Truck Bay flooding***

- Continue to manage North Truck Bay ponding via Outfall OF-2 and periodically monitor for soil and debris on ground surface, supplementally sweeping as needed.

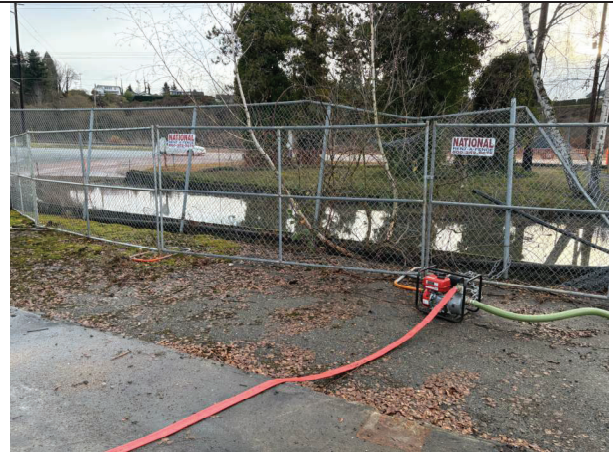
***Photo 2: North Truck Bay pumping setup***

- Install a dewatering silt bag in at the North Truck Bay pump discharge to CB DS-7. A silt bag appropriately sized to the pump will assist in filtering out potential sediment or debris being transported from the North Truck Bay. Silt bags should be replaced as they fill with fines according to manufacturer recommendations and appropriately disposed as nonhazardous solid waste.

- Consider establishing a sump appropriately sized to the pump to additionally minimize turbidity at the pump intake and extend the usable life of the silt bag. The sump should be free of sediment or debris and set at a height that allows accumulated water to flow over the top of the sump toward the pump inlet.

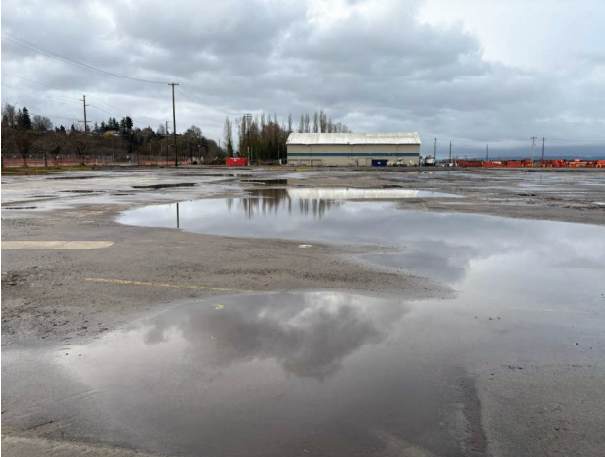
*Photo 3: Pad*

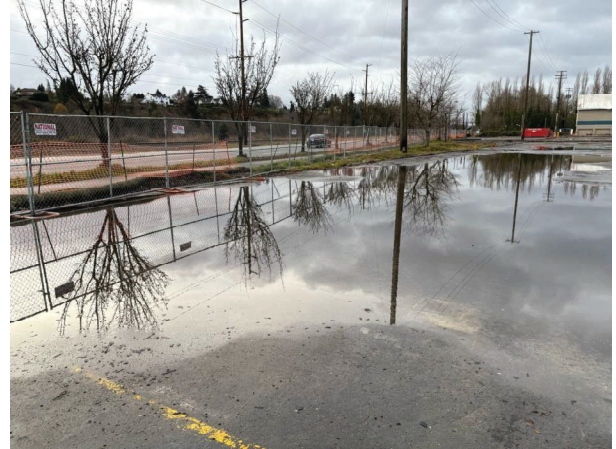
*Photo 4: Pad at east edge*

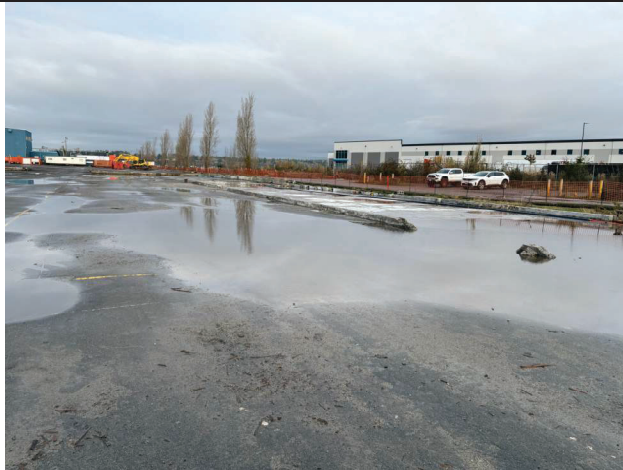
*Photo 5: Pad*

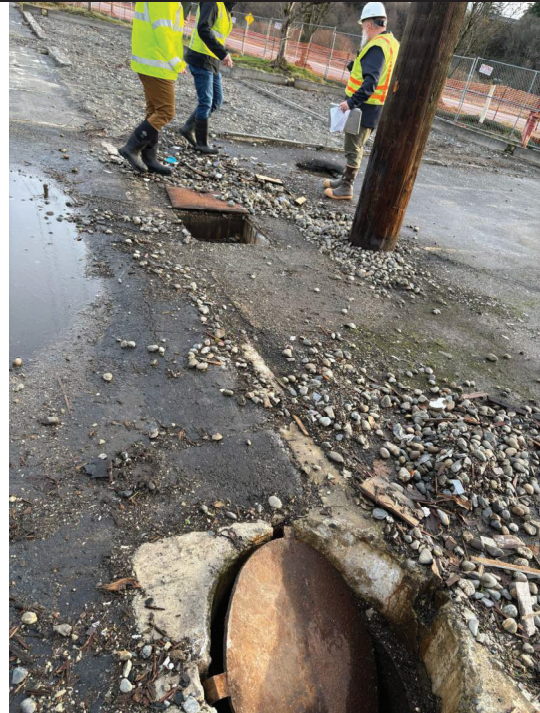
*Photo 6: Vaults near office rooms (need to fill in)*

- Three vaults near the previous office section of the main warehouse are open and are a falling hazard.
- We observed various levels of sediment and debris on top of the pad remaining from the demolition project.

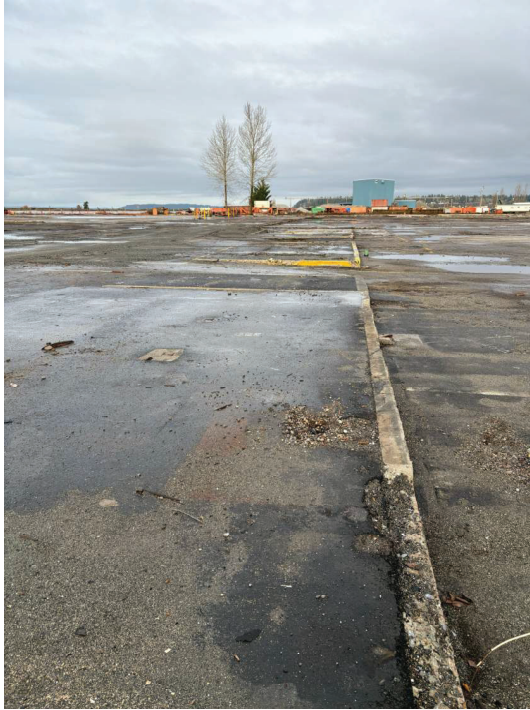
*Photo 7: Curb/ramps across whole pad*

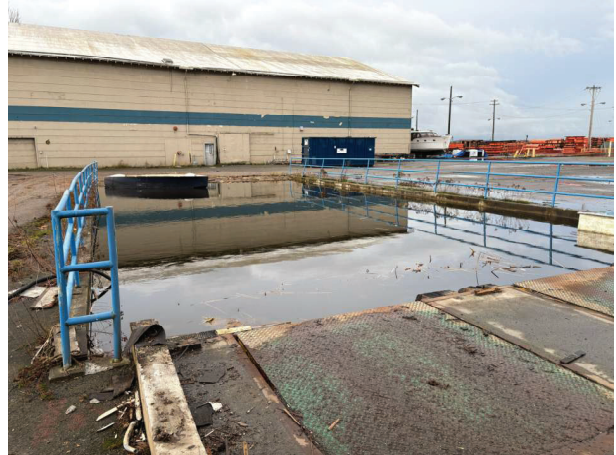
*Photo 8: South Truck Bay*

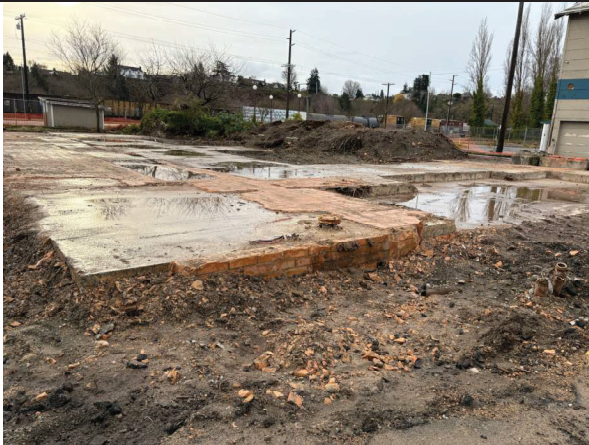
*Photo 9: Office building pad*

- The independent building pad of the Office Building is raised from the surrounding ground. The pad is proud of the surrounding area varying from 12-18".

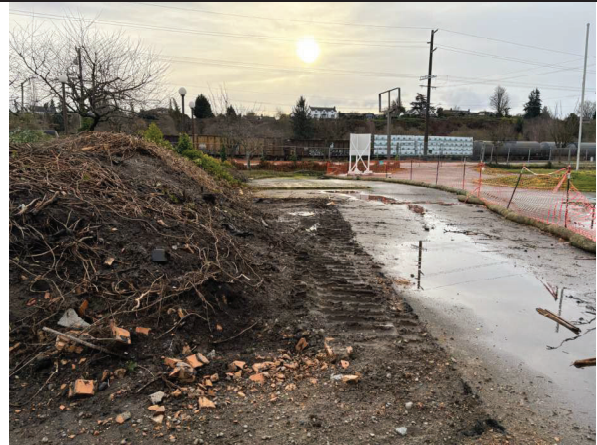
*Photo 10: Stockpile at office building*

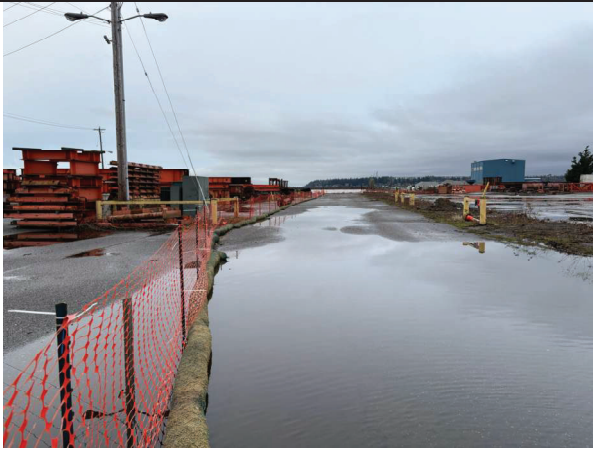
*Photo 11: Current drive aisle on south end*

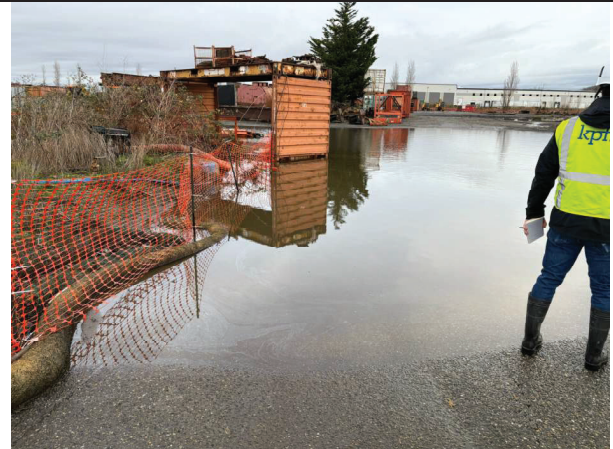
*Photo 12: Flooding at OF-5, ground sunk down*

- Ron remarked that over the last 4-5 years, the ground around OF-5 (where the ponding is observed) has been sinking. The conveyance system may be broken and transporting fine sediments away from the site and into the main waterway. This has not been verified and other causes of the settlement in the area may exist.

- The City should additionally confirm that the driveway area is the intended drainage basin for the currently nonfunctional catch basin.
- Clean out stormwater conveyance structures in the vicinity of the ponding near Outfall OF-5 (to be performed by Jeld-Wen in accordance with the Cleanup Action Plan).

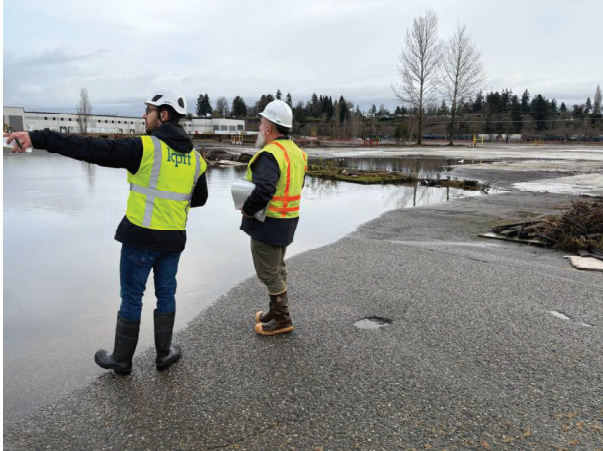
*Photo 13: Flooding at OF-5*

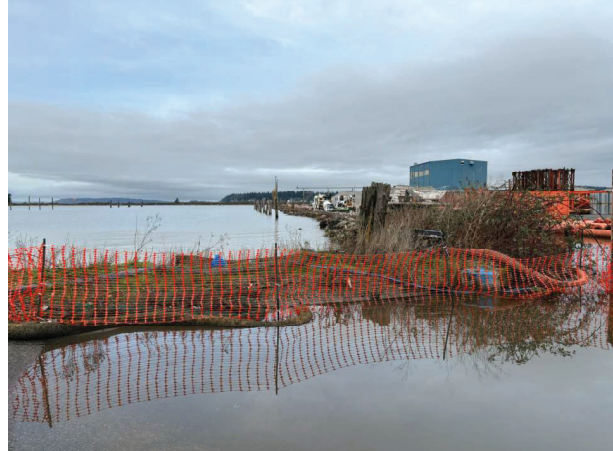
*Photo 14: Flooding at OF-5, water level even with tide*

- There is significant ponding at the corner near OF-5. The water elevation of the pond visually appeared to be the same as the adjacent tide elevation.

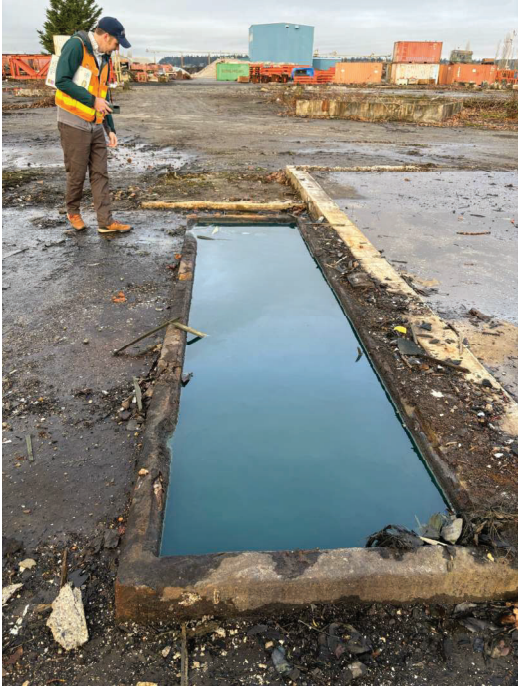
*Photo 15: Unknown blue water, suspect paint*

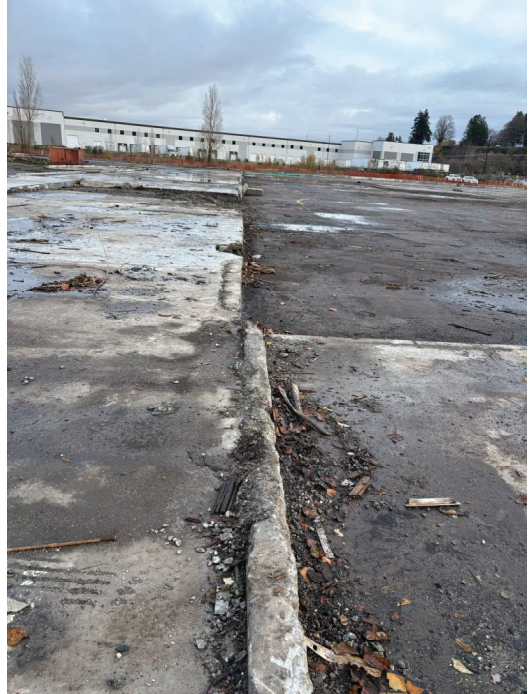
*Photo 16: Curb running north-south*

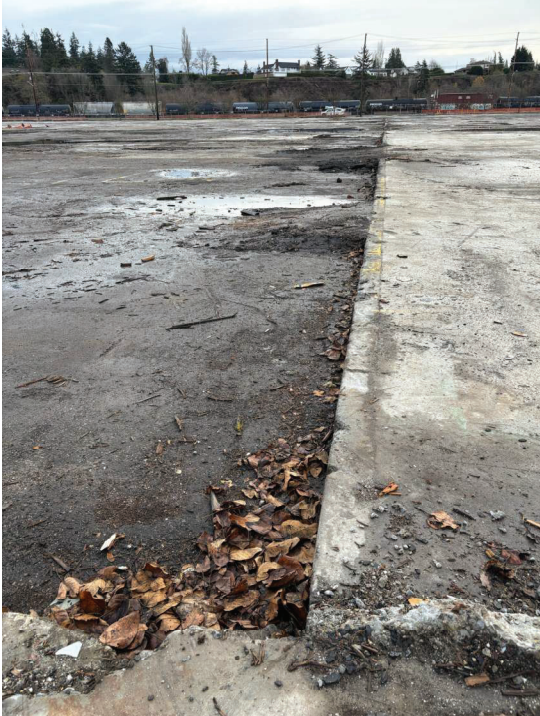
*Photo 17: Curb running east-west*

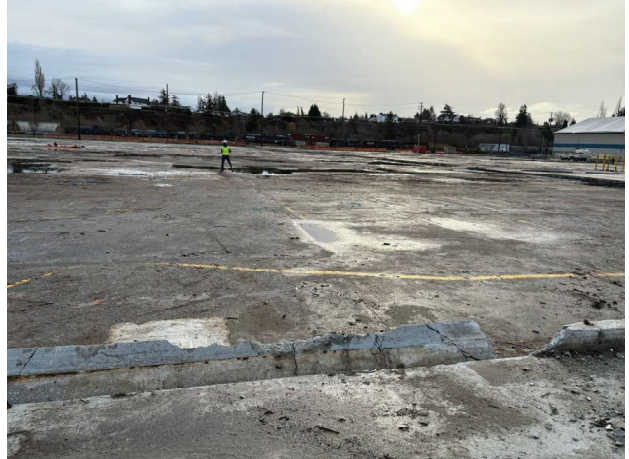
*Photo 18: Pad*

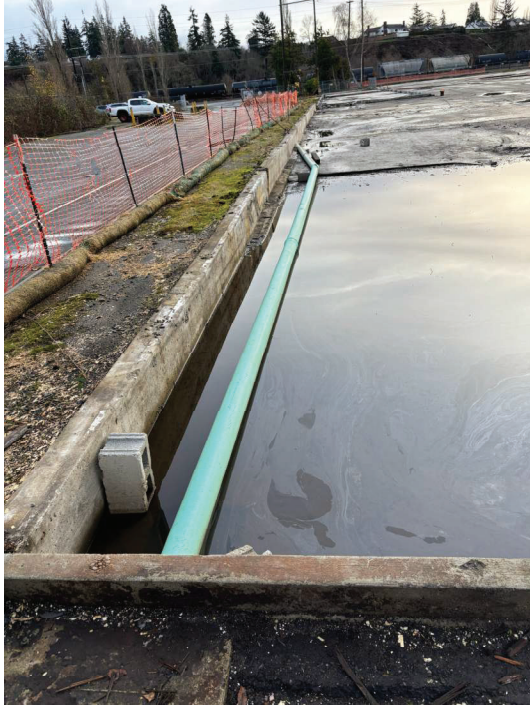
***Photo 19: Ponding post pumped North truck bay to CB (see Photo 20)***

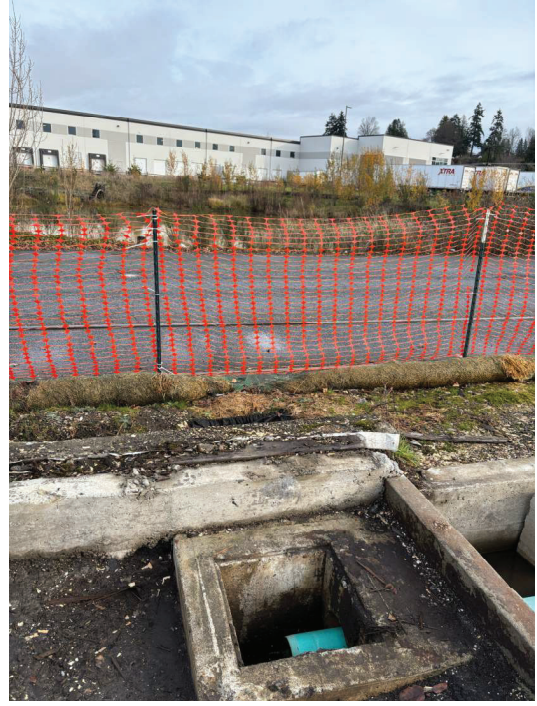
***Photo 20: Catch basin (DS-7) to OF-2***

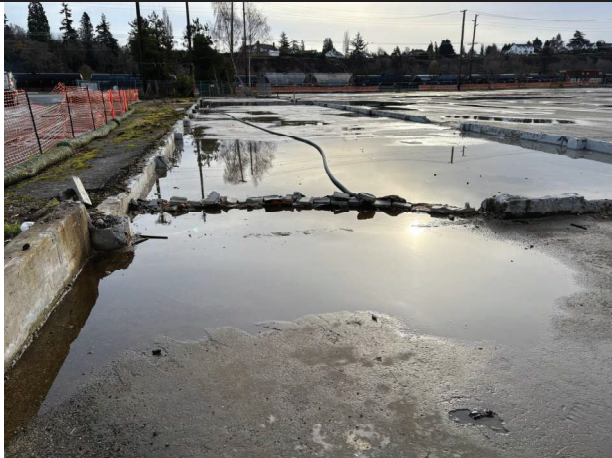
***Photo 21: Hose from North truck bay pump, surface flow to Photo 19 area.***

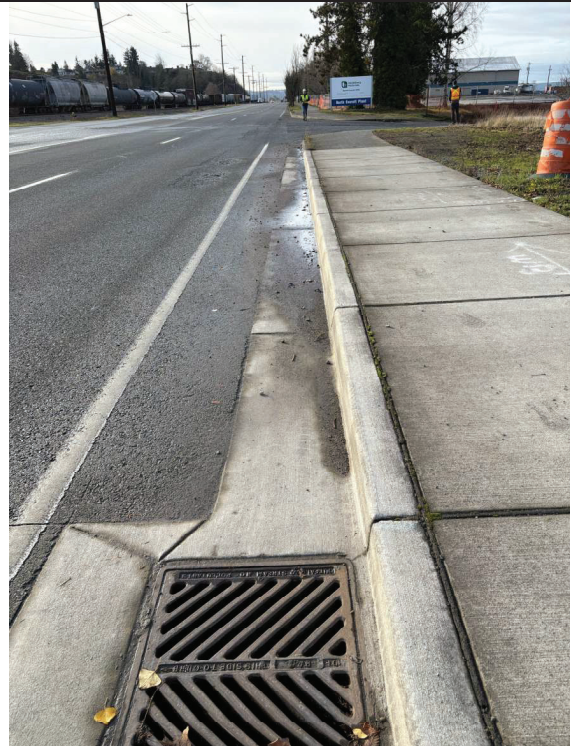
***Photo 22: Adjacent catch basins on W Marine Drive from main entrance. Each***

- The non-functional catch basin at the main northern entrance from W Marine Dr has flanking catch basins within the gutter in the driveway returns that appear to be functional. Each flanking catch basin is approximately 80 to 110 ft away from the center of the entrance driveway.
  - Chris from SLR previously observed (and has photos and videos of) significant runoff from the northern adjacent property (Baywood). This run-on flow is also likely contributing to the ponding at the Nort Truck Bay.
-

- Consider adding curbing to capture and redirect stormwater from W Marine View Drive to the City catch basin in the north driveway. Curbing could be installed by a qualified asphalt contractor.

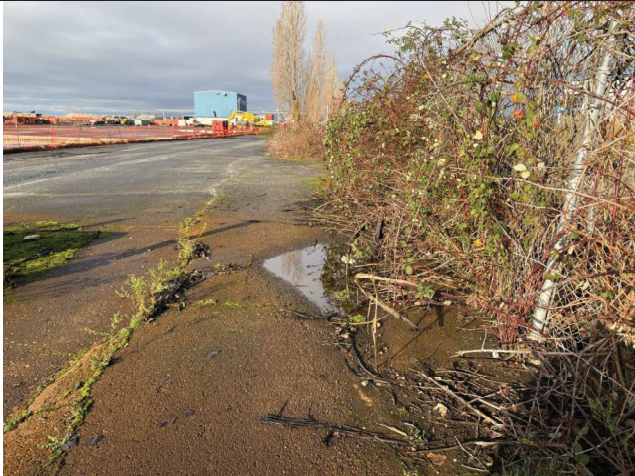
| <p><b><i>Photo 23: Property boundary with north property, evidence of water flowing from that property onto the site.</i></b></p> | <p><b><i>flanking CB is approximately 80-110 ft away from the center of the driveway.</i></b></p> |

- Consider placing a temporary sandbag or other berms along the north property boundary adjacent to Baywood. Notify Baywood of stormwater run-on concerns and the intent to place sandbags/berms along the property boundary.
