MEMORANDUM

From: David Templeton and Joy Dunay, Anchor QEA, LLC
Project: 040289-02.07

Re: Eddon Boat Park Long-Term Monitoring Plan Year 4 Memorandum

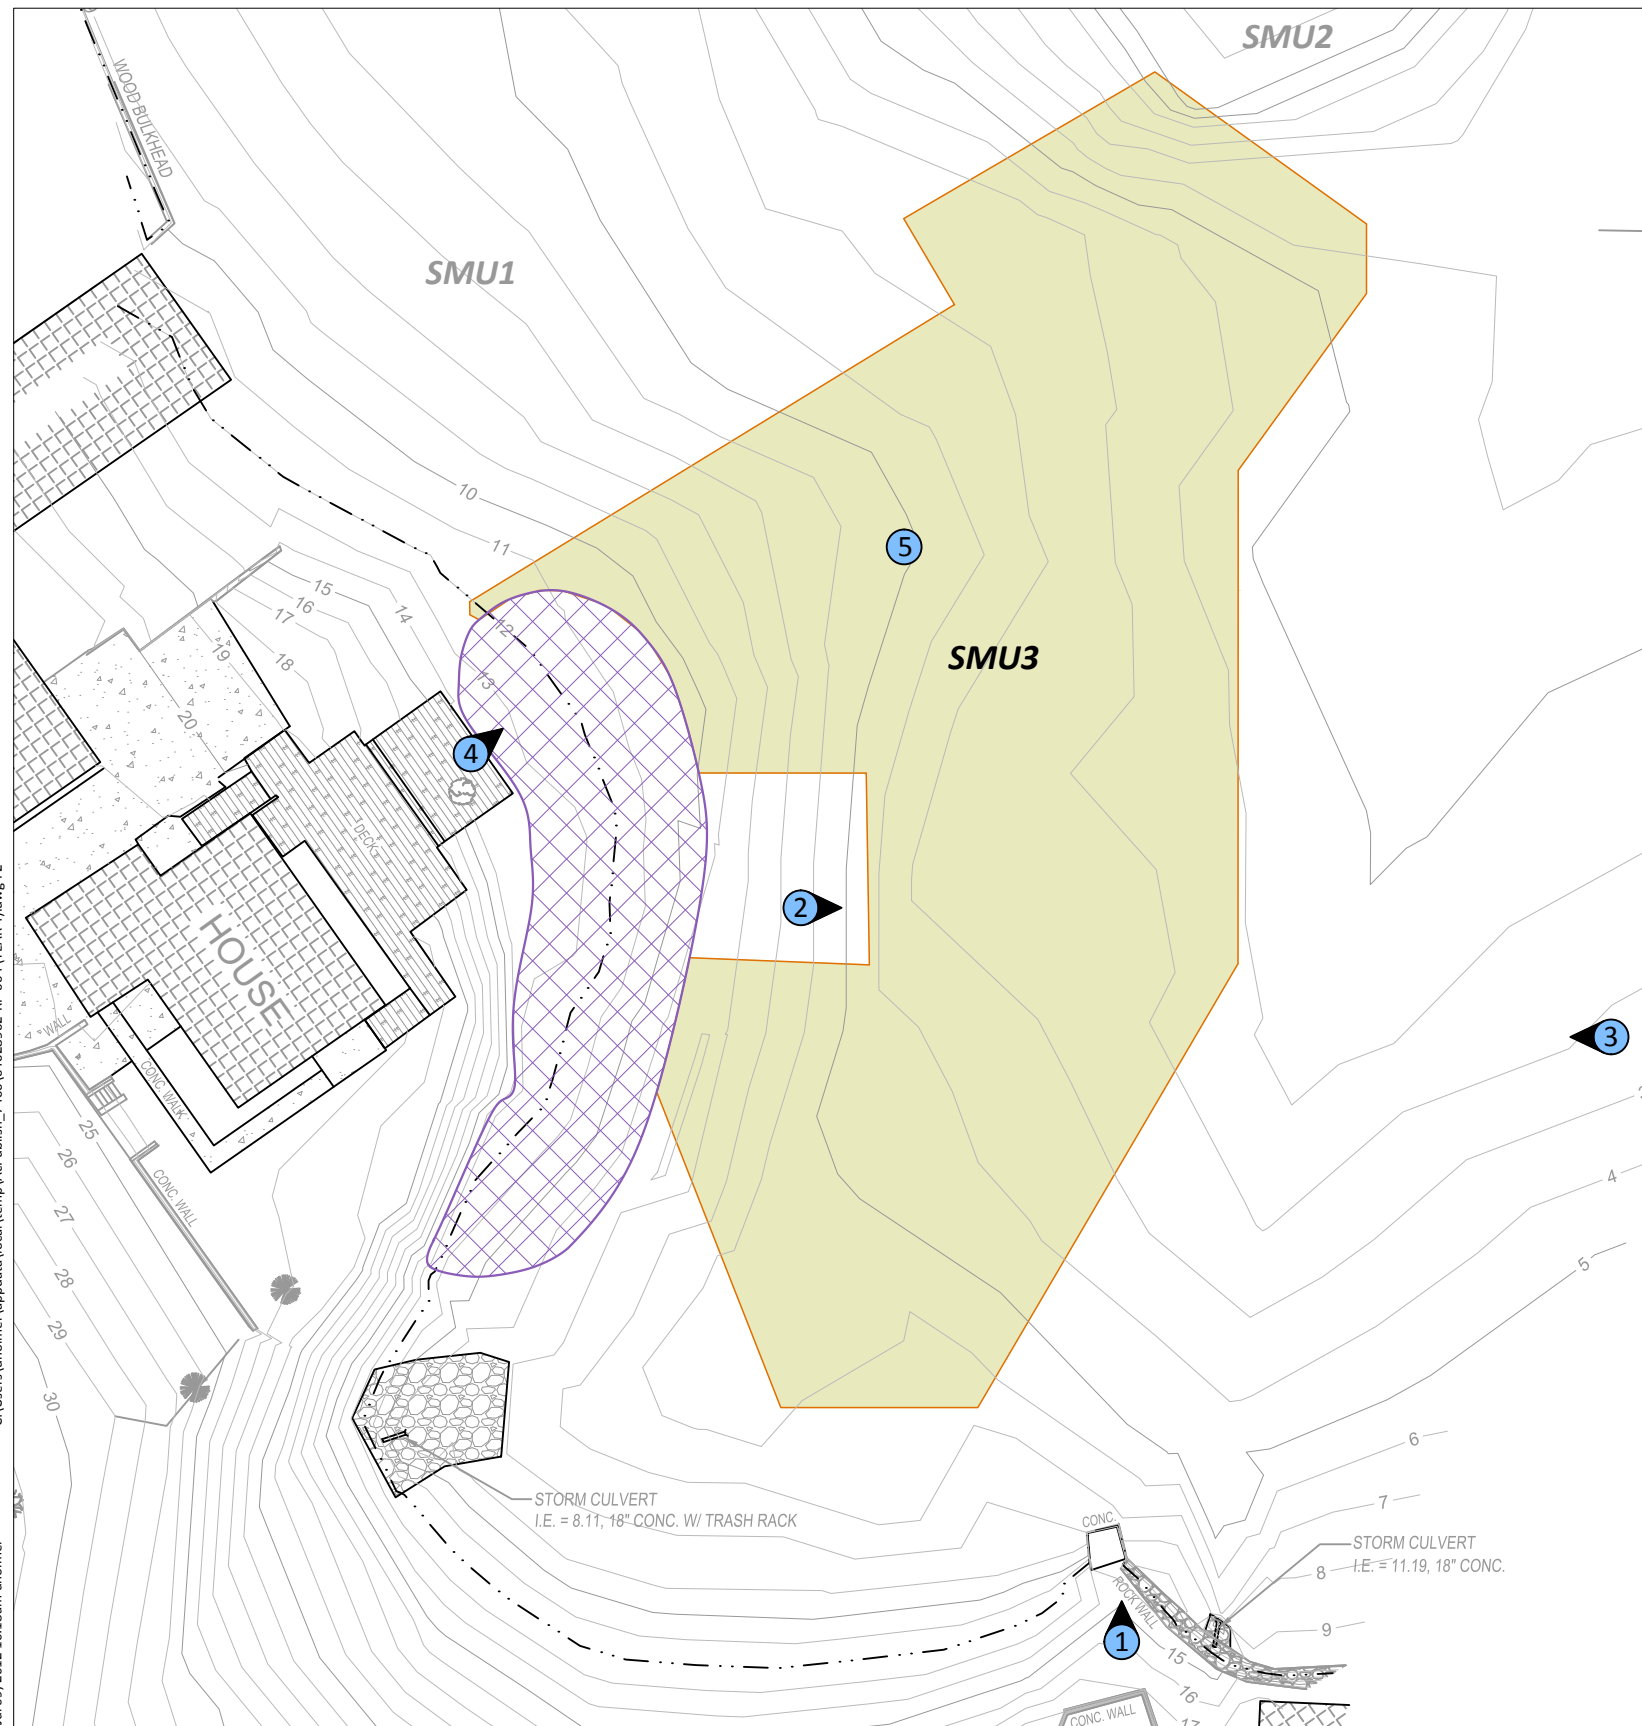
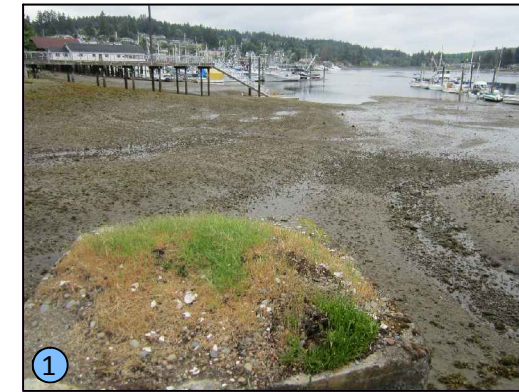
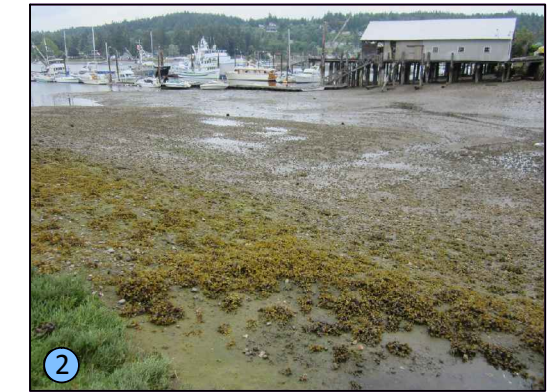
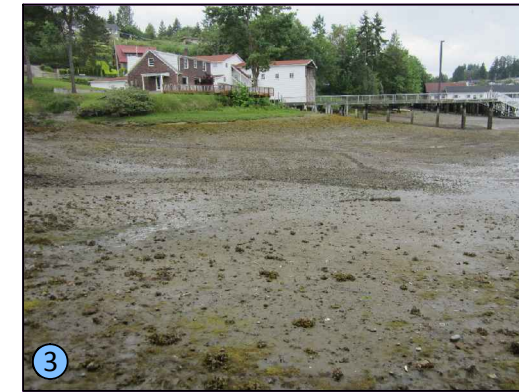
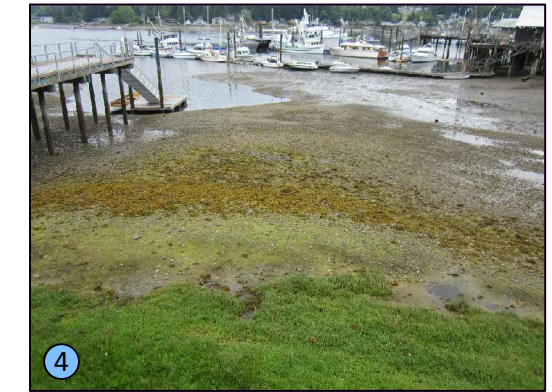
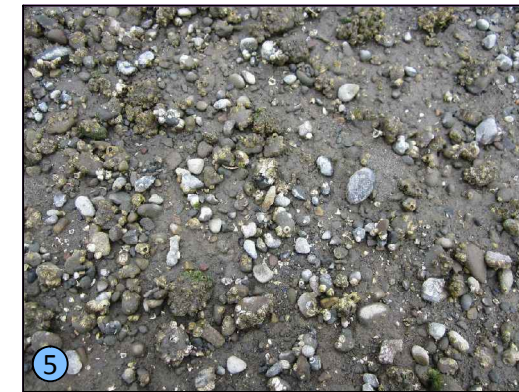
Figure 2
SMU-3 Visual Inspection Results
Long-Term Monitoring Plan - Year 4 Report
Eddon Boat Park

In conclusion, Year 4 monitoring was performed in accordance with the Ecology-approved LTMP. Visual inspection confirmed that the cap material is present in SMU-3 and shows no sign of erosion. As expected, fine-grained material is accumulating, and recolonization is evident. Similarly, the material placed in SMU-2 is present, has not eroded, and is showing signs of deposition. This is consistent with the yearly visual inspections conducted since 2009 and confirms that the cleanup action is functioning as desired and in accordance with the CAP.
