PERIODIC REVIEW

PACCAR Facility Site ID#: 2065 ISIS Cleanup Site ID# 788

1400 North 4th Street, Renton, Washington

July 2014

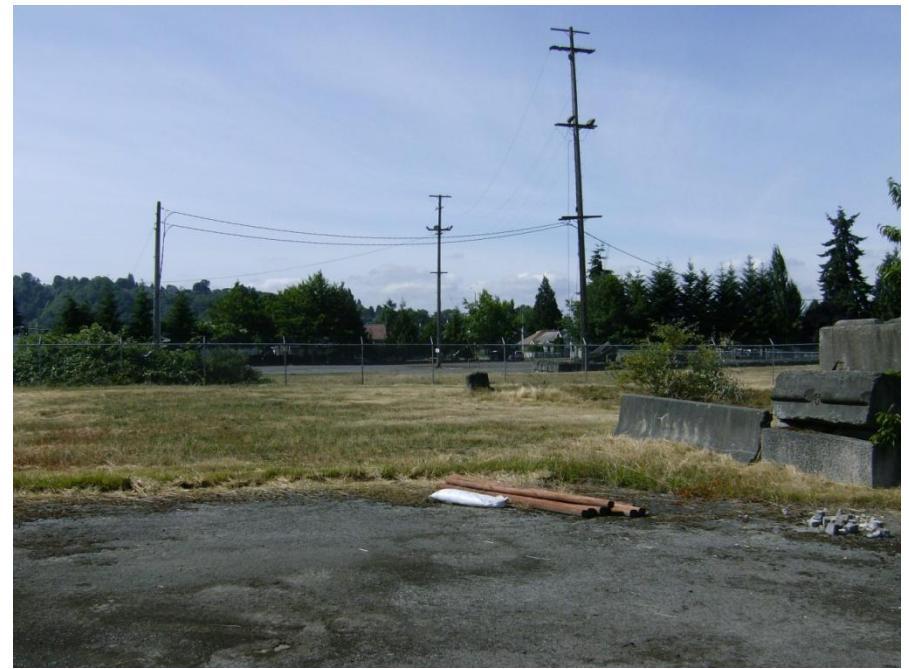
6.5 Photo log Photo 1: Soil capped southern portion – looking south

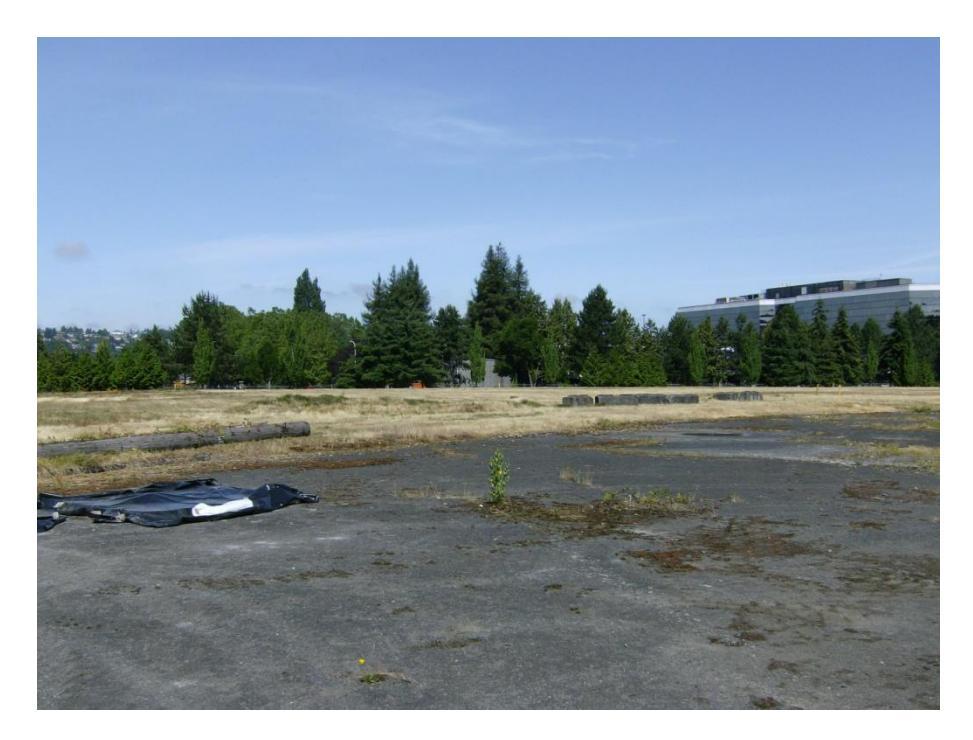
Photo 2: Soil capped southern portion – looking west

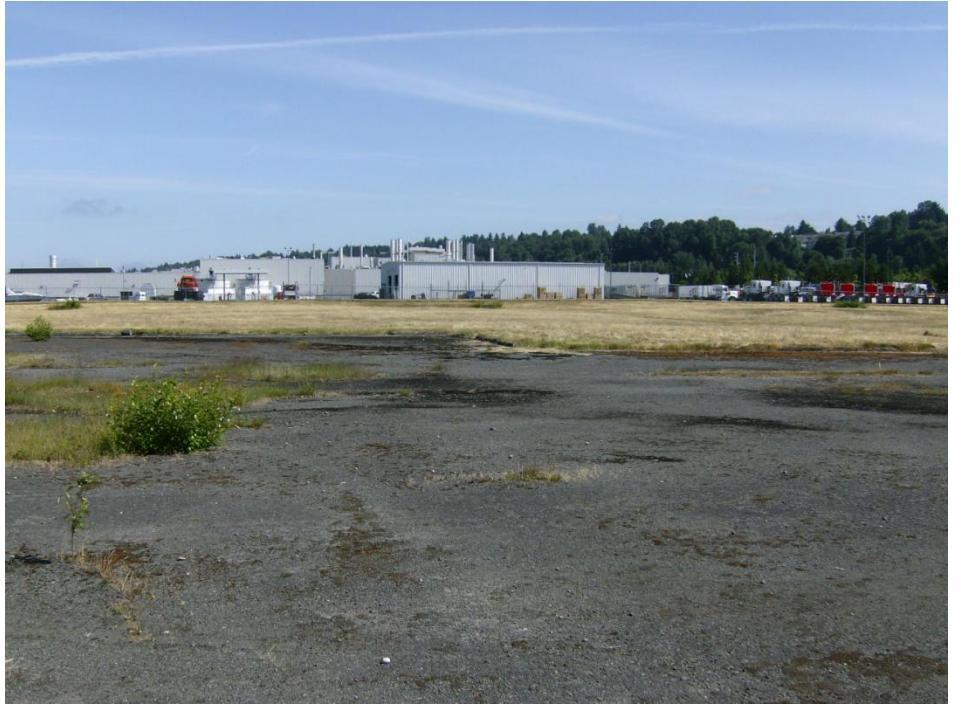
Photo 3: Soil capped southern portion w/ some asphalt – northern portion visible

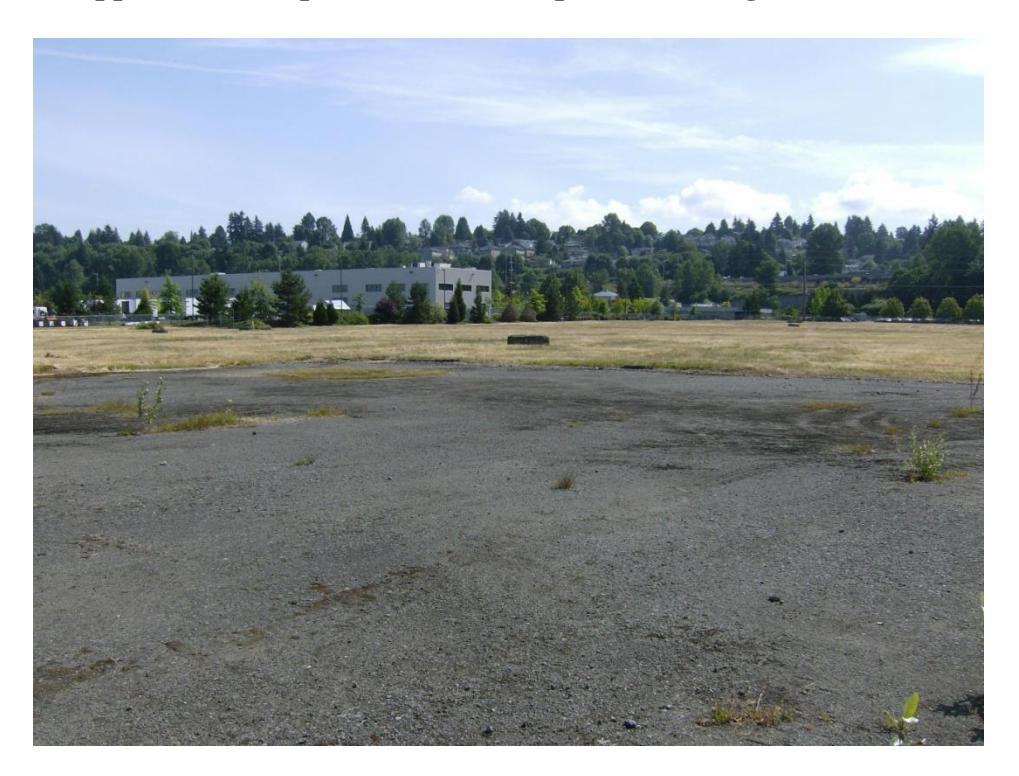
Photo 4: Soil capped southern portion w/ some asphalt – looking east
