**Lower Duwamish Waterway
Early Action Area 4
Final Summary of Existing
Information and Identification of
Data Gaps Report**

**Contract No. C0700036
Work Assignment No. EANE001**

June 2007

**WASHINGTON DEPARTMENT OF ECOLOGY
Toxics Cleanup Program
3190 160th Avenue SE
Bellevue, WA 98008-5452**

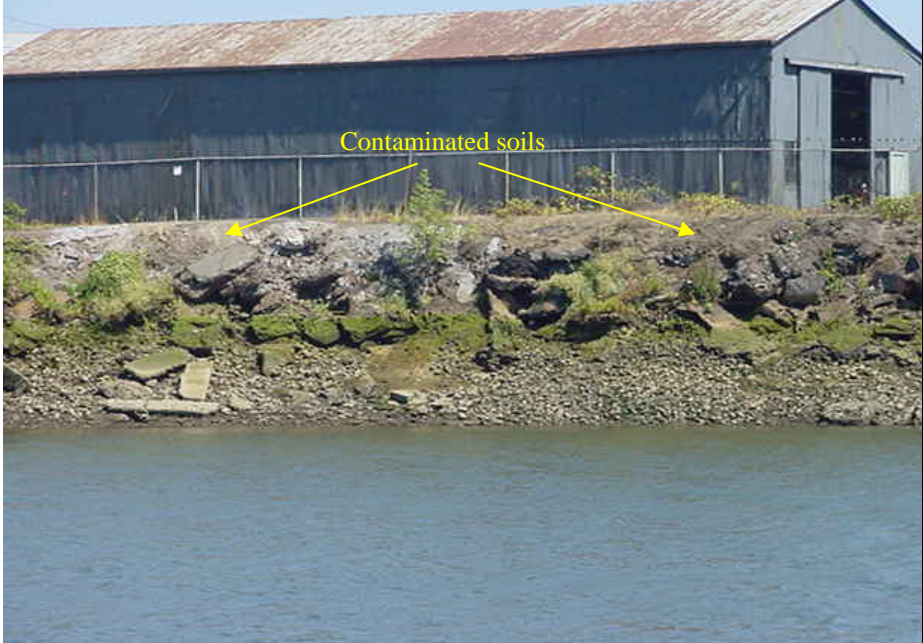
| EAA-4 PHOTOGRAPHIC LOG: 2 | |

| EAA-4 PHOTOGRAPHIC LOG: 2 | |
|---|---|
| Description: Locations of contaminated soils along shoreline. | A photograph of a shoreline area. In the foreground, there is a rocky and vegetated bank. A yellow text label "Contaminated soils" is positioned above the bank, with two yellow arrows pointing to specific areas of the bank. In the background, a large, dark industrial building with a corrugated metal roof is visible. The sky is clear and blue. |

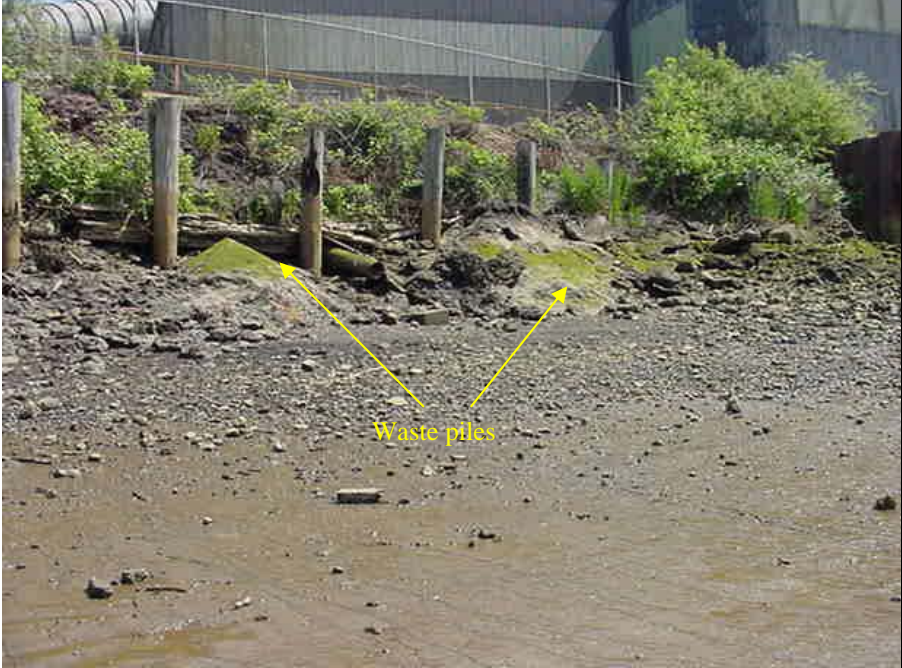
| EAA-4 PHOTOGRAPHIC LOG: 3 | |

| EAA-4 PHOTOGRAPHIC LOG: 3 | |
|--|---|
| Description: PCB-containing waste piles, along the Jorgensen shoreline. | |

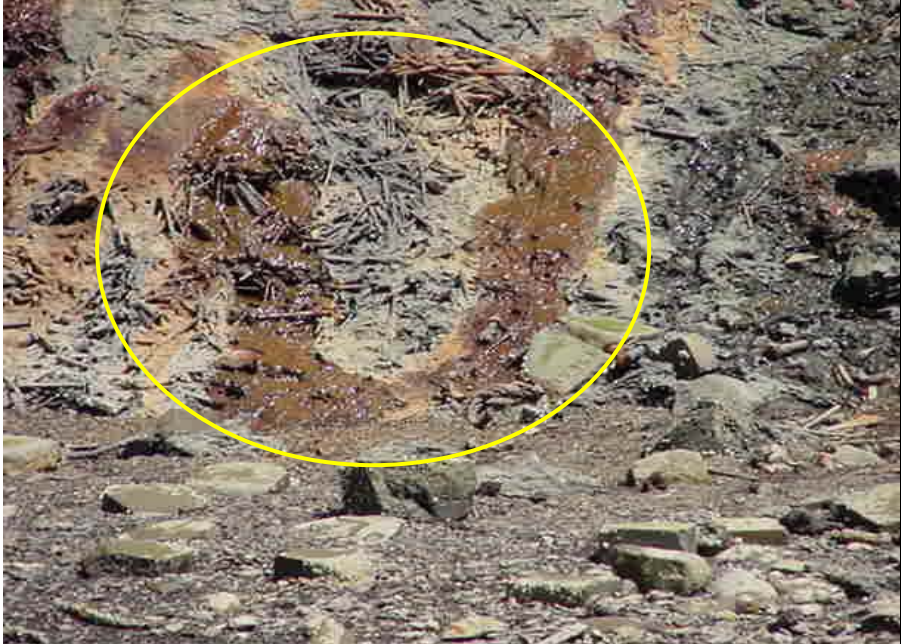
| EAA-4 PHOTOGRAPHIC LOG: 5 | |

| EAA-4 PHOTOGRAPHIC LOG: 5 | |
|---|--|
| Description: Close up of scrap metal waste | |
