STATE OF WASHINGTON
DEPARTMENT OF ECOLOGY

June 11, 2014

Re: Opinion on Proposed Cleanup of a Property associated with a Site:

- Property Address: 1332 West Marine View Drive, Everett, WA 98201
- Facility/Site No.: 9286485
- VCP Project No.: NW2842

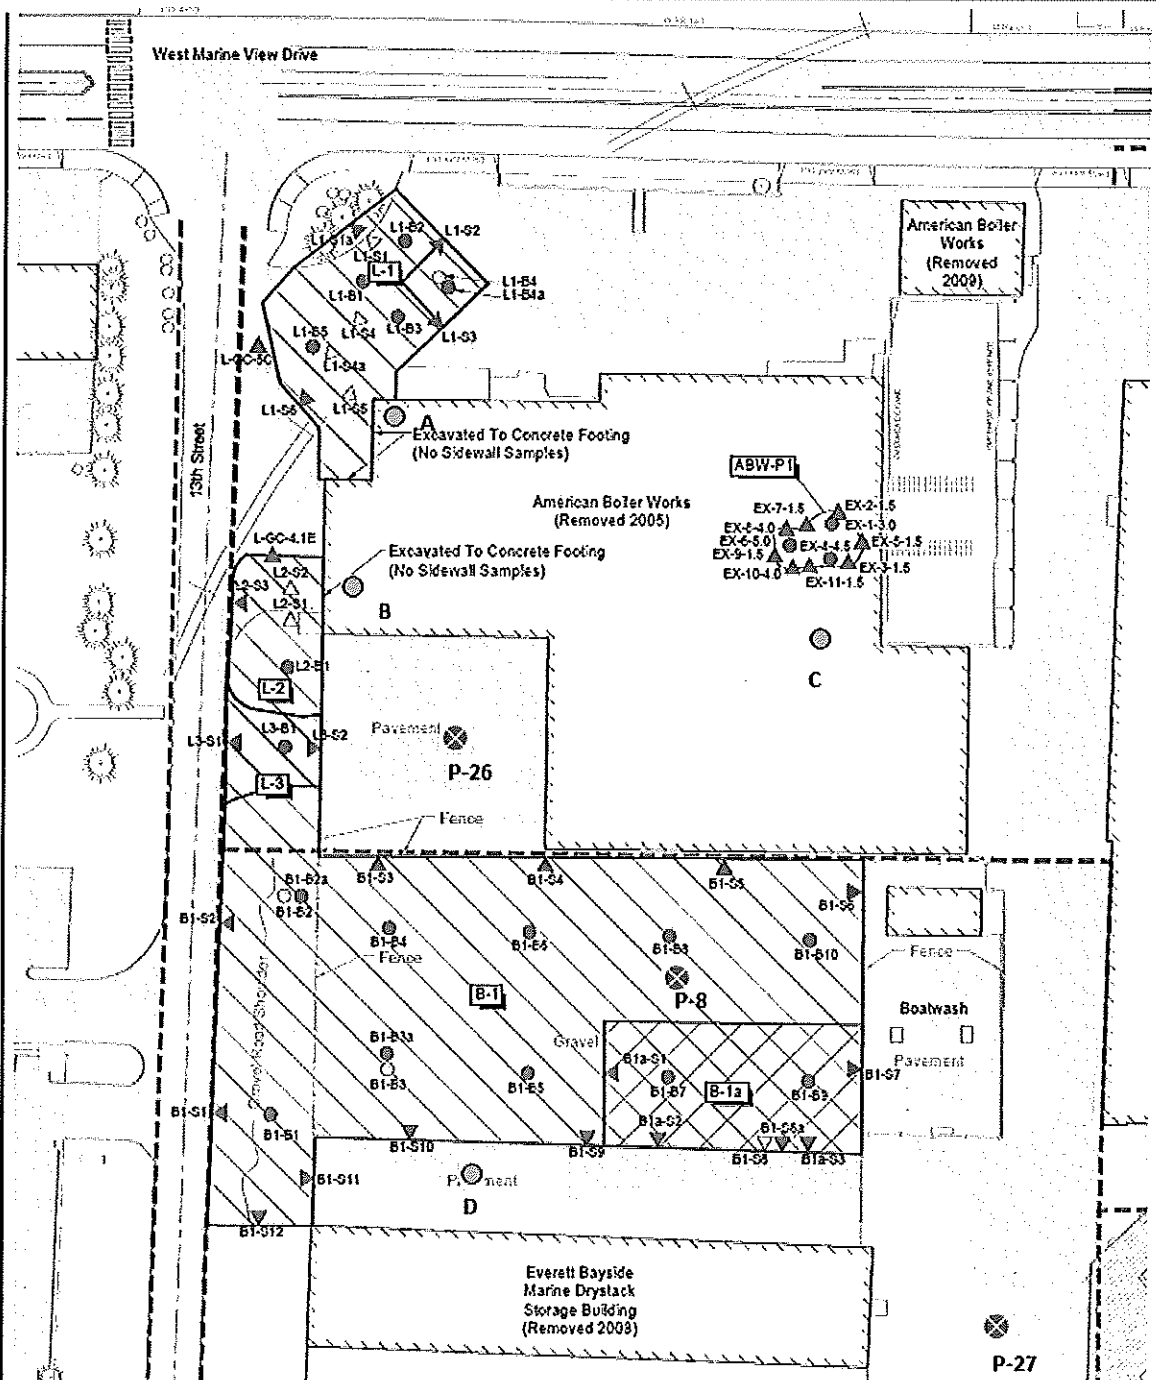
Subsurface soil investigation and compliance sampling have determined the lateral and vertical extent of releases in Cleanup Action Areas B-1a, L-3, and ABW-P1.

Subsurface soil investigation in the boat wash area (B-FA-20) and compliance sampling at the south sidewalls in Cleanup Action Area B-1 (B1-S6) and (B1-S7) have impacts remaining.

Based on results presented on Figure 9, the extent of arsenic contamination may not have been fully defined to the southwest of Cleanup Action Area L-1 and to the south of Cleanup Action Area L-2.

During 2006 and 2007, a total of 2,597 tons of contaminated soil was excavated and disposed of from Cleanup Action Area B-1. Cleanup Action Area B-1 consisted of cPAHs and arsenic contaminated soil. Sidewall samples, B1-S6 and B1-S7, located on the south side of Area B-1 exceeded the cleanup level for arsenic (34 mg/kg and 28 mg/kg, respectively). No additional excavation occurred here because the boat wash facility was obstructing further excavation. Arsenic-impacted soil will be excavated and removed as part of Action Area B-1b after the boat wash is decommissioned.

Ecology agrees with the cleanup action to excavate and remove contaminated soil in the proposed Cleanup Action Area B-1b which includes the contaminated soil remaining from Cleanup Action Area B-1 (B1-S6) and (B1-S7).

Additional characterization is warranted underneath the concrete slab of the former American Boiler Works building to determine the lateral extent of contamination and quality of fill material placed beneath the building footprint. Proposed soil boring locations are proposed on **Enclosure A**.

Monitoring wells should be installed and groundwater samples collected from the proposed borings to be advanced beneath the former American Boiler Works building. A minimum of two rounds of groundwater sampling is required to confirm concentrations of groundwater are less than the cleanup levels. If analytes are detected above the cleanup levels, then additional sampling will be required.
