Appendix Q

Habitat Assessment Photographs and Data Sheets

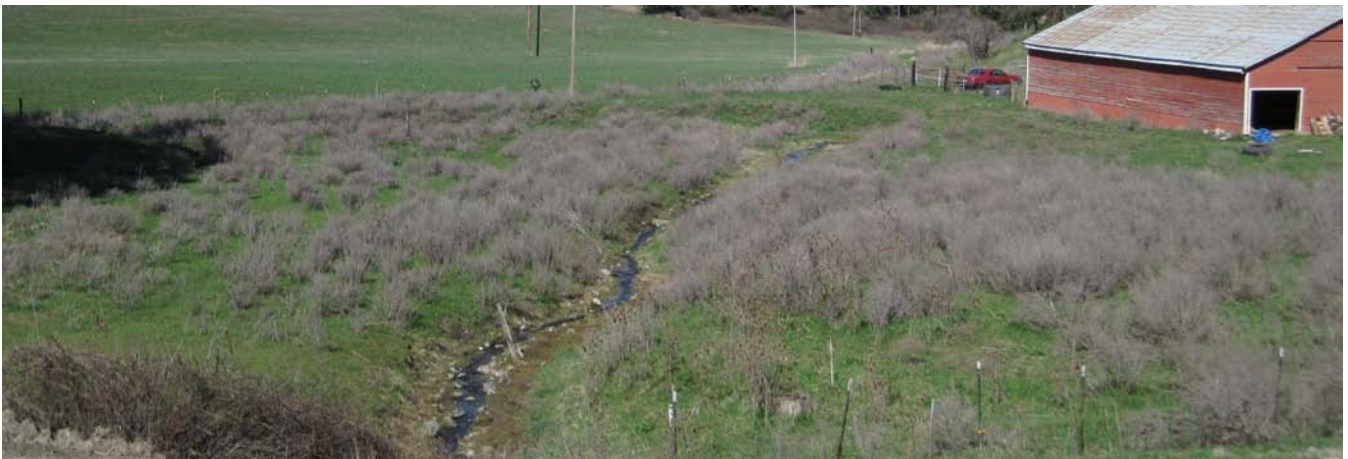
Figure 3: Downstream of spring sampling sites SW2 and SW3

Habitat Parameter	Condition Category			
	Optimal	Suboptimal	Marginal	Poor
1. Epifaunal Substrate/ Available Cover <i>Rocks / Cobble w/ some sediment</i> SCORE <i>0</i>	Greater than 50% of substrate favorable for epifaunal colonization and fish cover; mix of snags, submerged logs, undercut banks, cobble or other stable habitat and at stage to allow full colonization potential (i.e., logs/snags that are <u>not</u> new fall and not transient).	30-50% mix of stable habitat; well-suited for full colonization potential; adequate habitat for maintenance of populations; presence of additional substrate in the form of newfall, but not yet prepared for colonization (may rate at high end of scale).	10-30% mix of stable habitat; habitat availability less than desirable; substrate frequently disturbed or removed.	Less than 10% stable habitat; lack of habitat is obvious; substrate unstable or lacking.
	20 19 18 17 16	15 14 13 12 11	10 9 8 7 6	5 4 3 2 1 0

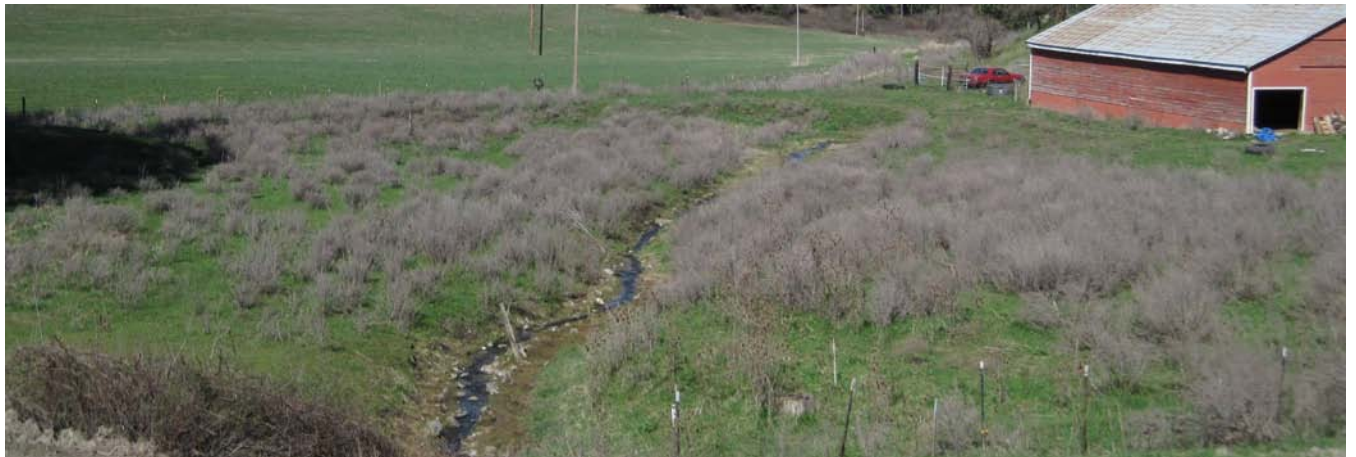
Figure 6: Downstream of spring sampling sites SW2 and SW3

3. Pool Variability SCORE <i>0</i>	Even mix of large-shallow, large-deep, small-shallow, small-deep pools present.	Majority of pools large-deep; very few shallow.	Shallow pools much more prevalent than deep pools.	Majority of pools small-shallow or pools absent.
	20 19 18 17 16	15 14 13 12 11	10 9 8 7 6	5 4 3 2 1 0

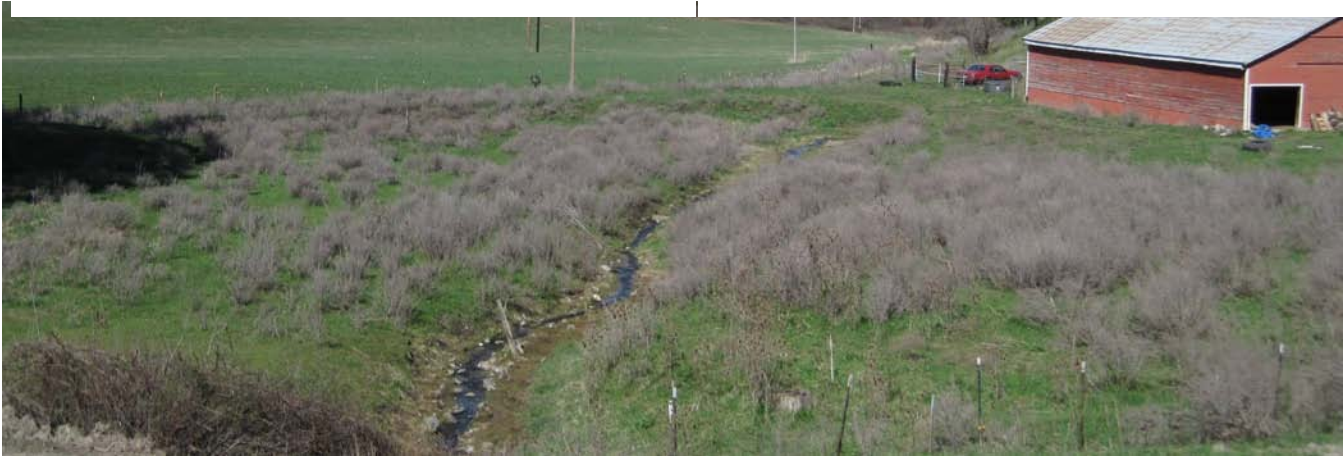
Figure 9: Downstream of spring sampling sites SW2 and SW3

SCORE <i>0</i> (LB)	Left Bank 10 9	8 7 6	5 4 3	2 1 0
SCORE <i>0</i> (RB)	Right Bank 10 9	8 7 6	5 4 3	2 1 0
10. Riparian Vegetative Zone Width (score each bank riparian zone)	Width of riparian zone >18 meters; human activities (i.e., parking lots, roadbeds, clear-cuts, lawns, or crops) have not impacted zone.	Width of riparian zone 12-18 meters; human activities have impacted zone only minimally.	Width of riparian zone 6-12 meters; human activities have impacted zone a great deal.	Width of riparian zone <6 meters; little or no riparian vegetation due to human activities.
SCORE <i>0</i> (LB)	Left Bank 10 9	8 7 6	5 4 3	2 1 0
SCORE <i>0</i> (RB)	Right Bank 10 9	8 7 6	5 4 3	2 1 0

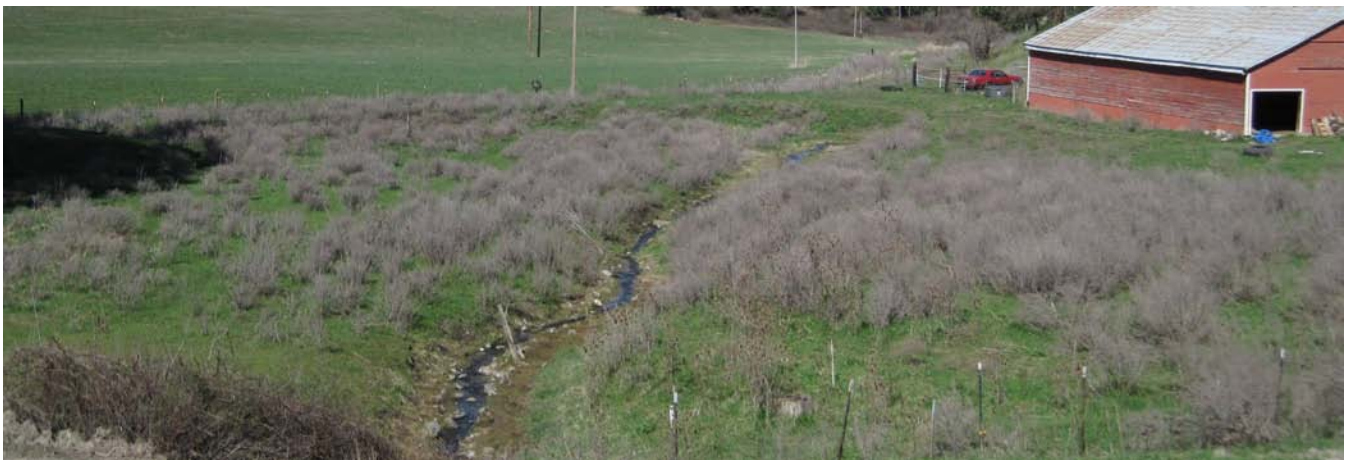
Figure 12: Downstream of spring sampling sites SW2 and SW3
