January 26, 2016

Re: Opinion Pursuant to WAC 173-340-515(5) on Remedial Action for the Following Hazardous Waste Site:

- Site Name: Gateway Center
- Address: 2525 6th Street, Bremerton, WA 98312
- Facility/Site No.: 94828632
- VCP No.: NW3003
- Cleanup Site ID No.: 12850

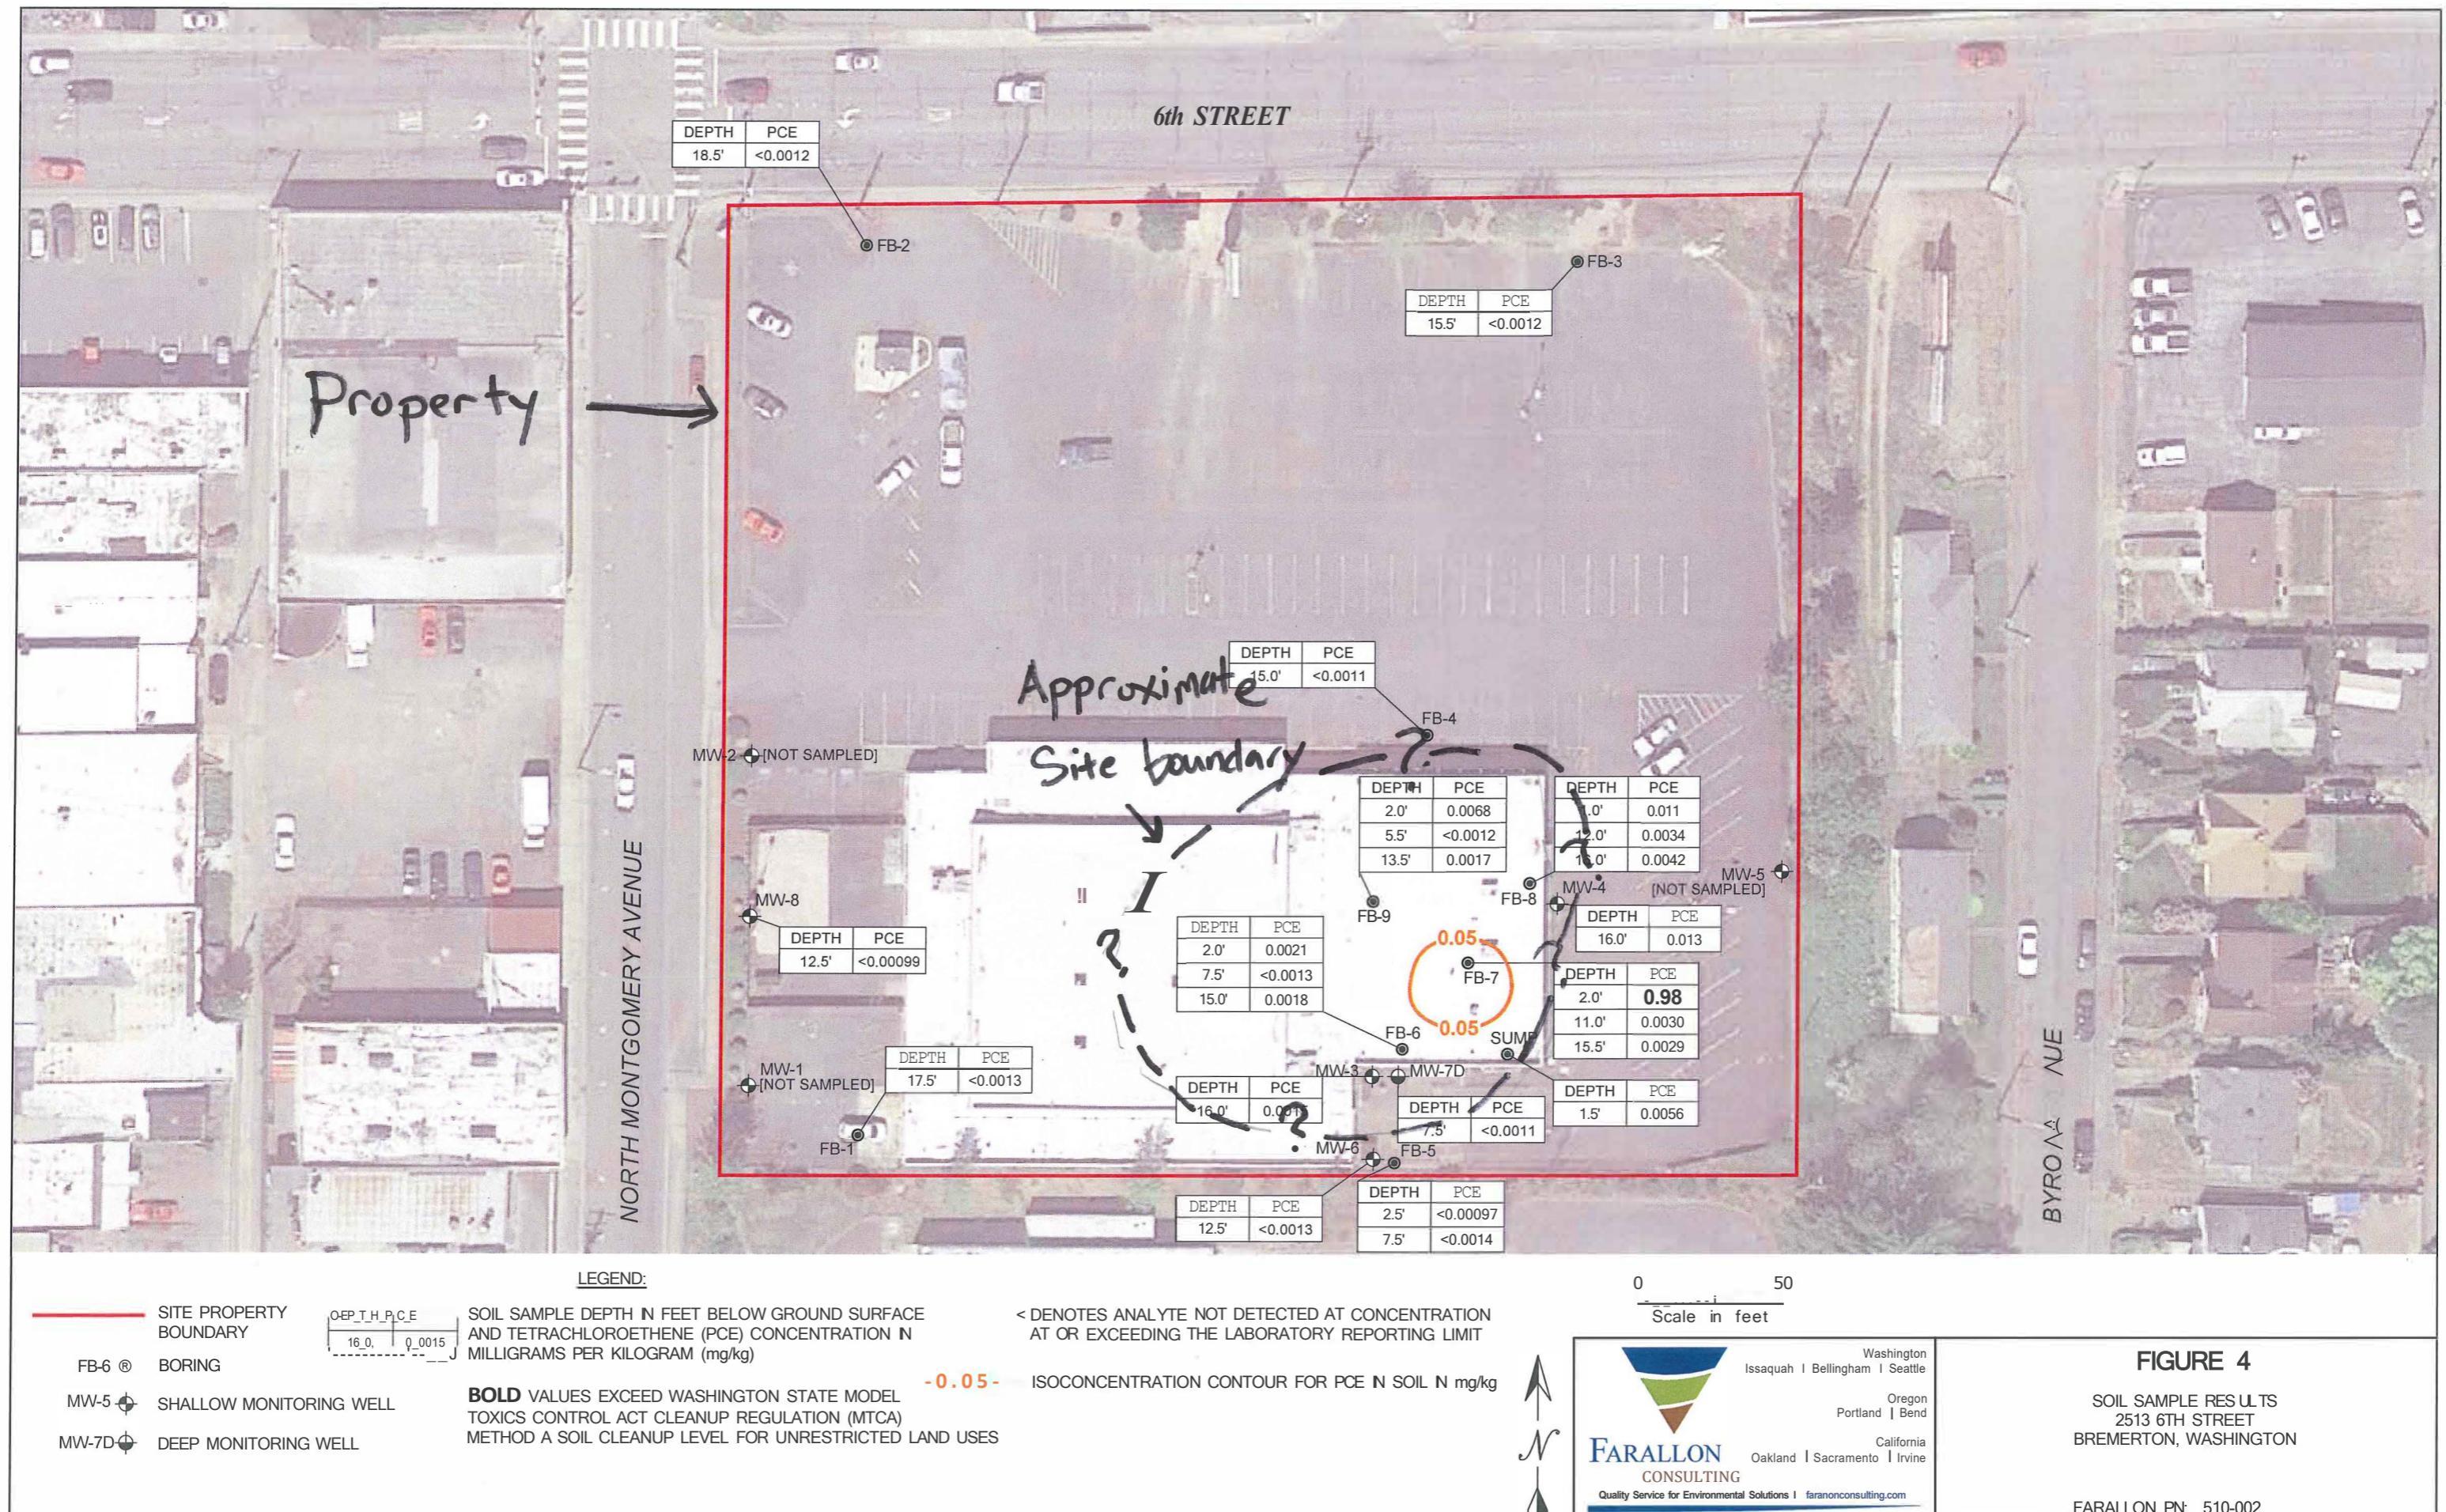
Washington quah I Bellingham I Seattle	FIGURE 4
Oregon Portland Bend	SOIL SAMPLE RESULTS 2513 6TH STREET BREMERTON WASHINGTON
kland Sacramento Irvine	BREMERTON, WASHINGTON
tions I faranonconsulting.com	FARALLON PN: 510-002
Checked By: BJ	Date: 6/26/2015 Disk Reference: 510-002_00

- The PCE concentration exceeded the MTCA Method A cleanup level in only one soil sample at approximately two feet below ground surface (bgs). However, ground water, which is at depths of approximately 12 to 13 feet bgs, has been contaminated as a result of release(s) beneath the building. Very little degradation seems to have occurred based on minimal detections of PCE degradation products. Based on the lack of detections of PCE by-products, it is likely that additional soil contamination exists that has not yet been identified. It is unknown where the dry cleaning machine(s) were located, how many were present, how long the machines were in operation, where the former floor drains were located and what the disposal practices were at the time PCE was being used at the Property. Therefore, additional sampling is needed to complete Site characterization and ensure that the selected cleanup action is not leaving behind contamination that could continue to impact ground water and air on the Site.

Release and Extent of Soil and Ground Water Contamination: The former laundromat was located in the eastern portion of the building. It is unknown where any of the dry cleaning machines were located or solvents were stored. The greatest concentrations of PCE in soil, ground water and sub-slab vapor samples (0.98 milligrams per kilogram, 8.4 micrograms per liter and 940 micrograms per cubic meter respectively) were identified in the southern portion of the eastern wing of the building. No PCE degradation products were detected in soil samples with the exception of sample location FB-7 where TCE was detected at a concentration below the MTCA Method A cleanup level. TCE and dichlorodifluoromethane were detected in ground water at concentrations below the respective MTCA Method A and B cleanup levels. Chloroform was detected in the ground water at a concentration exceeding the MTCA Method B cleanup level at location MW-7:0. The benzene concentration in a reconnaissance ground water sample collected from the eastern portion of the building exceeded the MTCA Method A cleanup level and TPH-g was detected in all reconnaissance ground water samples collected in all reconnaissance ground water samples. TPH-O was detected in soil at the northern Property boundary soil at a concentration below the MTCA Method A cleanup level.
