INITIAL INVESTIGATION FIELD REPORT

ERTS # <u>547010</u> County <u>King</u> Parcel # <u>3225059061</u> FS ID # 55481441

SITE INFORMATION				
Site Name (e.g., Co. name over door):	Site Address (including City and Zip+4):	Site Phone:		
Hilton Hotel	300 112 th Avenue SE	(425)455-1300		
	Bellevue, WA 98004			
Site Contact and Title (if any):	Site Contact Address (including City and Zip+4) if any:	Site Contact Phone:		
Harry Goren, PBS Environmental	2517 Eastlake Avenue East, Ste 100	(206)233-9639		
Ray, Hotel Facilities Engineer	Seattle, WA, 98102	FAX(206)762-4780		
Site Owner:	Site Owner Address (including City and Zip+4):	Site Owner Phone:		
PD Bellevue Associates LLC		() - () -		
Site Owner Contact (if any):	Site Owner Contact Address (including City and Zip+4) if any:	Owner Contact Phone: () - () -		
Previous/Additional Site Owner(s):	Previous/Additional Site Owner(s) Address (including City and Zip+4):	Phone: () - () -		
Alternate Site Names:	Comments:	Is property > 10 acres?		
Formerly Double Tree Hotel		Yes 🗌 🛛 No 🖾

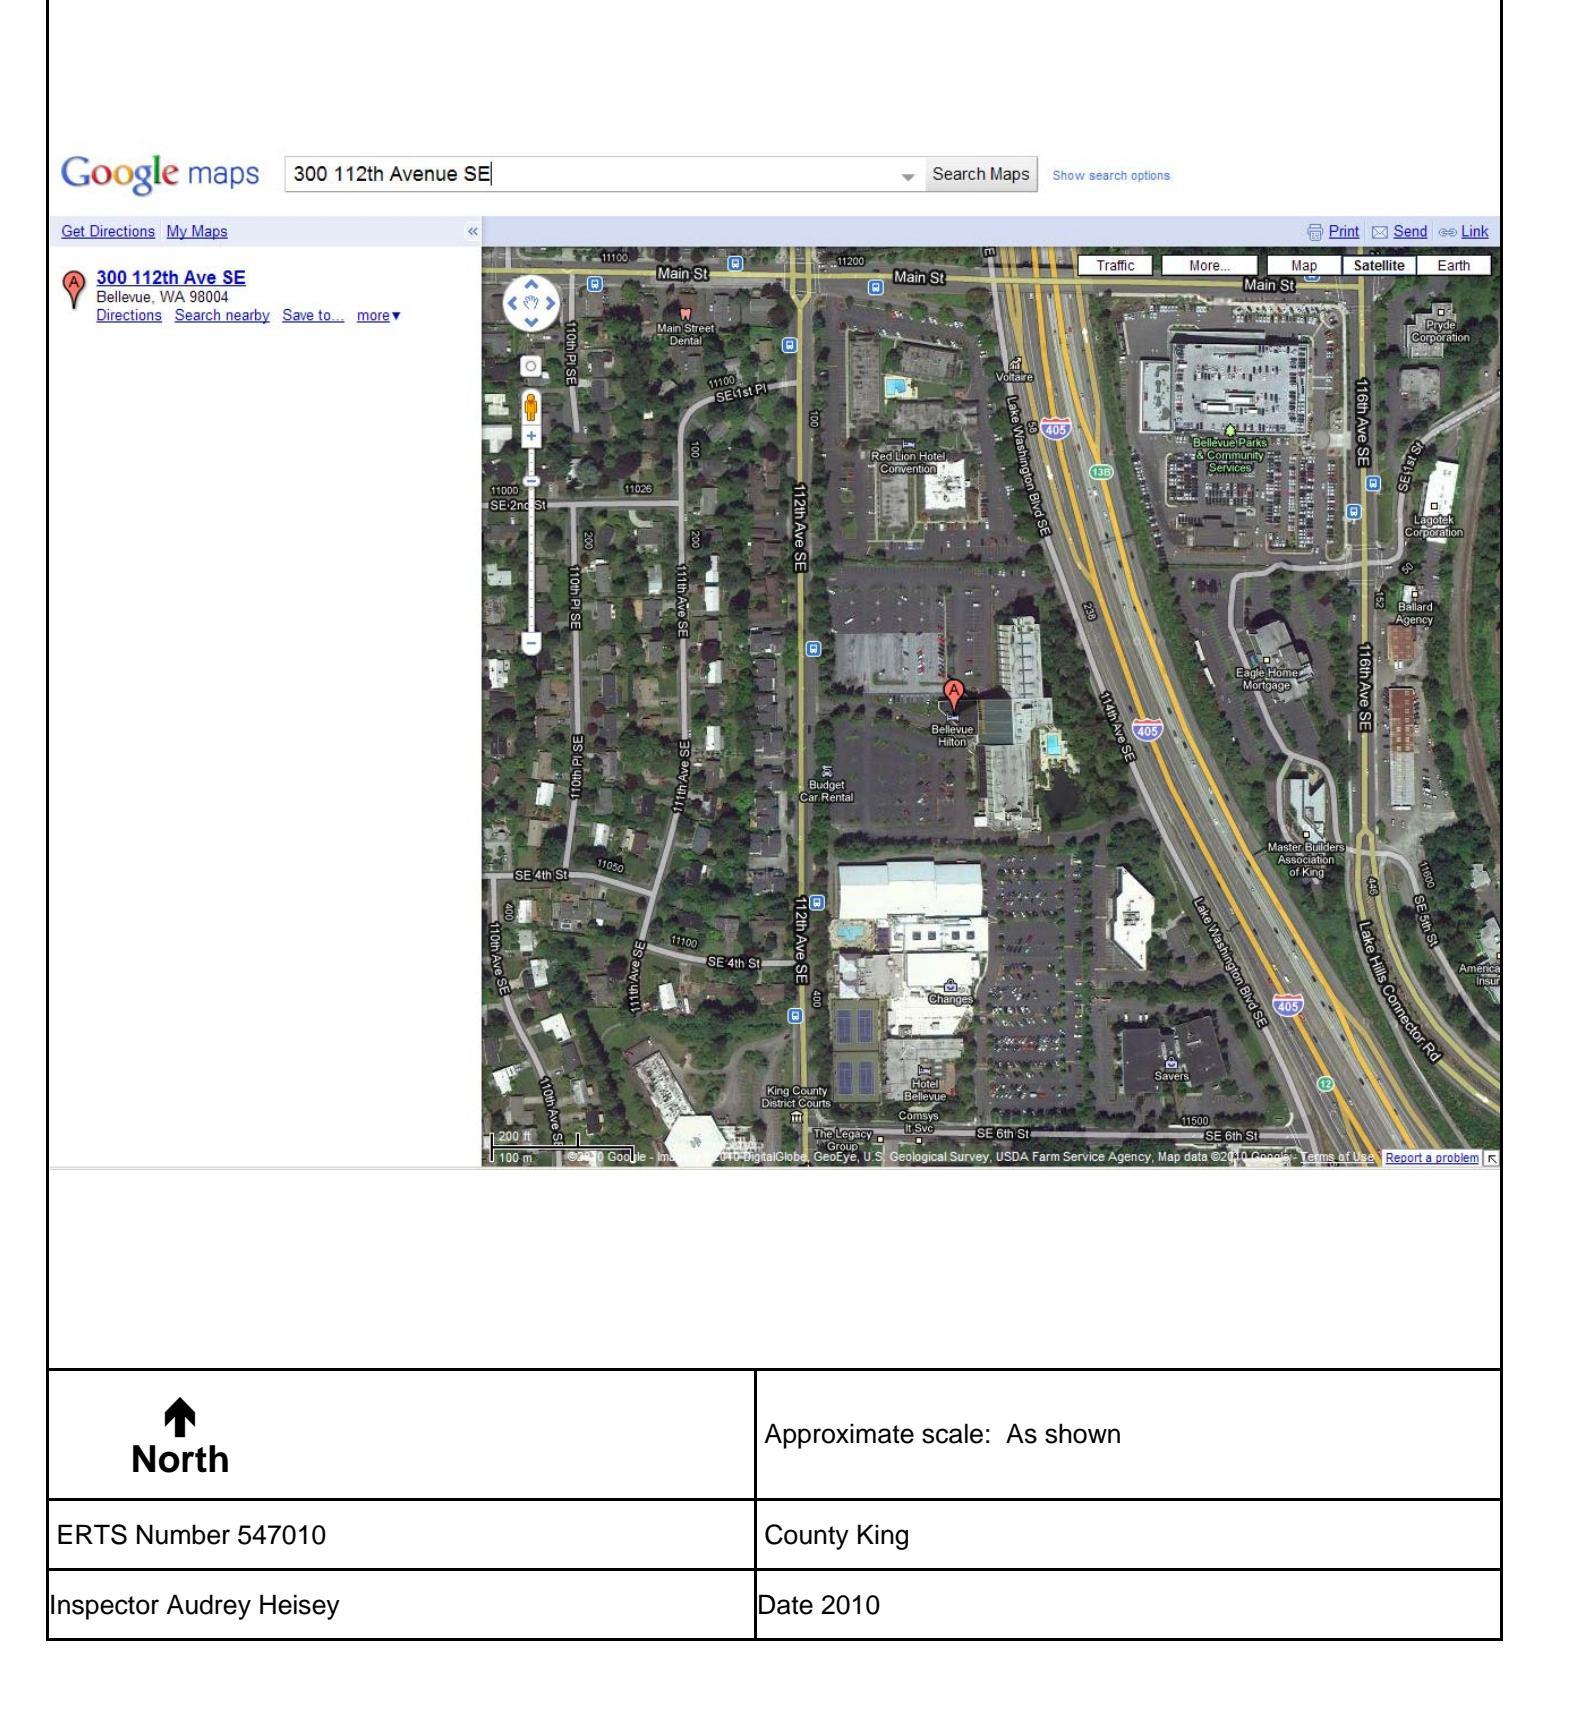
SITE MAP/DIAGRAM

Site Name: Red Lion Inn. See also maps included with consultant reports under Red Lion Bellevue LUST 418509 and assessors map included with this report.

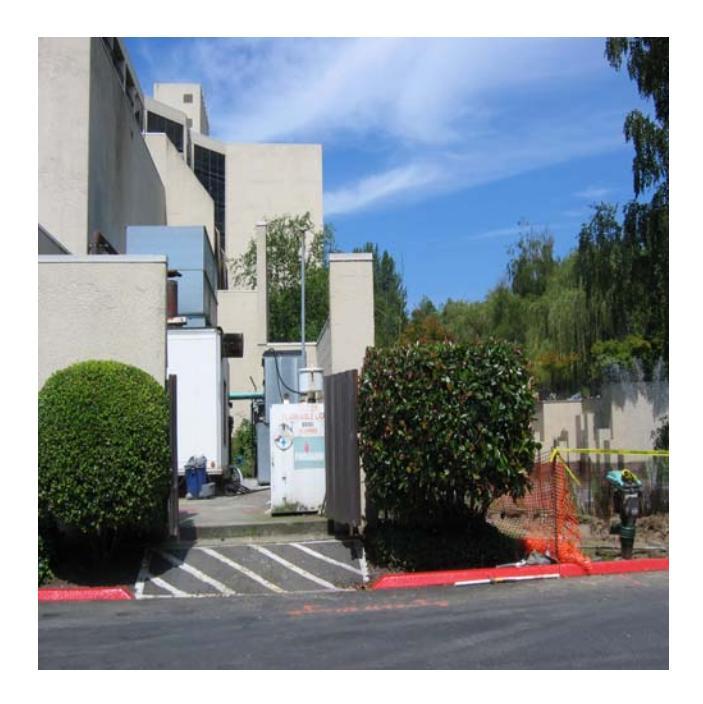
Looking north at the property from the southeast portion of the property toward the former EPG UST location. The former UST was located approximately below the AST shown at the right side of the enclosure.

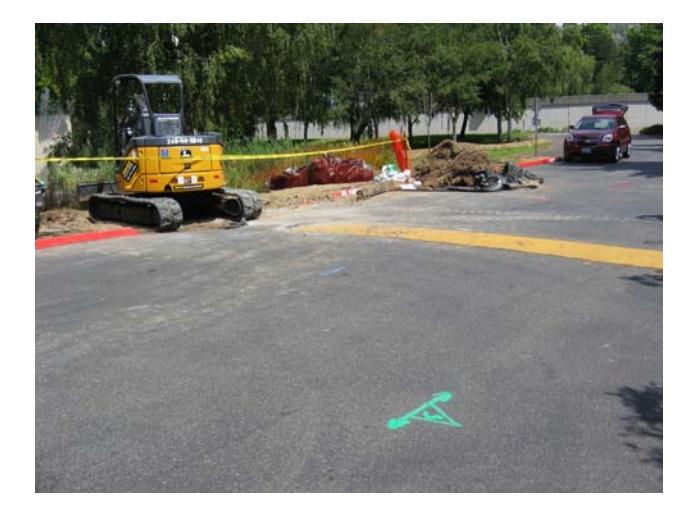
View looking east toward hotel green space. The HOT and heavy equipment used to remove the HOT are visible on the left side of the frame. The former UST enclosure is on the left (just outside the frame).

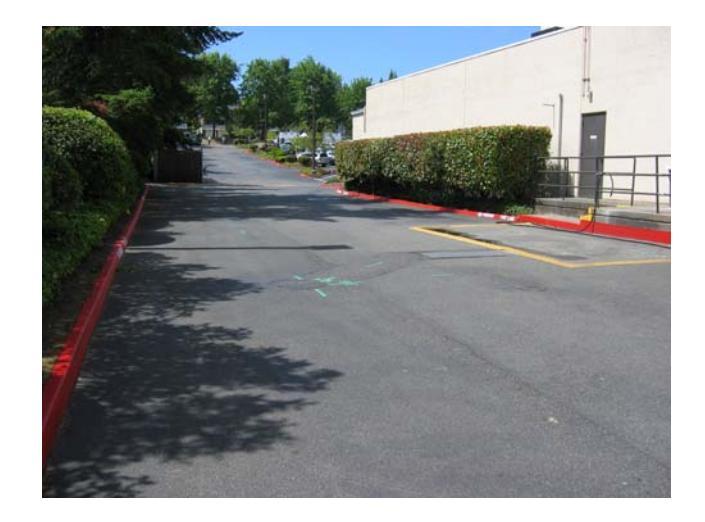
View looking west toward hotel parking lot. The former UST enclosure is on the right (just outside the frame).
