# GEOTECHNICAL REPORT PROPOSED OLYMPIA COMMONS 318 State Avenue Northeast Olympia, Washington

PROJECT NO. 15-135  
July 2015

Subject: Geotechnical Report  
Olympia Commons: 318 State Avenue Northeast, Olympia, Washington

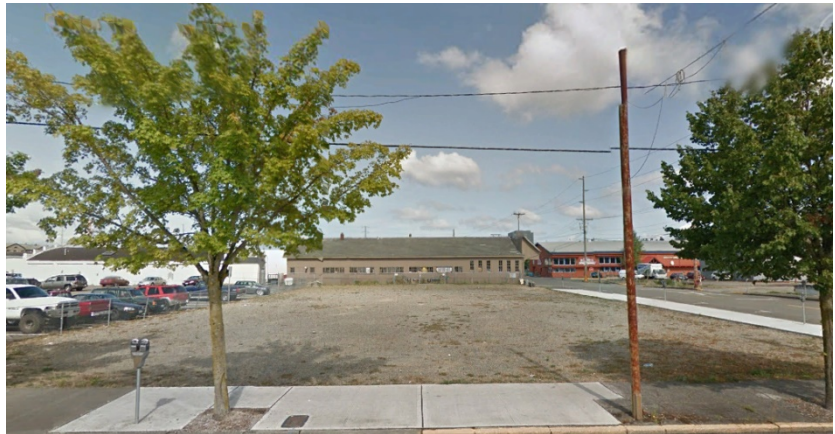
The site is currently undeveloped and is mostly surfaced with gravel with a sparse covering of grass. The site topography is relatively level, with less than two feet of elevation change across the length of the site. An overview of the general site conditions is shown on Plate 1, following page.

**Plate 1:** View from south to north providing overview the site conditions.

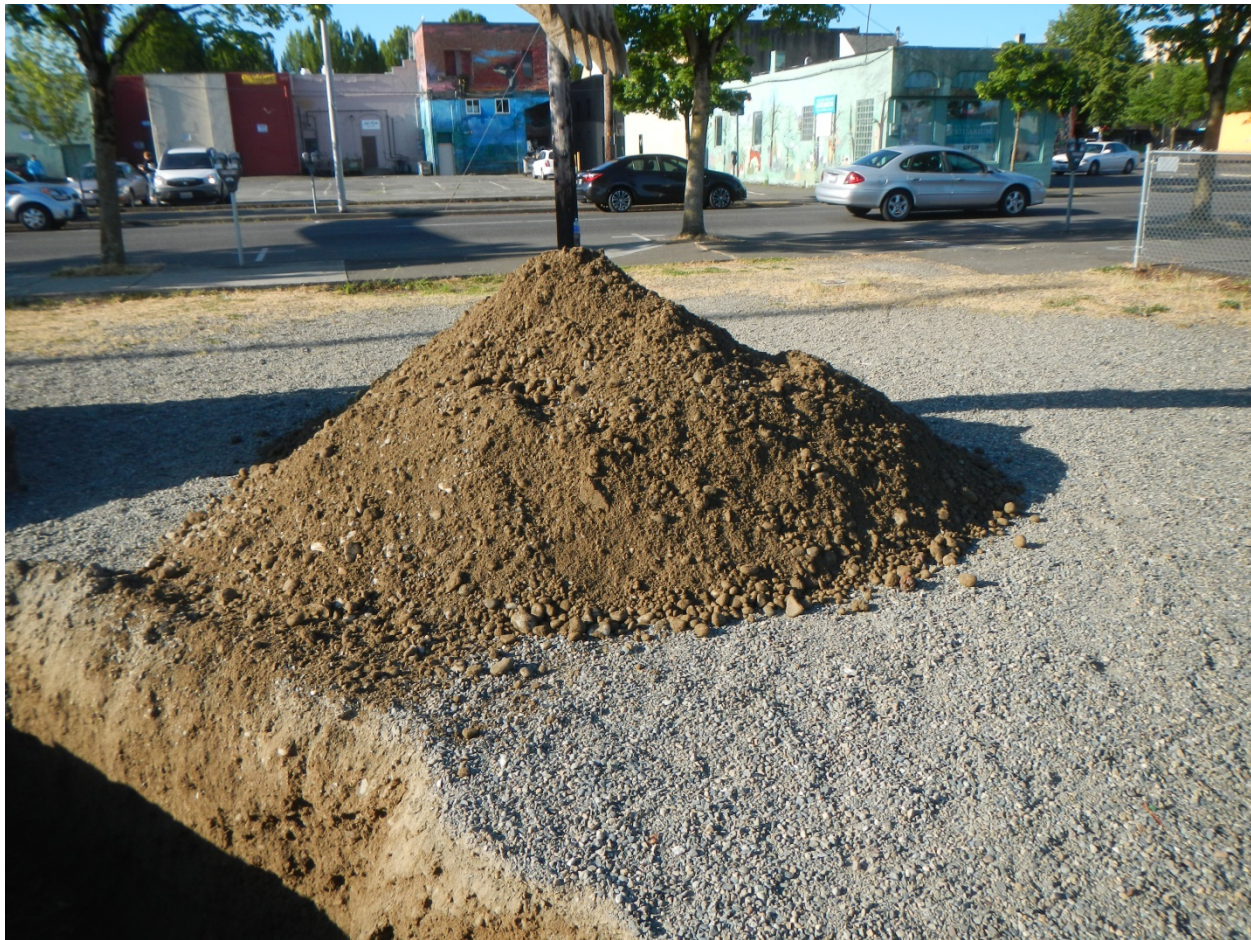
**Test Pit TP-1:** Spoils pile after completion of test pit excavation.

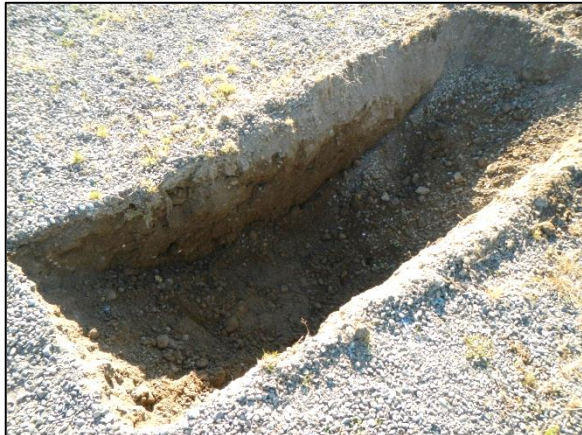
**Test Pit TP-2:** Test pit during excavation.

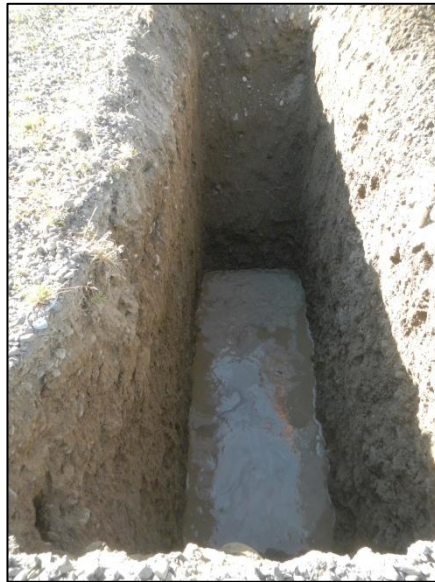
Heavy groundwater seepage was encountered in the quarry spall fill at the locations of Test Pits TP-2, TP-3 and TP-4 at about 7 feet below grade. The seepage rapidly filled our test pits up to

within about 6 feet below grade. No evidence of groundwater was observed in the other four test pits.

**Test Pit TP-2:** After excavation. Groundwater seepage filled the excavation to 6 feet below grade.

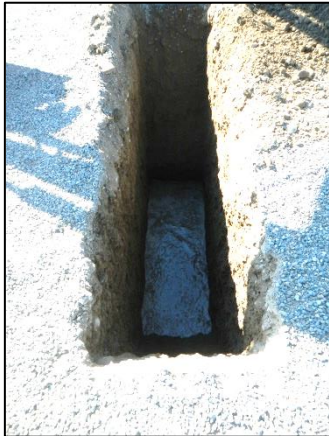
**Test Pit TP-3:** Groundwater in bottom of test pit after excavation.

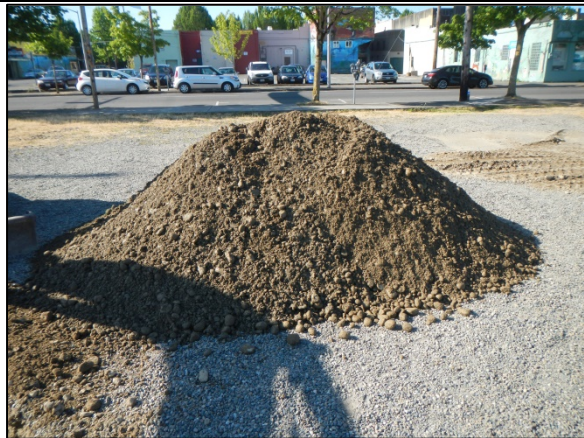
**Test Pit TP-3:** Spoils pile after completion of test pit.

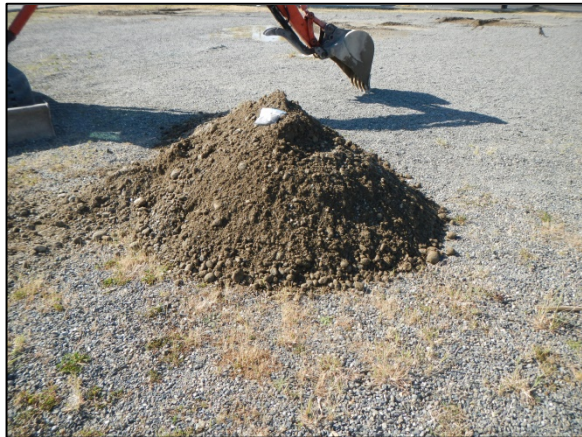
**Test Pit TP-4:** Spoils pile after completion of test pit.

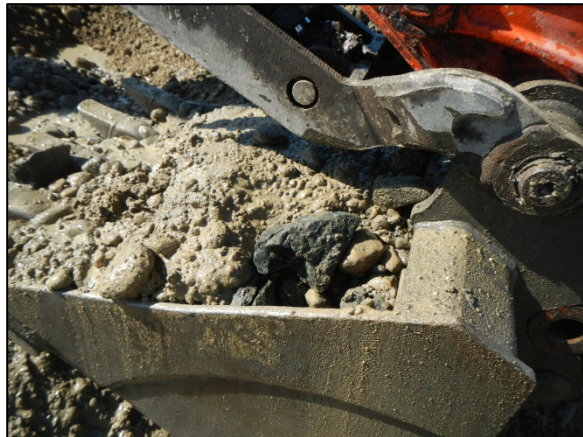
**Fill – Quarry Spalls:** Underlying the existing structural fill in TP-2 through TP-4, we encountered fill consisting of two to four inch quarry spalls. This material was encountered in close contact with the groundwater level at the time of our exploration and is likely backfill from the environmental remediation that was placed below the groundwater table. This was the deepest unit encountered in TP-2 through TP-4.

**Test Pit TP-4:** Soils in excavator bucket from bottom of test pit. Mixture of quarry spalls and gravel borrow fill.

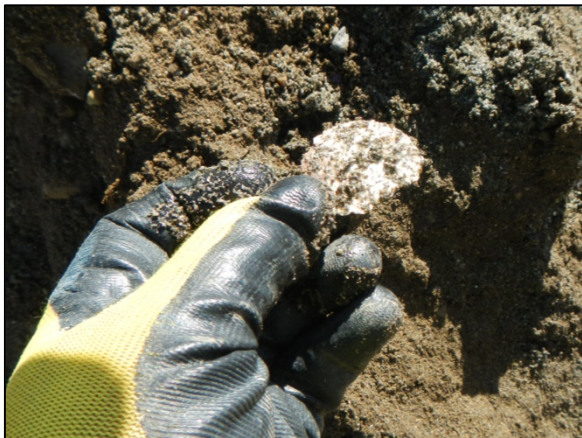
**Test Pit TP-5:** Shells encountered in Beach Deposits.

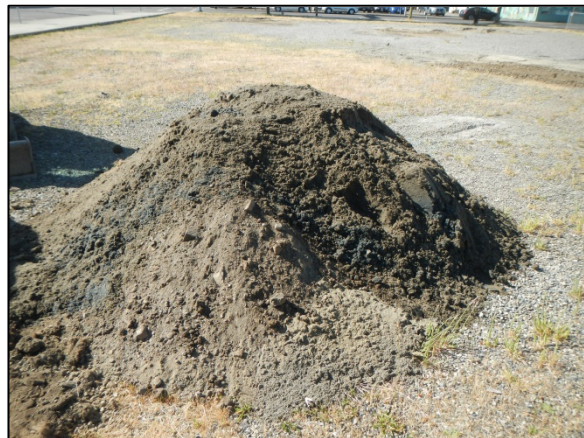
**Test Pit TP-5:** View of spoils pile after completion of test pit.

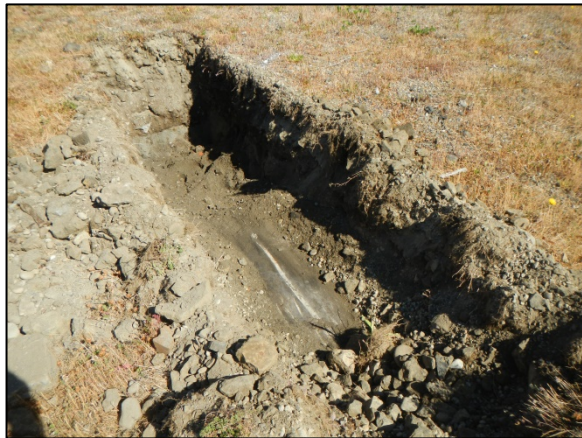
**Test Pit TP-6:** Top of intact concrete slab encountered at 1½ feet below grade. Test pit was moved 10 feet to the northwest.

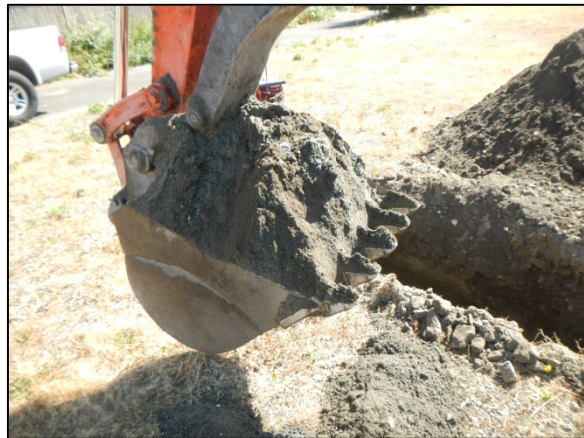
**Test Pit TP-6:** View of Beach Deposit soils from test pit excavation.

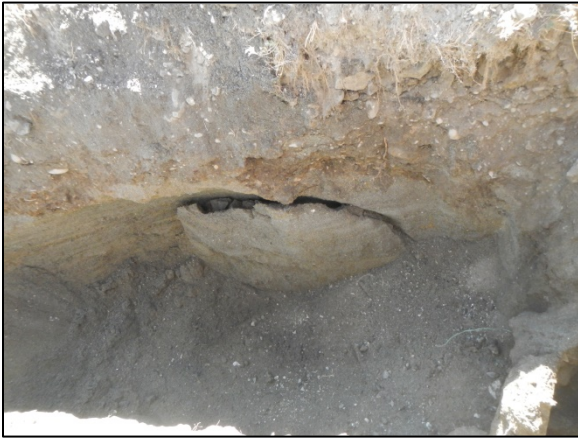
We encountered common fill at the locations of Test Pits TP-5, TP-6, and TP-7. The fill contained debris, including wood, concrete, glass, brick and asphalt rubble. The fill is not suitable for support of structural loads and is not suitable for use as structural fill. Due to the loose condition of the fill and the presence of organic and inorganic debris, the fill should be

**Test Pit TP-7:** View of sidewall of completed test pit. Upper portion of photo is fill. Lower portion is beach deposits.

overexcavated from structural areas and exported from the site or wasted in non-structural areas. The overexcavations should be backfilled with structural fill.
